Dominion Energy Kewaunee, Inc.
N490 Hwy 42, Kewaunee, WI 54216
Web Address: www.dom.com

DOMINION ENERGY KEWAUNEE, INC.
KEWAUNEE POWER STATION
RESPONSE TO REQUEST FOR ADDITIONAL INFORMATION FOR THE REVIEW
OF THE KEWAUNEE POWER STATION LICENSE RENEWAL APPLICATION -
AGING MANAGEMENT PROGRAMS

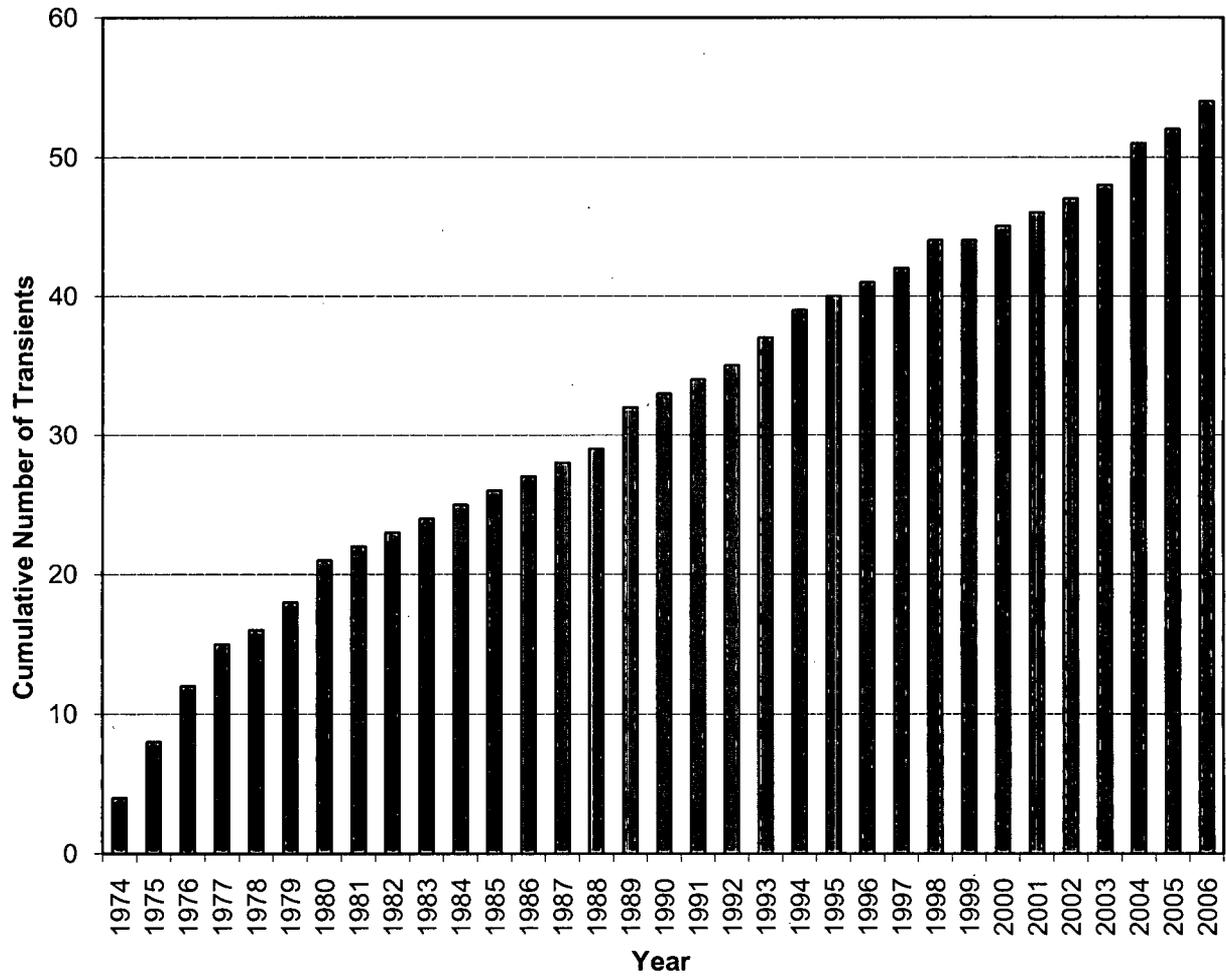
Heat-up

Histograms of cycles accrued for plant heatup and plant cooldown transients are shown on the following pages.
