ATTACHMENT I
PROPOSED TECHNICAL SPECIFICATIONS CHANGES
RELATED TO
STEAM GENERATOR TUBE PLUGGING LIMIT

NEW YORK POWER AUTHORITY
INDIAN POINT 3 NUCLEAR POWER PLANT
DOCKET NO. 50-286

4.9 STEAM GENERATOR TUBE INSERVICE SURVEILLANCE

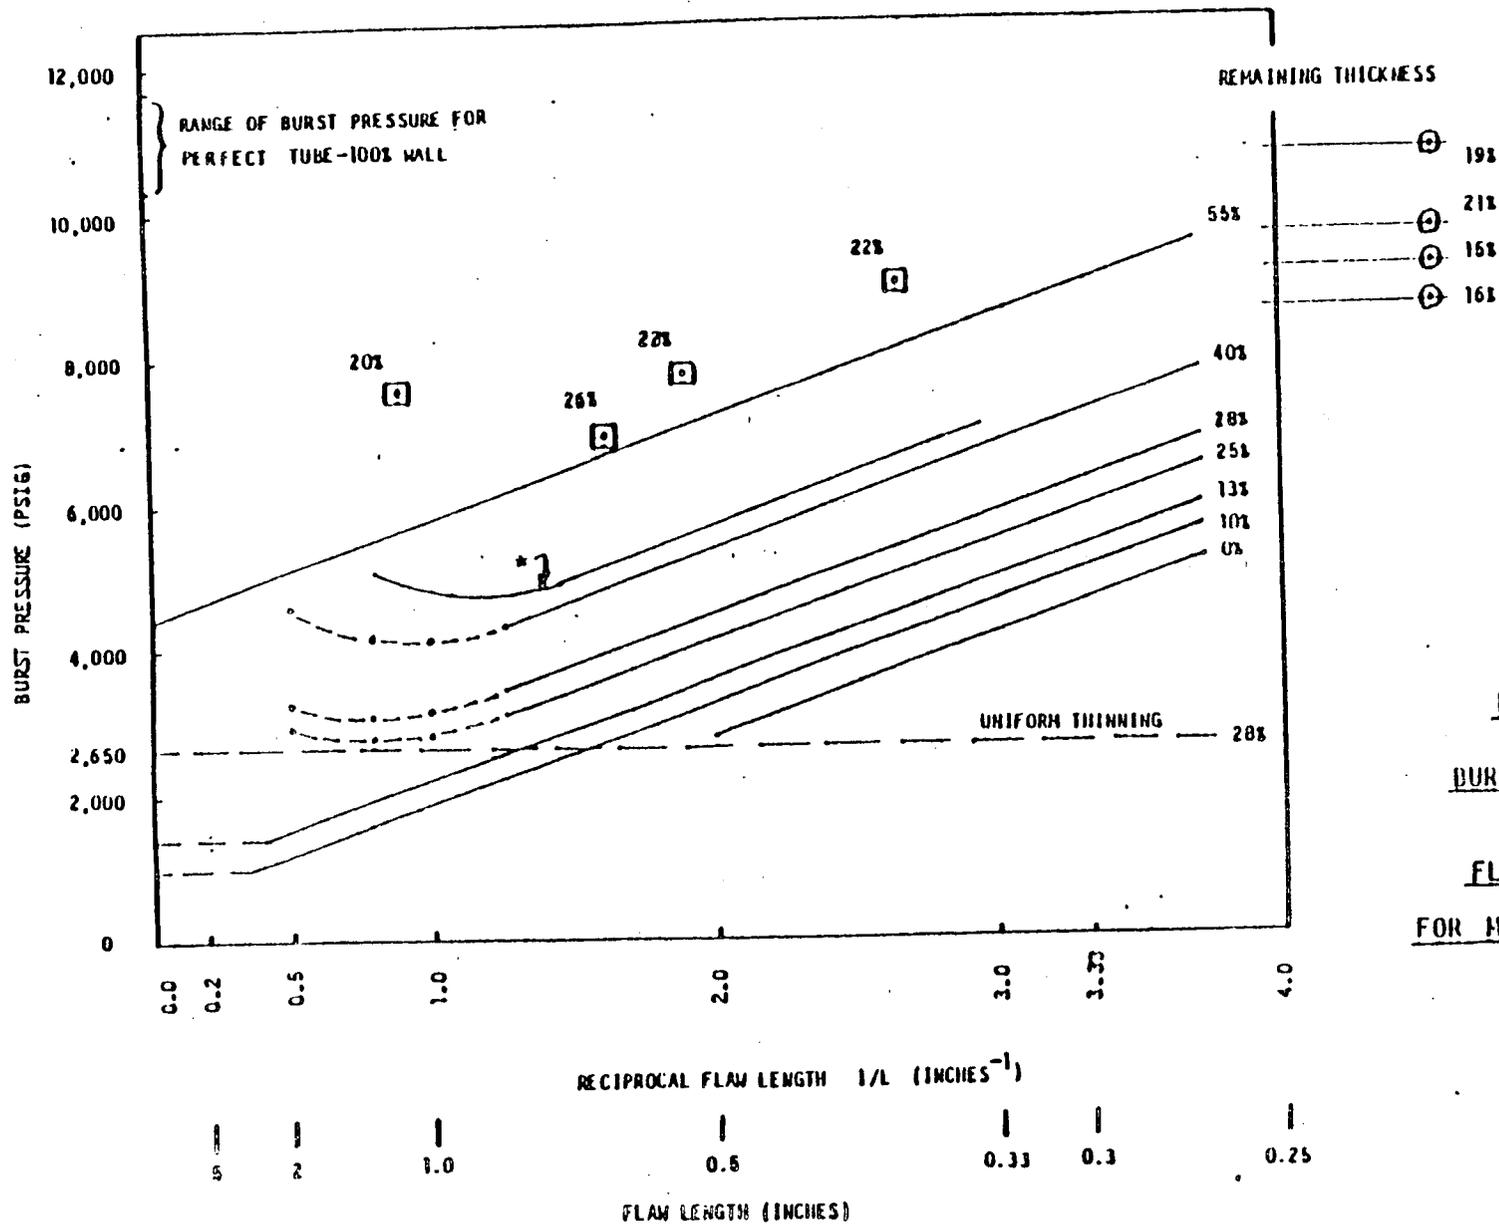
- NOTES: 1. BROKEN LINES (---) INDICATE CORRECTION TO ACCOUNT FOR SEGMENTED FLAWS
2. ROOM TEMPERATURE DATA - \odot SINGLE PIT DATA ($1/L \geq 0$); \square MULTIPLE PIT DATA
3. ASTERISK (*) - INDICATES 20% REMAINING THICKNESS SIMULATED PITS (DATA CORRECTED TO 600°F)

- The acceptable burst test results for machined flat type defects which conservatively simulate tubes with pits.
 - The fact that the acceptance criteria of no leak with a ΔP of 2650 psi is very conservative since this condition would only arise in the unlikely event of a main steam line break during the remainder of Cycle 4, for which this Technical Specification will apply.

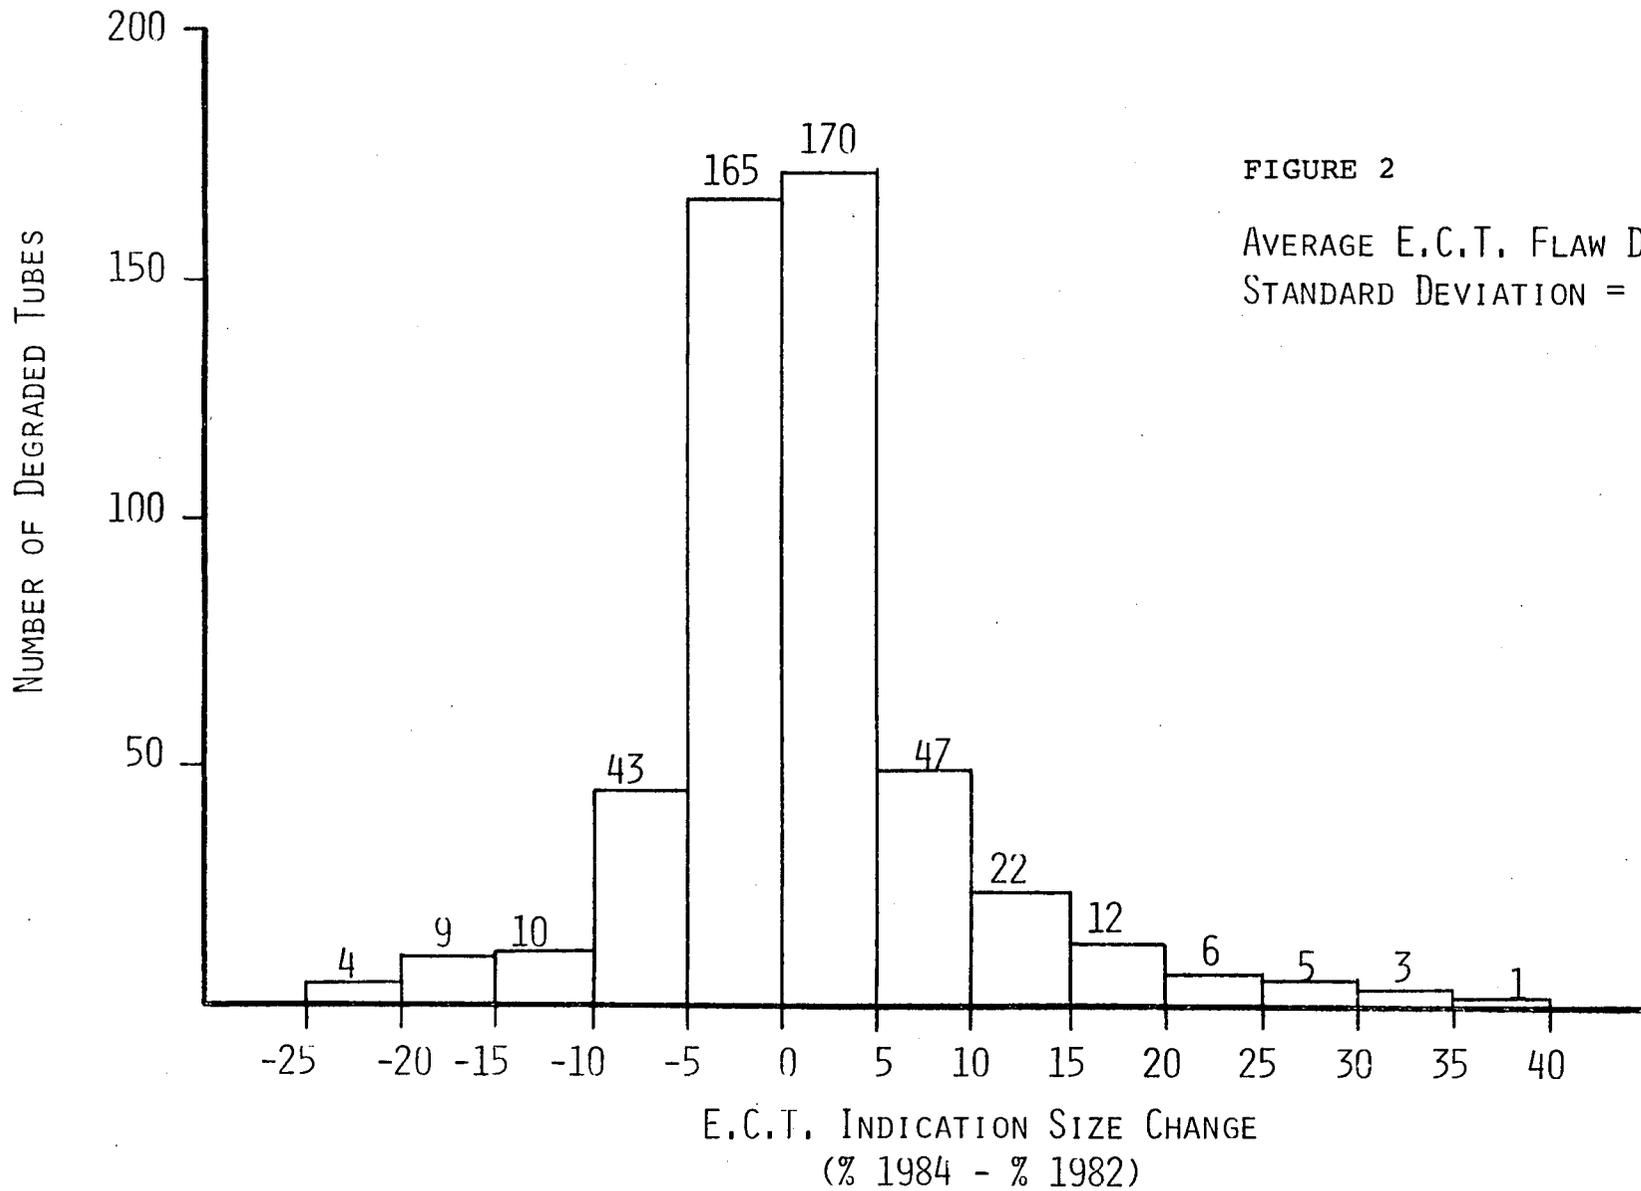
FIGURE 2

INDIAN POINT 3
1982/1984 INDICATION GROWTH DISTRIBUTION
(SAMPLE PROGRAM)

AVERAGE E.C.T. FLAW DELTA = 1.5%
STANDARD DEVIATION = 9.1%

for the remainder of Cycle 4, based on the 1984 midcycle (Cycle 4) outage results for 511 tube cold leg sample of 2 generators. These results indicate an average increase in defect size of less than 2% over a 9 month operating period, as shown in the attached Figure 2. As noted in Figure 2, the actual average flaw growth rate for 9 months is 1.5% with a standard deviation of 9.1%.
