Docket No. 50-323, OL-DPR-82
Diablo Canyon Unit 2
Licensee Event Report 2-2009-003-00
Containment Sump Recirculation Valve Position Interlock Failure
Due to Inadequate Testing

LICENSEE EVENT REPORT (LER)

4. TITLE
Containment Sump Recirculation Valve Position Interlock Failure Due to Inadequate Testing

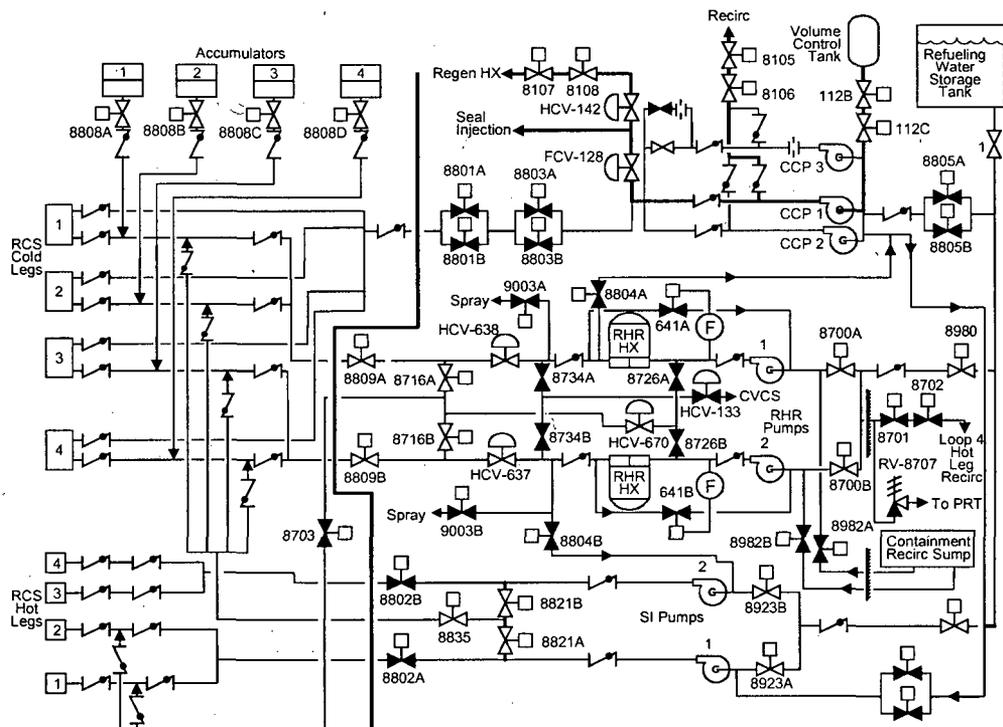
The Emergency Core Cooling System (ECCS)[BQ] is depicted below.

Emergency Core Cooling System (ECCS) Flow Paths

The ECCS is designed to cool the reactor core as well as provide additional reactor shutdown capability by injection of borated water following initiation of accident conditions for:

The residual heat removal (RHR)[BP] function, including the long term recirculation from the containment sump, was not adversely affected by this condition. Also, containment spray [BE], high head [BQ] and intermediate head [BP] safety injection from the refueling water storage tank (RWST) was not adversely affected by this condition.

However, in the event of a Loss of Coolant Accident, (LOCA) this condition would have prevented RHR flow from reaching containment spray, high head and intermediate head safety injection pumps following realignment to long term recirculation from the containment sump without additional operator action. The realignment to the long term recirculation is required to provide continued core cooling after the RWST is exhausted.
