Subject: MHI's Response to US-APWR DCD RAI No. 504-4028 REVISION 2

References: 1) "Request for Additional Information No. 504-4028 REVISION 2, SRP Section: 09.05.06 - Emergency Diesel Engine Starting System, Application Section: 9.5.6," dated December, 1, 2009

1. Responses to Request for Additional Information No. 504-4028 REVISION 2

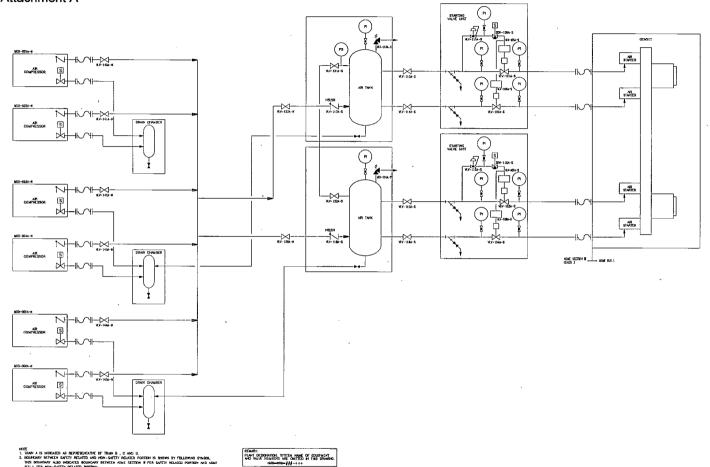
Figure 9.5.6-1 Gas Turbine Generator Starting System Schematic Diagram

Attachment A

Since these valves are aligned manually and since no power operated valves are shown in the compressor discharge piping on Revision 2 of DCD Figure 9.5.6-1, presumably the valves are manual valves that are normally open. If this is the case, the phrase "and these valves normally open..." should be revised to say "and these valves <u>are</u> normally open". The current phrasing implies that the valves are normally closed and will open to supply air to either air receiver.

The revised Figure 9.5.6-1 shows an ASME Section III/ASME B31.1 boundary at the piping inlet to the GT skid. The figure should also show the ASME Section III boundary at the air receiver inlet check valve. This boundary is shown as NS/SR. Note also that this symbol does not agree with the corresponding note on this figure - the note identifies the abbreviation as SR/NR, not NS/SR.

NOTE 2 in Figure 9.5.6-1 will be revised as follows:

Based on above, Figure 9.5.6-1 will be revised as shown in Attachment A.
