RAI Volume 2, Chapter 2.1.1.1, First Set, Number 2, Supplemental Question 1:

Clarify the apparent inconsistencies among the three documents: (1) the probable maximum flood inundation map provided as Figure 2 in the response to RAI 2.2.1.1.7-3-001; (2) the geologic repository operations area (GROA) North Portal site plan provided in the response to RAI 2.2.1.1.3-3-006; and (3) the GROA Aging Pad site plan provided as Figure 3 in the supplemental response to RAI 2.2.1.1.1-002.

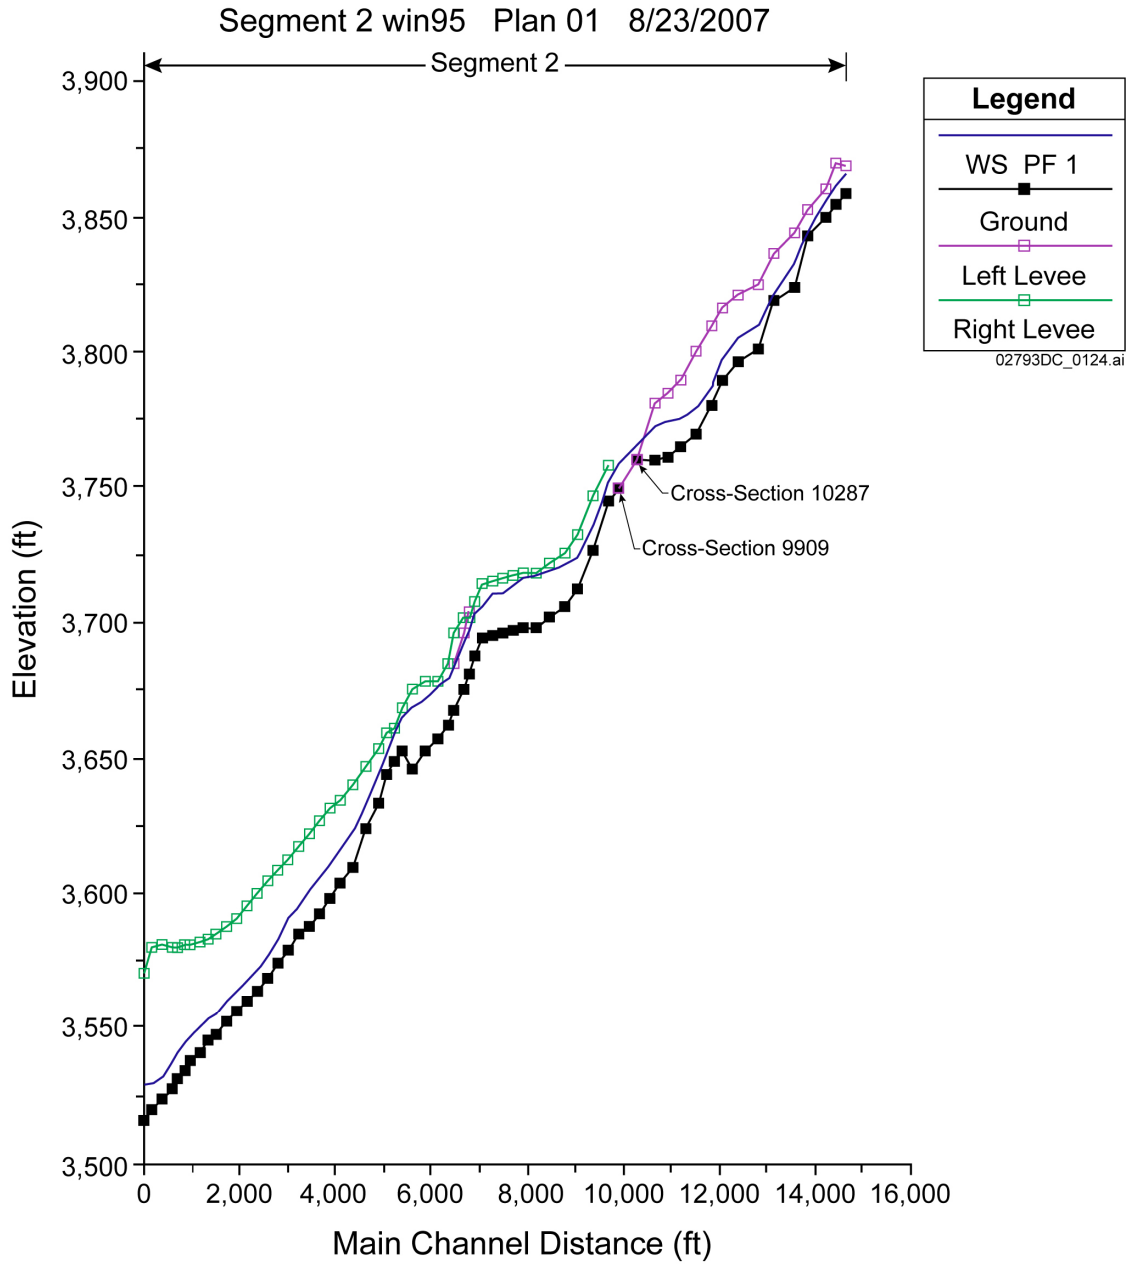
Figure 1. Water Surface Profile of Probable Maximum Flood for Segment 2

Clarification of the treatment of these openings in the dike system is provided by the following description of how the flow was modeled in channel segment 2 on the probable maximum flood inundation map and how it relates to the two site plans (BSC 2008a; 2008b).

On the probable maximum flood inundation map, channel segment 2 starts just north of the aging pads and follows the dike system along the west side of the Aging Facility (labeled Dike System West on *Geologic Repository Operations Area Aging Pad Site Plan* (BSC 2008a)). At the southwest corner of the Aging Facility, guided by topography and elevation changes, channel segment 2 turns east and passes through the opening in the dike system. Although the probable maximum flood inundation map shows this dike as continuous through this area, as explained in Section 1.1.1, the dike at this location is modeled as being at ground elevation. The space between dike segments is correctly shown on the *Geologic Repository Operations Area Aging Pad Site Plan* (BSC 2008a). Channel segment 2 then models the flow of water east between the Aging Facility and the North Portal facilities along the northern side of the dike system that protects the North Portal area and facilities (labeled Dike System South on the *Geologic Repository Operations Area Aging Pad Site Plan* (BSC 2008a)). At the southeast corner of the Aging Facility, channel segment 2 turns southeast, passes through the space between the eastern part of the Aging Facility dike system (labeled Dike System East on *Geologic Repository Operations Area Aging Pad Site Plan* (BSC 2008a)) and the northern part of the North Portal dike system (labeled North Portal Loop East on *Geologic Repository Operations Area North Portal Site Plan* (BSC 2008b)), and drains into the open terrain (labeled “floodway,” as shown on *Geologic Repository Operations Area North Portal Site Plan* (BSC 2008b)). This space between the two dike systems is shown on both of the site plans and on the probable maximum flood inundation map. Channel segment 2 is modeled as generally following the North Portal

The dike associated with channel segment 2 upstream of cross-section point 10642 is provided to protect the Aging Facility and is located to the east of the channel, placing it on the left side of the channel looking downstream. The dike associated with channel segment 2 downstream of cross-section point 9676 is provided to protect the North Portal facilities and is, therefore, located to the south of the channel, placing it on the right side of the channel looking downstream. Although no dike is physically required between those two points, the dike is modeled between cross-section points 10642 and 9676 in the *Yucca Mountain Project Drainage Report and Analysis* (BSC 2007) as being at ground elevation. Figure 1 is a color version of page 4 of Attachment D of *Yucca Mountain Project Drainage Report and Analysis* (BSC 2007). This figure includes an annotation identifying cross-section points 10287 and 9909 (which are between the endpoints of the dike system represented by cross-section points 10642 and 9676). Figure 1 shows that cross-section points 10287 and 9909 of channel segment 2 are modeled with the elevation of the dikes (labeled as “Left Levee” and “Right Levee” on Figure 1) as being at the ground surface (i.e., the purple open squares representing the left levee enclose the black solid squares representing the ground). For this reason, the dike is shown as being continuous on the probable maximum flood inundation map even though there is no physical structure between cross-section points 10642 and 9676.
