Perspectives and Insights from ACRS Review of Staff's Safety Evaluations of License Renewal Applications

Prepared By
Hossein P. Nourbakhsh
Senior Technical Advisor
Office of Advisory Committee on Reactor Safeguards

January 2010

Advisory Committee on Reactor Safeguards
U.S. Nuclear Regulatory Commission
Washington, DC 20555-0001

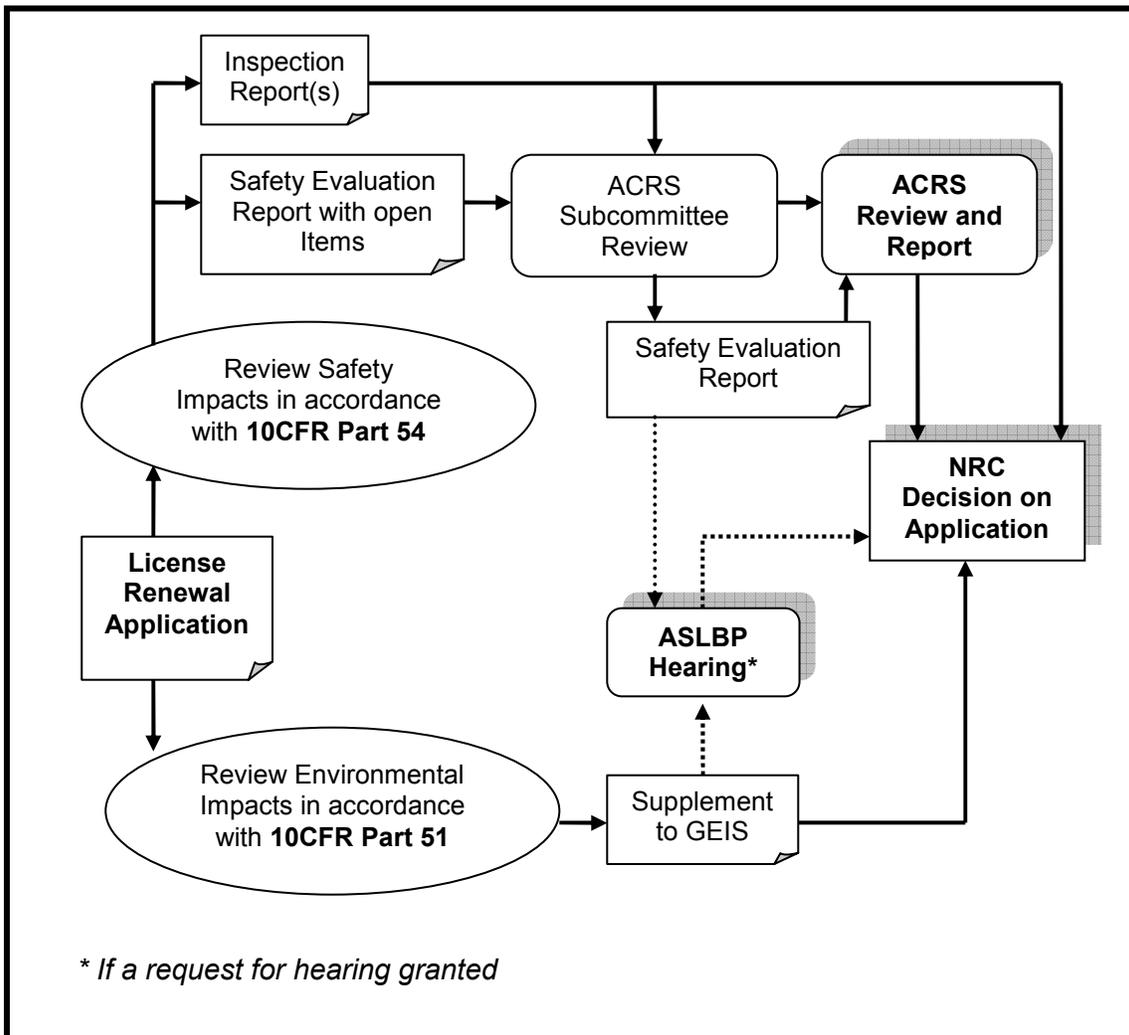
Figure 1 The License Renewal Review Process

The license renewal review process proceeds along two parallel paths: One is a safety review, which evaluates whether the plant can continue to operate safely during the period of extended operation. The other is an environmental review, which evaluates the interaction between the plant and the surrounding environment. Figure 1 illustrates the safety and environmental review process and the interrelationships among various review activities. According to 10 CFR 54.25, the safety evaluation aspect of each license renewal application is referred to the ACRS for a review and report. An ACRS review is essential, given the potential safety implications of extending power operation of a significant number of plants for 20 years beyond their current licensed terms.

The NRC Office of Nuclear Reactor Regulation (NRR) reviews the license renewal application and supporting documentation. The review results in a safety evaluation report. NRC also perform license renewal inspections to sample the process used by the utility to identify the structures and components requiring review and to verify that aging management is being implemented consistent with the application and the staff's safety evaluation report.
