Subject: UniStar Nuclear Energy, NRC Docket No. 52-016
Response to Request for Additional Information for the
Calvert Cliffs Nuclear Power Plant, Unit 3,
RAI No. 127, Circulating Water System

Figure 10.4-3 - {Circulating Water System Makeup System P&ID}

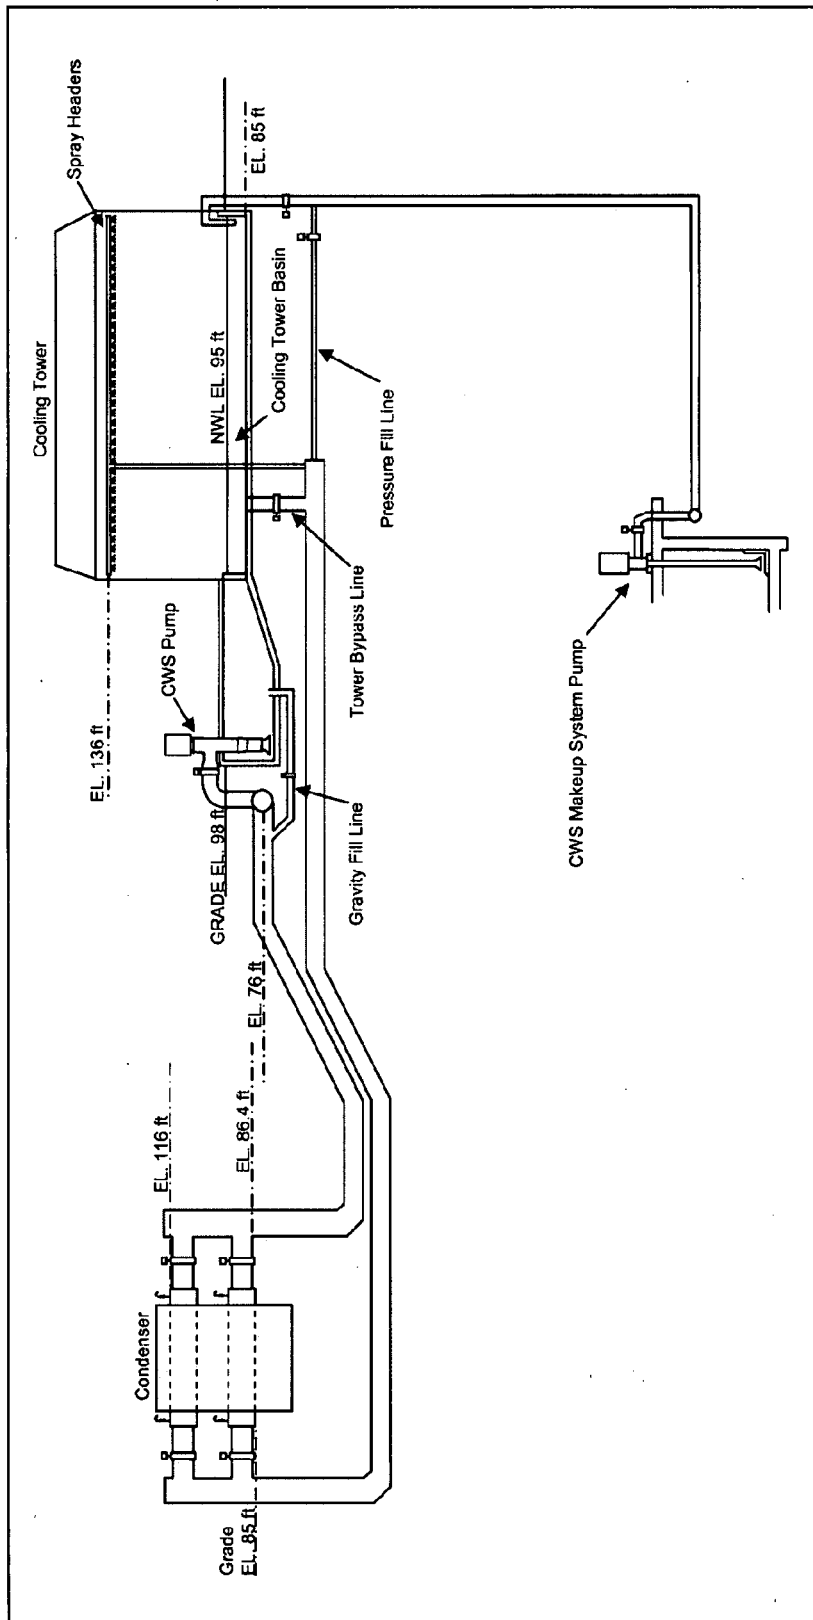
Figure 1 – Sketch of the CWS Section View (Not to Scale)

The CWS is filled and vented using gravity fill from the circulating water pump forebay and using the pressure fill line with the CWS makeup water system pumps (see Figure 1 below). First, the gravity fill line will be used to prime the Closed Cooling Water System (CLCWS) heat exchangers and fill a substantial portion of the condenser. During this operation, the circulating water makeup pumps provide water from the Chesapeake Bay directly to the cooling tower basin. Next, the pressure fill-line from the CWS makeup system will fill the remainder of the condenser and the rest of the CWS piping. The system is fully primed when fill water exits the condenser waterbox and CLCWS heat exchanger vent valves, and the cooling tower spray nozzles.

During normal system operation, either through the tower spray headers or the tower bypass line, the condenser and heat exchangers are under positive pressure. Therefore no vacuum priming system is required.
