3.10.5 Rod Misalignment Limitations

ATTACHMENT TO IPN-99-082  
SAFETY EVALUATION FROM SUBMITTAL IPN-99-015

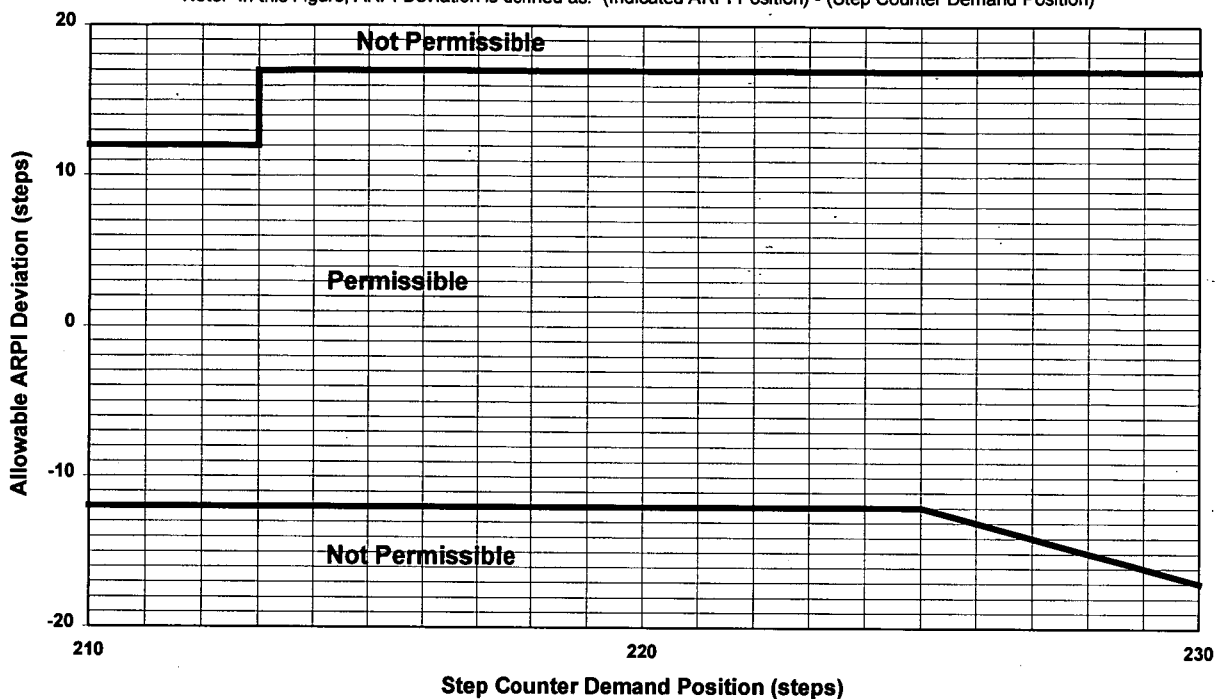
**Permissible Rod Misalignment vs. Step Counter Demand Position, > 85% of Rated Thermal Power**

Note: In this Figure, ARPI Deviation is defined as: (Indicated ARPI Position) - (Step Counter Demand Position)

Step Counter Demand Position	Maximum Deviation (ARPIs Reading ABOVE Step Counter Demand Pos)	Maximum Deviation (ARPIs Reading BELOW Step Counter Demand Pos)
≤ 212	12	-12
213	17	-12
214 - 225	17	-12
226	17	-13
227	17	-14
228	17	-15
229	17	-16
≥ 230	17	-17

WCAP-14668 Section 3 identifies the effects of indicated rod misalignments greater than  $\pm 12$  steps on the normal operation peaking factors. Section 4 of WCAP-14668 identifies the effects on the safety analyses. In summary, the increase in rod misalignment does not significantly affect the following: moderator or Doppler reactivity coefficients or defects, reactor kinetics data, boron worth or data generated for evaluation of boron dilution or boron system duty. Condition II transients, (rod out of position, dropped rod and single rod withdrawal) assume either all rods out (ARO) or rods at the insertion limit (RIL) as initial conditions. Since the precondition operation with the increased rod misalignment results in an  $F_{\Delta H}$  increase of less than 2.0%, the transient  $F_{\Delta H}$  increase due to the misalignment is
