U.S. NUCLEAR REGULATORY COMMISSION

Report No. 96-10

Facility: Indian Point 3 Nuclear Power Plant

Indian Point 3 Nuclear Power Plant NRC Inspection Report No. 50-286/96-10

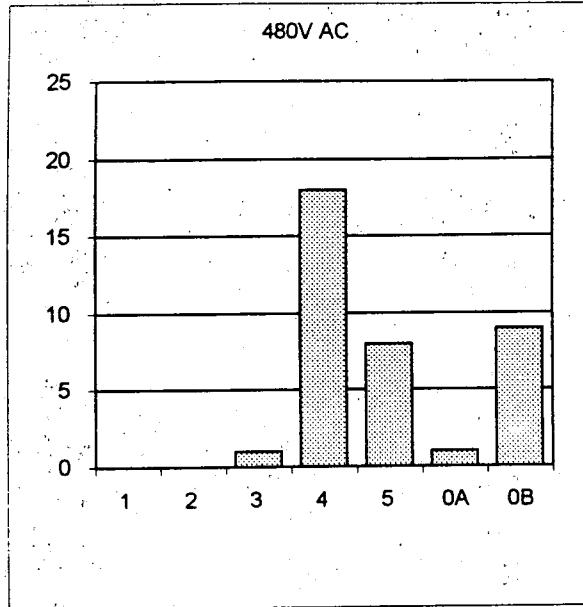
RISK SIGNIFICANT / SAFETY RELATED

WRs/PIDs by PRIORITY

BY PLANT SYSTEM CONTRIBUTION TO SAFETY

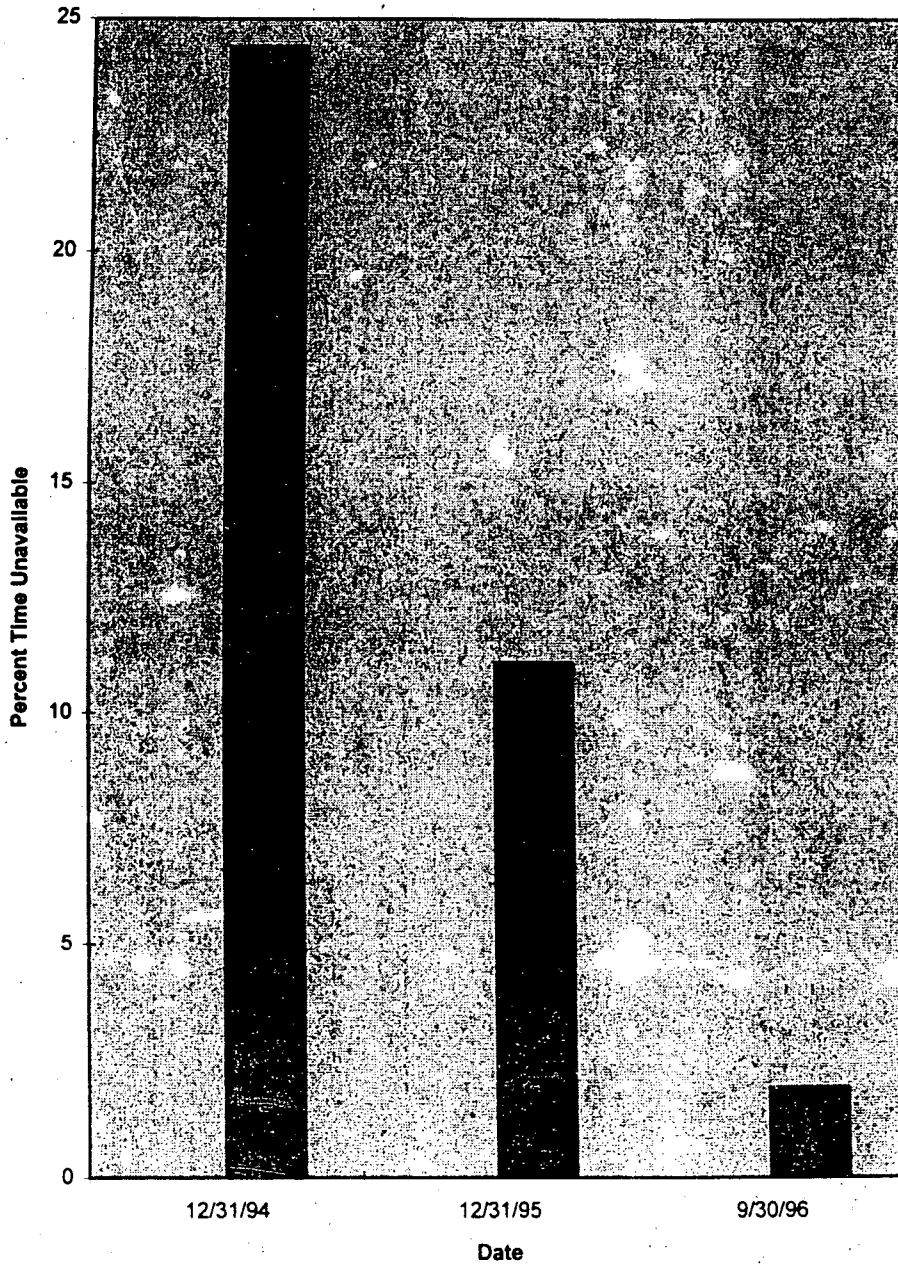
RMS Unavailability

RMS Availability Tracking

Date	Average Percent of Unavailability				
12/31/94	24.4				
12/31/95	11.1				
9/30/96	1.897
