NEI Steam Generator Task Force

Industry Update for NRC

February 25th, 2010

Survey results for -2 sigma 600TT tubes with cracks

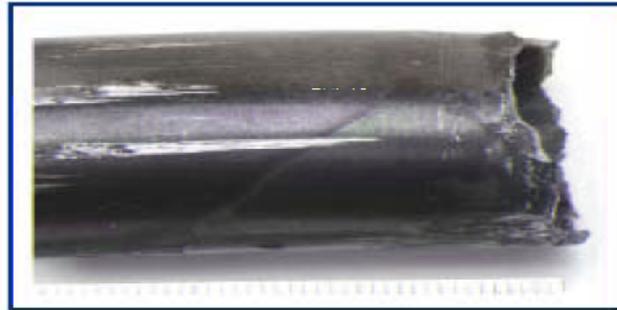
Operating Experience on 600-MA SG tubes

- ▶ The metallurgical examination of the fractured part at TSP1 of the BUG3 tube shows a multidirectional damage on the secondary side including a combination of IGA and IGSCC :
 - structural integrity analysis performed on the broken part of the tube shows significant margin against burst under design-basis accidental conditions
 - EC performed indicates that SG n°1 of BUG3 has an atypic behaviour
- ▶ Complementary examination on SG's are still ongoing, including :
 - met. exams on other pulled tubes
 - data analysis on different ECT exams
