From: Arora, Surinder
Sent: Thursday, February 04, 2010 4:21 PM
To: Wilson, Joshua; Segala, John
Cc: CCNPP3COL Resource; Hearn, Peter; Colaccino, Joseph
Subject: FW: RAI 127 Response
Attachments: CC3 RAI 127 Response.pdf

Subpart (b): Potential Flooding due to CWS Pipe Failure in the Yard

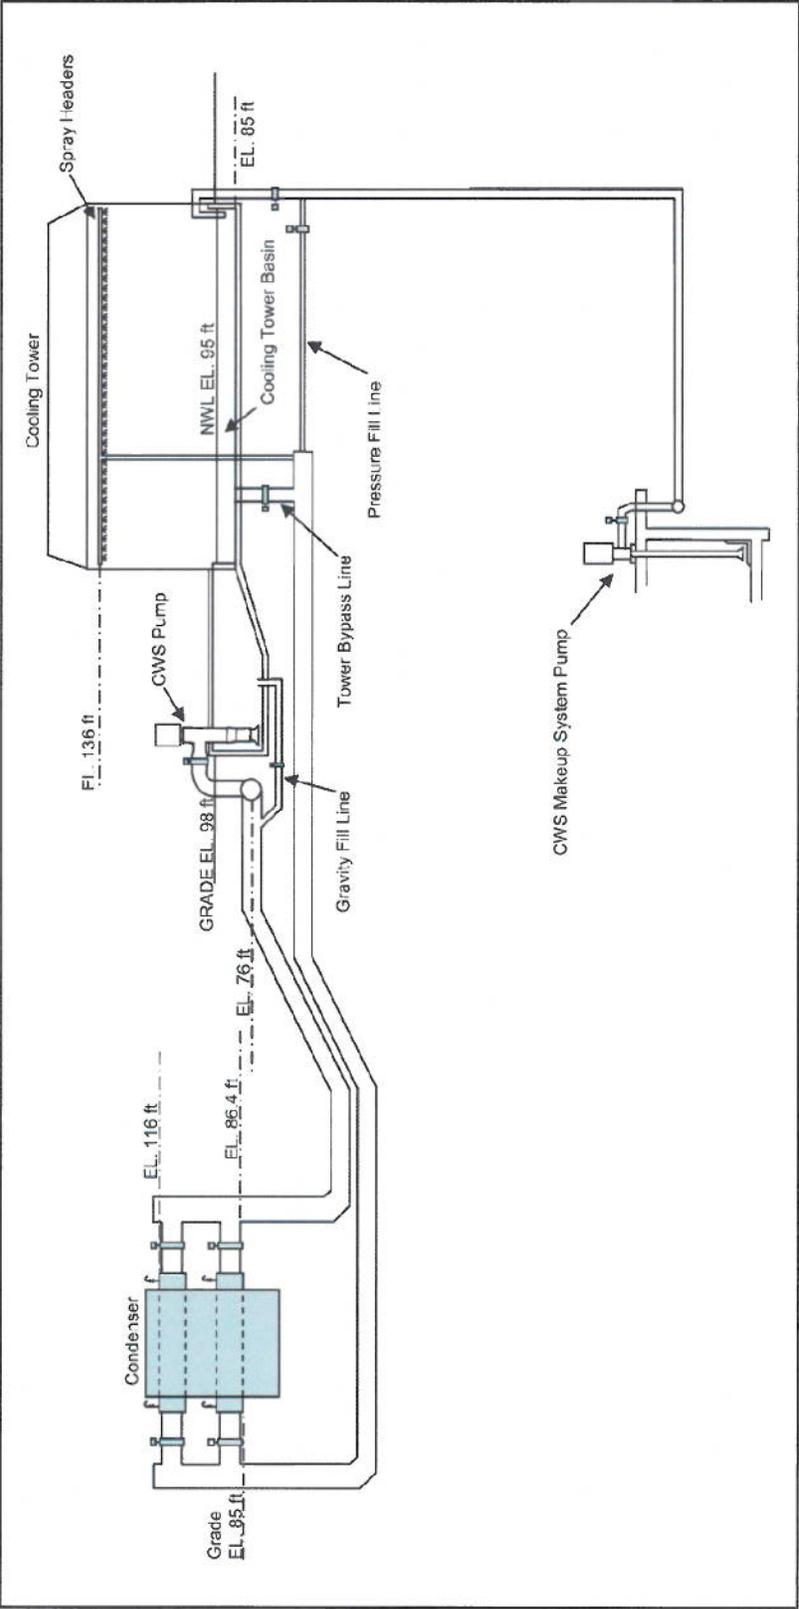
Figure 1 – Sketch of the CWS Section View (Not to Scale)

The CWS is filled and vented using gravity fill from the circulating water pump forebay and using the pressure fill line with the CWS makeup water system pumps (see Figure 1 below). First, the gravity fill line will be used to prime the Closed Cooling Water System (CLCWS) heat exchangers and fill a substantial portion of the condenser. During this operation, the circulating water makeup pumps provide water from the Chesapeake Bay directly to the cooling tower basin. Next, the pressure fill-line from the CWS makeup system will fill the remainder of the condenser and the rest of the CWS piping. The system is fully primed when fill water exits the condenser waterbox and CLCWS heat exchanger vent valves, and the cooling tower spray nozzles.

During normal system operation, either through the tower spray headers or the tower bypass line, the condenser and heat exchangers are under positive pressure. Therefore no vacuum priming system is required.

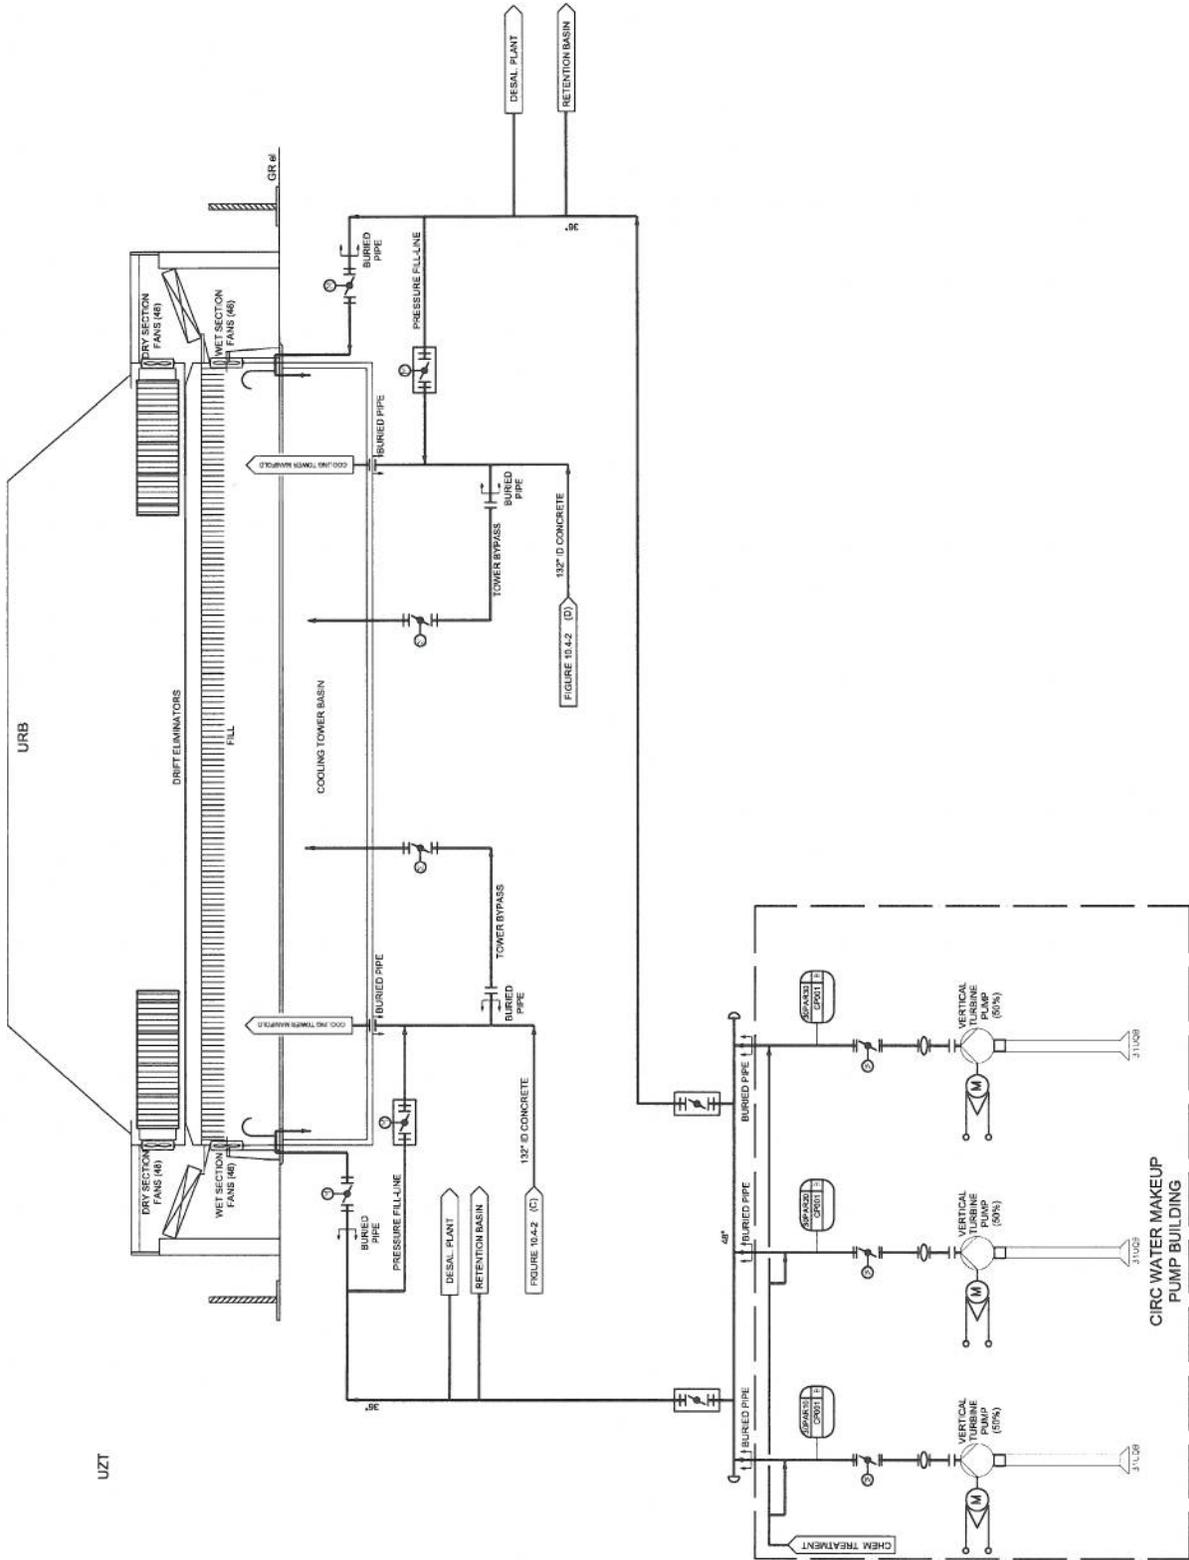
Figure 10.4-3 - {Circulating Water System Makeup System P&ID}

FSAR Figure 10.4-3 will be revised to show the pressure fill line from the CWS makeup water system to the CWS.

FSAR Figure 10.4-3 will be replaced with the following figure in a future COLA revision:
