U.S. NUCLEAR REGULATORY COMMISSION  
REGION I

Report Nos. 50-54/90-02  
70-687/90-04

Licensee: Cintichem, Incorporated  
P. O. Box 816  
Tuxedo, New York 10987

Facility Name: Reactor and Hot Laboratory

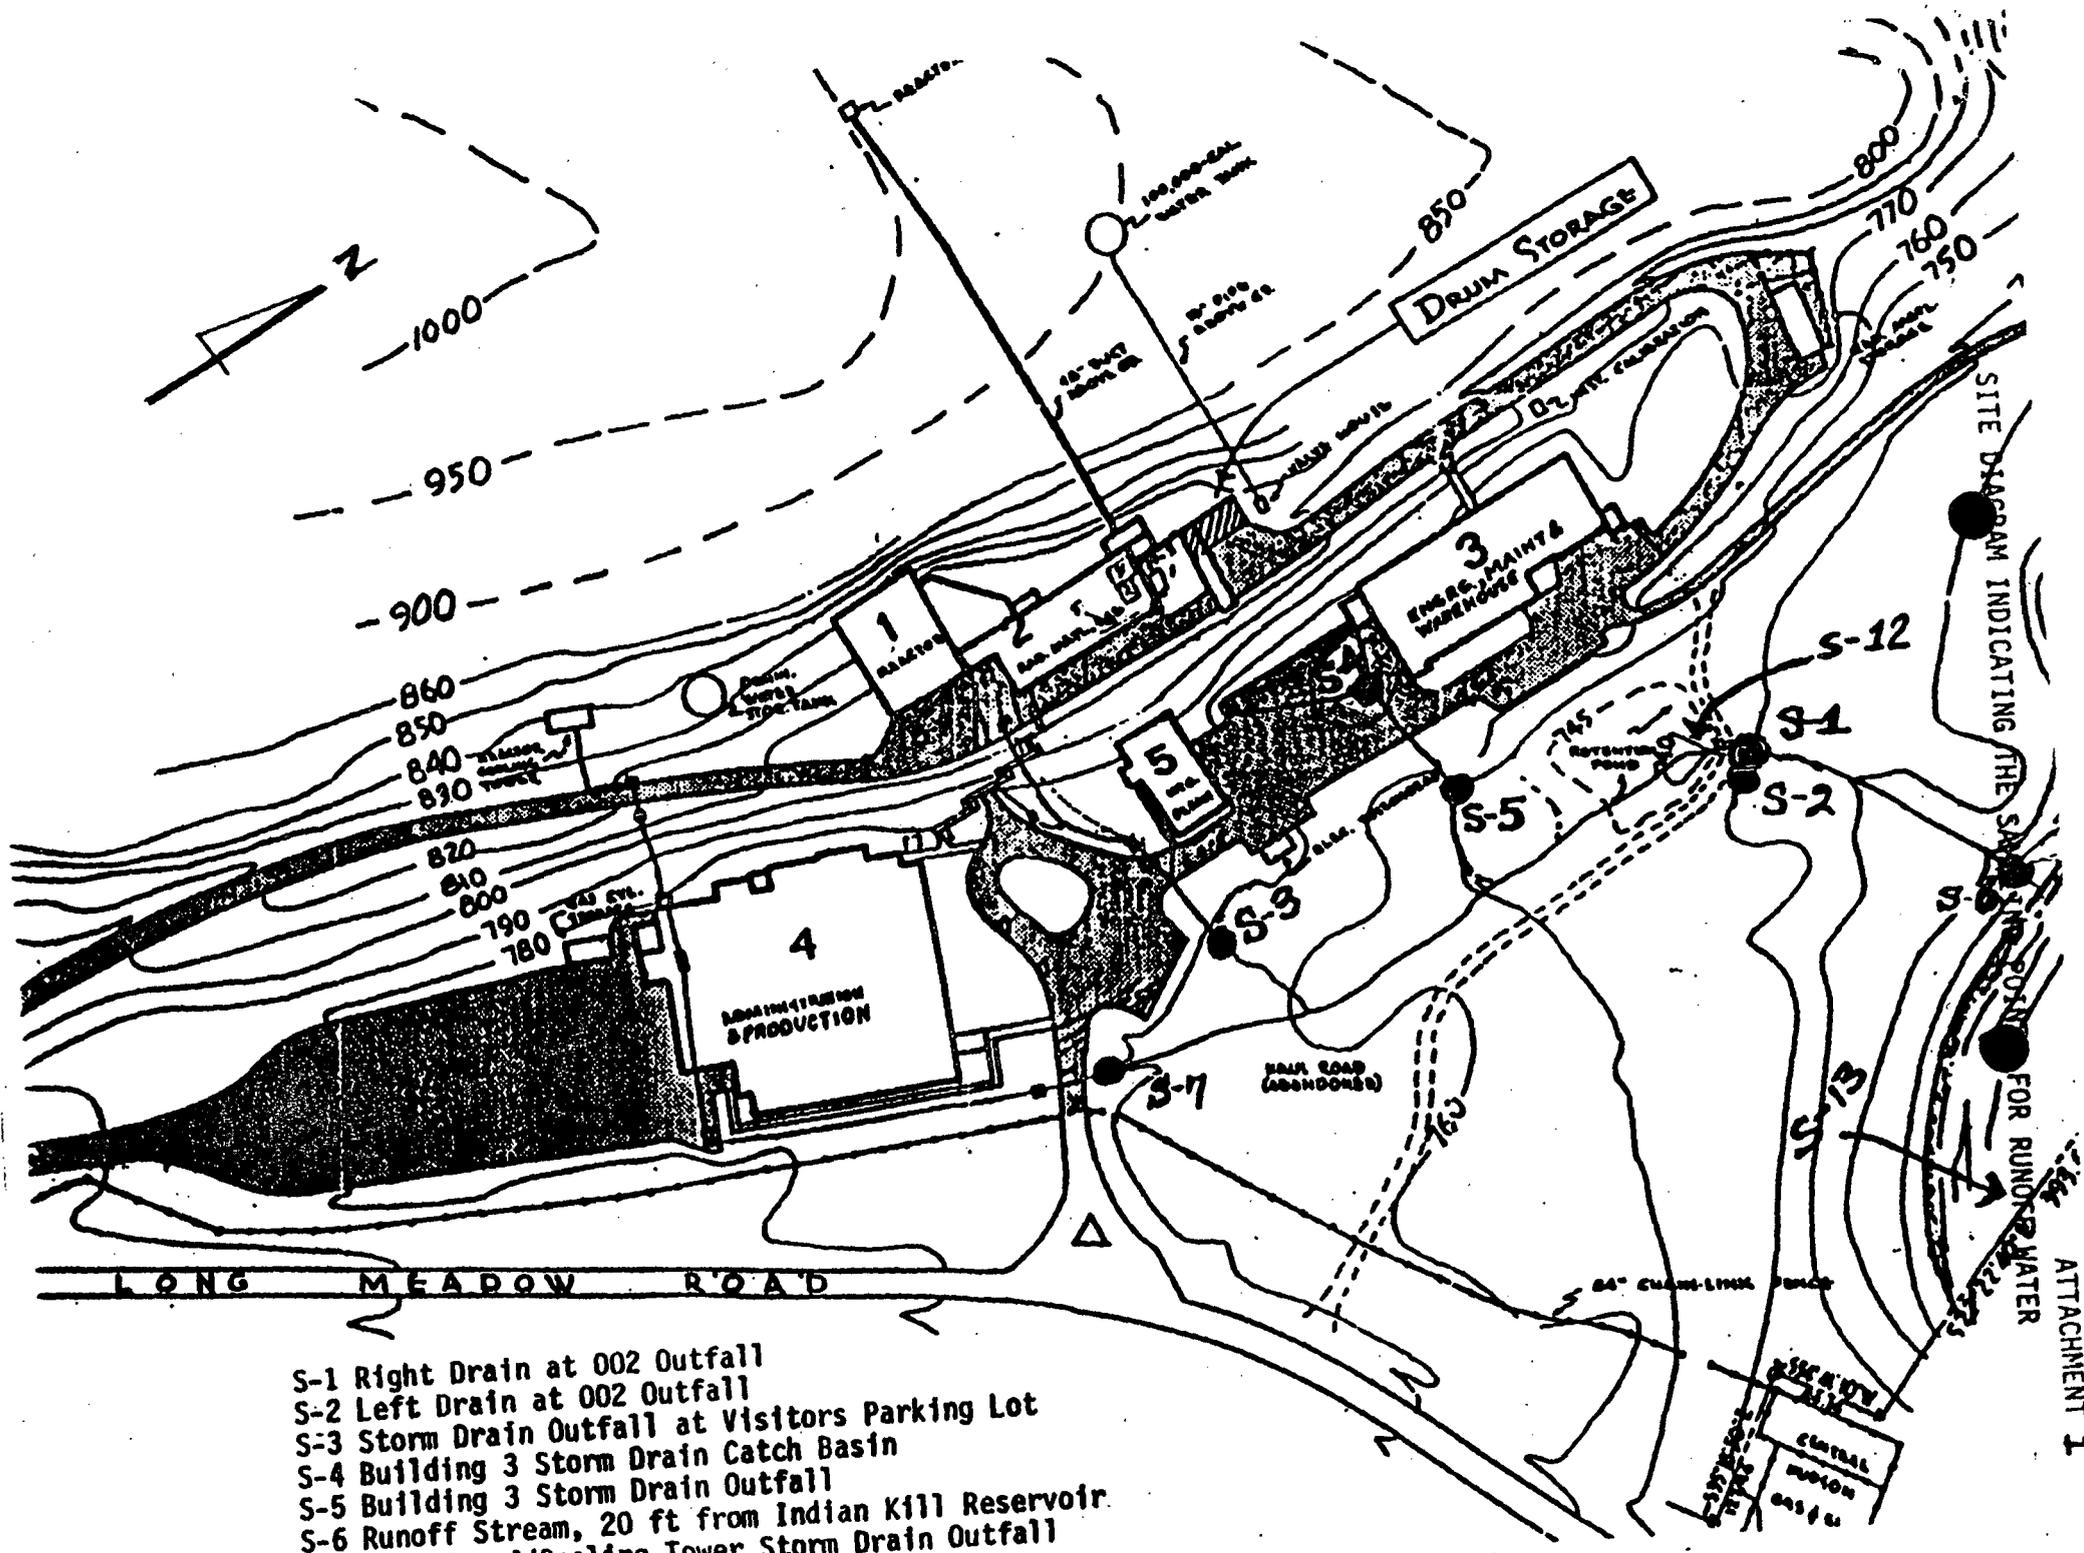
- S-1 Right Drain at 002 Outfall
- S-2 Left Drain at 002 Outfall
- S-3 Storm Drain Outfall at Visitors Parking Lot
- S-4 Building 3 Storm Drain Catch Basin
- S-5 Building 3 Storm Drain Outfall
- S-6 Runoff Stream, 20 ft from Indian Kill Reservoir
- S-7 Building 4/Cooling Tower Storm Drain Outfall

S-12 Holding Pond Inside Berm

the retention pond (S-12) and in any seepage from the berm (S-1). The inspector noted that the analytical sensitivities for all of the examined records were at least sufficient to detect ten percent of the applicable maximum permissible concentration (MPC). No activity was detected in any of the S-12 or S-1 samples since the last inspection.

The inspector noted that the licensee continued to pump the liquid discharges from storm drain S-3 to a holding tank. The contents of the tank were sampled and analyzed to ensure applicable release requirements were met prior to release to the 001 discharge. The inspector's review of selected records since the previous inspection indicated that no detectable activity was measured at S-3 since March 9, 1990.

Water from sample point S-4 of the storm drain system which had been contaminated as a result of a leaking underground ventilation duct (See Inspection Report 50-54/90-80; 70-687/90-80) from the hot cells, was still being processed through a deionization system. At the time of this inspection, the I-131 activity at S-4 was approximately  $1 \text{ E-7}$  microcuries/cc, which is one third of the MPC for I-131 in water. The levels were continuing to decline at approximately the same rate as the half-life for I-131. The inspector noted that the activity measured at S-4 was approximately the same concentration as was measured from the shallow monitoring well (MW-2S) on the hill near Building 2.

from the retention pond under severe storm conditions, to ensure that the retention pond would not overflow nor breach the berm and flow into the reservoir. The licensee indicated that the full-flow capacity of the discharge line from the retention pond to the 001 discharge point was approximately 700 gallons per minute (gpm). The licensee's consultants have indicated that under severe storm conditions, the 001 discharge line capacity would be inadequate to ensure that the integrity of the retention point wasn't breached due to the collection of water at much higher fill rates than discharge capability. The licensee proposed that in order to prevent the water with highest contamination potential from being released from the retention pond under severe weather conditions, the low contamination-potential water from S-7 be diverted around the retention pond and allowed to flow to the reservoir.
