Nuclear Material Events Database

Annual Report

Fiscal Year 2009

Prepared for the U.S. Nuclear Regulatory Commission
by the Idaho National Laboratory (INL/EXT-10-17653)

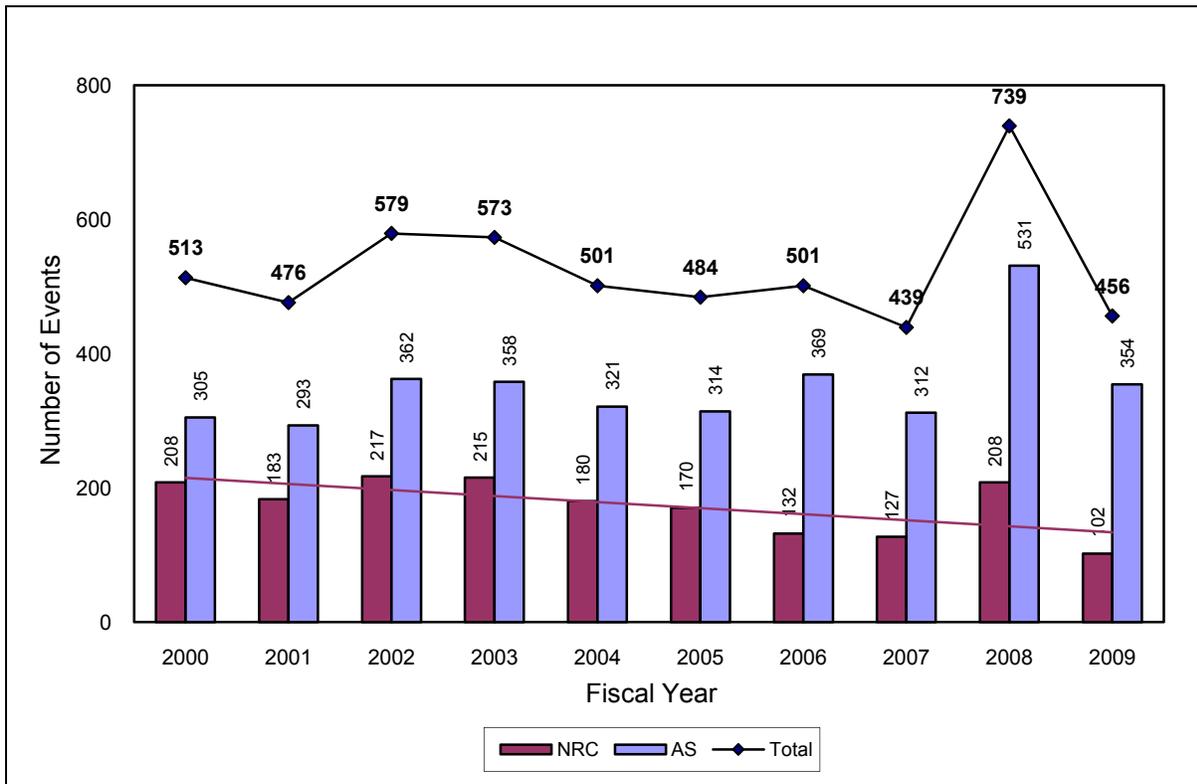
Figure 1 displays the annual number and trend of NMED events that occurred during the 10-year period. The trend analysis determined that the data represent a statistically significant decreasing trend in the number of NRC-regulated events (indicated by the trend line). However, the Total events and Agreement State-regulated events do not represent statistically significant trends (indicated by the absence of trend lines). Therefore, variations within the Total and Agreement State values represent random fluctuation around the average of the data.

Figure 1. All NMED Events (5,261 total)

The following observations are made regarding the data in Figure 1.

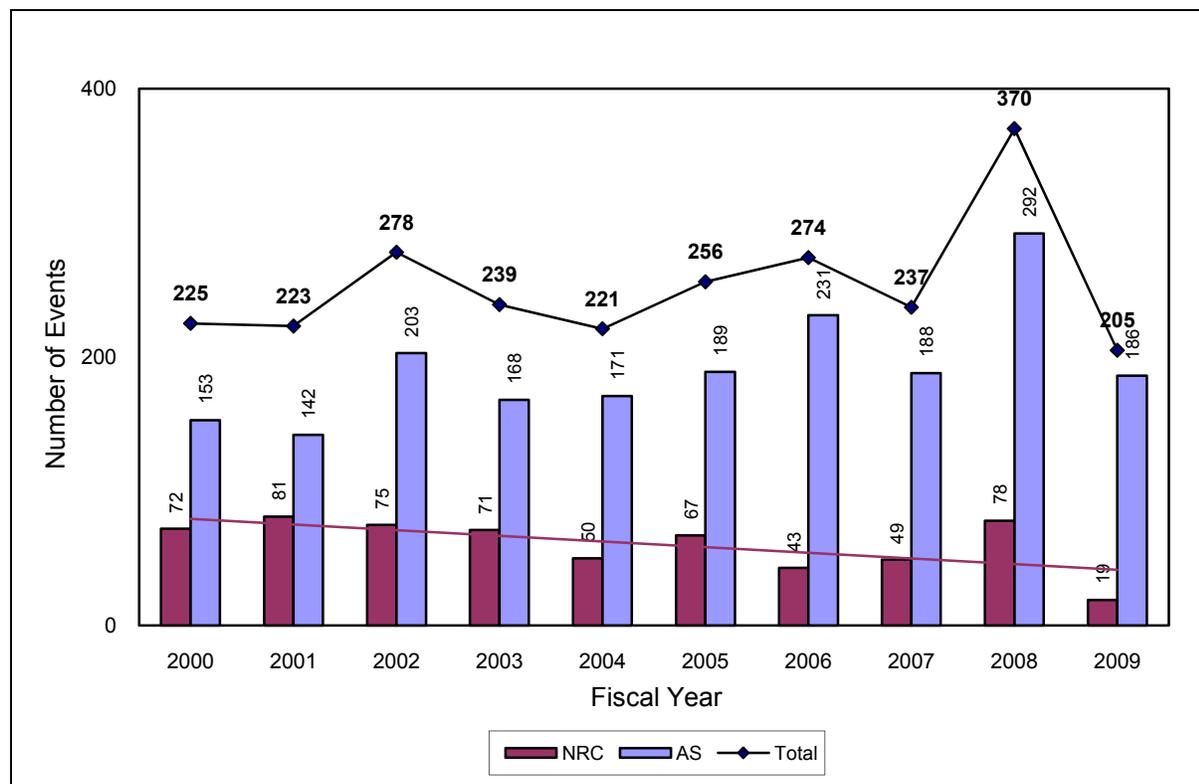
Figure 2 displays the annual number and trend of LAS events that occurred during the 10-year period, excluding irretrievable well-logging sources abandoned in accordance with 10 CFR 39.77. The trend analysis determined that the data does not represent statistically significant trends in the Total and Agreement State-regulated events (indicated by the absence of trend lines). Therefore, variations within those annual values represent random fluctuation around the average of the data. However, the NRC-regulated events represent a statistically significant decreasing trend (indicated by the trend line).

Figure 2. Lost/Abandoned/Stolen Material Events (2,528 total)

The FY08 and 09 data include 142 and 45 LAS events respectively that resulted from Wal-Mart's one-time review of their tritium exit sign inventory.

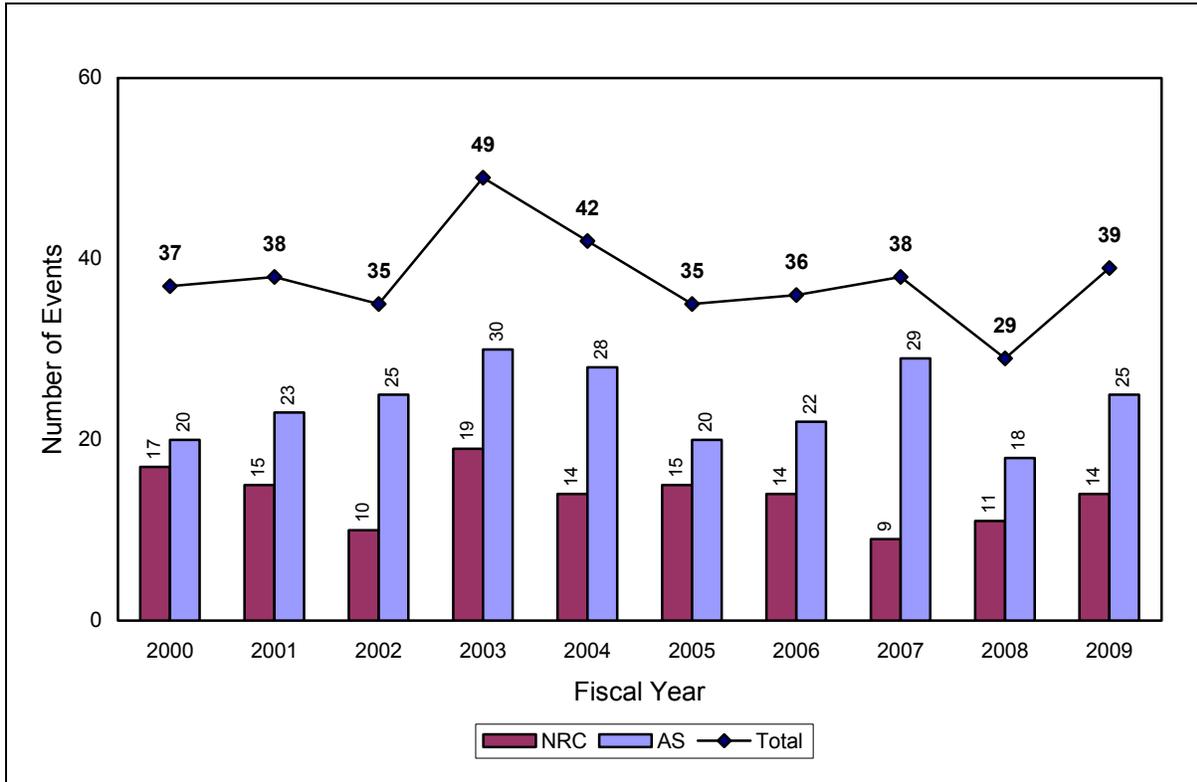
Figure 3 displays the annual number and trend of MED events that occurred during the 10-year period. The trend analysis determined that the data does not represent statistically significant trends in the number of events (indicated by the absence of trend lines). Therefore, variations within those annual values represent random fluctuation around the average of the data.

Figure 3. Medical Events (378 total)

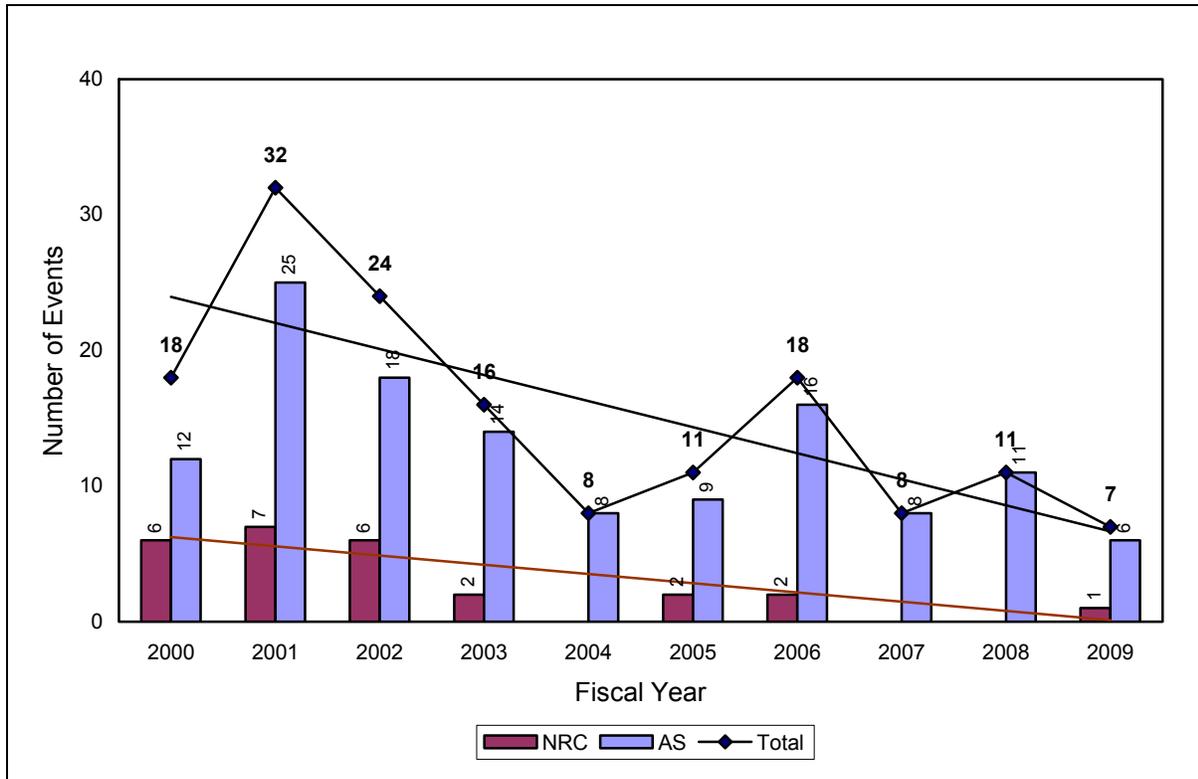
Figure 4 displays the annual number and trend of EXP events that occurred during the 10-year period. The trend analysis determined that the Agreement State-regulated events do not represent a statistically significant trend in the number of events (indicated by the absence of a trend line). Therefore, variations within those annual values represent random fluctuation around the average of the data. However, the Total and NRC-regulated events represent statistically significant decreasing trends (indicated by the trend lines).

Figure 4. Radiation Overexposure Events (153 total)

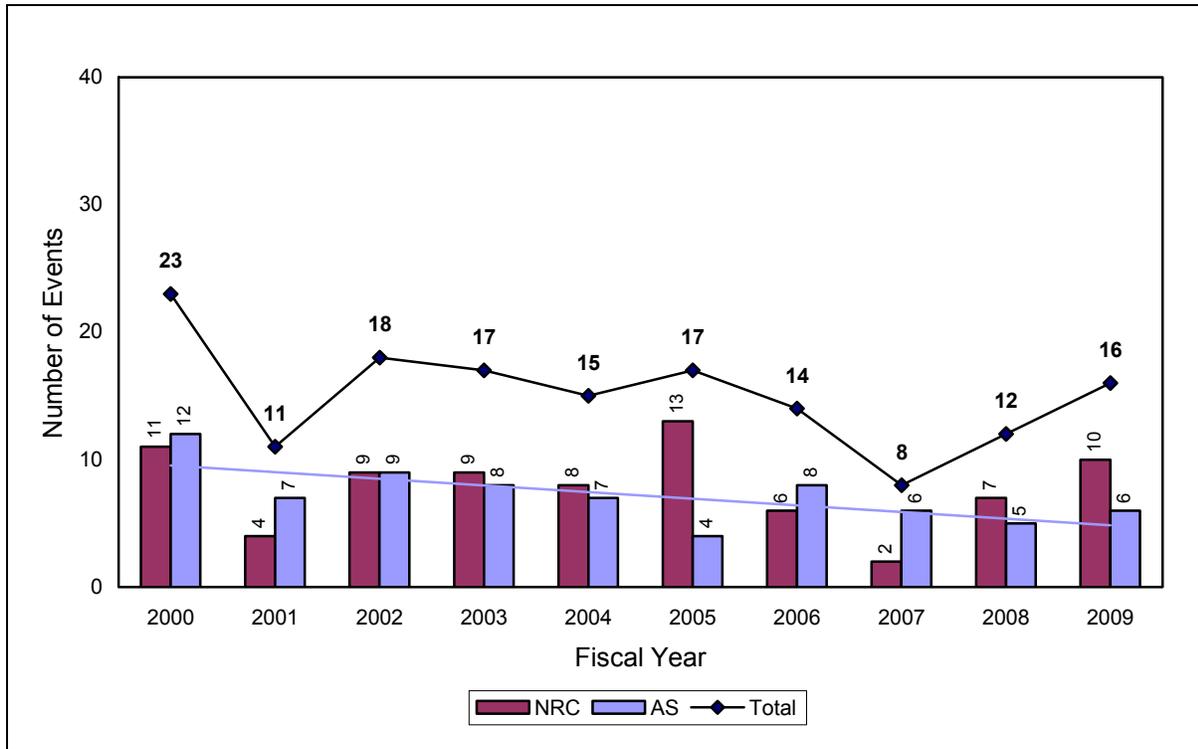
Figure 5 displays the annual number and trend of RLM events that occurred during the 10-year period. The trend analysis determined that the Total and NRC-regulated events do not represent statistically significant trends in the number of events (indicated by the absence of trend lines). Therefore, variations within those annual values represent random fluctuation around the average of the data. However, the Agreement State-regulated events represent a statistically significant decreasing trend (indicated by the trend line).

Figure 5. Release of Licensed Material or Contamination Events (151 total)

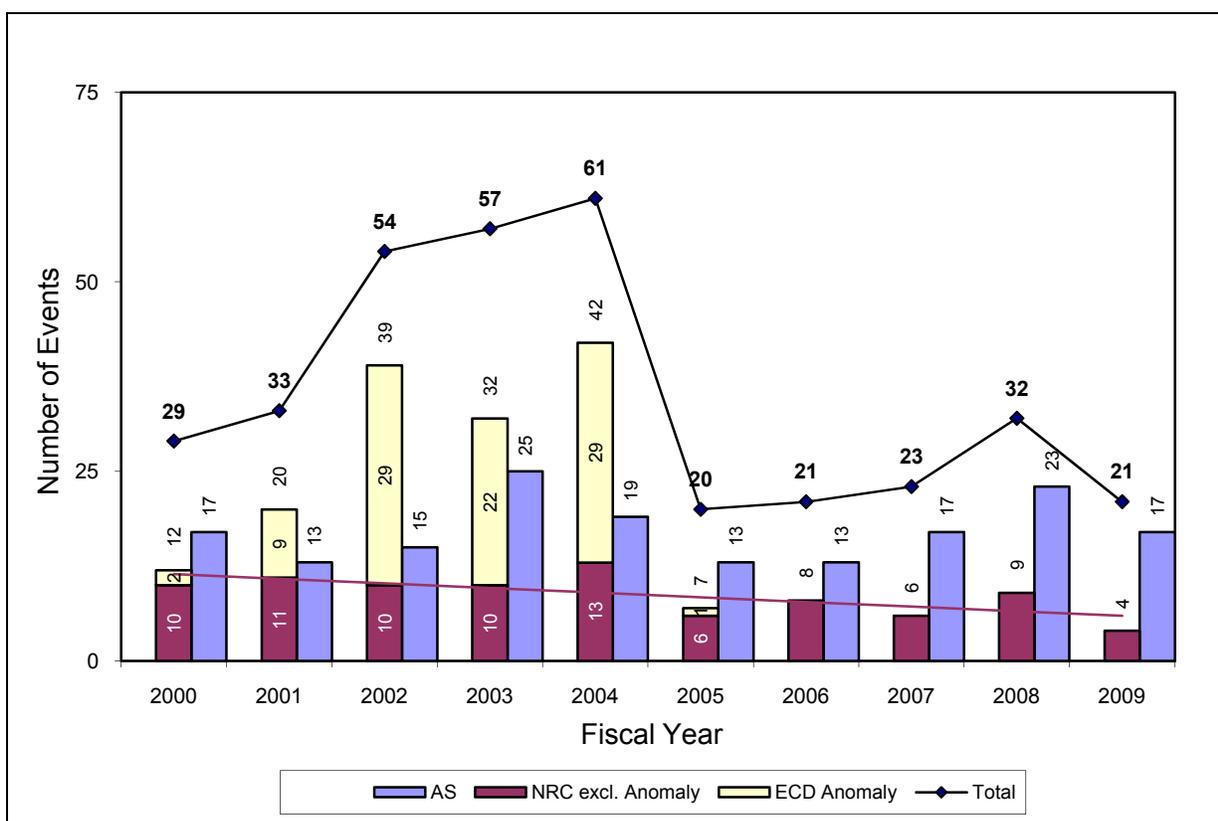
Figure 7 displays the annual number and trend of LKS events that occurred during the 10-year period. An event reporting anomaly associated with a single electron capture detector (ECD) manufacturer occurred from Fiscal Year 2000 through early 2005, which notably increased the number of LKS events. The anomalous events were not significant and involved leaking ECD sources (Ni-63 foil sources) that had been returned to the manufacturer for refurbishment. The manufacturer discontinued refurbishing ECDs and now disposes of the returned sources without leak testing. To show this affect, Figure 7 displays the anomalous events as yellow shaded bars. The trend analysis determined that the Total and Agreement State-regulated events do not represent statistically significant trends in the number of events (indicated by the absence of trend lines). Therefore, variations within those annual values represent random fluctuation around the average of the data. However, the NRC-regulated events (excluding the anomalous data) represent a statistically significant decreasing trend (indicated by the trend line).

Figure 6. Leaking Sealed Source Events (351 total)

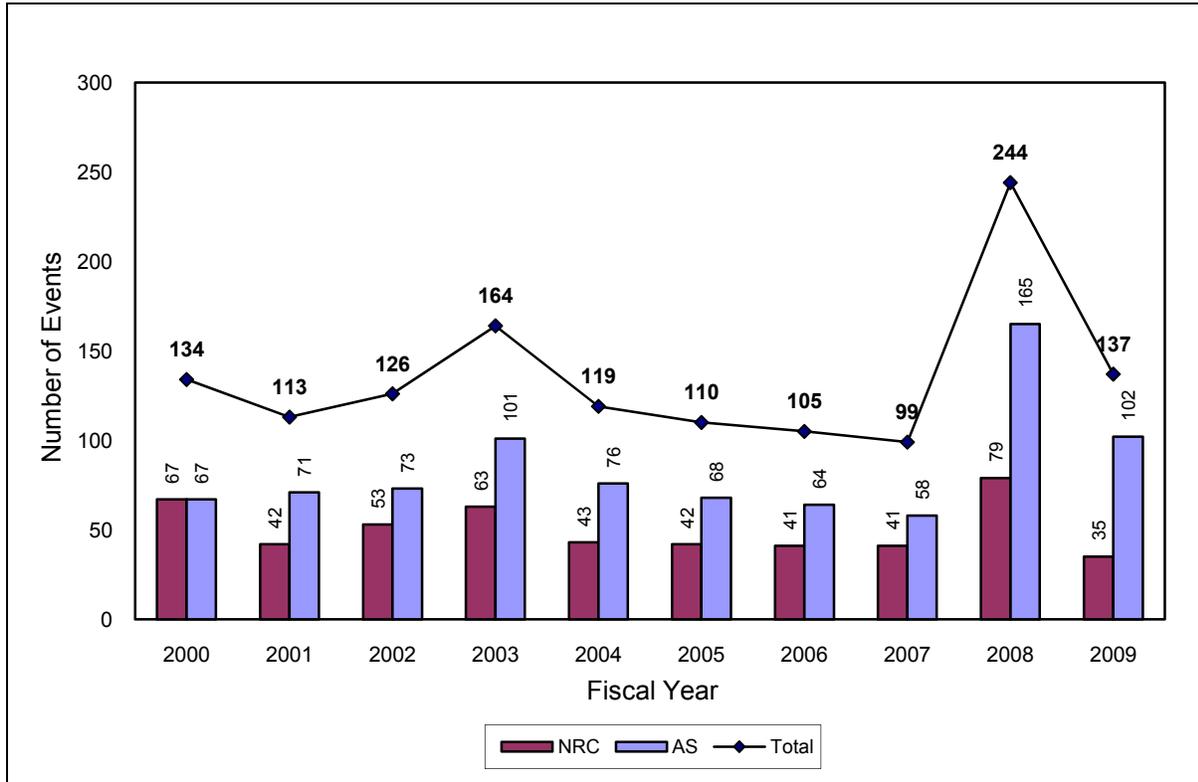
Figure 9 displays the annual number and trend of EQP events that occurred during the 10-year period. The trend analysis determined that the data does not represent statistically significant trends in the number of events (indicated by the absence of trend lines). Therefore, variations within those annual values represent random fluctuation around the average of the data.

Figure 7. Equipment Events (1,351 total)

The FY08 and 09 data include 130 and 20 EQP events, respectively, which resulted from Wal-Mart's one-time review of their tritium exit sign inventory.

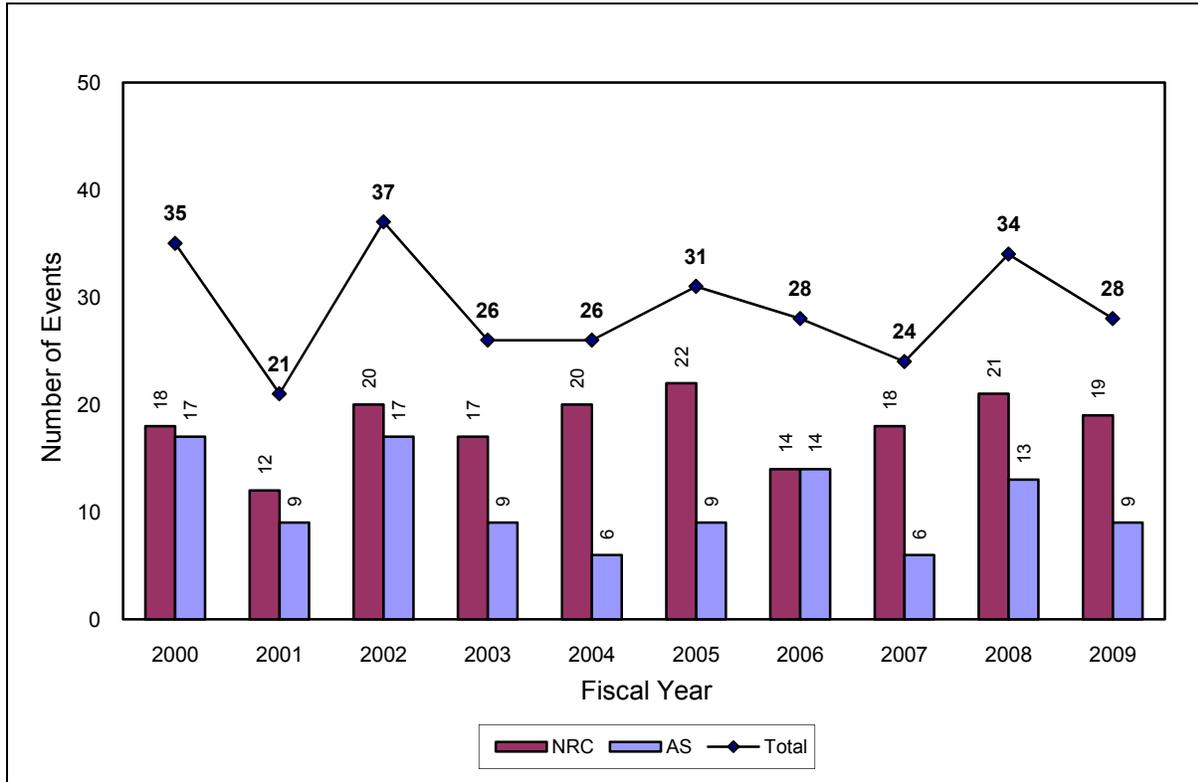
Figure 9 displays the annual number and trend TRS events that occurred during the 10-year period. The trend analysis determined that the data do not represent statistically significant trends in the number of events (indicated by the absence of trend lines). Therefore, variations within those annual values represent random fluctuation around the average of the data.

Figure 8. Transportation Events (290 total)

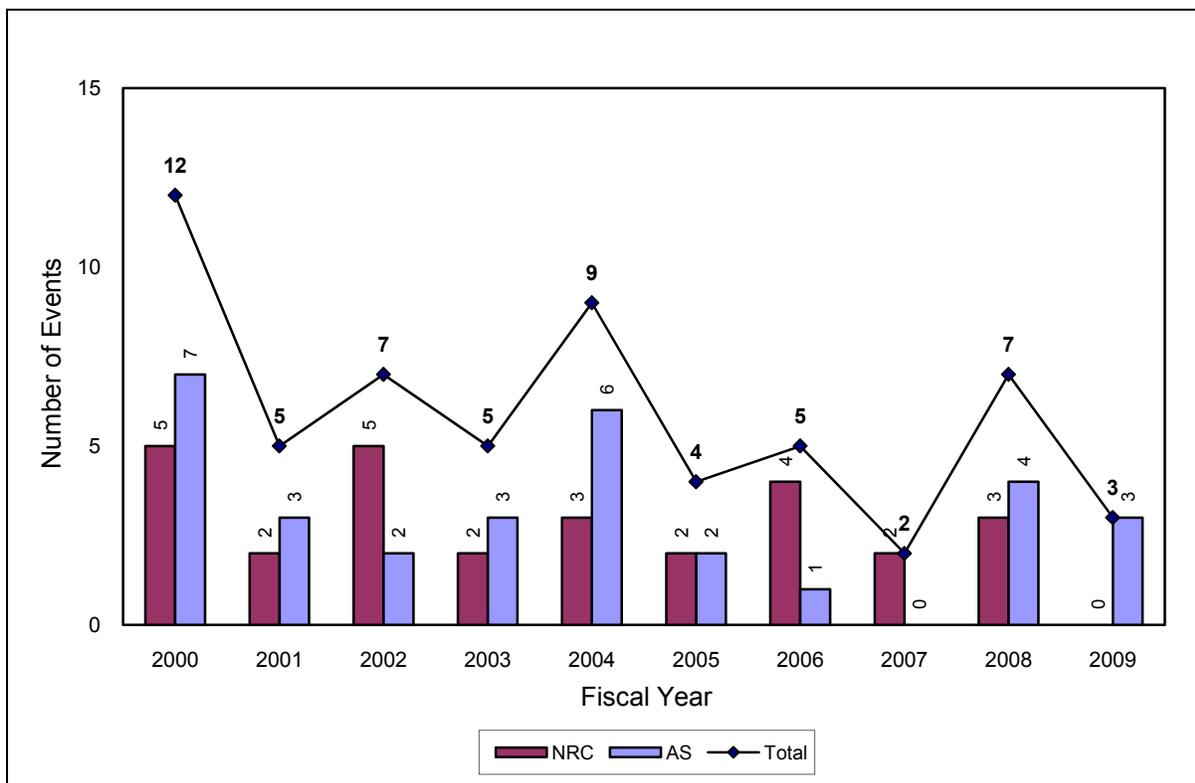
Figure 10 displays the annual number of OTH events that occurred during the 10-year period. Because OTH events do not fit a defined criterion that ensures consistency within the data, trending analysis is not performed on this data.

Figure 9. Other Events (59 total)

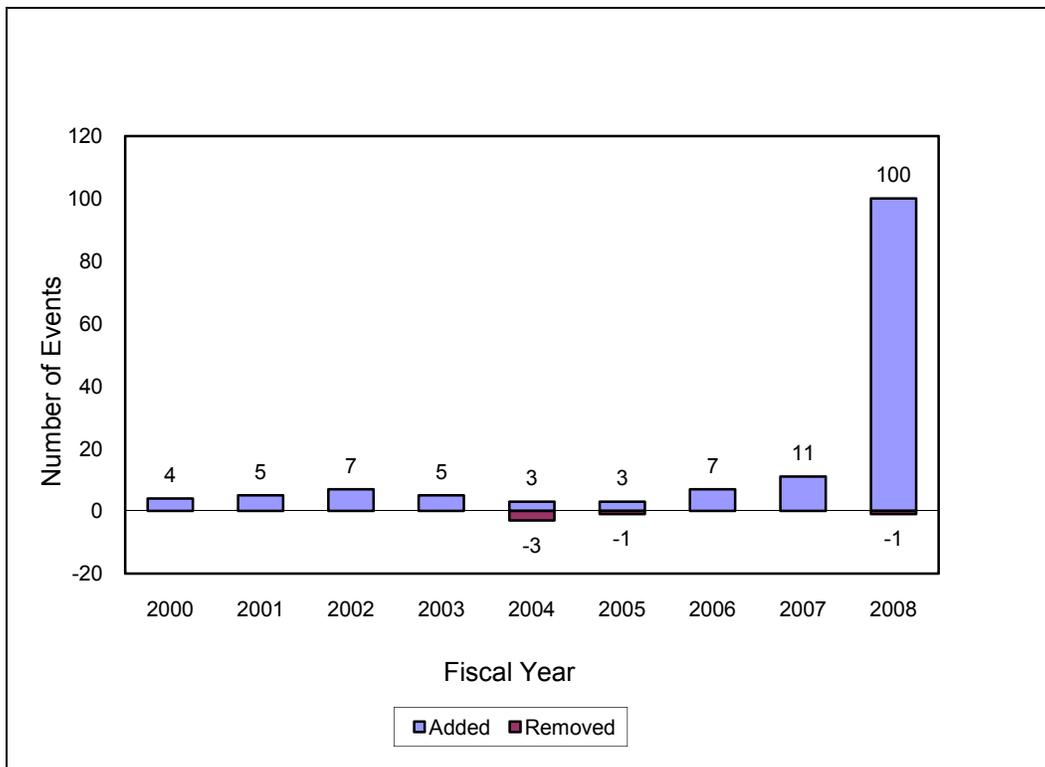
Figures D-1 through D-9 below display the changes in the data published in the previous annual report. A positive value indicates that records were added and a negative value indicates that records were removed.

Figure D-1. Changes to All NMED Event Data

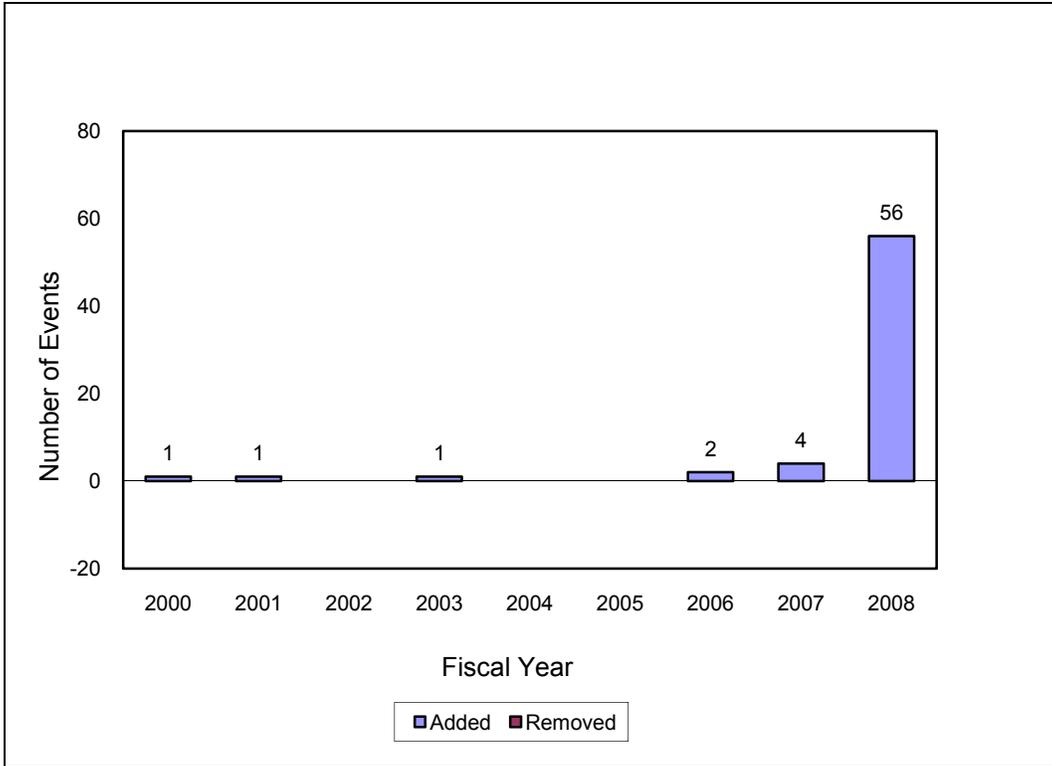
Figure D-2. Changes to LAS Data

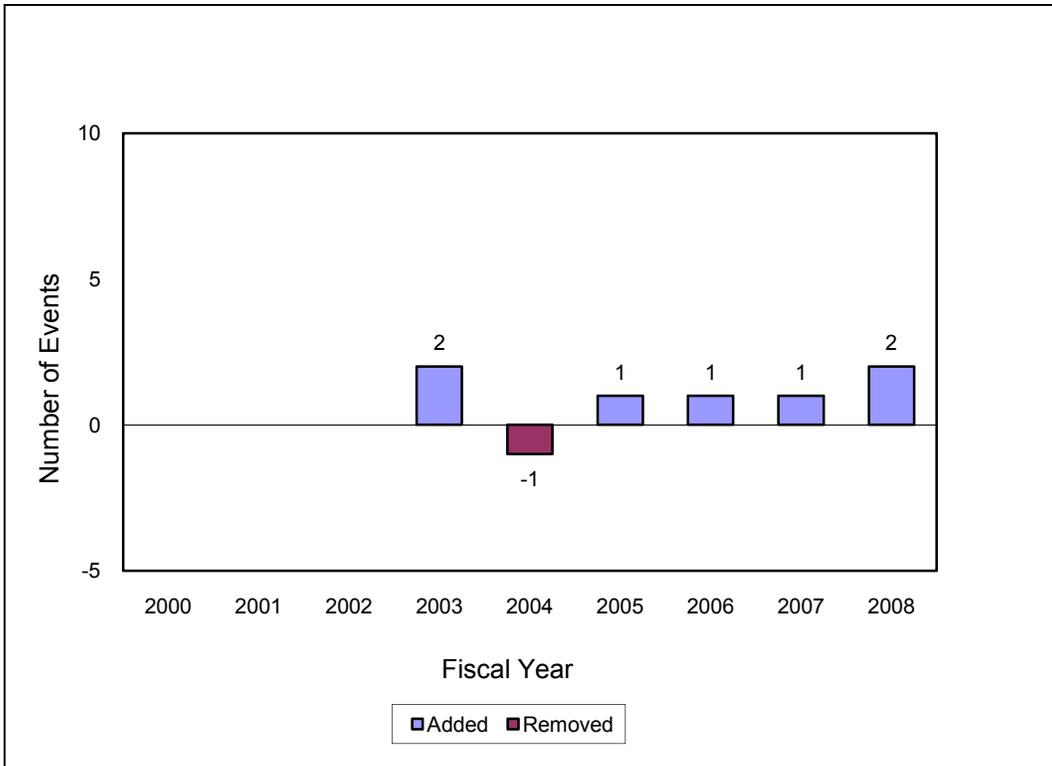
Figure D-3. Changes to MED Data

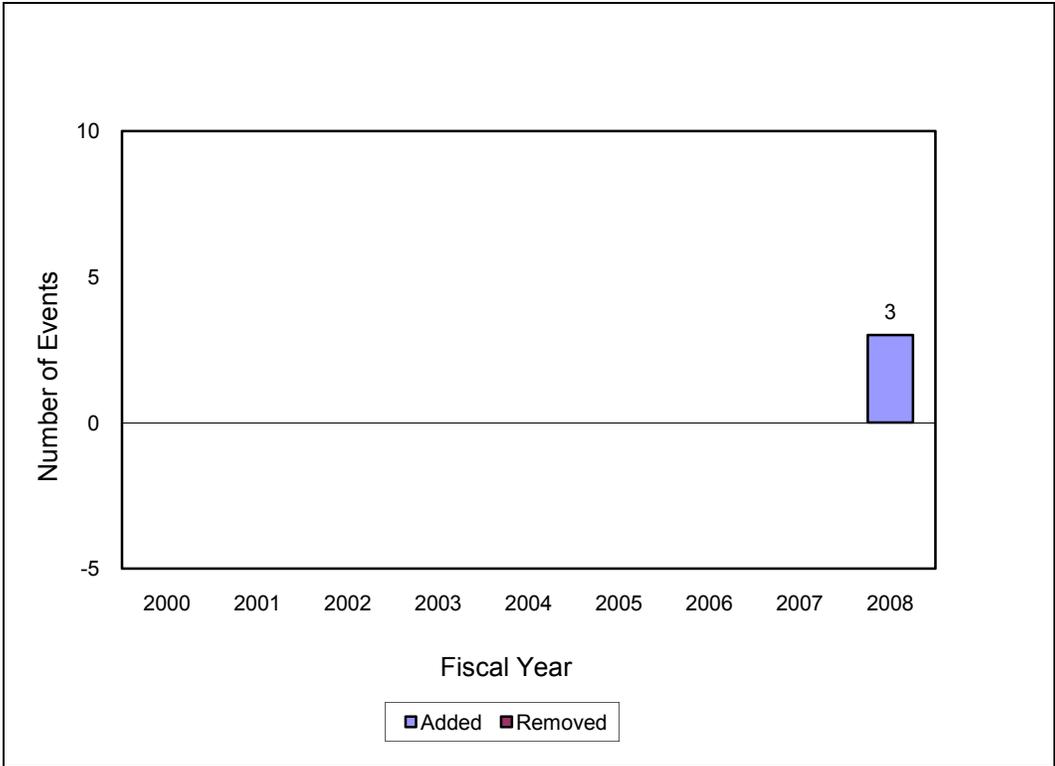
Figure D-4. Changes to EXP Data

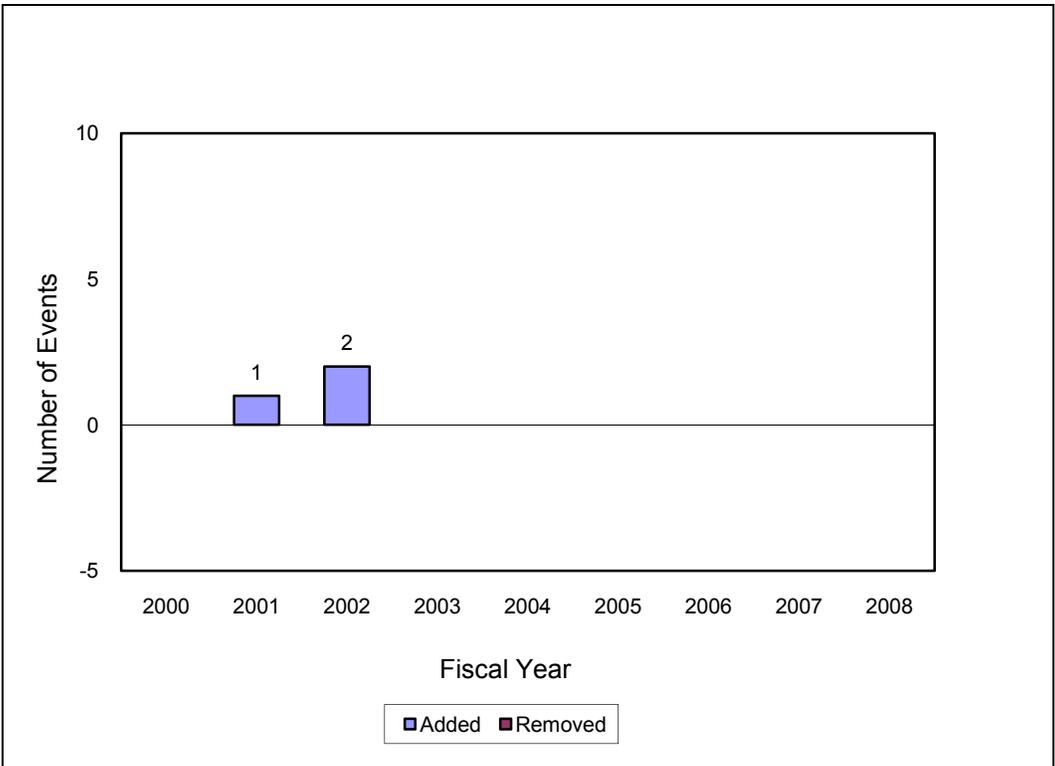
Figure D-5. Changes to RLM Data

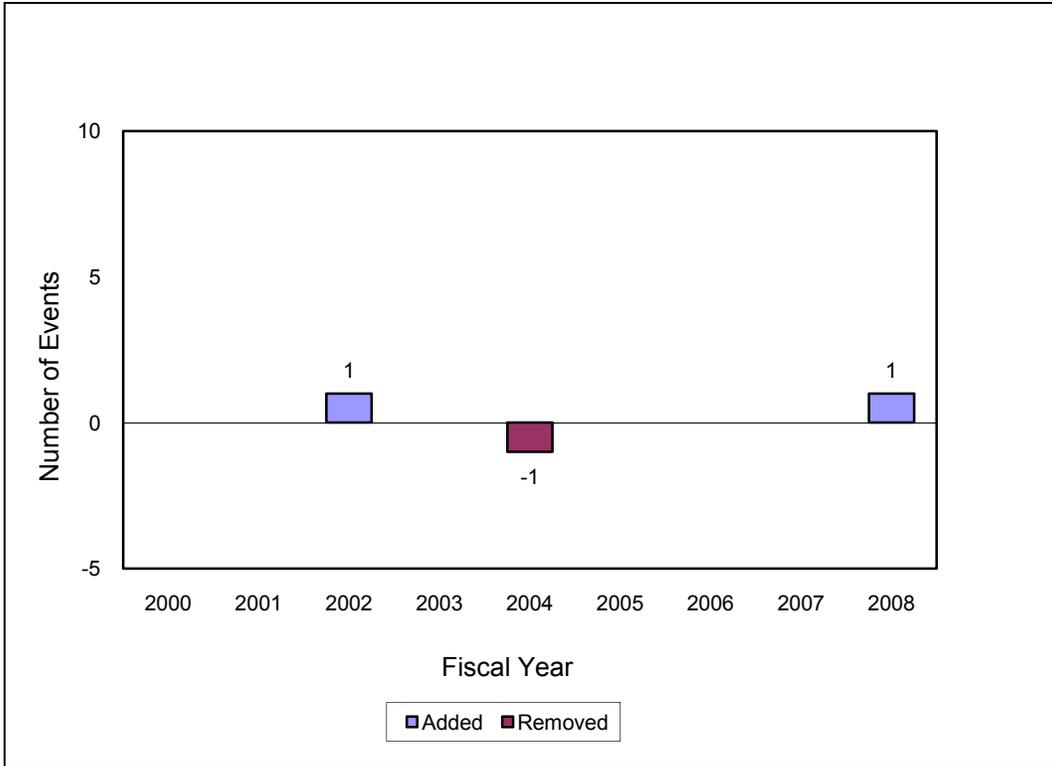
Figure D-6. Changes to LKS Data

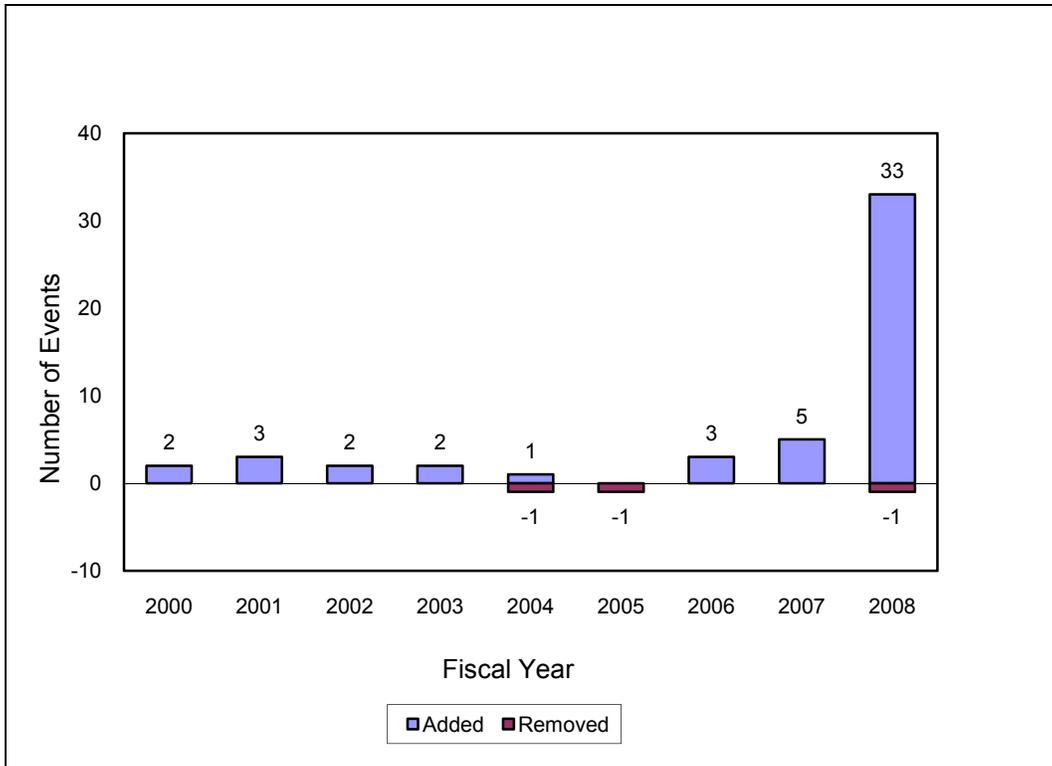
Figure D-7. Changes to EQP Data

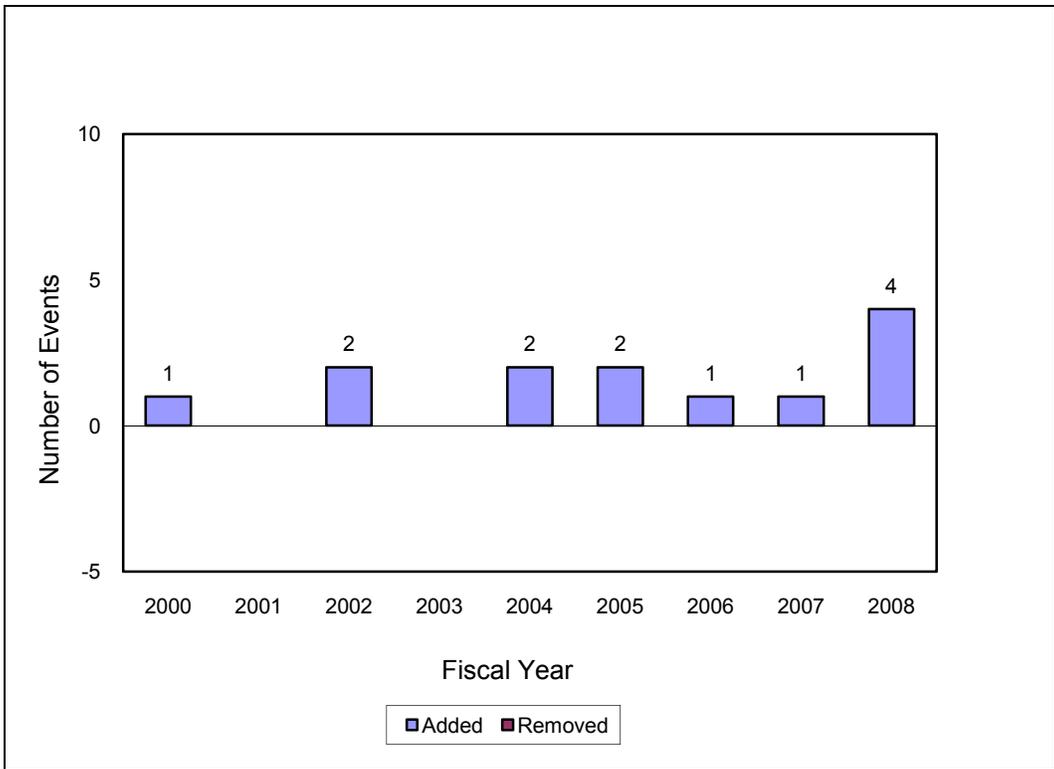
Figure D-8. Changes to TRS Data

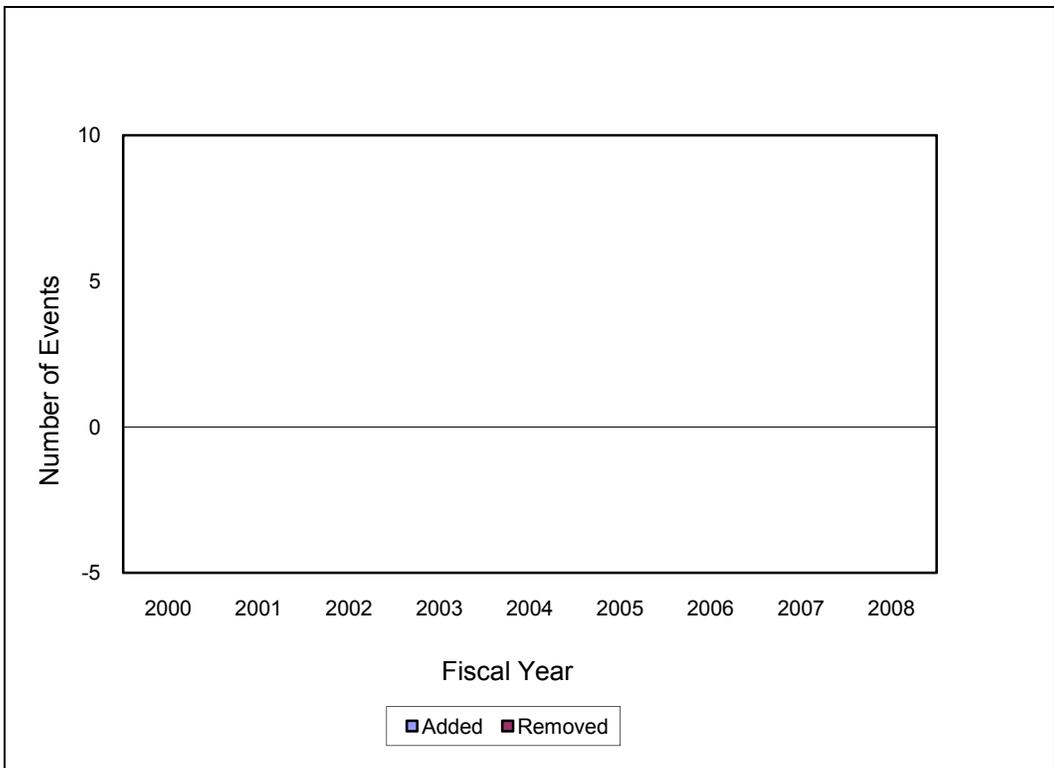
Figure D-9. Changes to OTH Data
