Research Report  
LTKK / Nuclear Safety Research Unit

SUPPLEMENTING CONDENSATION POOL  
EXPERIMENTS WITH NON-CONDENSABLE GAS

YTY-01/2002

Lappeenranta, 21.10.2002

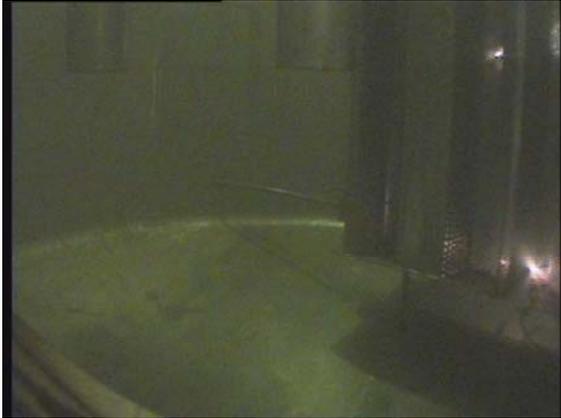
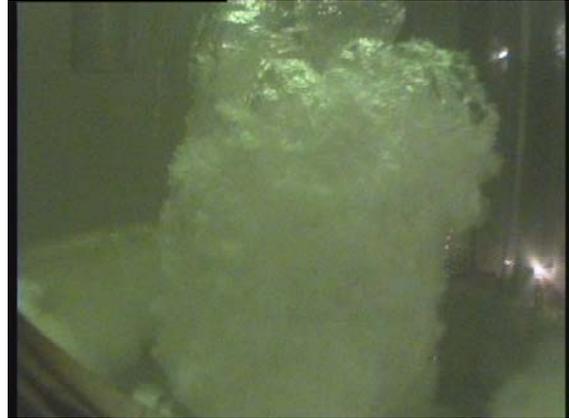
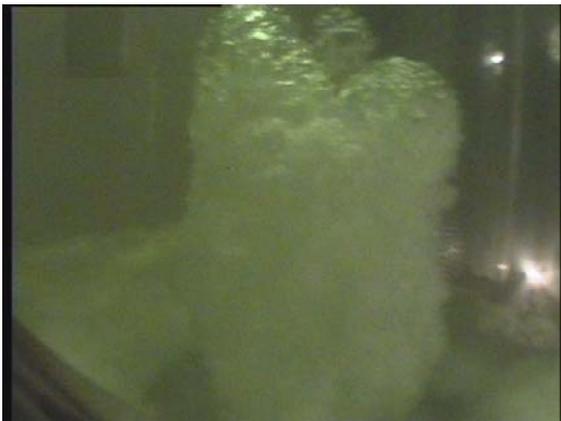
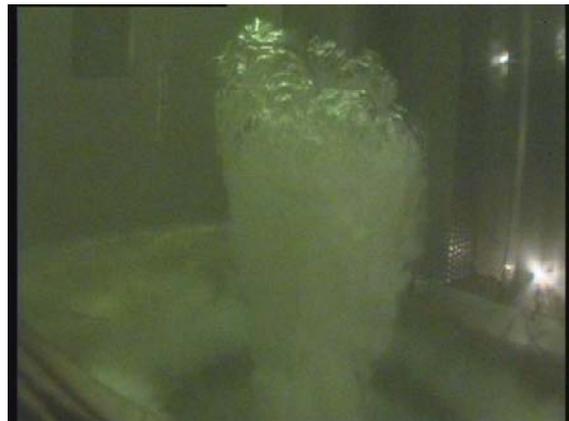
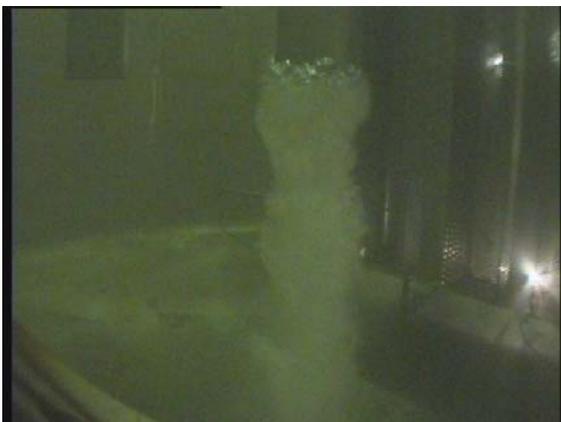
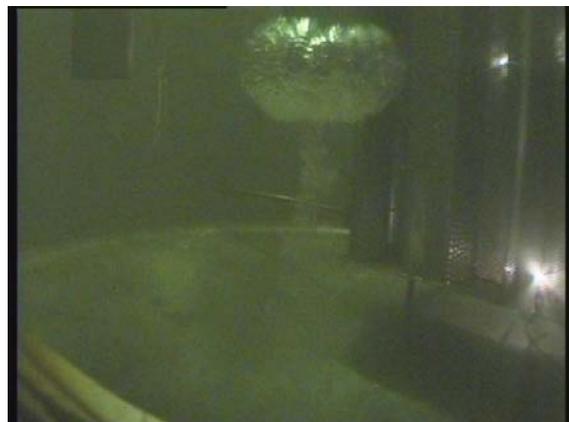
The pool before air was blown

Test 14.02

Test 14.04

Test 14.06

Test 14.08

Test 14.10

*Figure 3. The first airflow jet penetrating to the pool during tests 14.01-14.10.*

Maximum airflow velocities can be higher than presented in Fig. 2 because the vortex flowmeters use a low pass filter. Fig. 3 shows how the first airflow jet penetrated to the pool in tests 14.01-14.10.

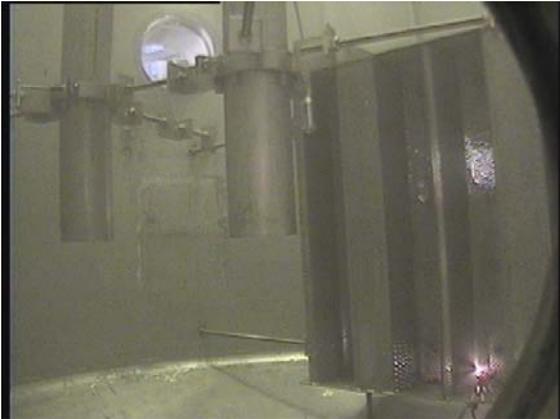
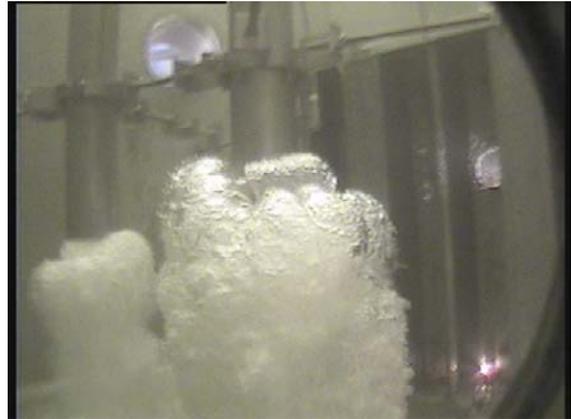
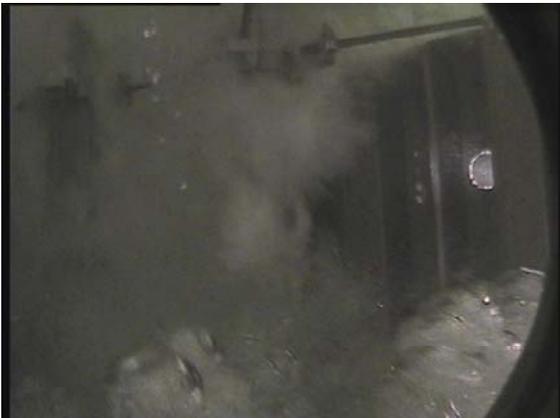
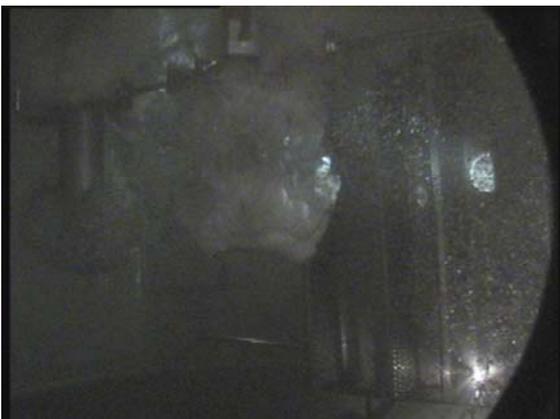
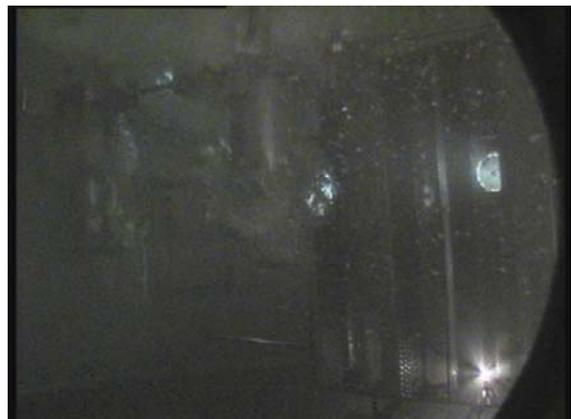
The pool before air was blown.

The first airflow jets hit to the bottom of the pool.

1 s

20 s

40 s

60 s

*Figure 5. Airflows penetrating to the pool during test 15.01.*

Figure 4 shows airflow velocities, pressure differences over the pump and water volume flow rates in tests 15.01-15.05. Airflow pressures have been normalized to 1 bar pressure. Neither pressure difference nor water volume flow rate declined when air was blown to the pool. Table 3 shows some comparison between tests 15.01-15.05. Figures 5 and 6 show how much air bubbles were detected in the pool during tests 15.01 and 15.05.

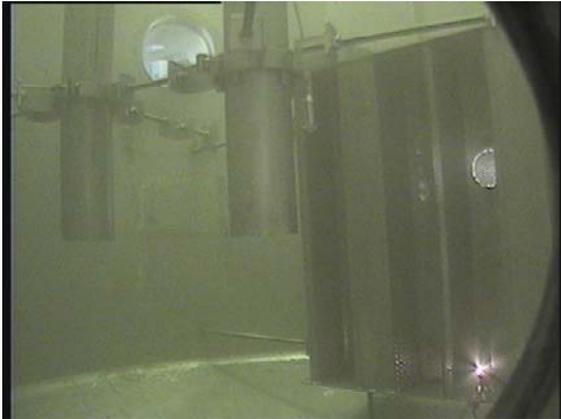
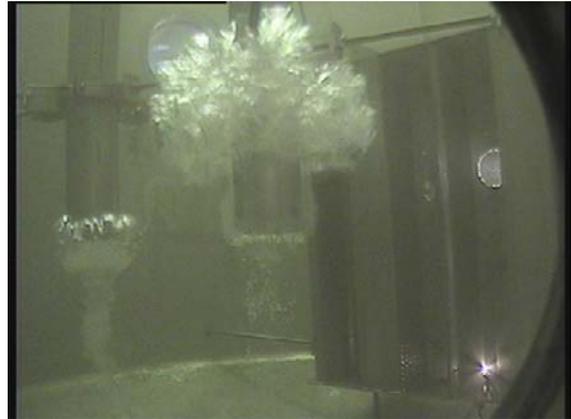
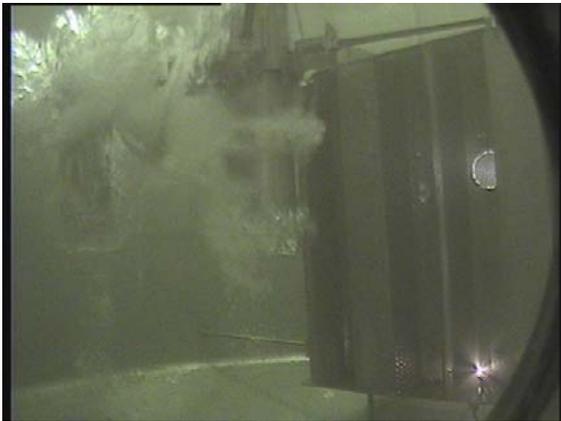
The pool before air was blown.

The first airflow jets didn't hit to the bottom of the pool.

1 s

20 s

40 s

60 s

*Figure 6. Airflows penetrating to the pool during test 15.05.*
