Watts Bar Nuclear Plant, Unit 2  
NRC Docket No. 50-391

**Subject: WATTS BAR NUCLEAR PLANT (WBN) UNIT 2 – REQUEST FOR  
ADDITIONAL INFORMATION REGARDING CONSTRUCTION  
REFURBISHMENT PROGRAM PLAN (TAC NO. MD6581)**

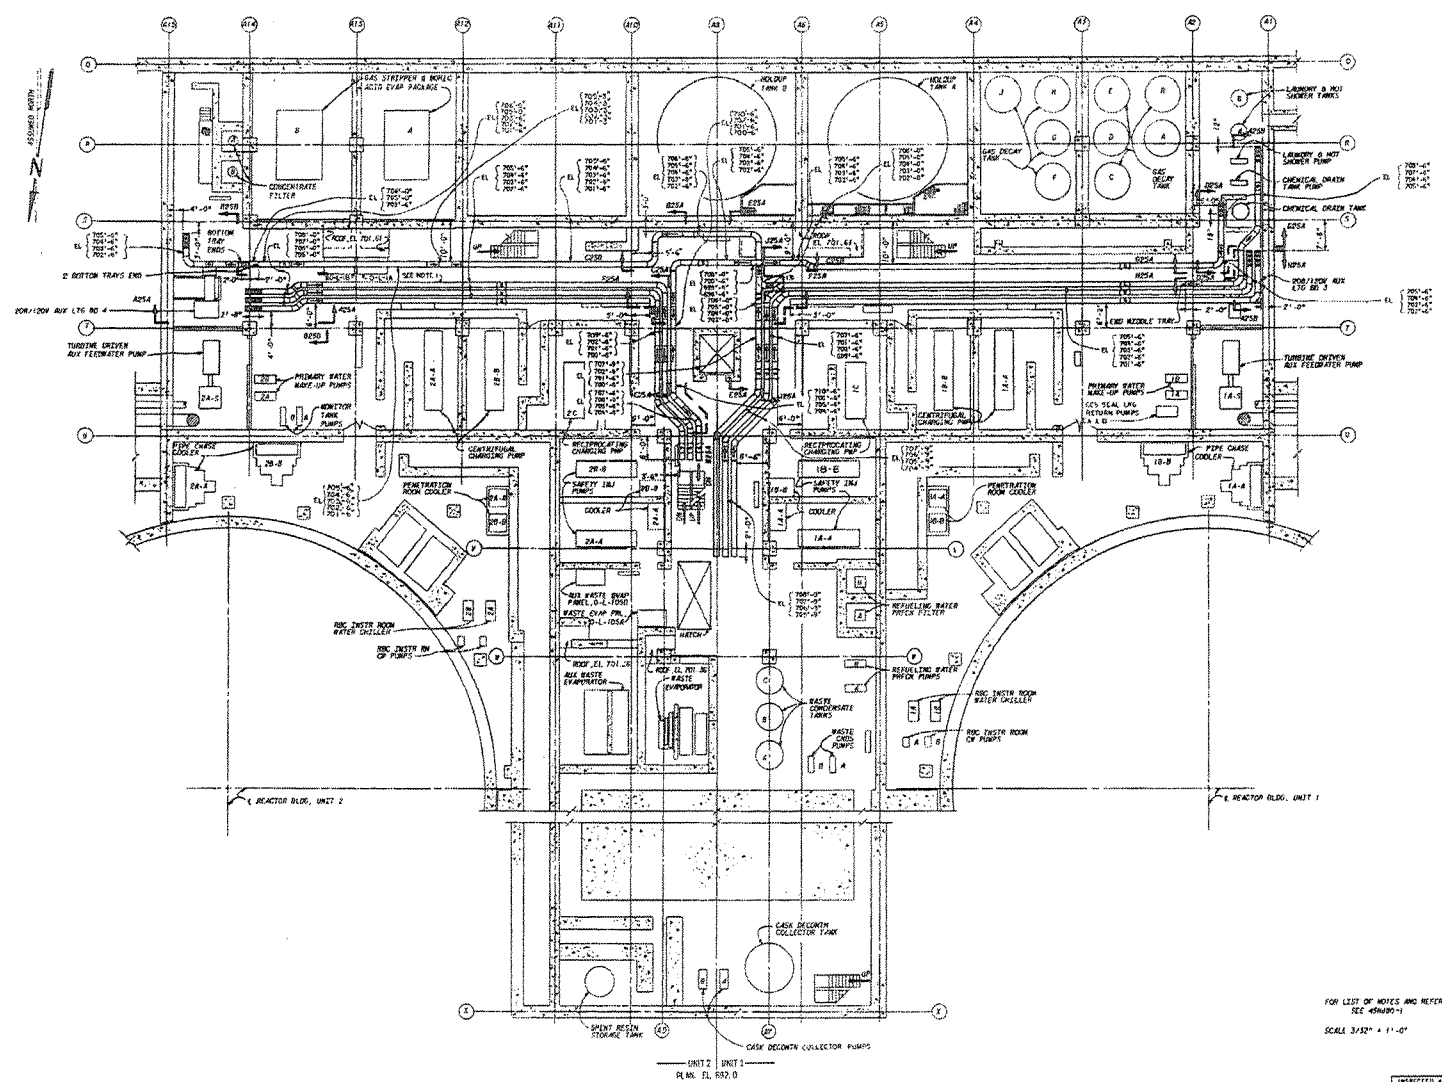
NOTES:  
1. THE SEPARATION BETWEEN PARALLEL CABLE TRAY RUNS SHALL BE A MINIMUM OF 3" (75mm) IN ALL CASES EXCEPT THE TRAY RUNS REST ON HORIZONTAL MEMBERS WHEN ARE ATTACHED TO VERTICAL SUPPORTS AT EACH END.

POWERHOUSE AUXILIARY BUILDING - UNITS 1 & 2	
CONDUIT & GROUNDING CABLE TRAYS-EL 6320, COL A1-A15, Q-X PLAN & DETAILS	
WATTS BAR NUCLEAR PLANT TENNESSEE VALLEY AUTHORITY DIVISION OF ENGINEERING DESIGN	
SUBMITTED H.B. Banting	RECOMMENDED R.D. Rink
DESIGNED H.B. Banting	APPROVED R.D. Rink
KNOXVILLE 12-12-76 AS E 45W860-11 02
