PSEG Power, LLC

PSEG Site ESPA
Part 2, Site Safety Analysis Report

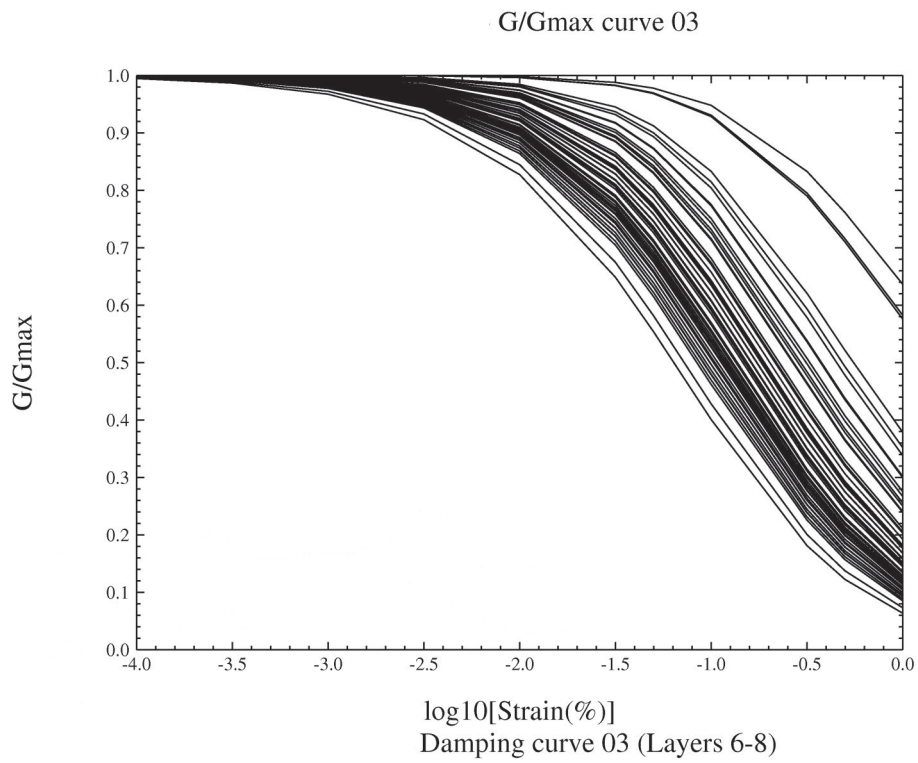
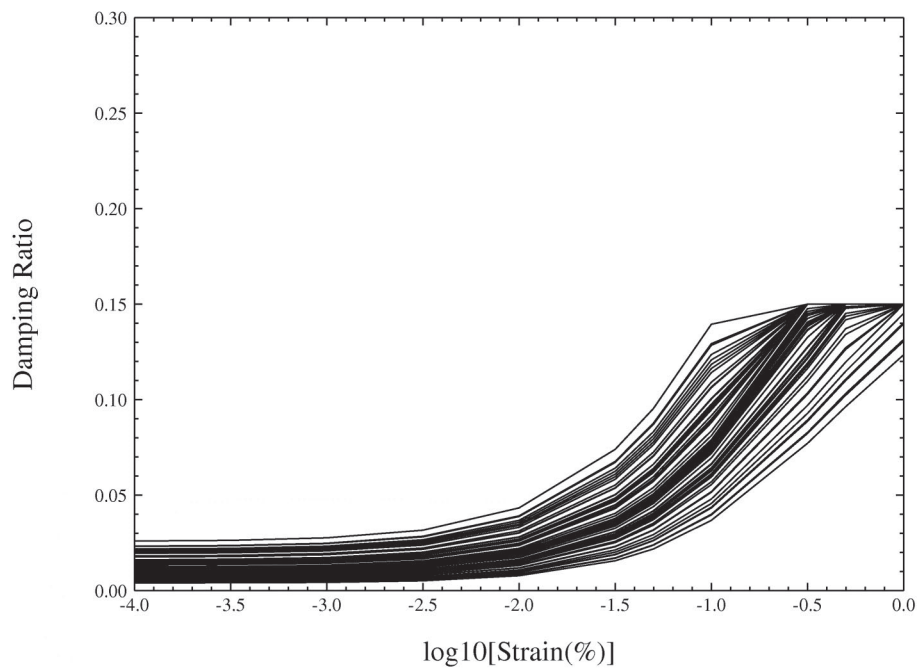
FIGURE 2.5.2-39

Synthetic Modulus and Damping
Degradation Curves for Soil
Layers 6 through 8
