# **ITS NRC Questions**

## Enclosure - Q&A to Attachment 1 Volume 05 (Section 3.0) Page 3 of 415 DISCUSSION OF CHANGES ITS 3.0, LCO AND SR APPLICABILITY

# FIGURE 1-1 TOTAL CORE DAMAGE FREQUENCY FOR INTERNAL AND EXTERNAL EVENTS

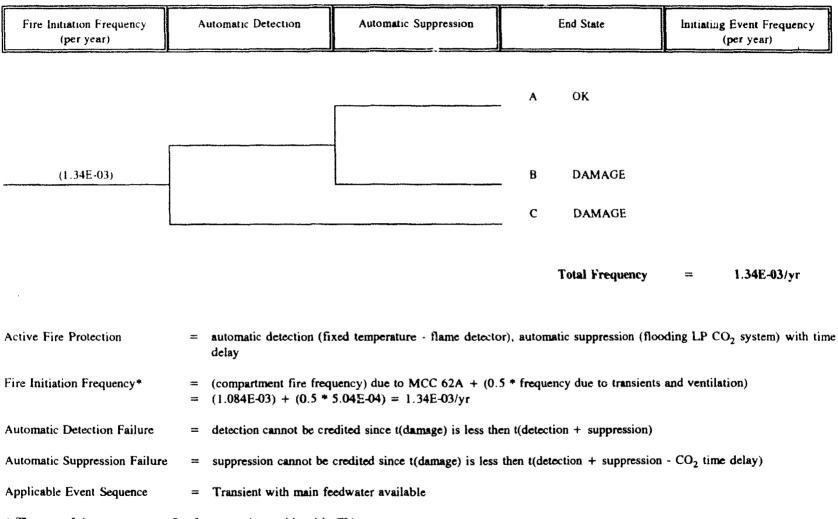
## Enclosure - Q&A to Attachment 1 Volume 05 (Section 3.0) Page 312 of 415 Figure 4-2: TU-92 (FI2) INITIATING EVENT FREQUENCY DIESEL GENERATOR ROOM B (MCC 62A)

\* The rest of the compartment fire frequency is considered in FI4.

Figures 4-1 through 4-8 show the derivation of the initiating event frequency for each scenario. The transient with main feedwater, transient without main feedwater or loss of offsite power event sequence was used depending on the scenario.

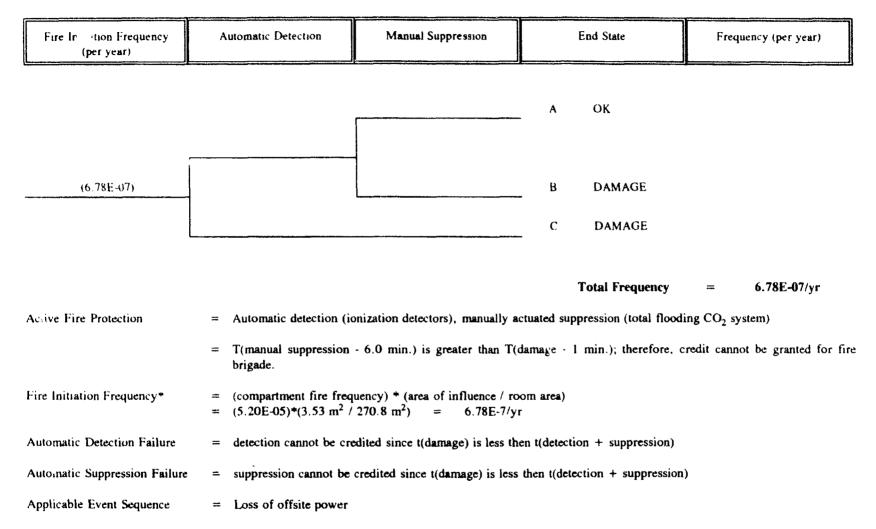
## Enclosure - Q&A to Attachment 1 Volume 05 (Section 3.0) Page 315 of 415 Figure 4-5: AX-30 (FI5) INITIATING EVENT FREQUENCY RELAY ROOM, FIRE NEAR VERTICAL CABLE TRAYS (EL 606')

"The Fire initiation frequency given in Table 4-1 is entirely due to electrical cabinets. Since it was shown in Section 4.3.1.9b that fires in the cabinets do not propagate, these are not applicable to this scenario. Instead it was assumed that the fire is from transient combustibles. This is conservative because transient combustibles in the relay room are kept to an absolute minimum. The compartment fire frequency is then:

F(t) \* WF(LS)0.0013 \* 1/25 = 5.20E-5

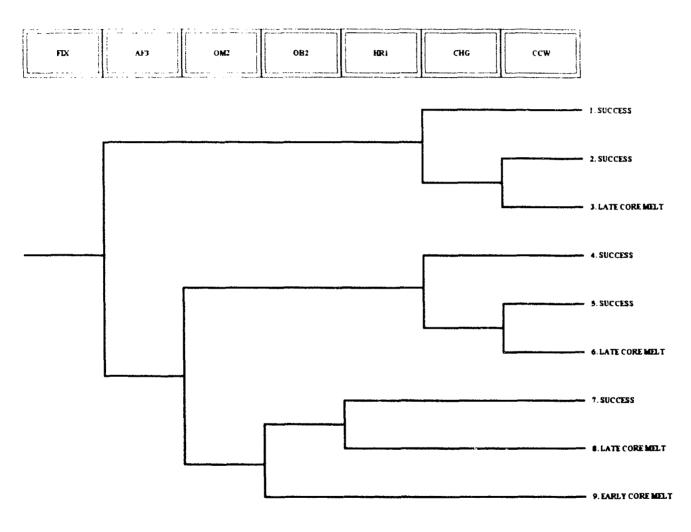
FIGURE 4 9

TRANSIENTS WITH MAIN FREDWATER AVAILABLE EVENT TREE

THIS EVENT TREE IS USED FOR FIRES FILAND FI2

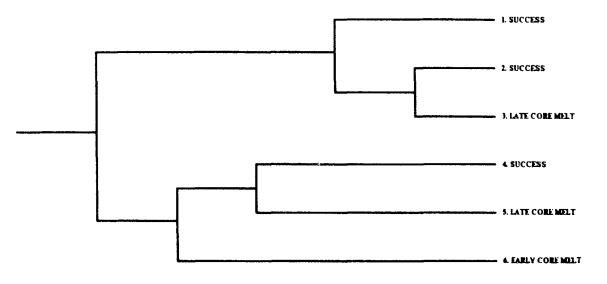
#### TRANSIENTS WITHOUT MAIN FEEDWATER EVENT TREE

THUS EVENT THEE IS USED FOR FURE FD

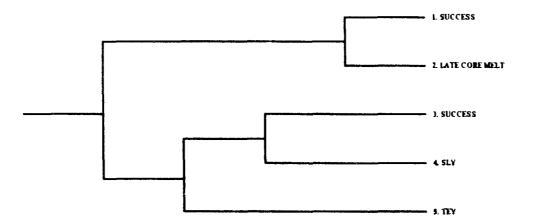
#### ALTERNATE SHUTDOWN SYSTEM EVENT TREE

THIS EVENT TREE IS USED FOR FIRES FM AND FID

"THESE NODES ARE USED IN OTHER EVENT TREES, THEY ARE CONDITIONAL HERE DUE TO THE INITIATOR.
