**Pacific Gas and  
Electric Company®**

PG&E Letter DCL-10-077

Docket No. 50-275, OL-DPR-80  
Docket No. 50-323, OL-DPR-82  
Diablo Canyon Units 1 and 2  
Response to NRC Letter dated June 21, 2010, Request for Additional Information  
(Set 5) for the Diablo Canyon License Renewal Application

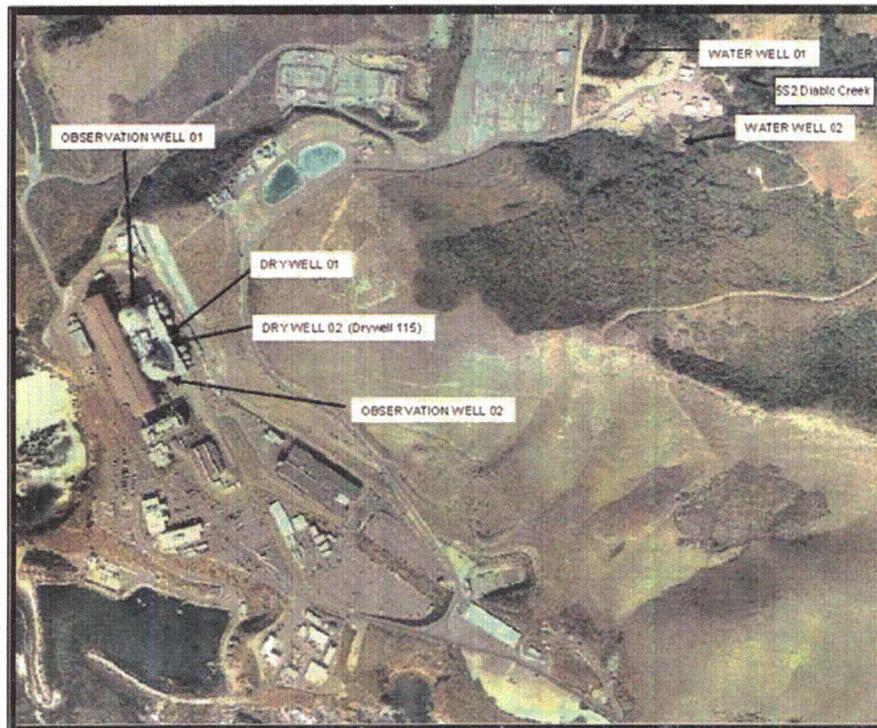
Figure - DCPG Groundwater Sampling Locations

- a) Observation Well 01 (OW1) - located inside the well room at the north end of the auxiliary building, with the wellhead at elev. 85 ft. This observation well has two "french-drain" style circuits that collect groundwater and discharge into the well. One french drain encircles Unit 1 Containment foundation at elev. 70 ft and the other is located directly under the Unit 1 Containment reactor cavity at the elev. 51.5 ft.
- b) Observation Well 02 (OW2) - located inside the well room at the south end of the auxiliary building, with the wellhead at elev. 85 ft. This observation well has two "french-drain" style circuits that collect groundwater and discharge into the well. One french drain encircles Unit 2 Containment foundation at elev. 70 ft and the other is located directly under the Unit 2 Containment reactor cavity at the elev. 51.5 ft.

- c) Dry Well 115 ft (DY1) - located outdoors, in the radiologically controlled area, near the center of the eastern wall of the auxiliary building, with the wellhead at elev. 115 ft. This sample point collects groundwater from both Dry Well 02 and Dry Well 01 (inaccessible due to blockage of the opening by structural elements), which are interconnected by four horizontal "french drains." The purpose of these wells is to relieve any hydrostatic pressure on the outside surface of the eastern wall of the auxiliary building, due to potential ground flow downwards from the slope to the east of the power block structures. Each well includes a gravity drain at elev. 90 ft, which discharges to the transformer yards (elev. 85 ft) at the north and south ends of the auxiliary building.

In support of the license renewal application (LRA), groundwater samples were collected from the three locations, on a monthly basis, from August 2008 through July 2009, and tested for PH, sulfates, and chlorides. This amount of data was considered to be sufficient for making a groundwater aggressiveness determination. A summary of the results of the groundwater sampling is provided in the table below. An evaluation of the data in the table below indicates that the groundwater is non-aggressive in the vicinity of the power block structures.
