**PILGRIM WATCH'S NOTICE TO COMMISSION REGARDING
NEW INFORMATION PERTAINING TO PILGRIM WATCH'S PETITION
FOR REVIEW OF LBP- 06-848**

On November 12, 2008, Pilgrim Watch filed with the Commission *Pilgrim Watch's Petition for Review of LBP- 06-848, LBP-07-13, LBP-06-23 and the Interlocutory Decisions in The Pilgrim Nuclear Power Station Proceeding.*

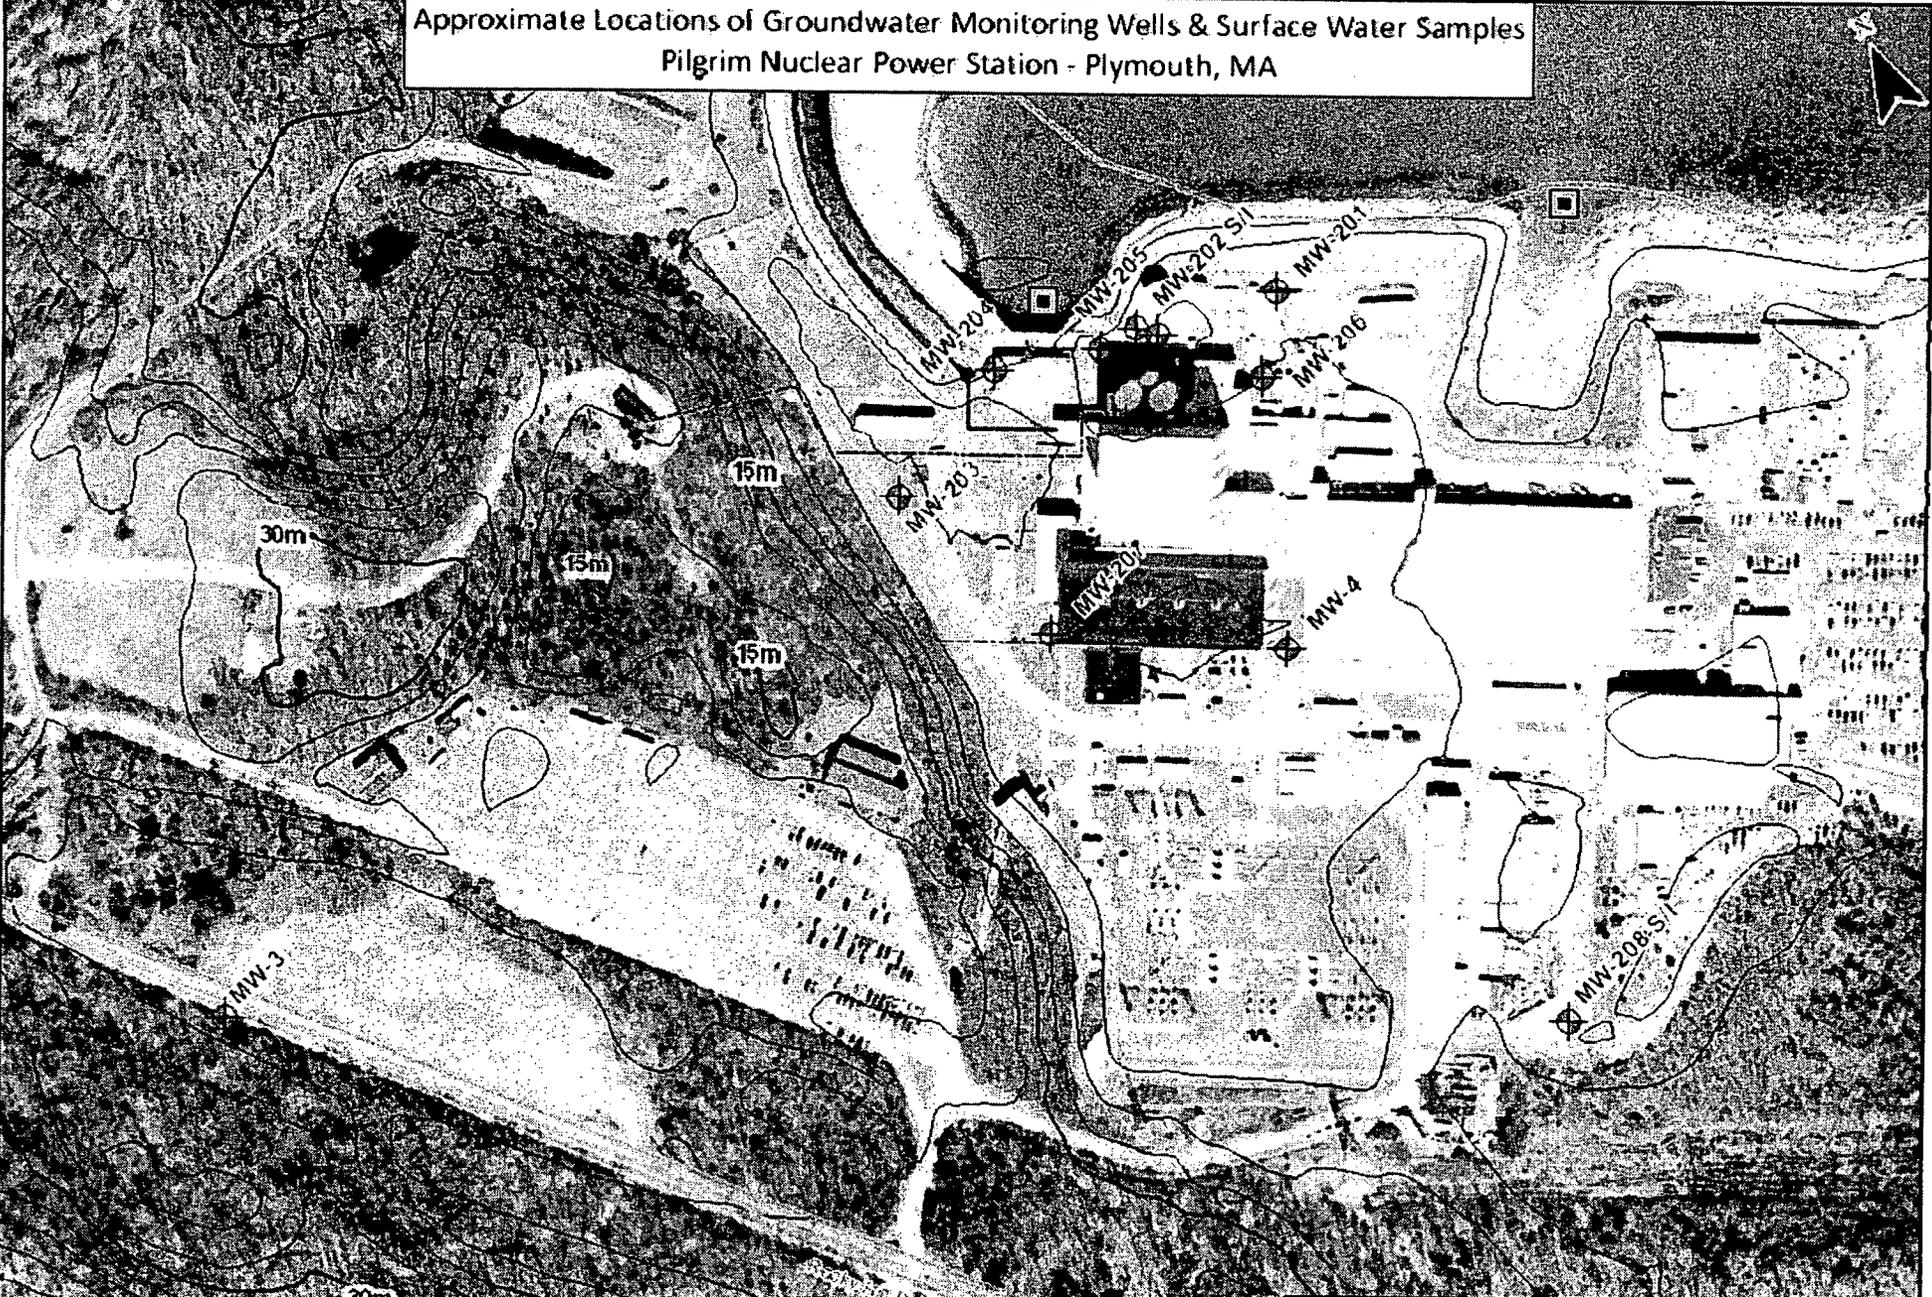
Approximate Locations of Groundwater Monitoring Wells & Surface Water Samples
 Pilgrim Nuclear Power Station - Plymouth, MA

- Groundwater Monitoring Well
- Surface Water Sampling Location
- 3 Meter Contours
- Augmented Off Gas System
- Soil Service Water System
- Local Roads
- Parcel Boundary

It is our understanding that current well locations were selected based on the general assumption that groundwater flows towards Cape Cod Bay. However, as discussed previously in this memo, localized variations in groundwater flow beneath and around the footprint of the facility have not been well characterized. PNPP’s previous consultant noted that additional data points would be needed to adequately assess horizontal and vertical gradients and flow directions across the site and in the vicinity of the structures (GZA, 2009). Thus, further assessment of site-specific hydrogeology would be required to rule out a possible cross-gradient groundwater pathway. In addition, much of the information on localized groundwater flow direction is based on information gathered prior to PNPP construction and subsurface conditions may have changed during construction and subsequent operation of the plant. Factors that could influence localized groundwater flow after construction of PNPP need to be further evaluated such as the impact of some facility structures reaching a depth below the water table and mounding of groundwater.

Although the additional groundwater monitoring wells installed in April 2010 are an enhancement to PNPP's previous groundwater monitoring efforts, given the recent sampling results and that many nuclear power plants across the country are dealing with aging underground pipes and tritium leaks in groundwater, it would be prudent for PNPP to consider installation of a few additional wells. In particular, MDPH recommends that the area along the shore east/southeast of the facility be better addressed as part of the plant's routine monitoring program. PNPP staff have reported that their consultant, ERM, Inc., is currently preparing a report that will include additional information on hydrology and potential tidal influence at PNPP. In addition, Entergy plans to hire a consultant to conduct an enhanced risk ranking of subsurface structures and underground piping at PNPP. Both of these reports are expected to be informative in helping MDPH to determine specific locations for additional groundwater monitoring wells, such as in the area east/southeast of MW-201, MW-206 and the facility buildings along the shoreline.

prevent potential off-site implications. Specifically, MDPH recommends that Entergy: 1) install at least two additional groundwater monitoring wells in the area directly east/southeast of the facility buildings to better characterize an area that currently has no monitoring wells and that may be impacted by facility operations or leaks, 2) collect surface/bay water samples from two locations in the bay between the facility shoreline and breakwater (i.e., directly down-gradient from monitoring wells MW-205, and MW-202S/I and to also sample surface water at the entrance of the breakwater) to ensure no detectable levels of tritium are present, 3) provide better characterization of site-specific groundwater flow gradients in and around PNPP subsurface structures and components (this is consistent with the NEI initiative guidelines and is reportedly being addressed with a detailed hydrogeological study being conducted by ERM), and 4) provide better characterization of possible groundwater sources of tritium (also recommended by NEI guidance and reportedly being addressed by Entergy) and documentation on the potential contribution of the licensed tritium releases including mass balance analysis and dispersion modeling.
