NUCLEAR REGULATORY COMMISSION

Title: Advisory Committee on Reactor Safeguards

Plant License Renewal Subcommitee Prairie Island Nuclear Generating Station

Date: Tuesday, July 7, 2009

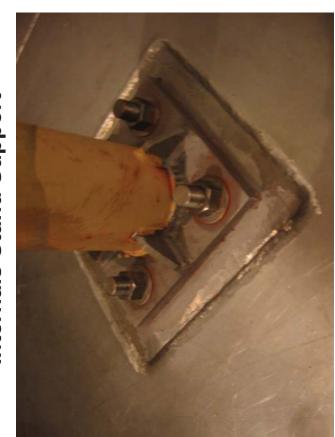
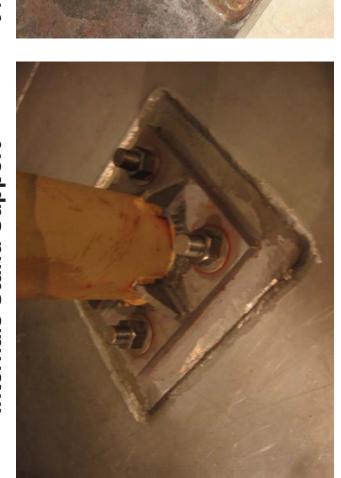
Typical Reactor Vessel Internals Stand Support

Refueling Cavity Leakage Leak Locations

- Following Most Recent Refueling Outage **Root Cause Evaluation was Performed**
- Sources of Leakage were Determined to be Stands and Rod Control Cluster Change **Embedment Plates for Reactor Internals Fixture**

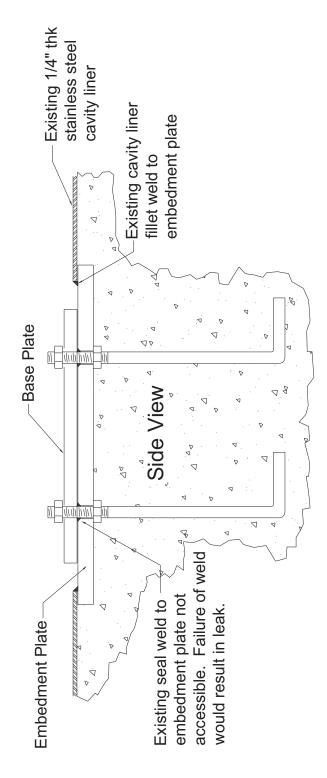
General Arrangement of Change Fixture Supports

Refueling Cavity Leakage -eak Locations

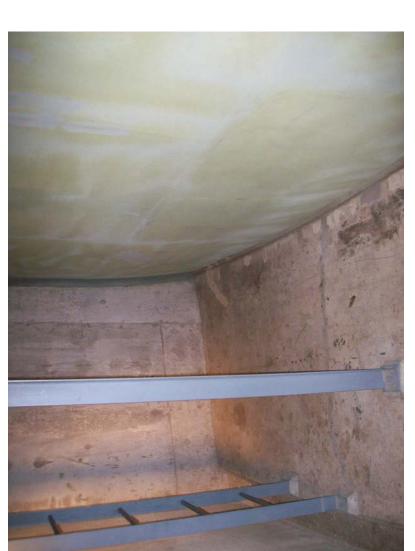
Shield Building Annulus

annulus was performed.
Scanned 18' long x 2' high area with all readings above 1.5 inch nominal plate thickness. UT exam of containment vessel from
