Entergy Nuclear Operations, Inc. )  
(Indian Point Nuclear Generating )  
Units 2 and 3) )

Docket Nos.  
50-247-LR  
and 50-286-LR

**RIVERKEEPER OPPOSITION TO ENTERGY'S MOTION  
FOR SUMMARY DISPOSITION OF RIVERKEEPER TECHNICAL  
CONTENTION 2 (FLOW-ACCELERATED CORROSION)**

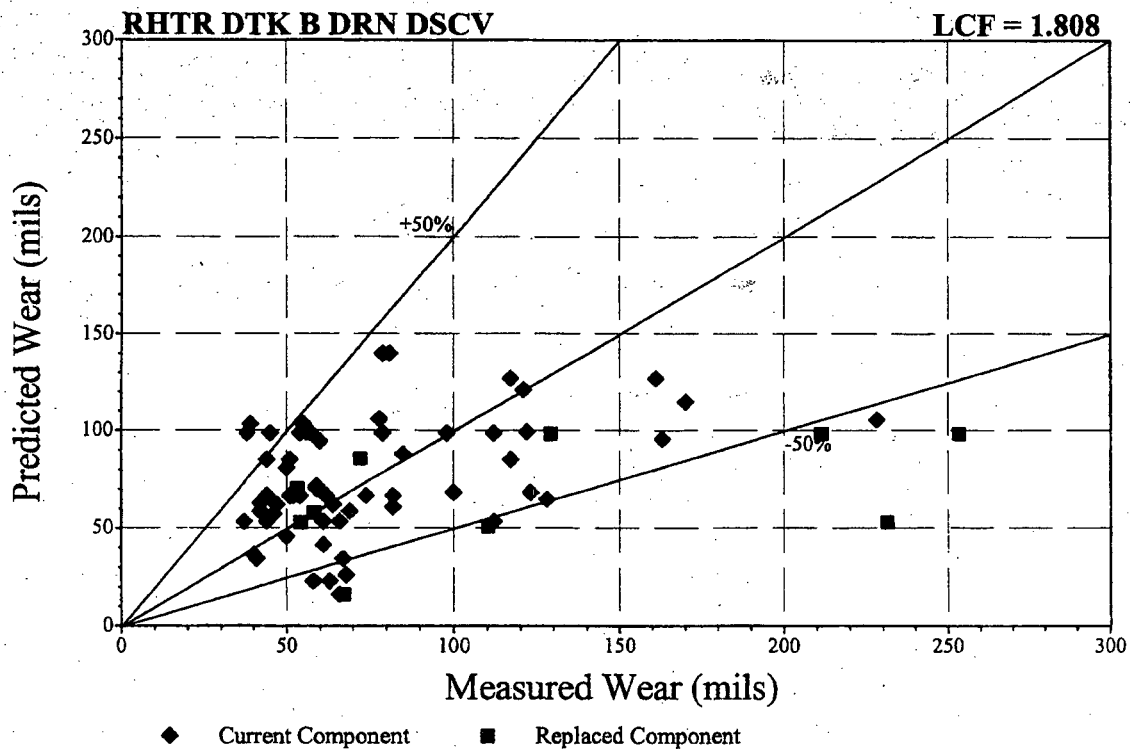
FIGURE 3

### Comparison of Wear Predictions

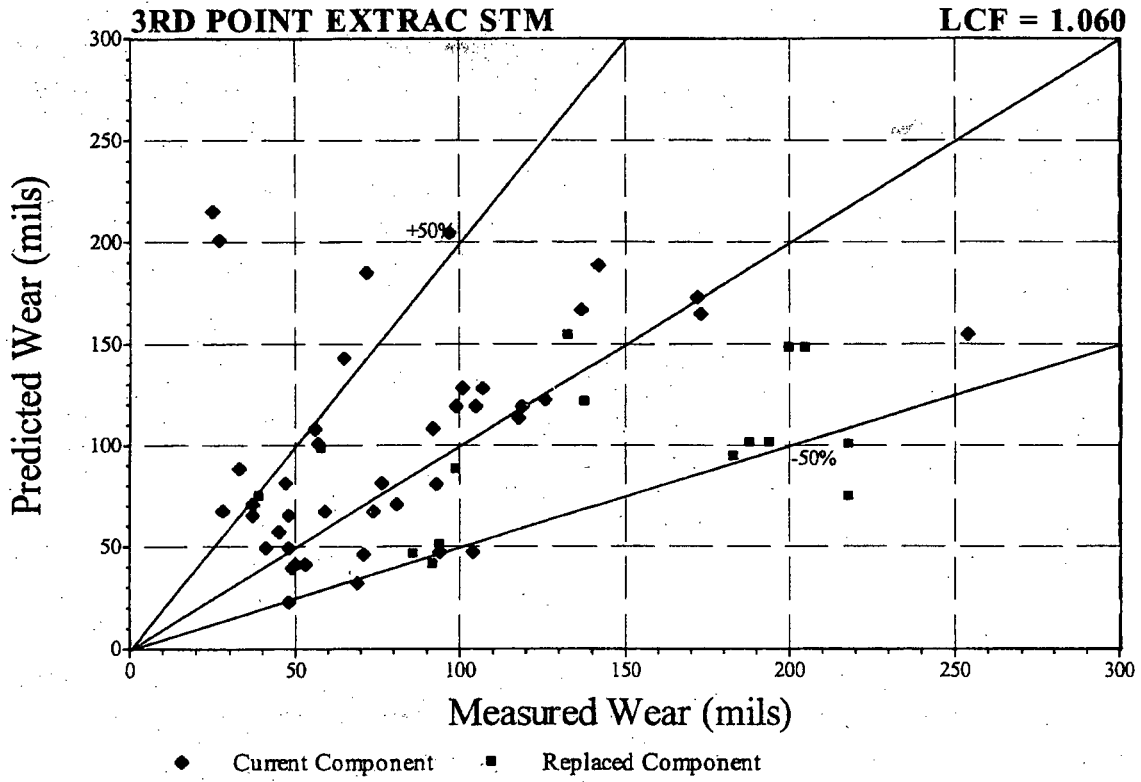
FIGURE 4

### Comparison of Wear Predictions

Many of these graphs show that points outside these two lines can deviate by as much as a factor of +/- 10. *See Attach. 7.* For example, the data point furthest to the left in Figure 4

represents an actual measured wall thickness of a given component of about 20 mills (abscissa) while the corresponding CHECWORKS prediction was over 200 mills. On the other hand, Figure 7 shows that the predicted wall thickness of the data point furthest to the right in the figure was about 10 mills while the corresponding measured value was over 100 mills. Thus, CHECWORKS can either under-predict or over-predict FAC by a factor of 10 or 1000%. It is, thus, apparent, and my expert opinion, that CHECWORKS cannot predict FAC to any degree of accuracy. Considering that typically, wall thinning rates in pressurized water reactors range from 5 to 50 mills per year, and the wall thickness of the components ranges between 300 to 1000 mills, one would expect that more and more components would become prone to failures after 40 years of service. In my professional opinion, the margin of error in CHECWORKS predictions is too large and, therefore, CHECWORKS is not a reliable tool for identifying locations for inspections.

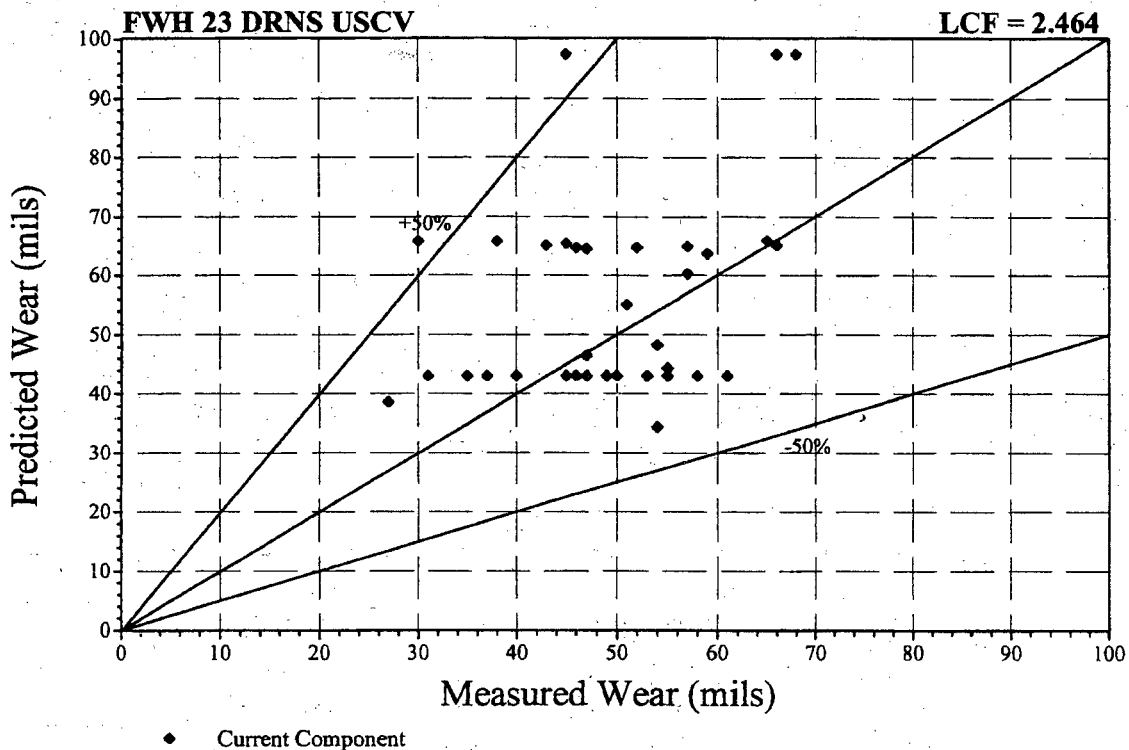
FIGURE 5

### Comparison of Wear Predictions

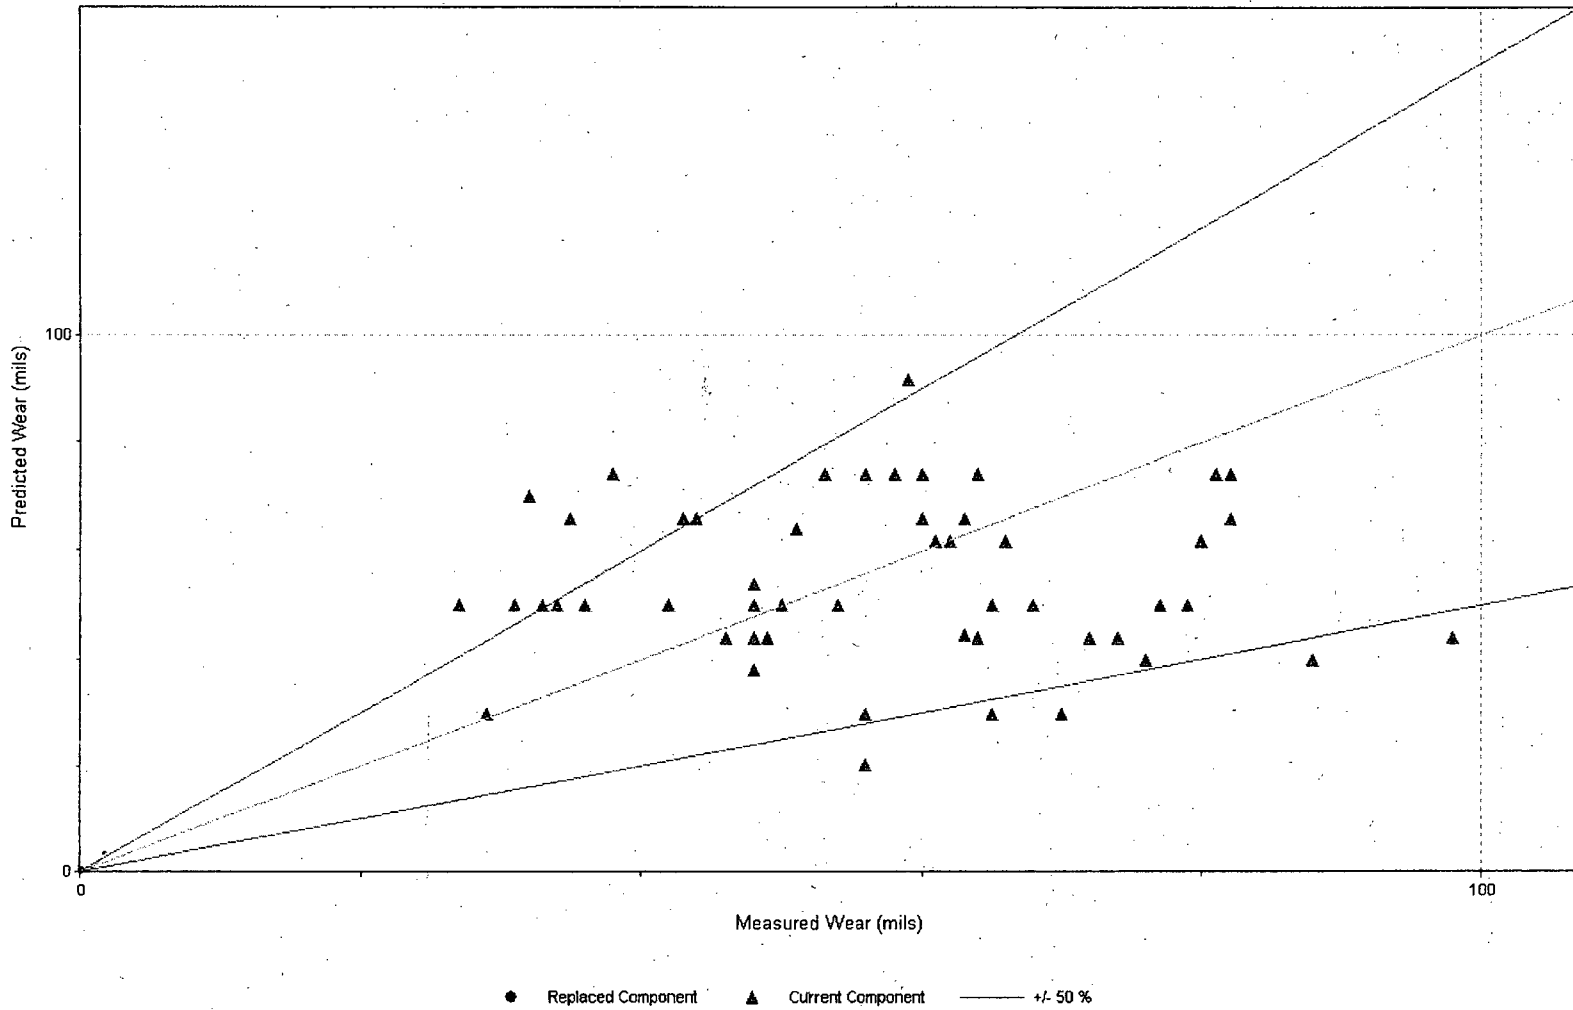
FIGURE 6

Comparison of Wear Predictions - RHTR DRN TK 21A USCV @CYCLE 19

LCF = 1.03313

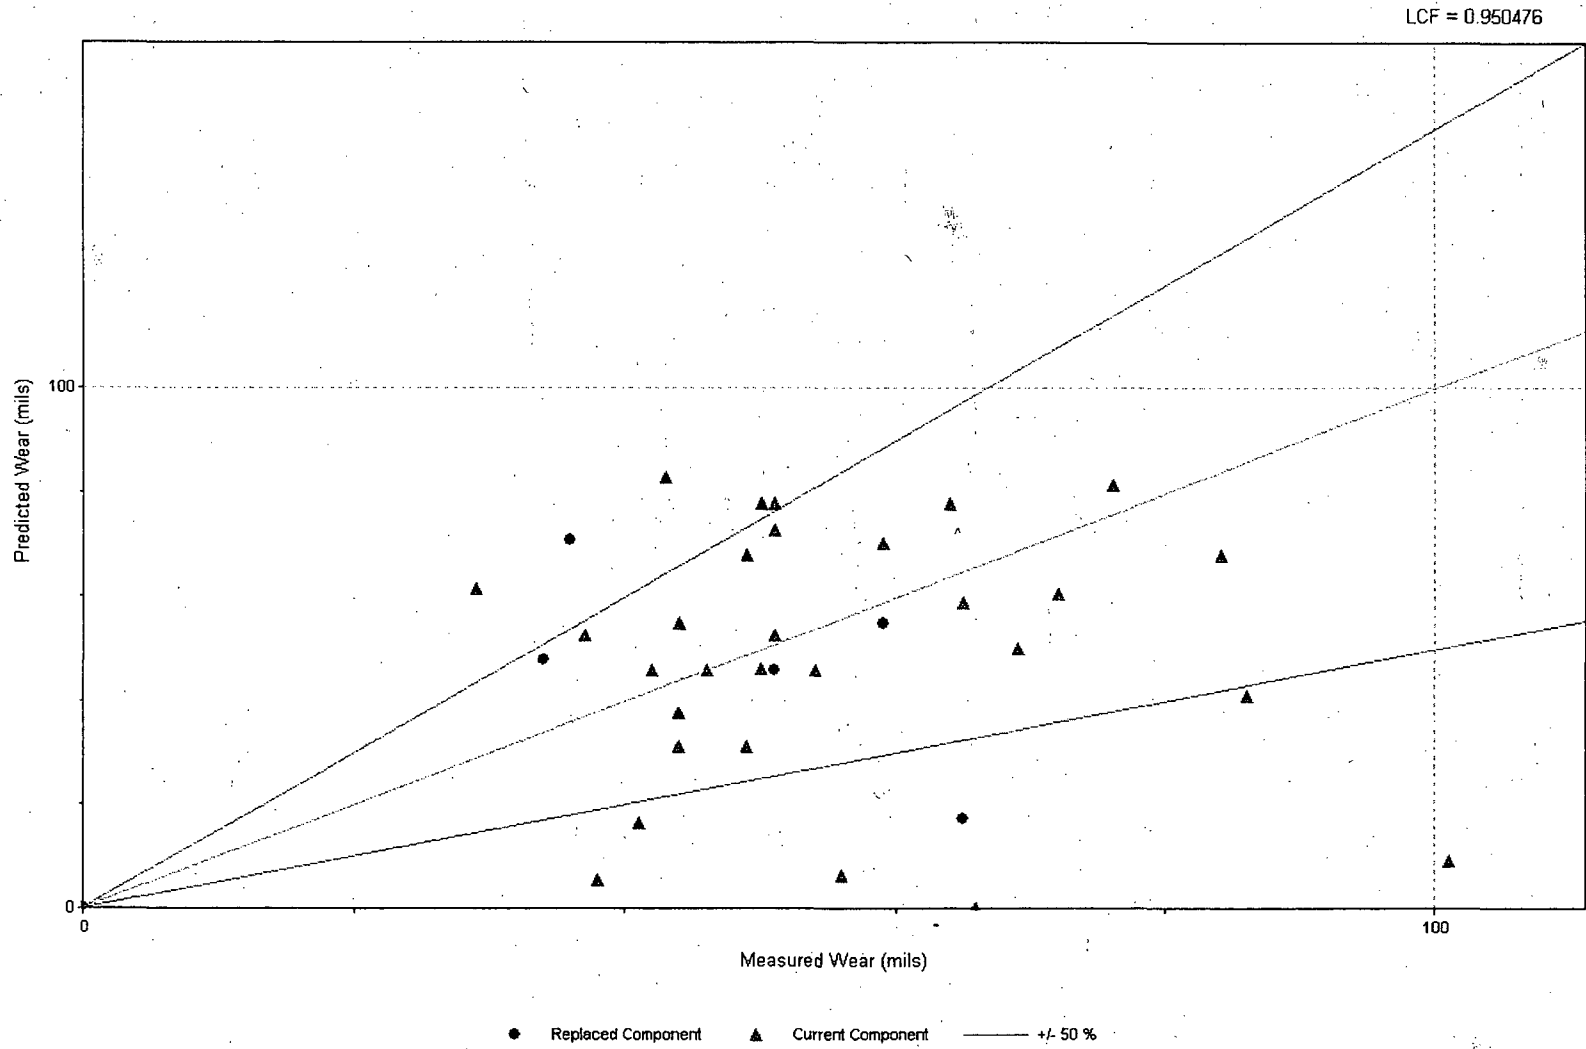
FIGURE 7

Plot J.32: RHTR DRN TK 23B USCV

Comparison of Wear Predictions - RHTR DRN TK 23B USCV @CYCLE 19

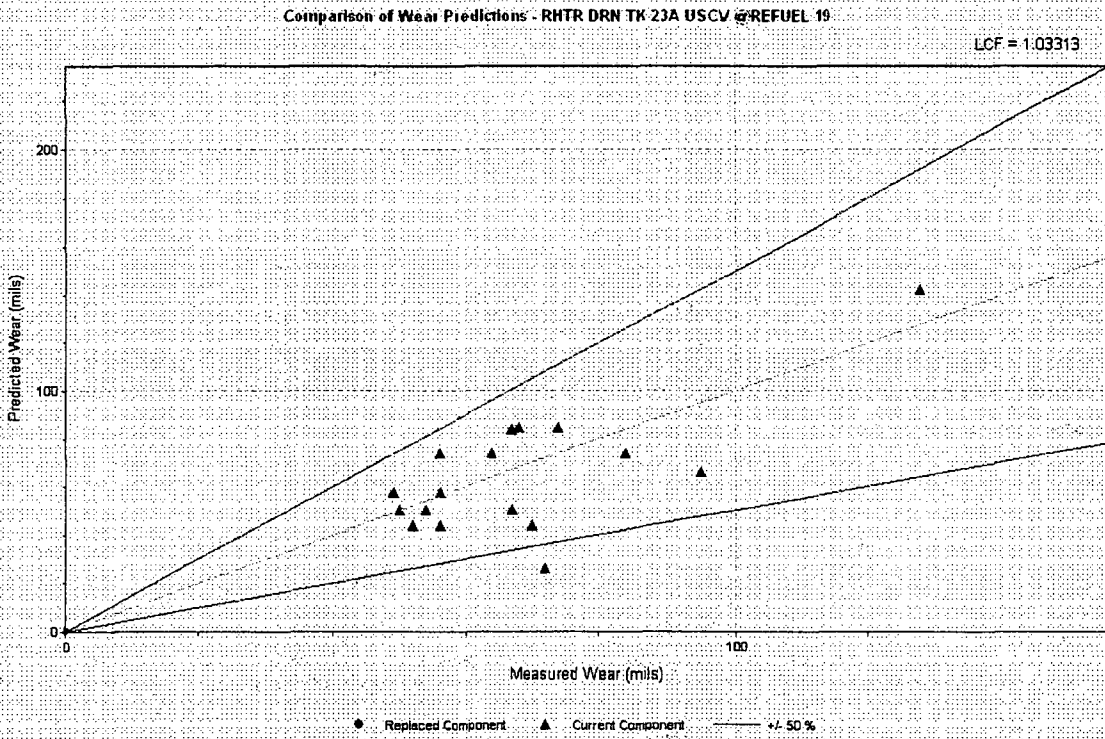
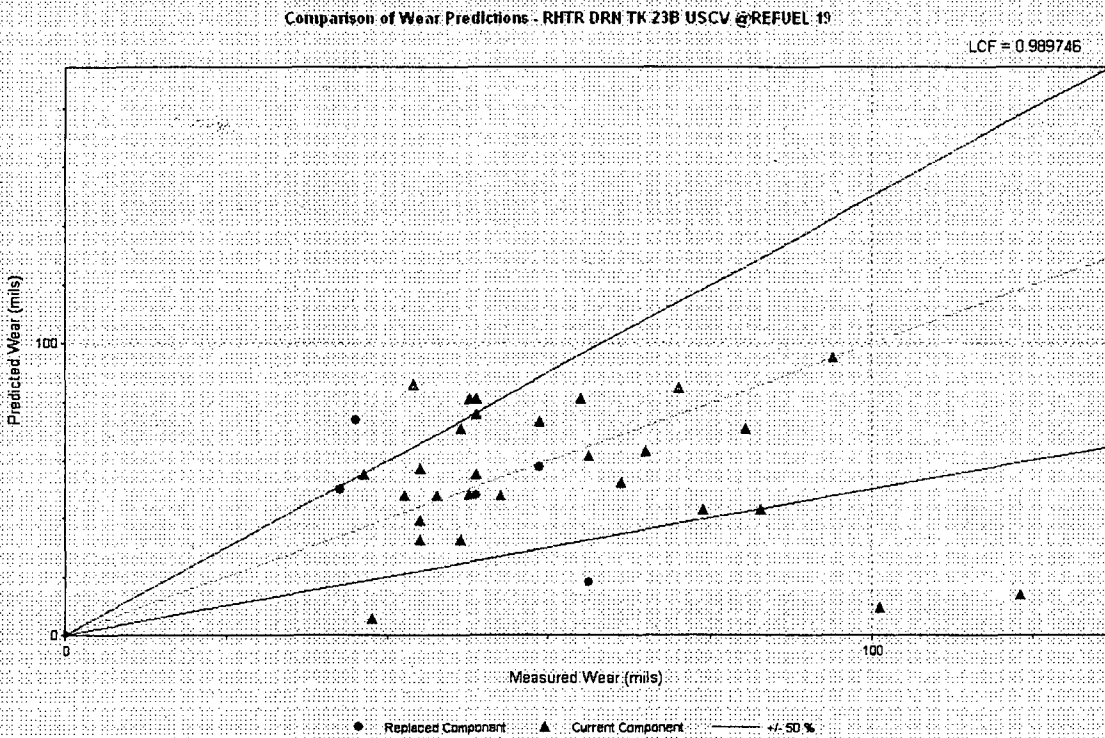
# FIGURE 8

### Plot J.35: RHTR DRN TK 23A USCV

### Plot J.36: RHTR DRN TK 23B USCV

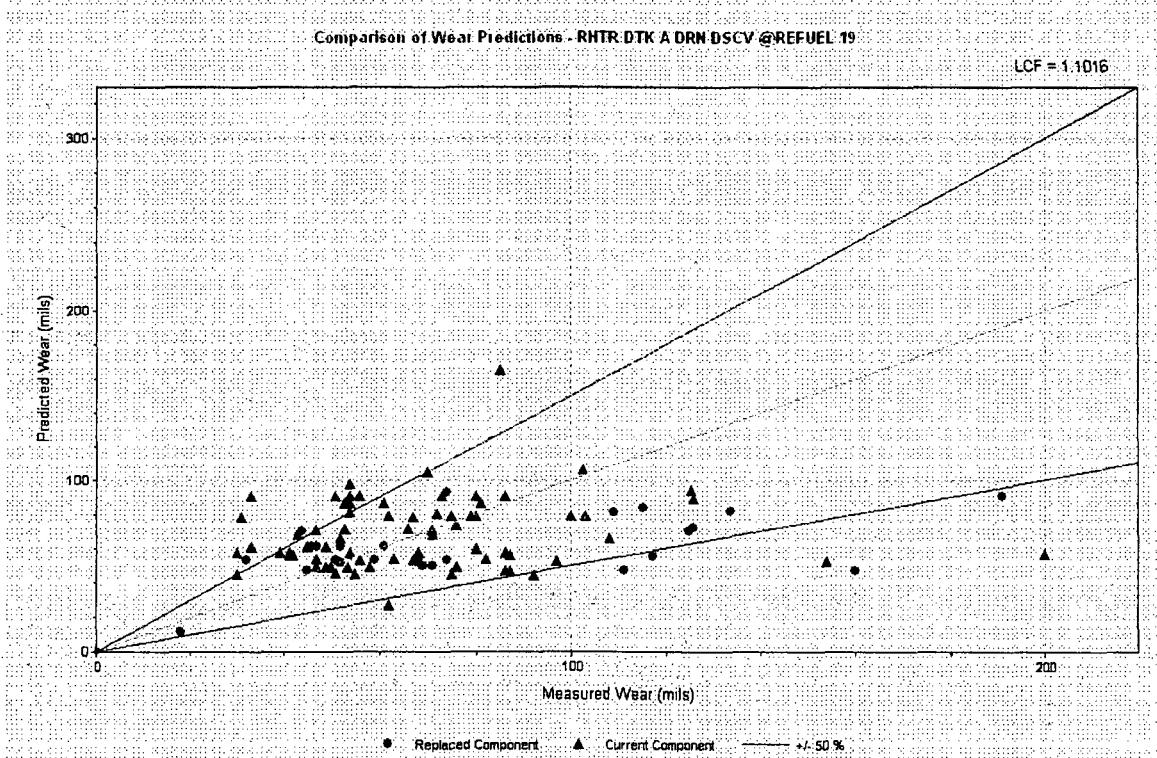
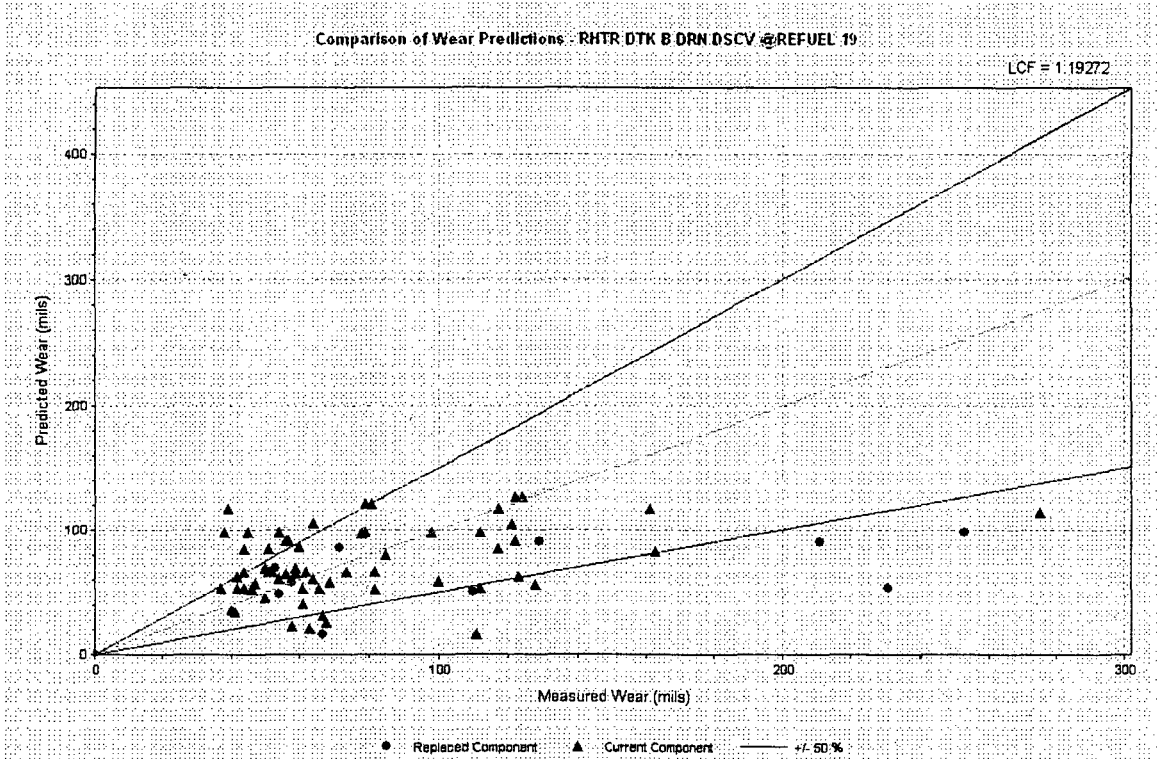
FIGURE 9

Plot J.37: RHTR DTK A DRN DSCV

Plot J.38: RHTR DTK B DRN DSCV

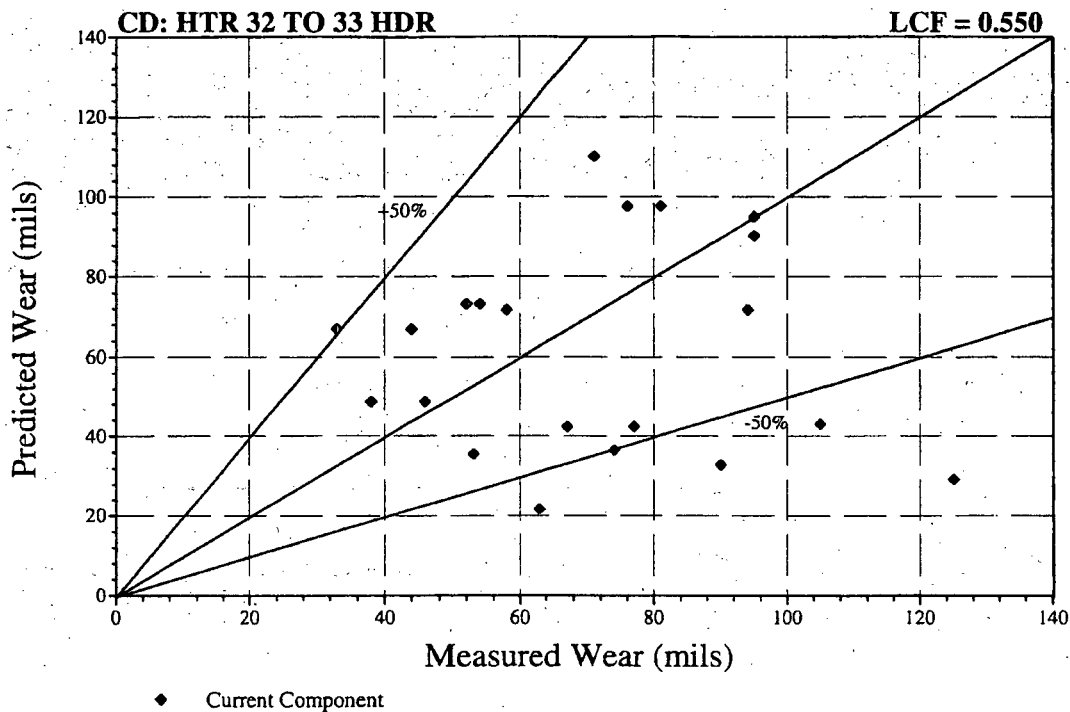
FIGURE 10

### Comparison of Wear Predictions

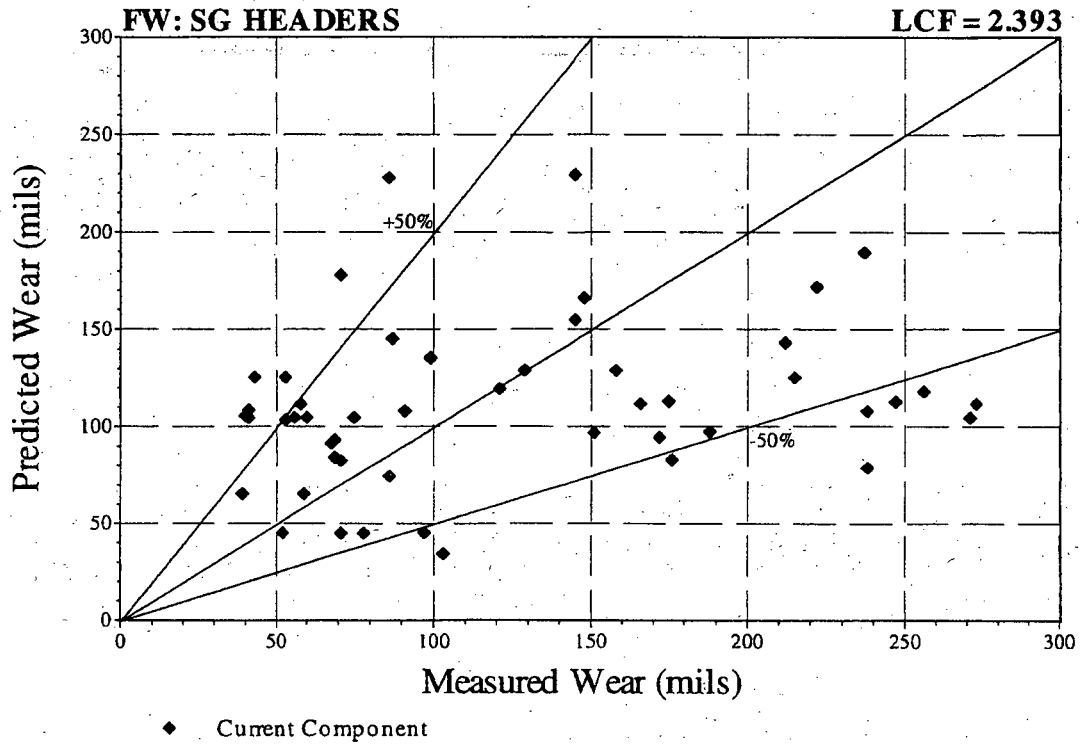
FIGURE 11

### Comparison of Wear Predictions

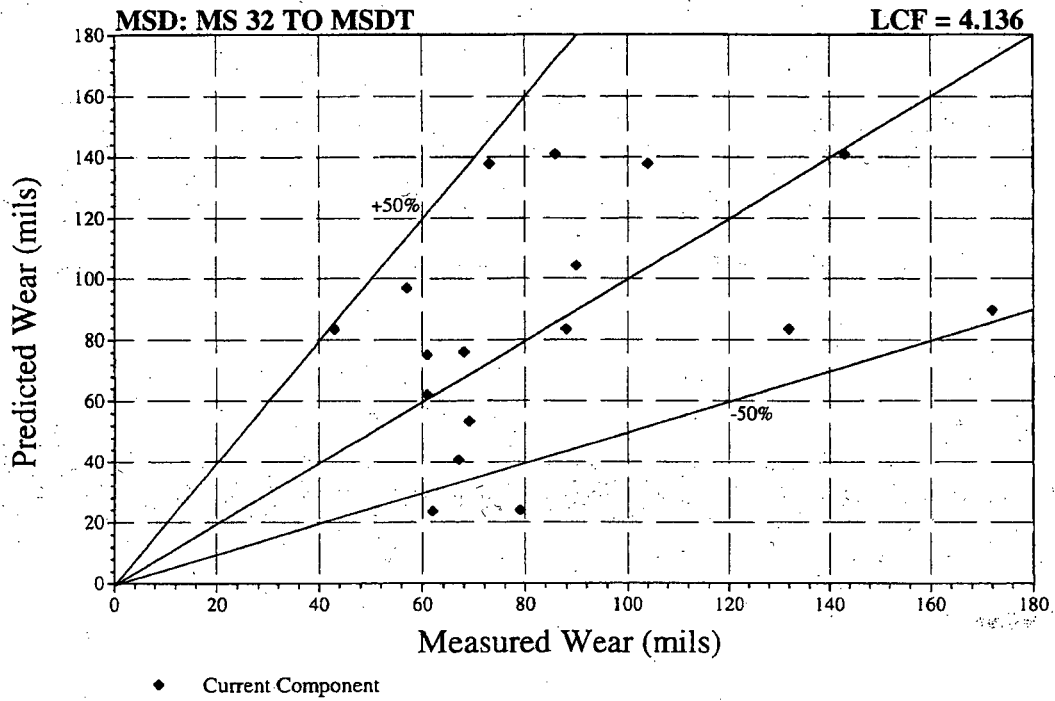
FIGURE 12

### Comparison of Wear Predictions

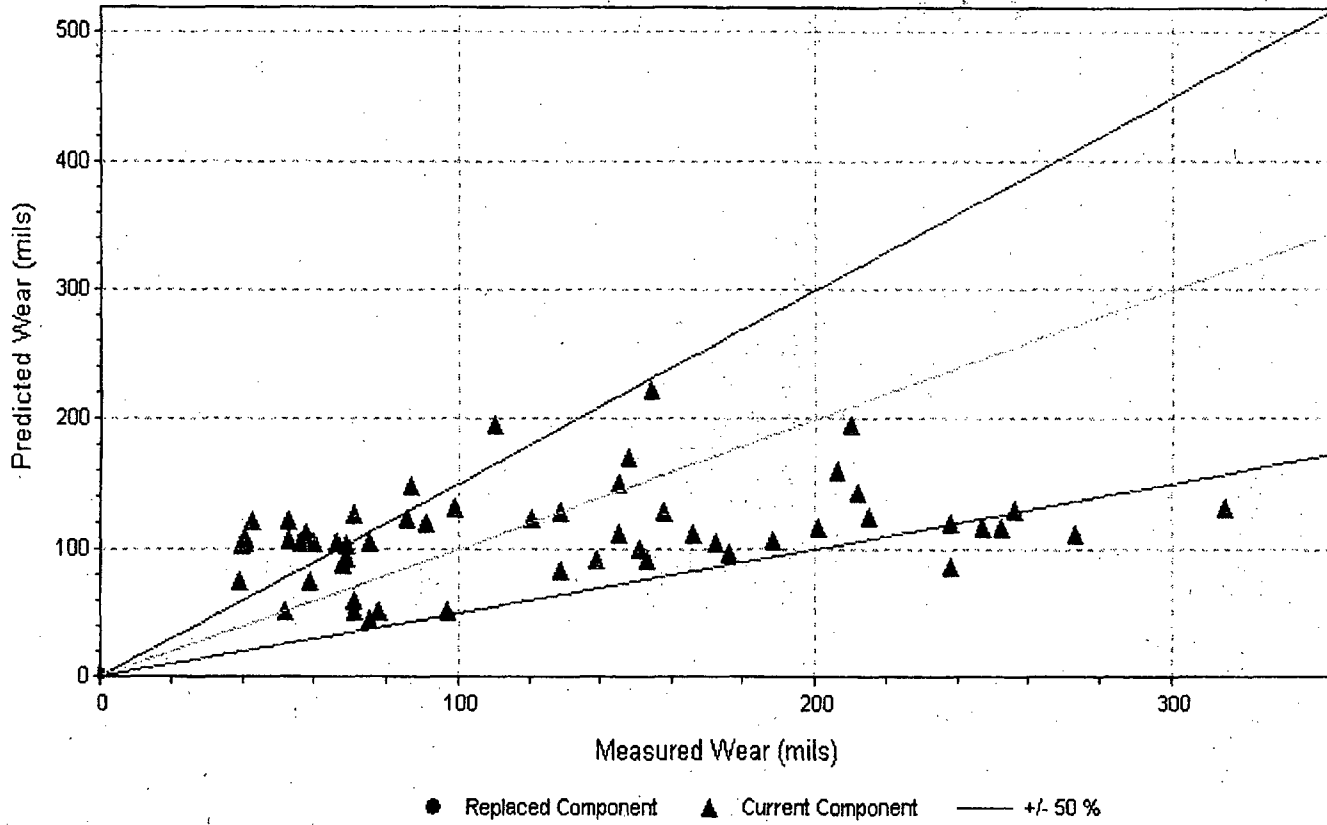
FIGURE 13

Comparison of Wear Predictions - FW: SG HEADERS @Cycle 15

LCF = 3.42342

The LCF indicates the degree to which CHECWORKS over or under-predicts wear. A reasonable LCF should be between 0.5 and 2.5 [7.8]. An LCF outside this range may be the result of inaccuracies in the model (e.g., incomplete chemistry history) or non-representative inspection data.

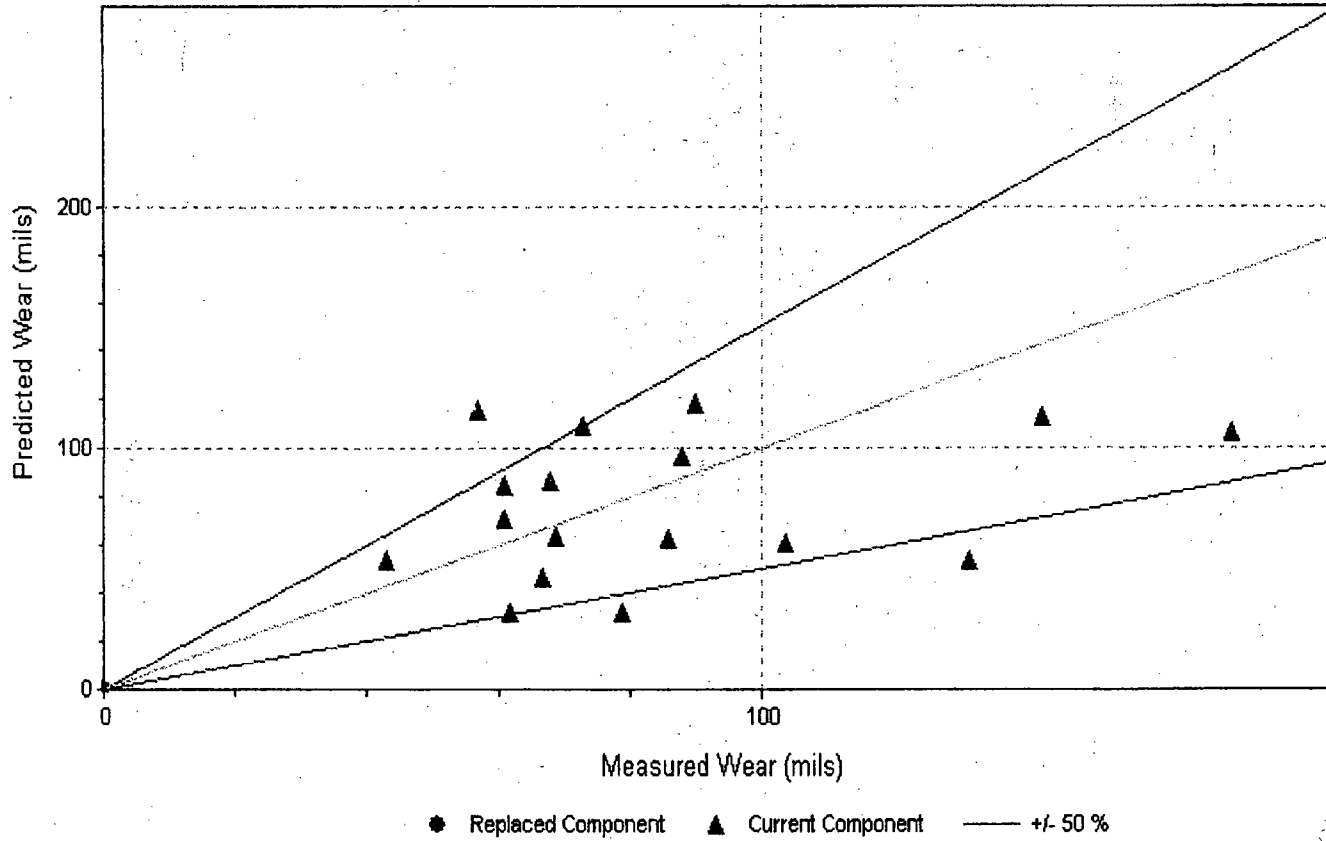
FIGURE 14

Comparison of Wear Predictions - MSD: MS 32 TO MSDT @Cycle 15

LCF = 13.9913

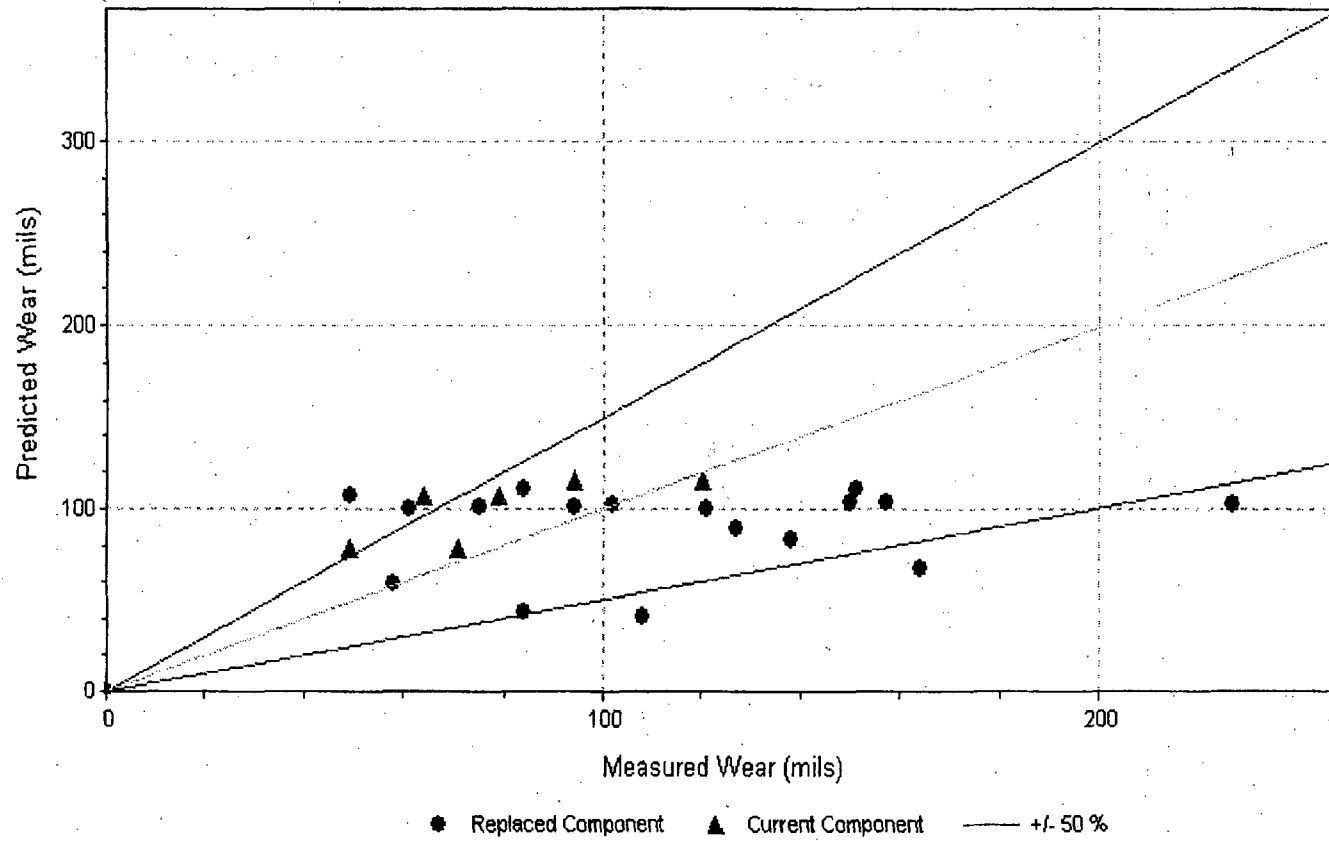
FIGURE 15

Comparison of Wear Predictions - MSD: MSDT 33 TO HDT @ Cycle 15

LCF = 3.76998

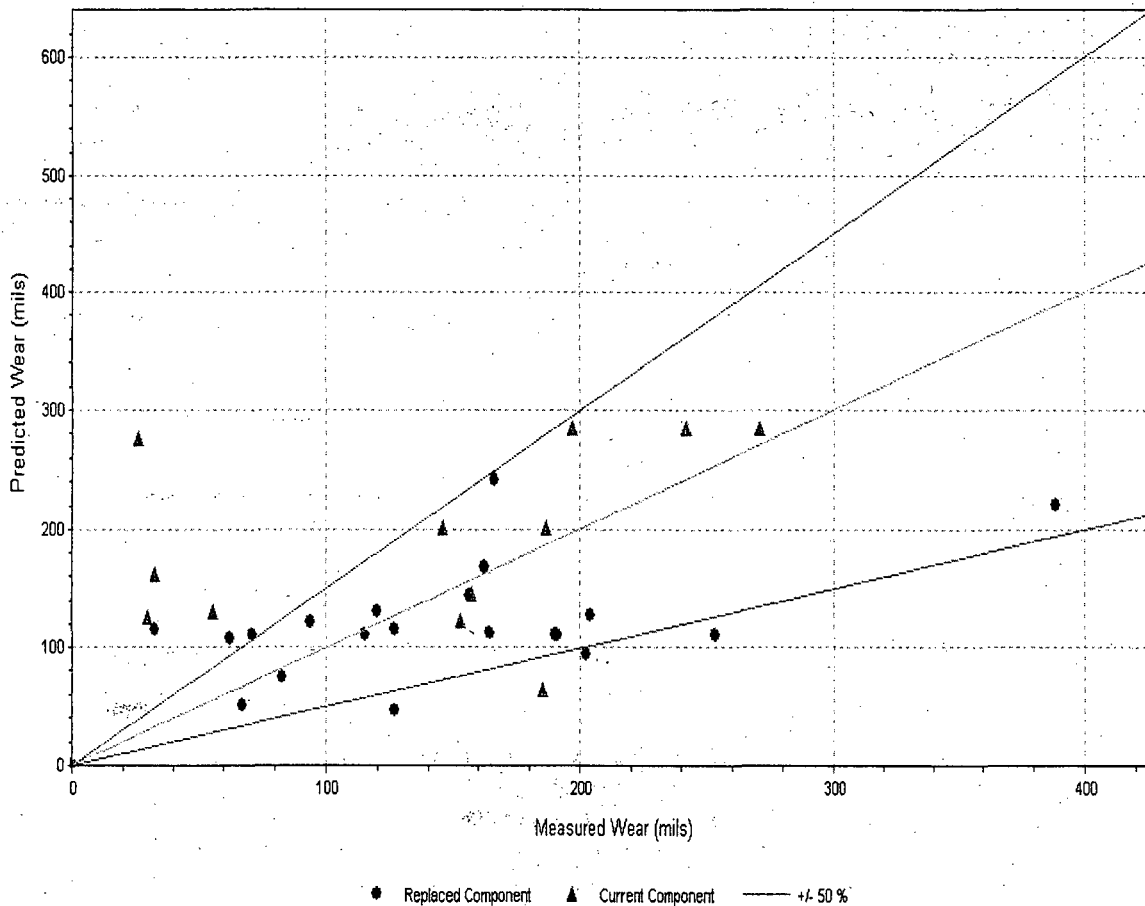
Comparison of Wear Predictions - ES: PRESEP TO 35 HDR @Cycle 16

LCF = 2.06052

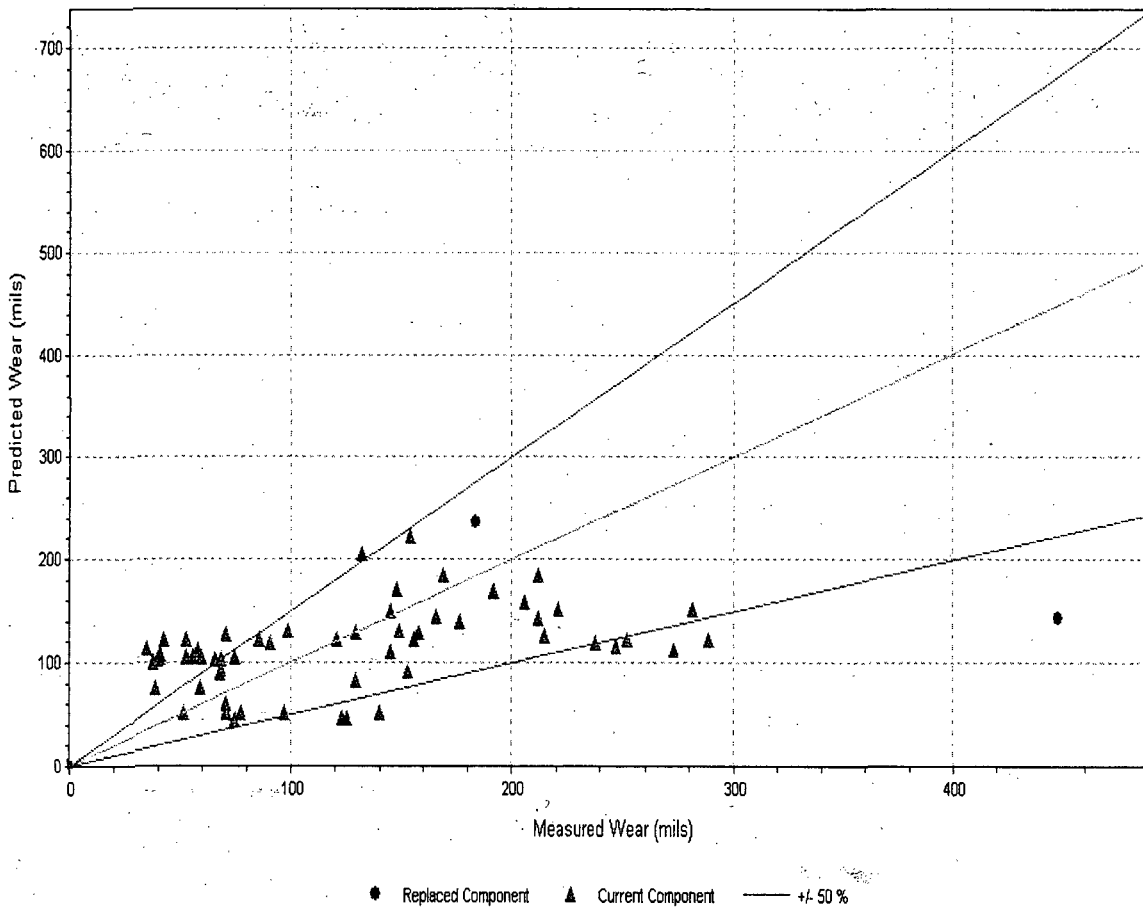
Plot J.23: FW: SG HEADERS

Comparison of Wear Predictions - FW: SG HEADERS @Cycle 16

LCF = 3.42342

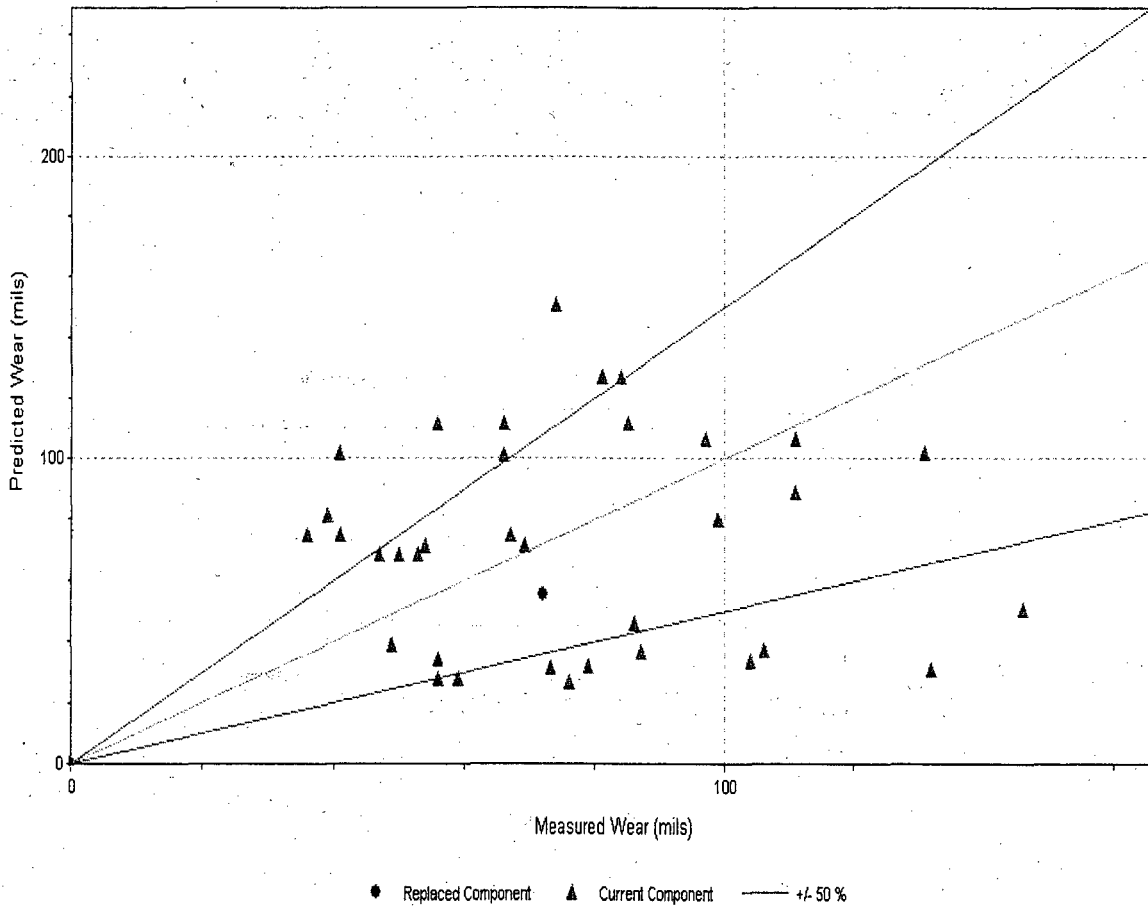
Plot J.41: RHD: RH 32B TO HDR

Comparison of Wear Predictions - RHD: RH 32B TO HDR @Cycle 16

LCF = 2.93243
