SUBJECT: Technical Specification 5.6.7 - IP2 Steam Generator Tube Inspection Report -
Spring 2010 Refueling Outage
Indian Point Unit No. 2
Docket No. 50-247
License No. DPR-26

**Steam Generator Examination Program Results
2010 Refueling Outage (2R19)**

Steam Generator Landmark Information

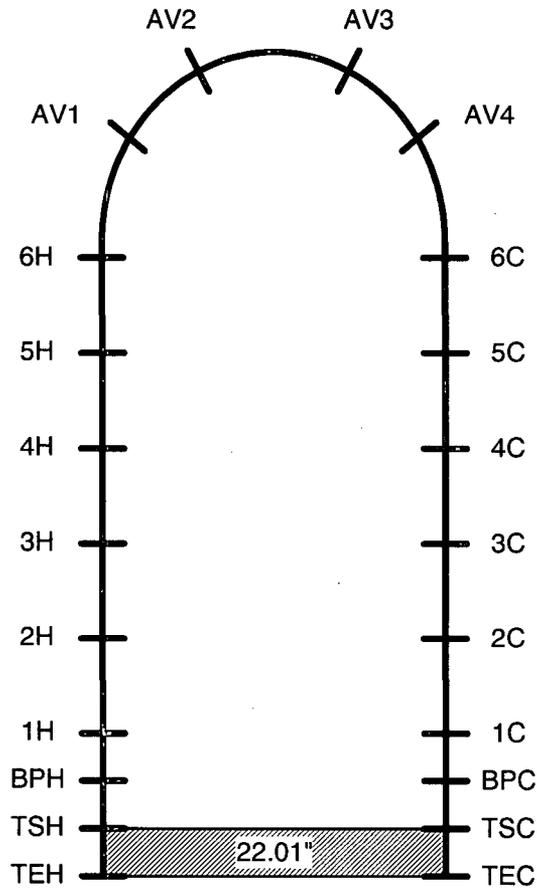
**Indian Point 2
Steam Generator
Location Landmarks**

Westinghouse Model 44F
Steam Generator
