CR #: 632816

Root Cause Analysis

1. **Title:** High Winds Caused Tritiated Water from West Waste Water Treatment (TR) Lagoon to Spill onto the Ground due to procedural inadequacies and cross contamination.
2. **Unit(s):** Braidwood Unit 0
3. **Event Date:** 05/23/07
Event Time: 1055
4. **Action Tracking Item Number:** 632816
Report Date: August 16, 2007
5. **Sponsoring Managers:** John Moser, RP Manager
6. **Investigators:**
 - Dan Morse - RP (Team Leader) Root Cause Qualified
 - Roxana Taylor - Maintenance, Root Cause Qualified
 - Scott Butler - Training, Root Cause Qualified
 - James Crawford - Maintenance, Root Cause Qualified
 - Bob Claes - Chemistry
 - Brian Bergmann - Operations
 - Jim Gosnell - Engineering
 - Dave Kapinus - Project Management
 - Karen Eppers - Organizational Specialist
 - Tim Meents - Chemistry
 - Sondra Massey - Security (Developmental Root Cause Personnel)
7. **Executive Summary:**

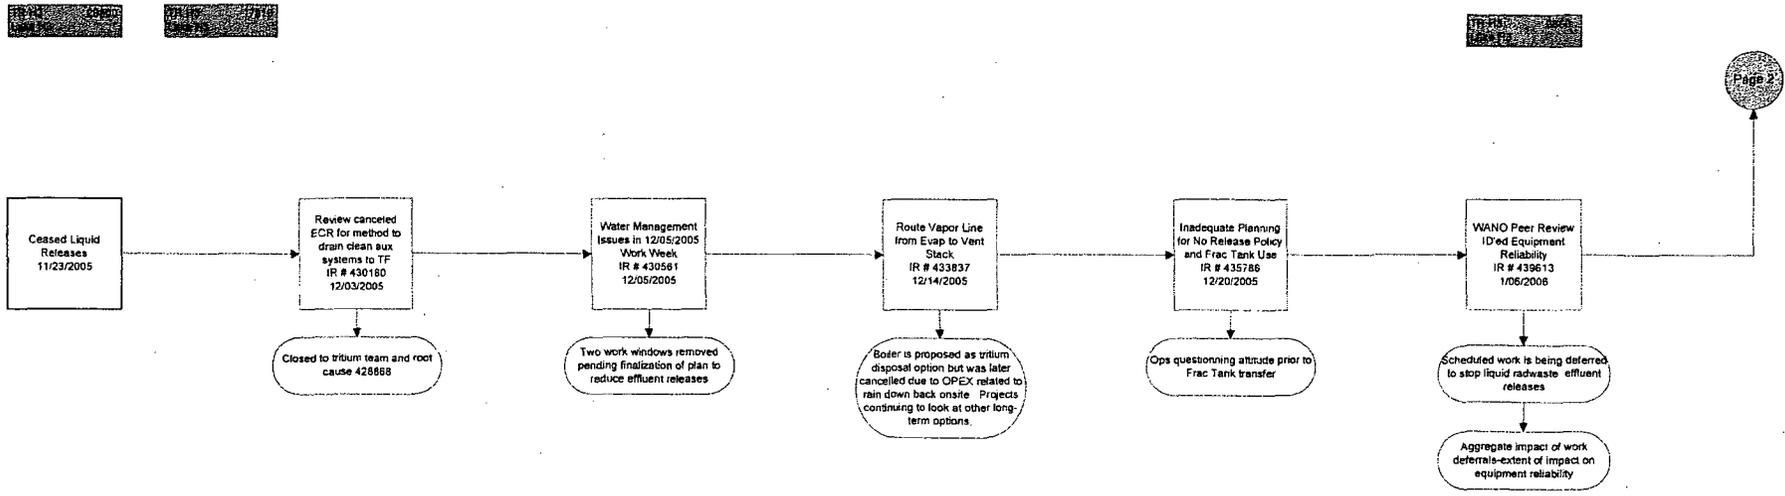
Event and Causal Factor Chart
TR Lagoon/Tritium Recycle
Root Cause Report
IR# 632816

Blue boxes represent Tritium levels
circles represent a trail to another page.
Failed barrier

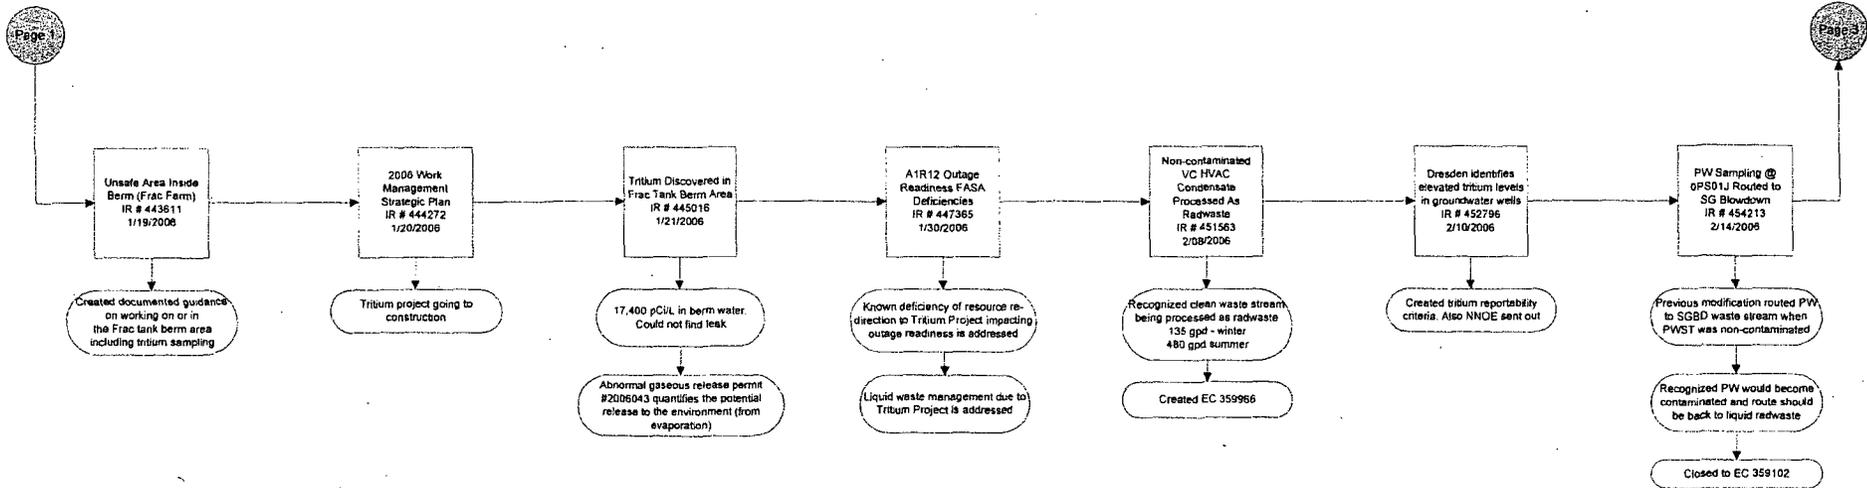
Event and Causal Factor Chart
 TR Lagoon/Tritium Recycle
 Root Cause Report
 IR# 632816

Blue boxes represent Tritium levels
 circles represent a trail to another page.
 Failed barrier

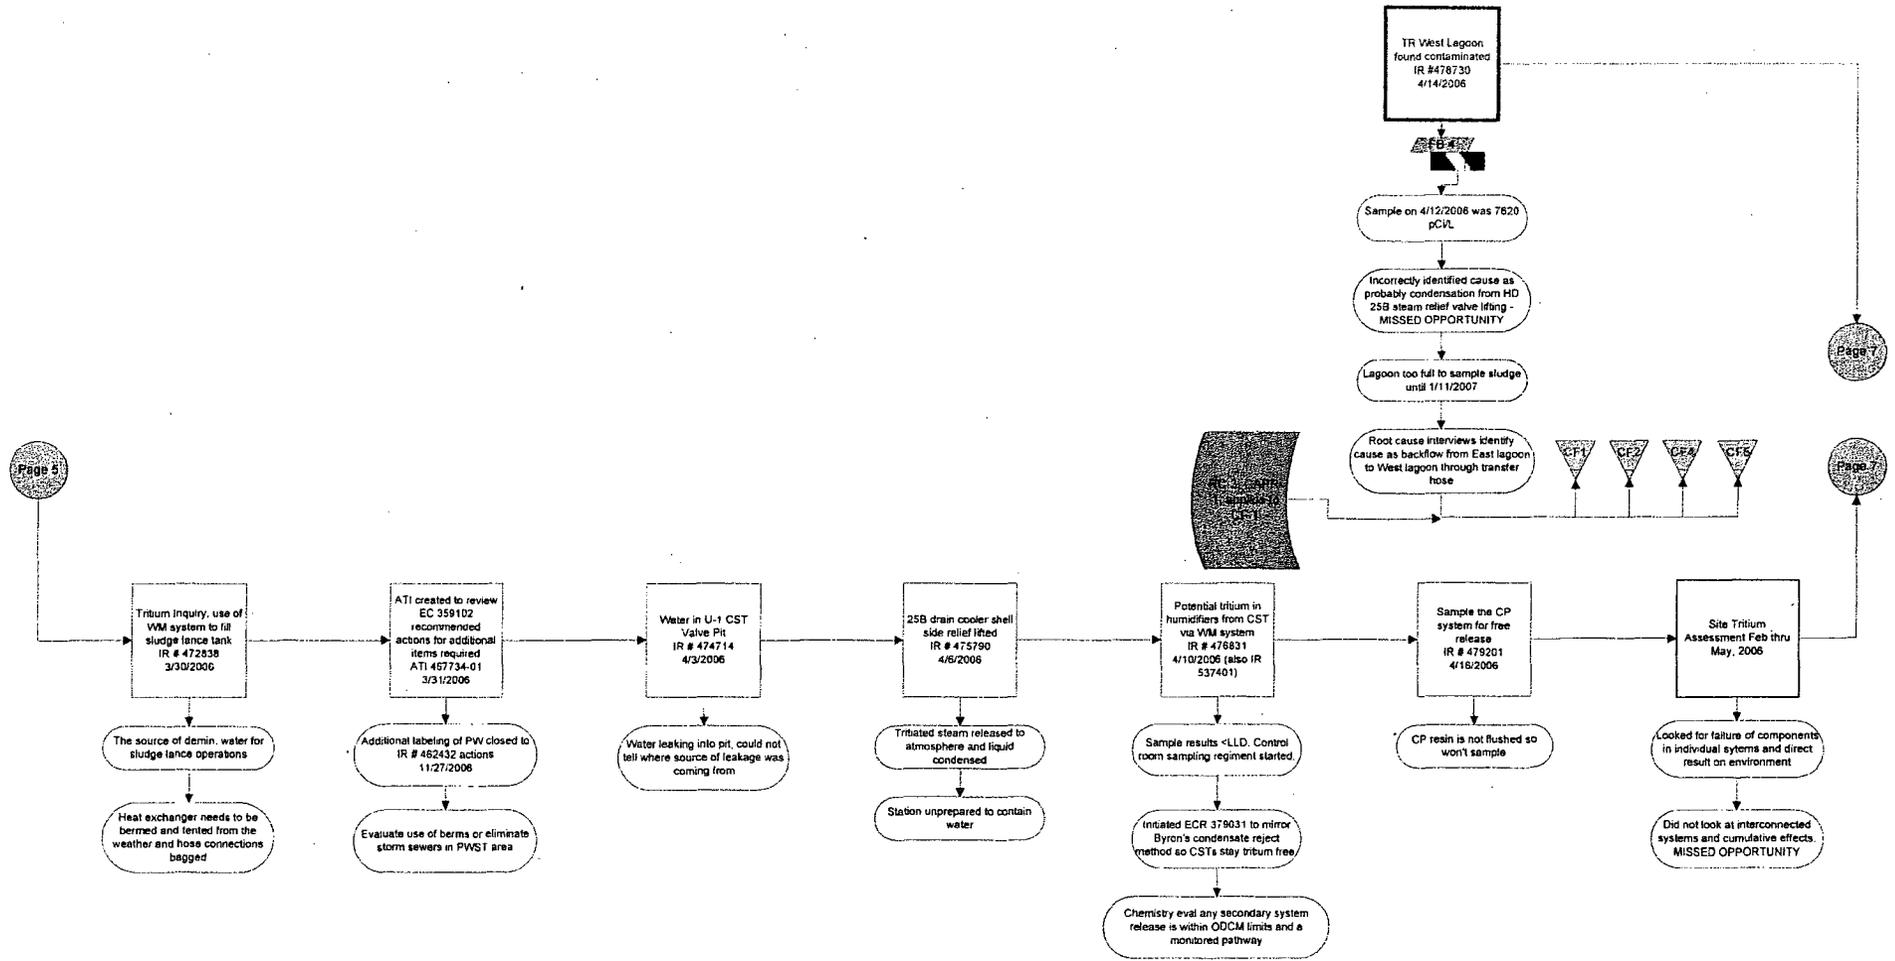
Event and Causal Factor Chart
 TR Lagoon/Tritium Recycle
 Root Cause Report
 IR# 632816

Blue boxes represent Tritium levels
 circles represent a trail to another page.
 Failed barrier

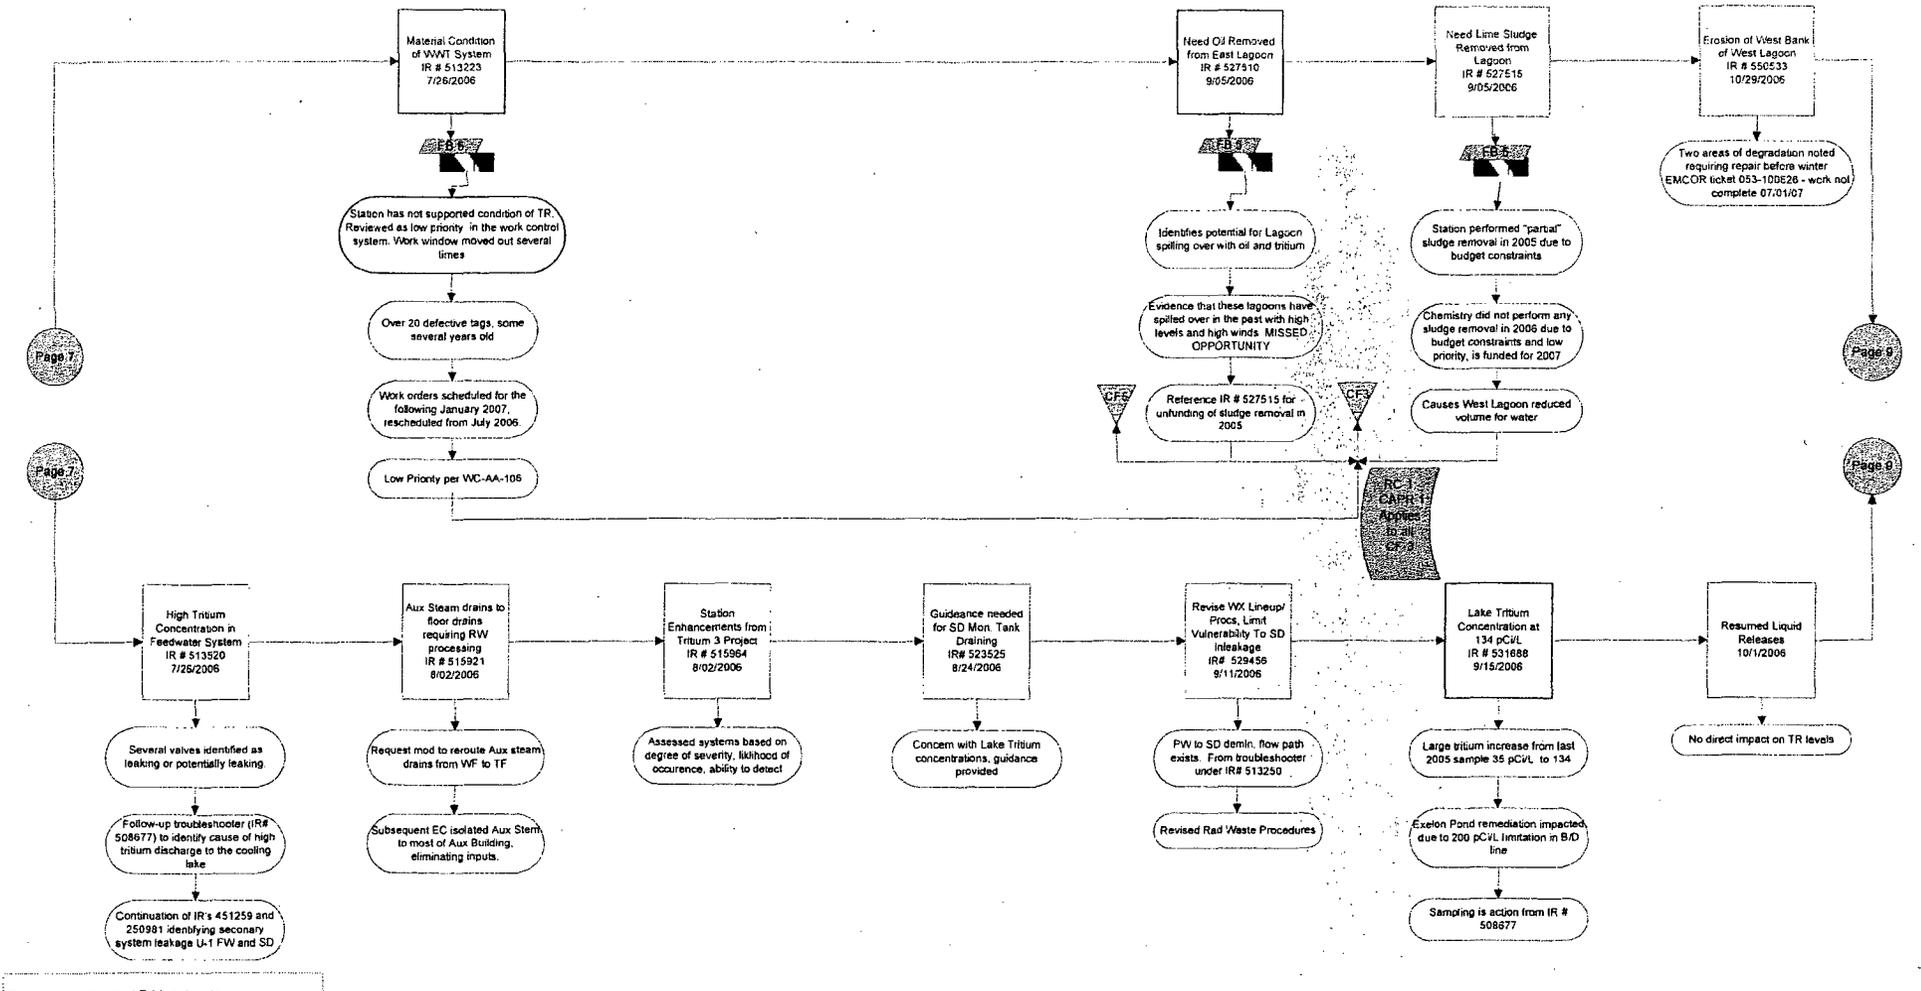
Event and Causal Factor Chart
TR Lagoon/Tritium/Recycle
Root Cause Report
IR# 632816

Blue boxes represent Tritium levels
circles represent a trail to another page.
Failed barrier

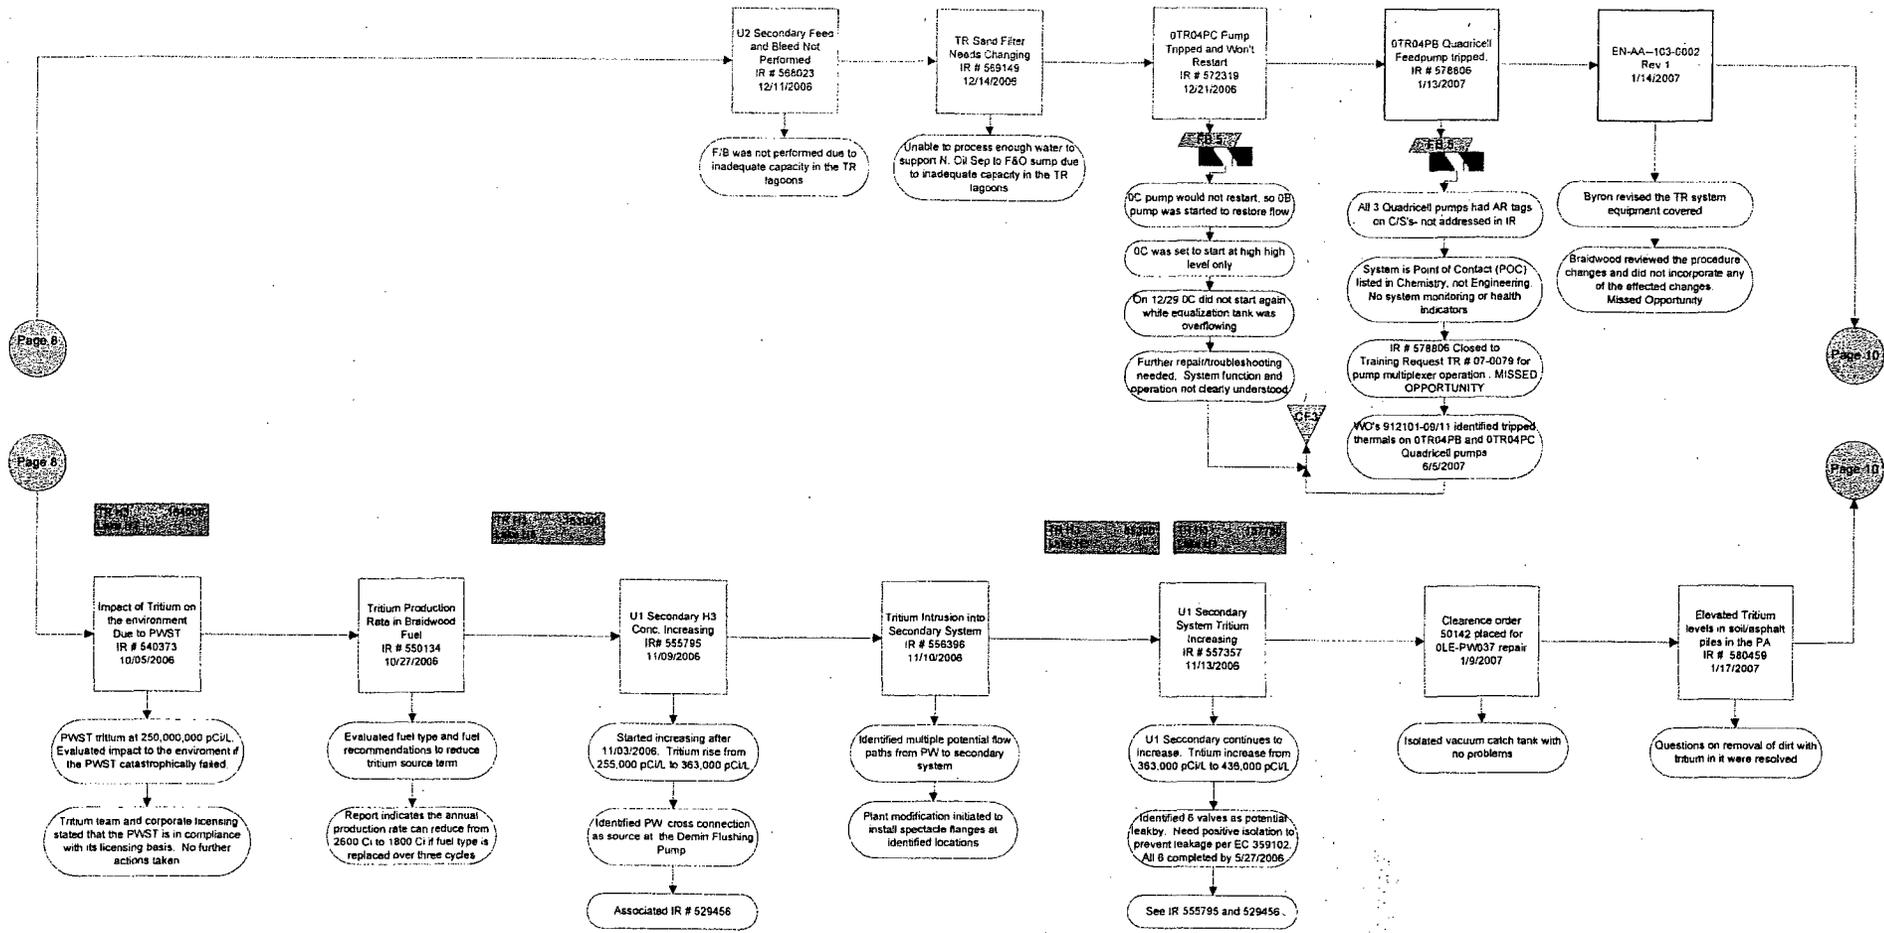
Event and Causal Factor Chart
TR Lagoon/Tritium Recycle
Root Cause Report
IR# 632816

Blue boxes represent Tritium levels
circles represent a trail to another page.
Failed barrier
Barrier
Leger box
