WRITTEN EXAMINATION POST-EXAM SUBMITTAL

Question 38:

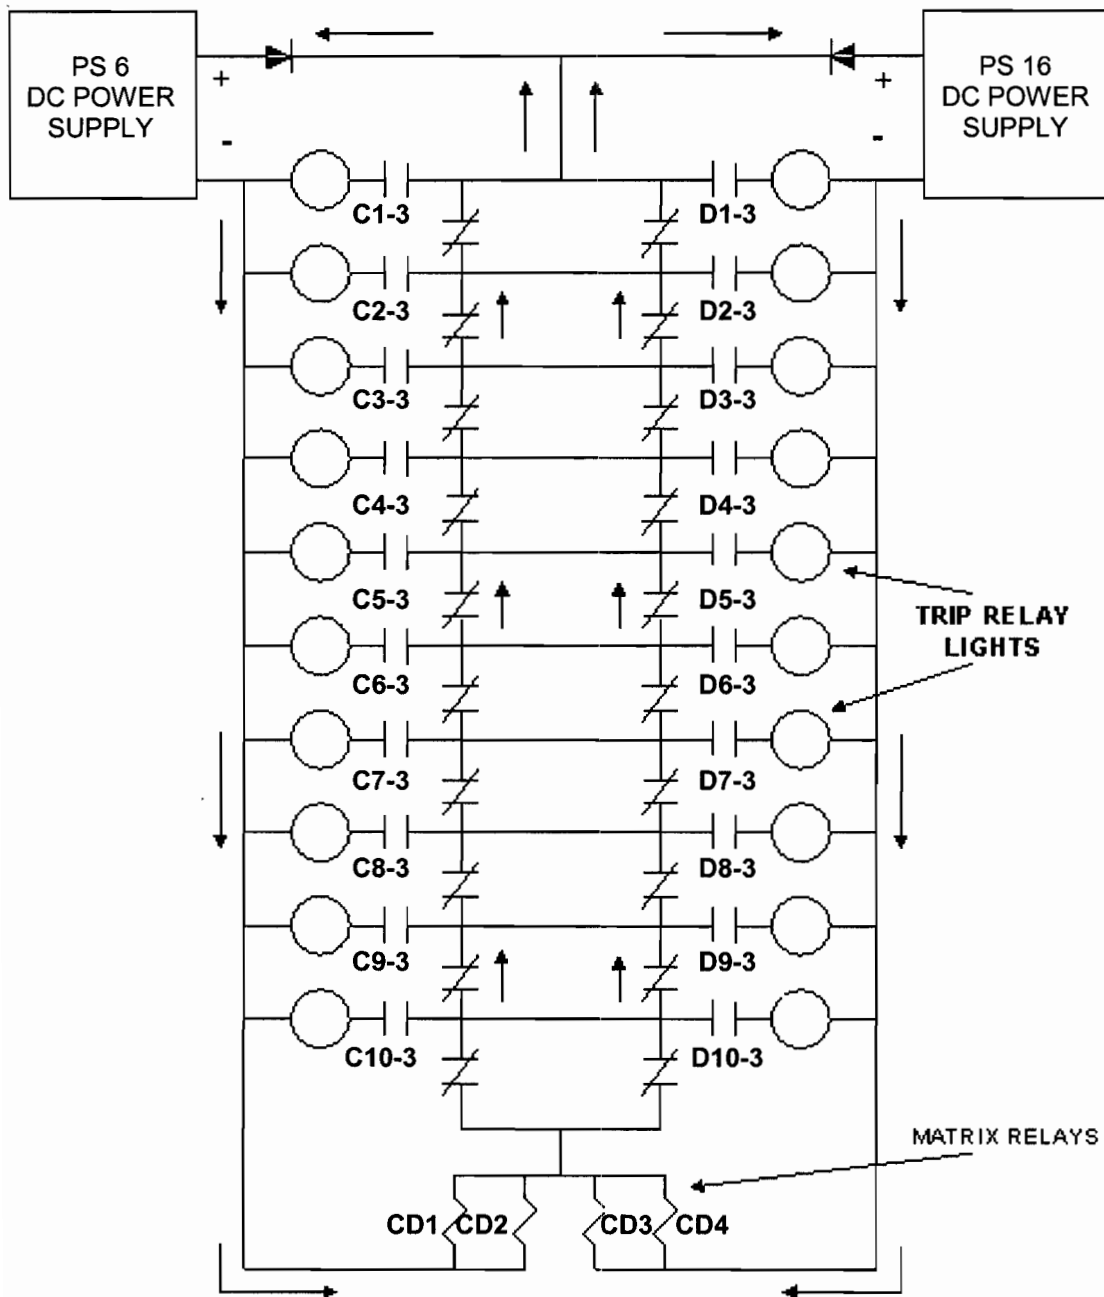
Figure 1
CD Matrix Ladder Energized – No Trip Exists

Figure 1 shows the CD Matrix Ladder in a normal energized state with all trip units reset and no trip units bypassed. In this configuration, the matrix relays (CD1 thru CD4) are energized from their respective power sources (PS 6 and PS 16).

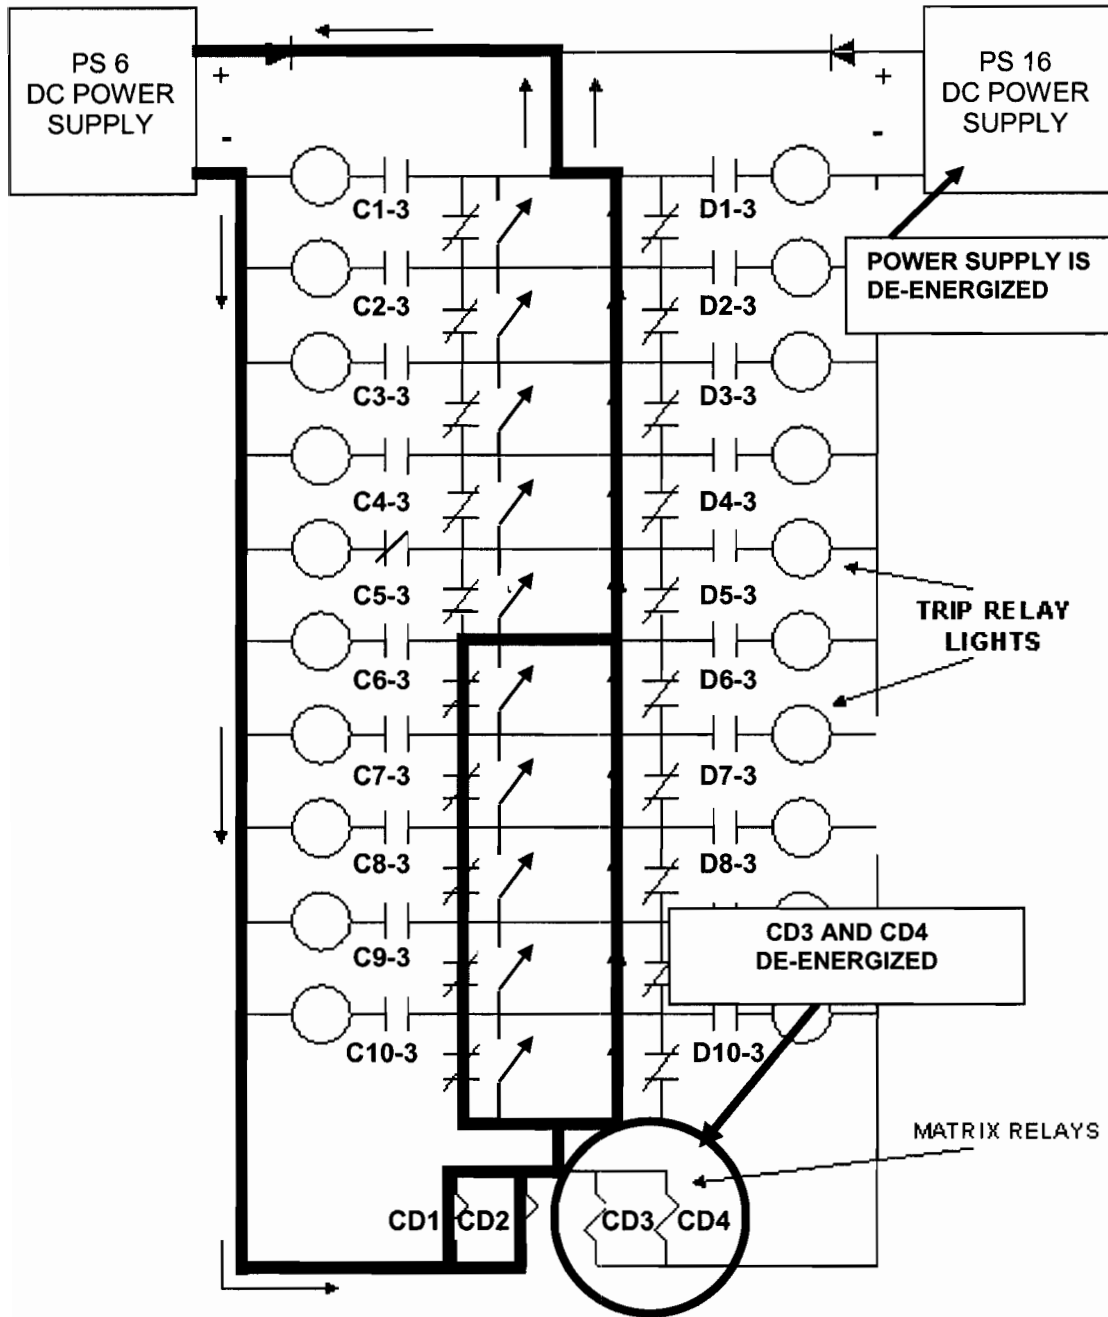
Figure 4
CD Matrix Ladder – Channel D RPS De-Energized
With Bypass Keys in Bypass and Trip on Channel C

Figure 4 shows the effect of a trip (Trip Unit 5 in this example) on Channel C within the CD matrix ladder when Channel D is de-energized with all Channel D bypasses in the Bypass position. The figure demonstrates that the CD1 and CD2 relays will continue to remain energized through the bypass switches on RPS Channel D. The effect is similar in the other two matrix ladders related to Channel D (AD and BD). A reactor trip will not be generated by any of these three ladders (AD, BD, or CD) because of the position of the bypass keys, even with Channel D de-energized.

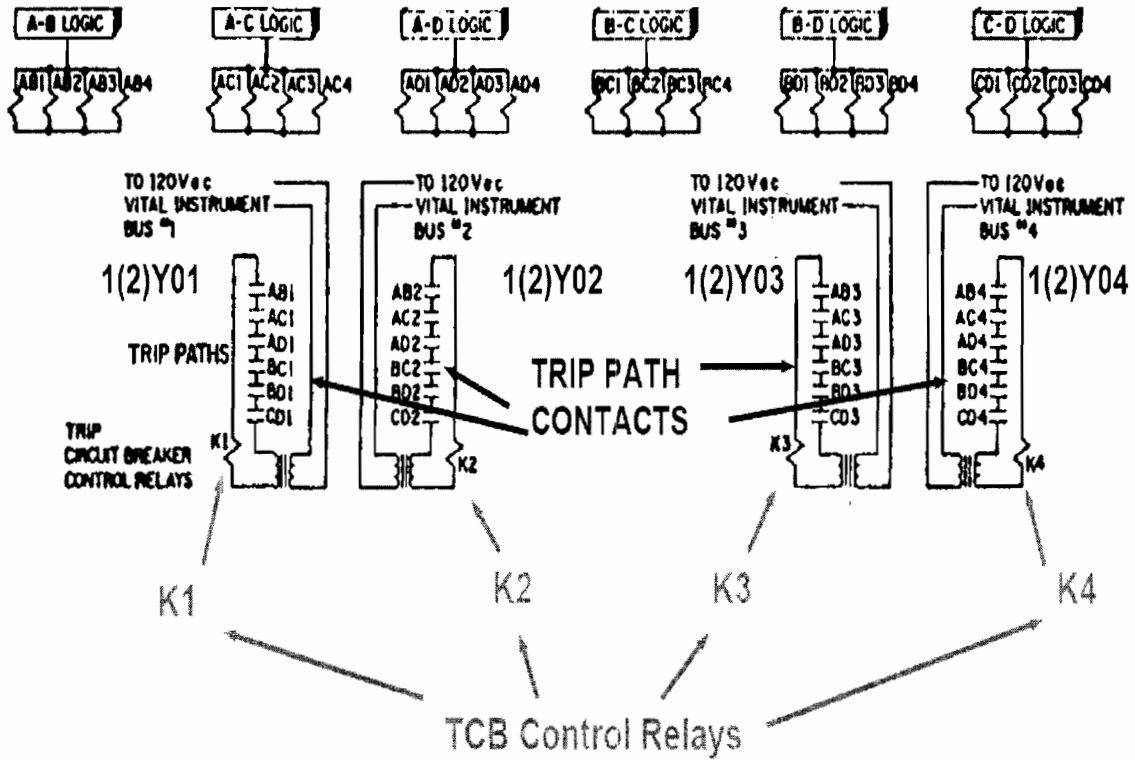
Figure 5
K-Relay Trip Paths

Figure 5 shows that K3 and K4 relays de-energize because of contacts operated by the CD3 and CD4 relays in Matrix Ladder CD (as well as equivalent contacts from the AD and BD ladders). This results in opening of the trip breakers in one of the two redundant trip breaker paths. CEAs remain energized through the other trip breaker path.
