**From:** Williams, Charles R. [Charles.Williams@pgnmail.com] 2 pages  
**Sent:** Thursday, December 31, 2009 4:43 PM  
**To:** Lake, Louis; Thomas, George; 'nausdj@ornl.gov'; Carrion, Robert; Pugh, C-Glenn; 'daniel.fiorello@exeloncorp.com'  
**Subject:** Emailing: FM 1.6 Exhibit 3 FSAR Ch 2 Selected Pages.pdf, FM 1.6.pptx, FM 1.6 Exhibit 1 Gilbert Study Section 1.2.11.pdf, FM 1.6 Exhibit 2 Containment Exterior Surface Survey Data.pdf 9 pages  
**Attachments:** FM 1.6 Exhibit 3 FSAR Ch 2 Selected Pages.pdf; ~~FM 1.6.pptx~~ 11 pages; FM 1.6 Exhibit 1 Gilbert Study Section 1.2.11.pdf; FM 1.6 Exhibit 2 Containment Exterior Surface Survey Data.pdf 4 pages

Attached for your review is the draft for FM 1.6 and its Exhibits. If you have any questions, please contact either Craig Miller or me.

# 1.6 Inadequate Design against Ground Movement

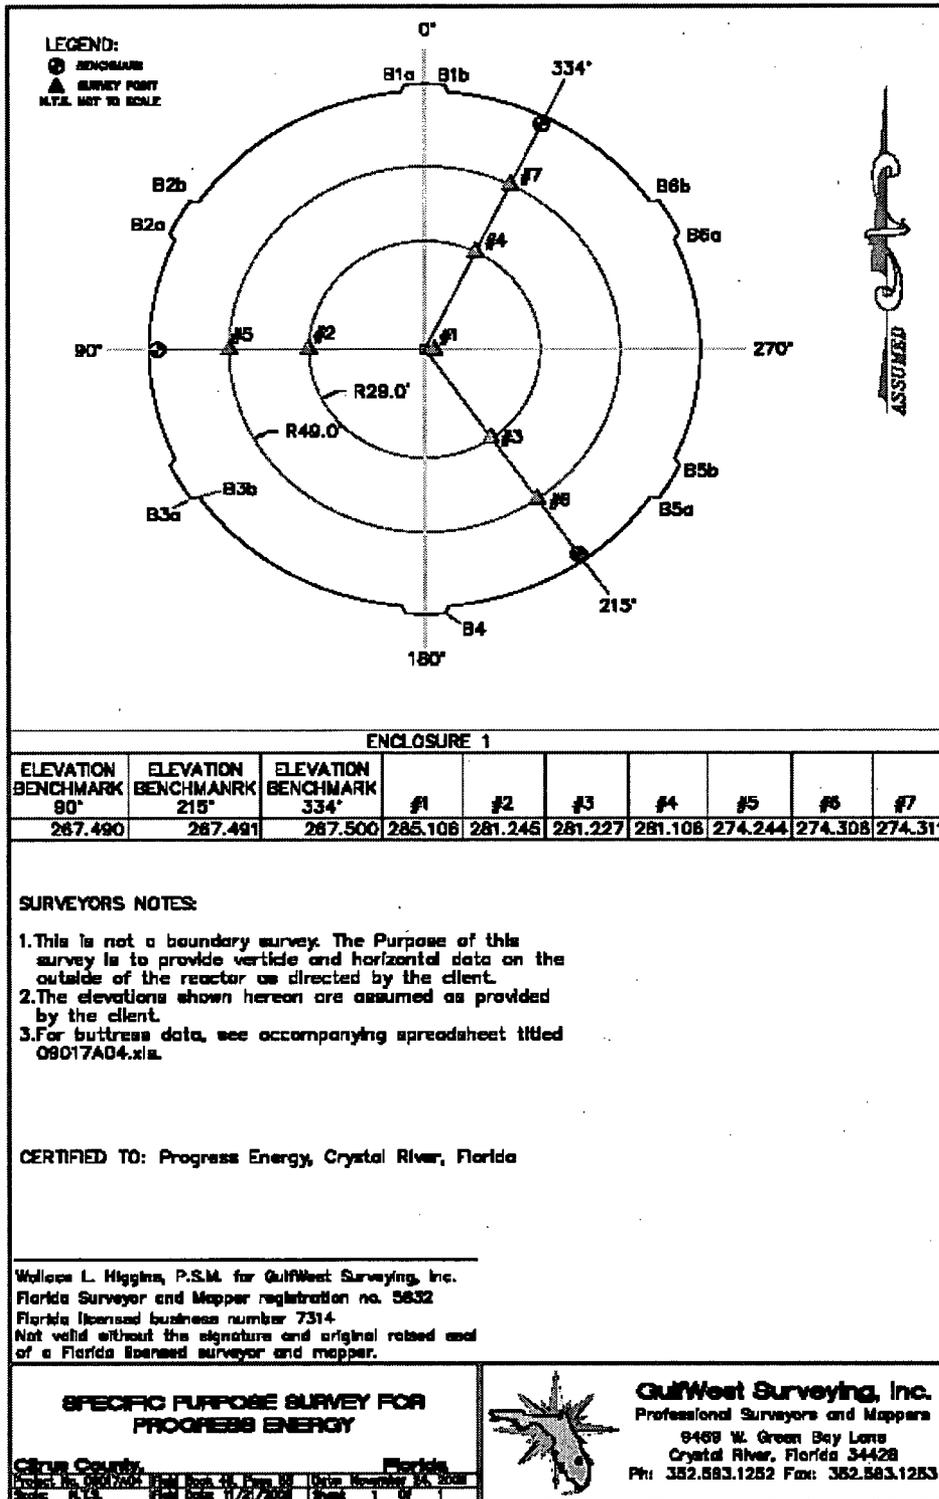
Attachment 1

The current survey of the dome was performed using SP-180 as a guide. The original benchmark and survey point pins were found on the surface of the dome. Elevations were taken at each of the benchmarks and survey points. Delta elevations were determined by subtracting the elevation of each survey point from the average of the three benchmark elevations. The change in elevation is shown below as well as the original acceptance criteria and the results from the last survey performed in 1982.

The % change from the 1982 survey is considered insignificant with respect to detecting a change in the structure similar to the delamination found between buttress 3 and 4. In addition, a review of the boroscope video of the seven core bores in the dome did not find any delamination.

\*The top two survey points were compared and found to have a lateral offset, from the highest to lowest survey point, of 0.9" in the East direction over a length of 6.8'. Surface variations exist that can cause a shift in lateral locations. The lateral offset for this location is reduced to less than 3" by eliminating the highest survey point.

- Uneven surfaces between placements along form edges
- Cosmetic grout repairs along the face of the buttresses along the corner causes a radial change in to or out of the plane of the buttress
- Corners exhibit loss of cover concrete along the tendon bearing plate area, which causes a shift in lateral location of the corners

These conditions affect the accuracy of the survey data. As noted above, eliminating one survey point at Buttress ID B1b reduced the lateral offset by 0.9". The vertical alignment tolerance provided in ACI 117-90 is considered to be satisfied based on the localized surface variations affecting the accuracy of the survey data.
