Field Performance Assessment of Synthetic Liners for Uranium Tailings Ponds: A Status Report

D. H. Mitchell
G. E. Spanner

March 1984

Prepared for the
U.S. Nuclear Regulatory Commission
under Contract DE-AC06-76RLO 1830

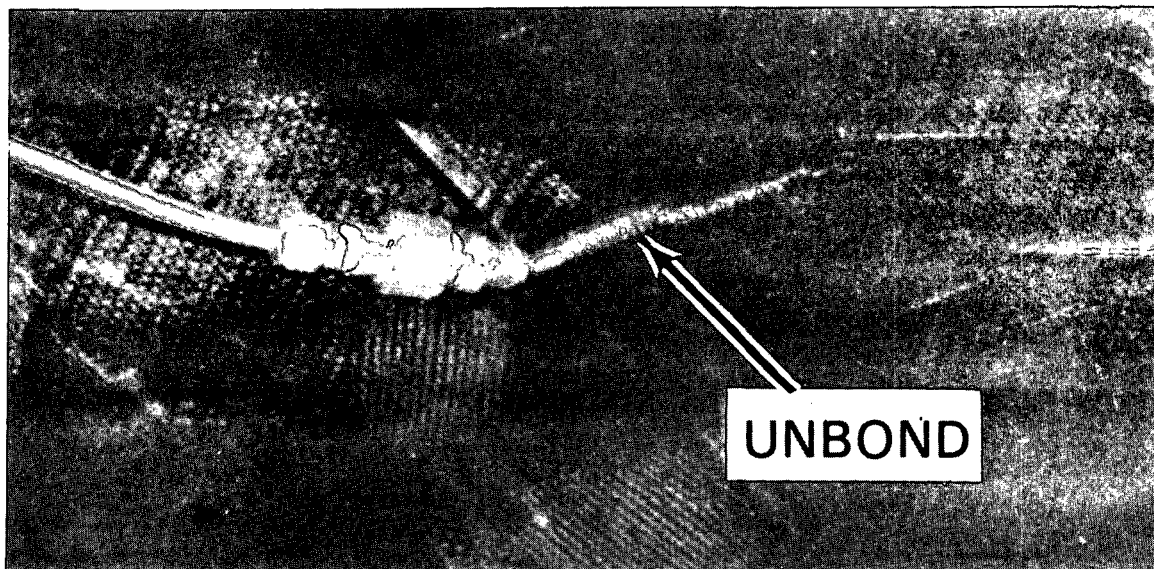
FIGURE 2. Air Lance Detecting an Unbond in a Chlorosulfonated Polyethylene Seam

Air Lance--This technique effectively determines how far across the seam an unbond extends. A jet of air is blown at the edge of the top piece on a seam. Any openings along the edge become inflated and easily visible. The air lance requires a careful operator to detect unbonds, and works only if the defect is open on the top surface of a seam (see Figure 2).

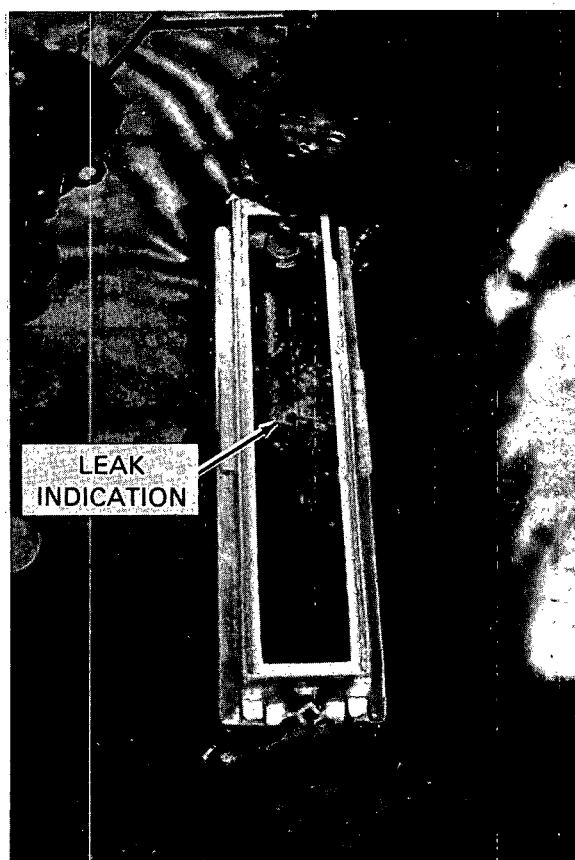
FIGURE 3. Vacuum Chamber Detecting a Leak in a Chlorosulfonated Polyethylene

Vacuum Chamber--In the vacuum test, a 1-m long gasketed chamber is placed over a section of seam that has been coated with liquid soap. The chamber, which has a transparent top, is then partially evacuated using an air pump. Any unbonds that extend across the seam are then indicated by the presence of soap bubbles. This test is very sensitive to small leaks, and has the additional feature of stressing the seam to cause marginally bonded areas to become unbonded, thereby indicating a leak (see Figure 3).

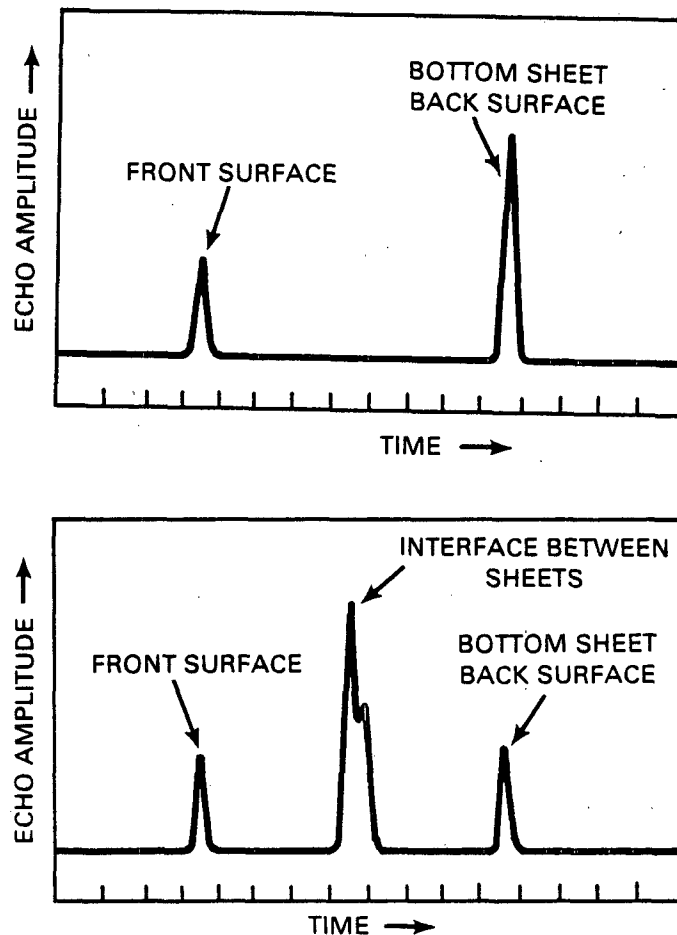
FIGURE 4. Sketches of a Typical Pulse-Echo Ultrasonic Screen Display for
a) a Well-Bonded Seam and b) a Faulty Bond of Nonreinforced Material

Pulse-Echo Ultrasonics--This technique involves transmitting an ultrasonic pulse of energy into the seam and interpreting the returned echo on a time-based cathode ray tube. A well-bonded area would produce an echo later in time than an unbond because the ultrasound pulse would have traveled round trip through two sheet thicknesses, whereas at an unbonded area the echo returns after a round trip through only the top sheet thickness (see Figures 4a and 4b). To assure good bonding throughout a seam, the entire surface area of the seam must be scanned with a transducer. Pulse-echo ultrasonic testing is currently being used by one high density polyethylene installer, and our research indicates that the technique works equally well on all the nonreinforced materials that we tested, such as polyvinyl chloride and elasticized polyolefin.

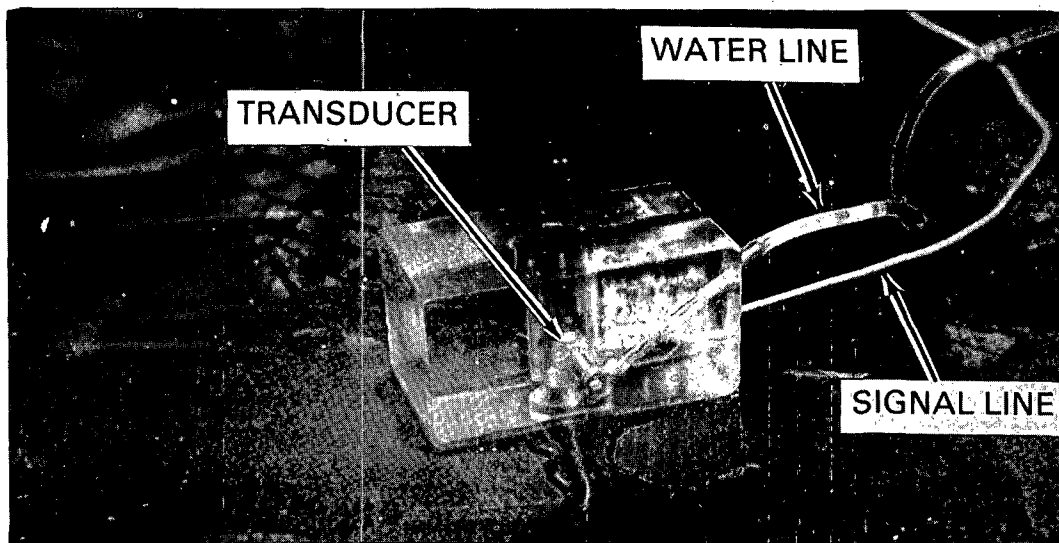
FIGURE 5. PNL-Designed Holder for the Ultrasonic Impedance Plane Instrument

At the USBR laboratories we demonstrated a conventional pulse-echo ultrasonic unit and the instrument that operates on the ultrasonic impedance plane principle. The pulse-echo instrument was a Krautkramer-Branson USL-38, while the ultrasonic impedance plane instrument was an NDT Instruments Bondascope 2100. For these demonstrations, the pulse-echo frequency was between 5 MHz and 15 MHz and the ultrasonic impedance plane frequency was 167 kHz. Two types of couplant were used to help transmit ultrasonic energy into the materials: gel couplant for pulse-echo and tap water for ultrasonic impedance plane testing. The gel couplant was also used between two liner layers to simulate a good bond when calibrating the ultrasonic impedance plane instrument. The only modification we made to either instrument was to build a transducer holder for the ultrasonic impedance plane instrument. As shown in Figures 5 and 6, the holder is a transparent block that has a water supply line attached to it. A cavity around the transducer retains water so that adequate acoustic coupling is assured at all times. The holder allows observation of the alarm light and is more comfortable for the operator to hold, so it helped increase the ultrasonic impedance plane inspection rate while preventing false alarms from lack of couplant.

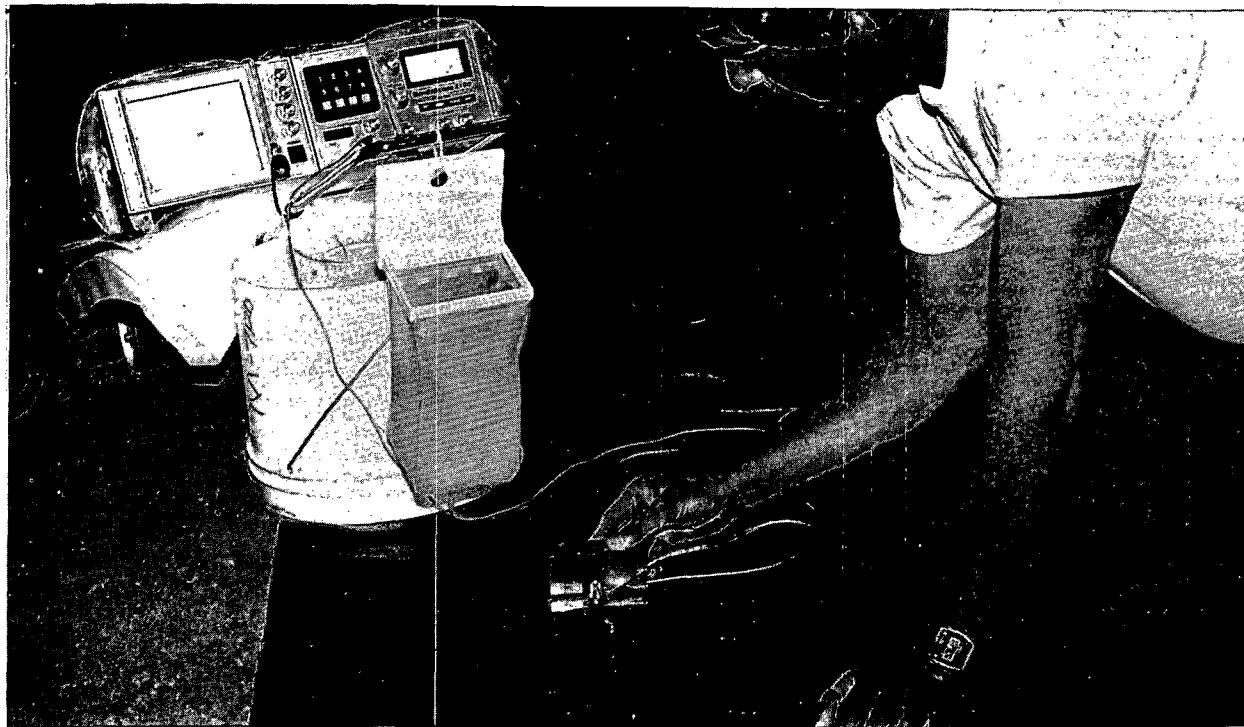
FIGURE 6. Seam Inspection Transducer Holder with the Ultrasonic Impedance Plane Instrument

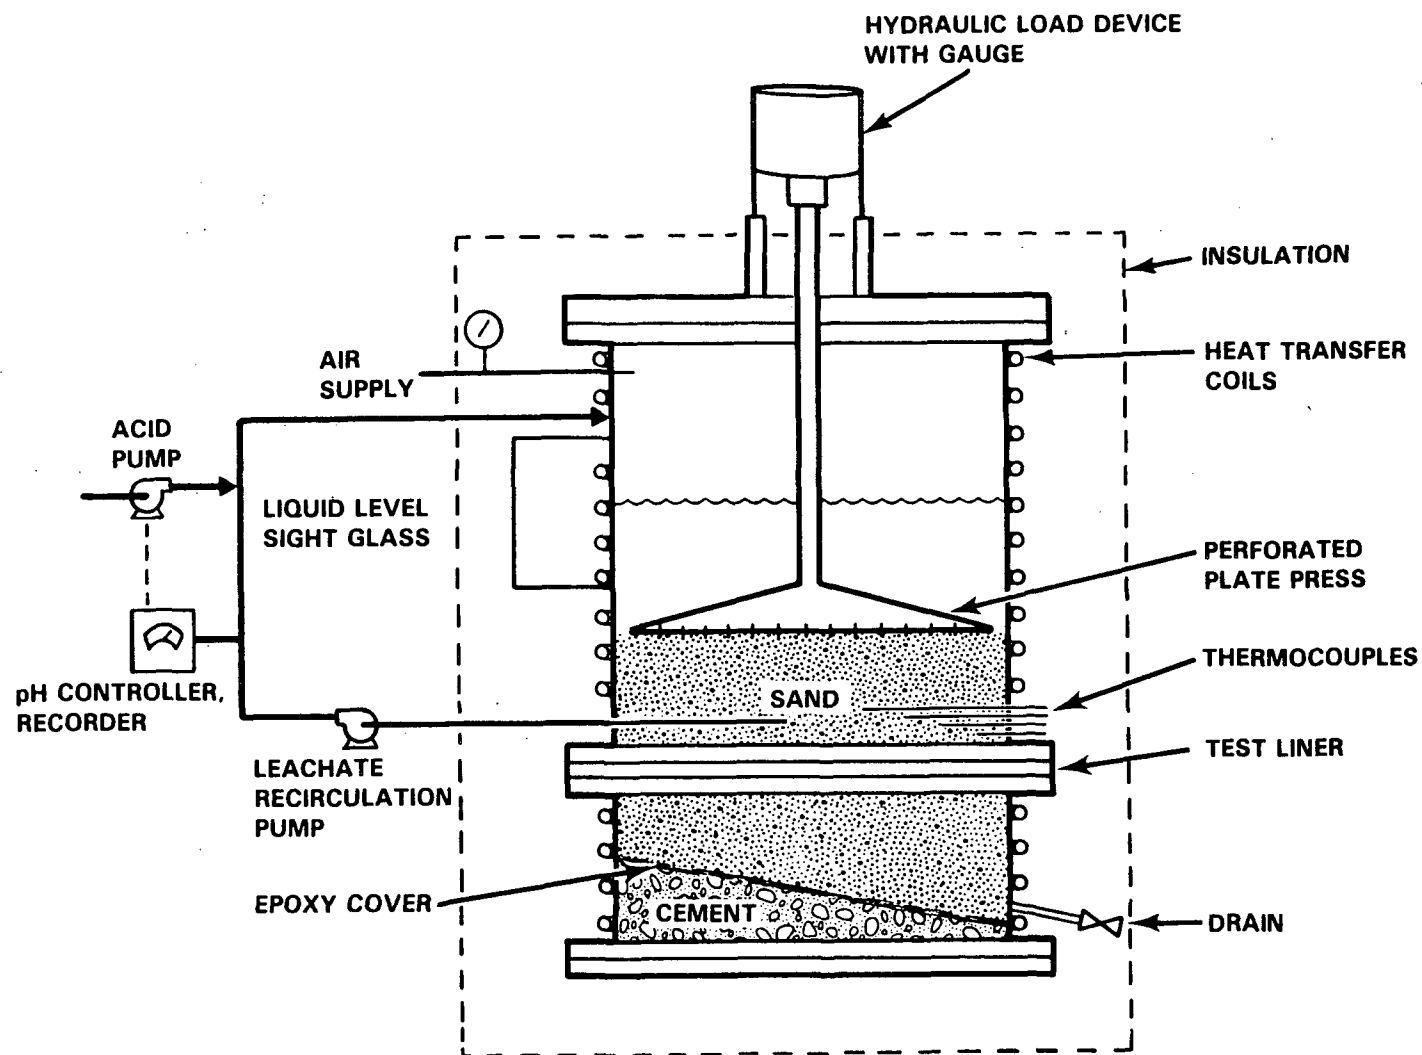
FIGURE 7. Schematic of Accelerated Aging Column

Three test columns were assembled according to the schematic of Figure 7. The columns are made of 0.61-m (24-in.) stainless steel pipe. The columns are heated or cooled by fluid circulating in copper coils around the column exterior. Insulation helps maintain the liner at the desired temperature across the diameter of the column. The column at 18°C is cooled by a heat pump. The other columns are heated by fluid circulating from heated drums.

A press on top of the column is used to load the sand above the liner. The simulated depth of tailings provides some stress that may affect aging. The loading on the press is checked weekly and is equivalent to 2.3 m (7.7 ft) of tailings.

Air pressure is maintained at 5 kg/cm^2 (8 to 9 psig), simulating a liquid head of 6 m (20 ft) of water. The column pressure is bled weekly and repressurized to keep the oxygen concentration at 21%.

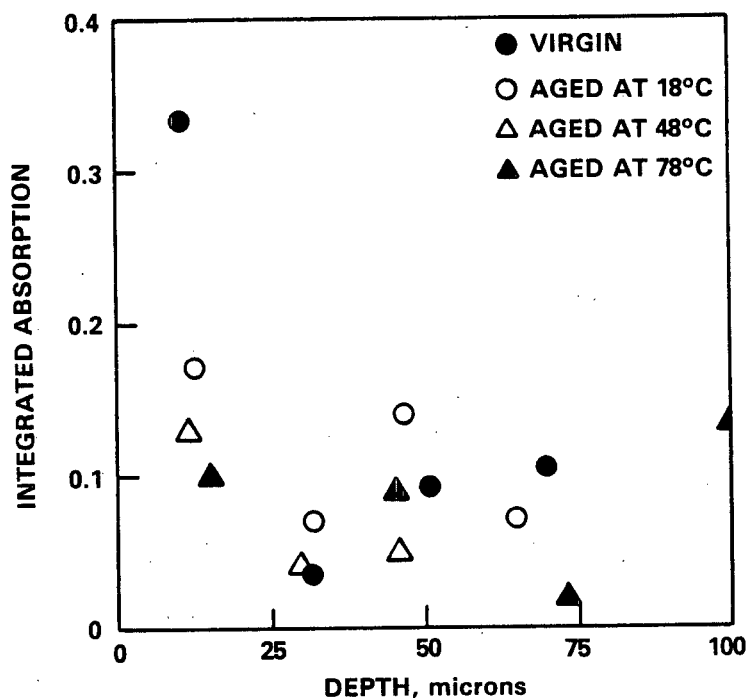
FIGURE 8. Results of Differential Infrared Analysis of Aged High Density Polyethylene Samples Indicating Relative Carbonyl Concentrations

The results of differential infrared spectroscopy in the carbonyl absorbing region are shown in Figure 8. These data show that changes in the carbonyl concentration in high density polyethylene are insignificant following an 18 week exposure in acidic leachate at all the temperatures tested. It appears that either oxidation rates are extremely low for high density polyethylene in this environment, or oxidation products are being dissolved in the leachate.

The latter explanation is being investigated further; however, no surface attack was visible, and the thickness and density of the high density polyethylene remained unchanged in all three exposure columns.

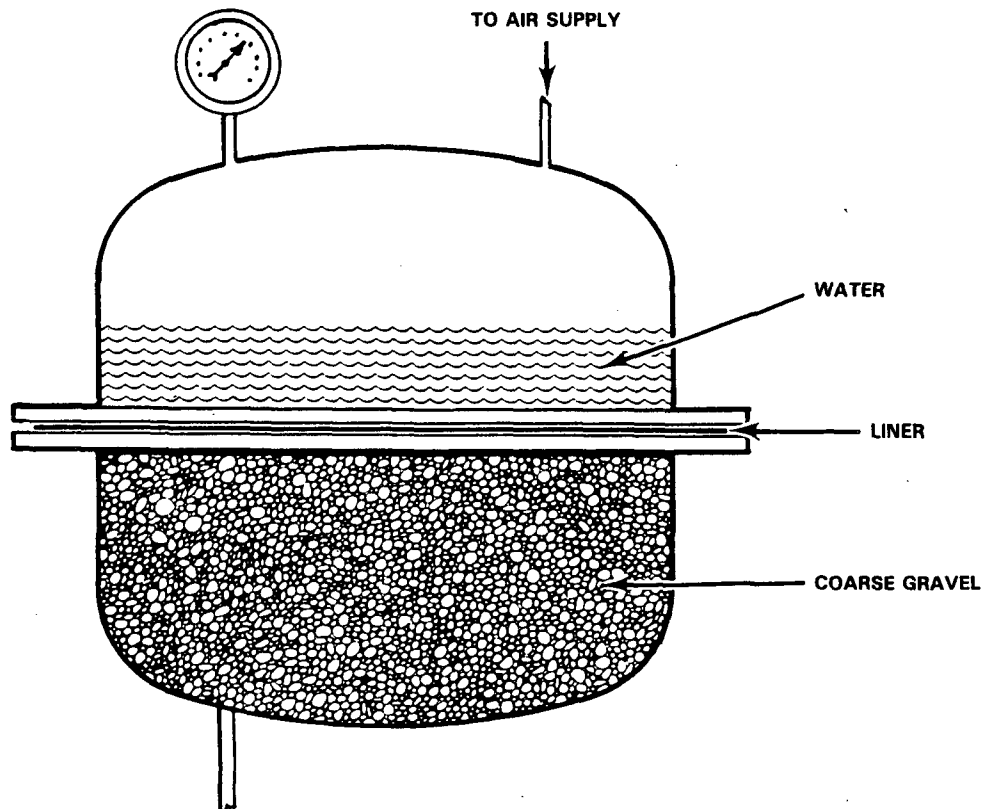
FIGURE 9. Schematic of Anomaly Conformance Test Device

We have constructed a device operating on the same principle as the previously discussed systems. A schematic of the device is shown in Figure 9. The tester is made of 0.25-m pipe flanges and pipe caps. To prevent shifting of rocks between tests, an epoxy glue was poured over rocks in the tester, forming a conglomerate piece without affecting the surface features. The rock size

ranged between 19 and 38 mm in diameter. Some rocks were round and some were sharp. A mixture of round and crushed rock in the size range of 19 to 38 mm is used in the test device.

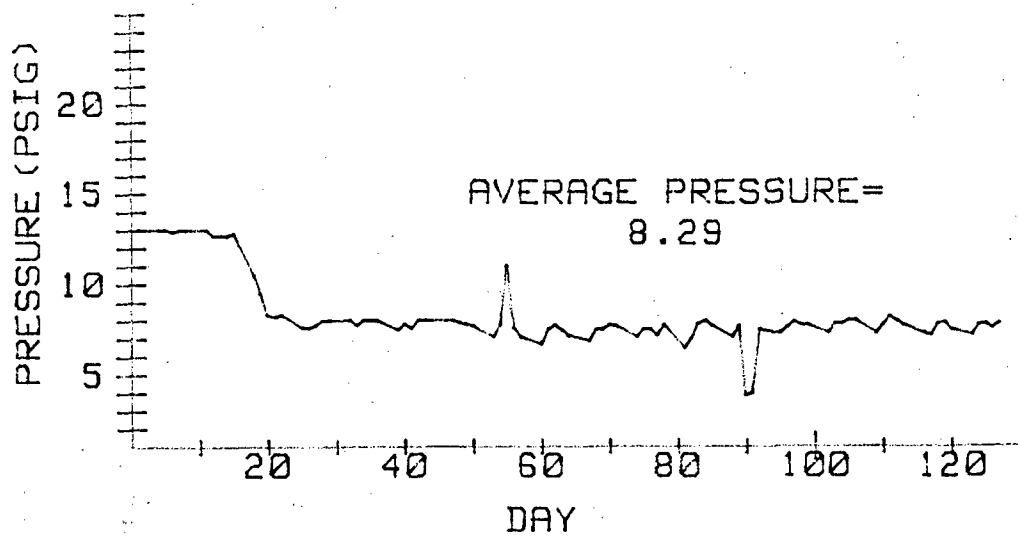
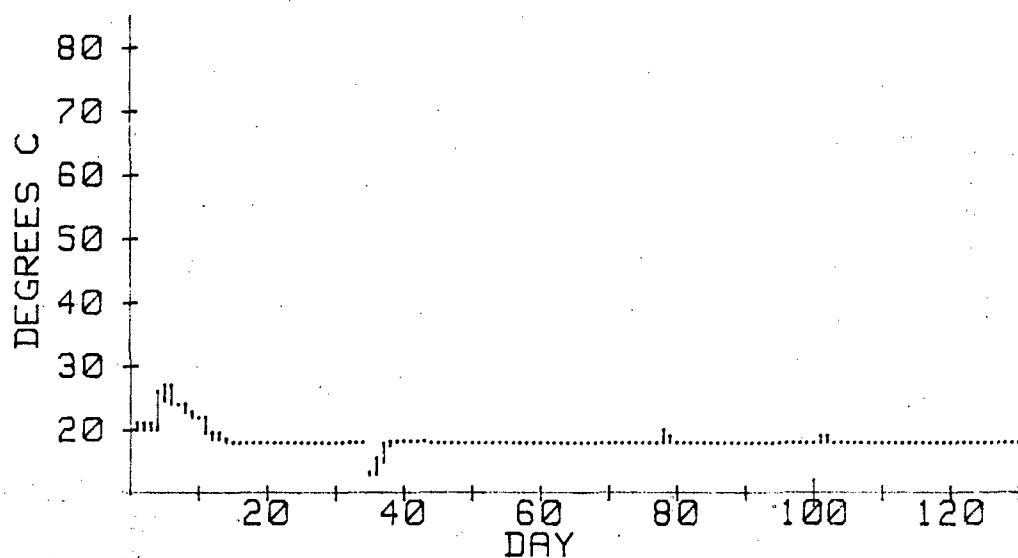
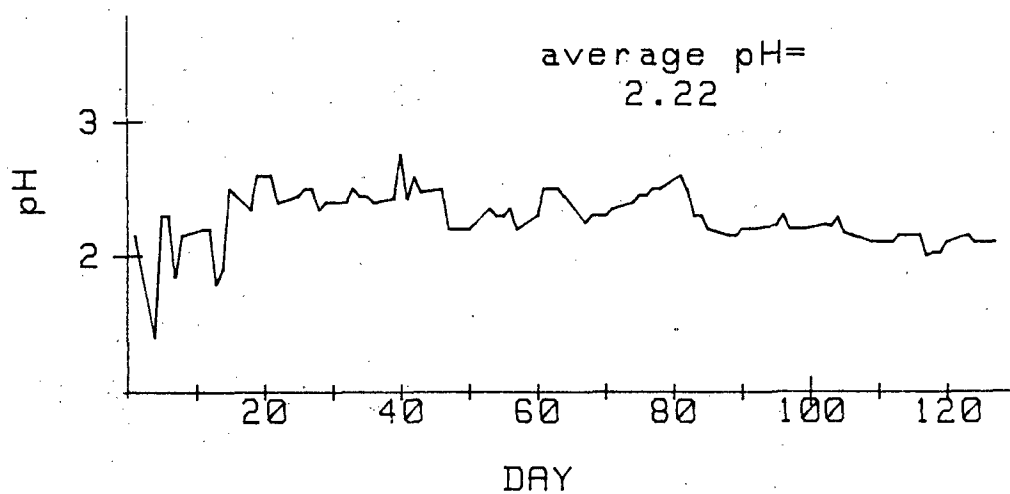
FIGURE C.1. Exposure Conditions for Aging of High Density Polyethylene at 18°C

The daily conditions in the columns were monitored and plotted (see Appendix C). The average conditions over the 18 week period of exposure are listed in Table 9. The leachates from the columns were sampled near the beginning and at the termination of the tests. The leachate composition varied slightly between the columns due to increased corrosion of the stainless steel as the temperature rose. Apparently 316 stainless steel, which is recommended for dilute sulfuric acid, is not totally compatible with the mixture of materials in the leachate. A Teflon lined column might prevent this problem.

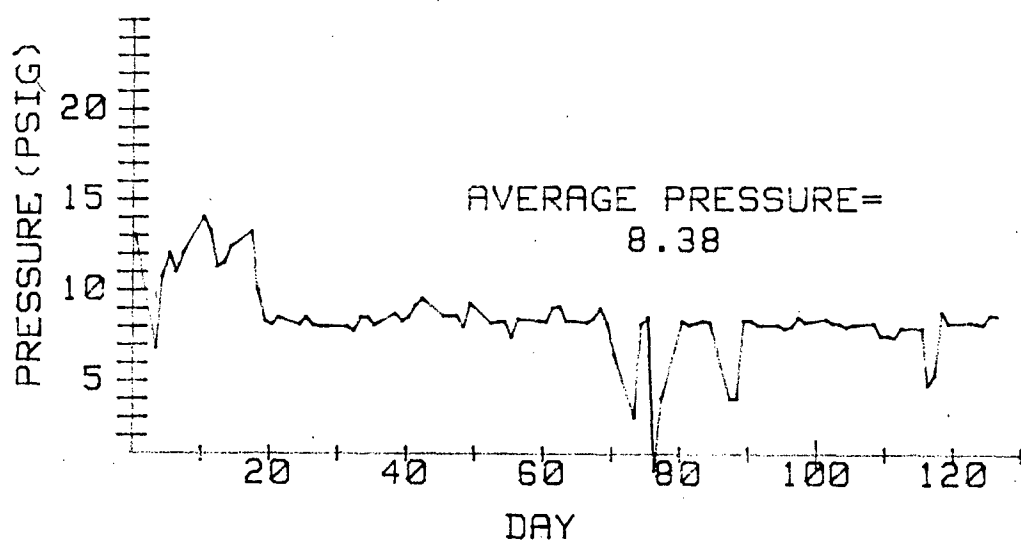
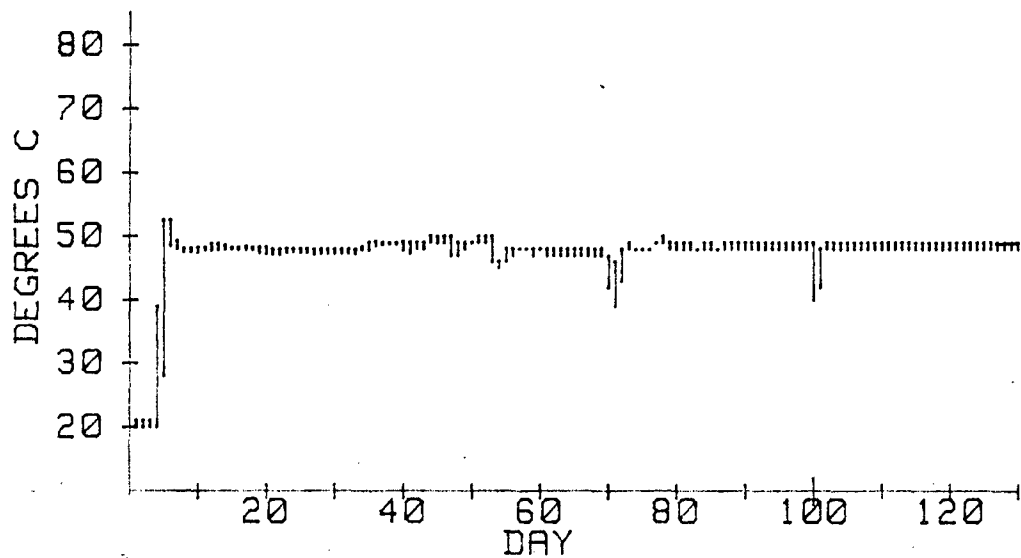
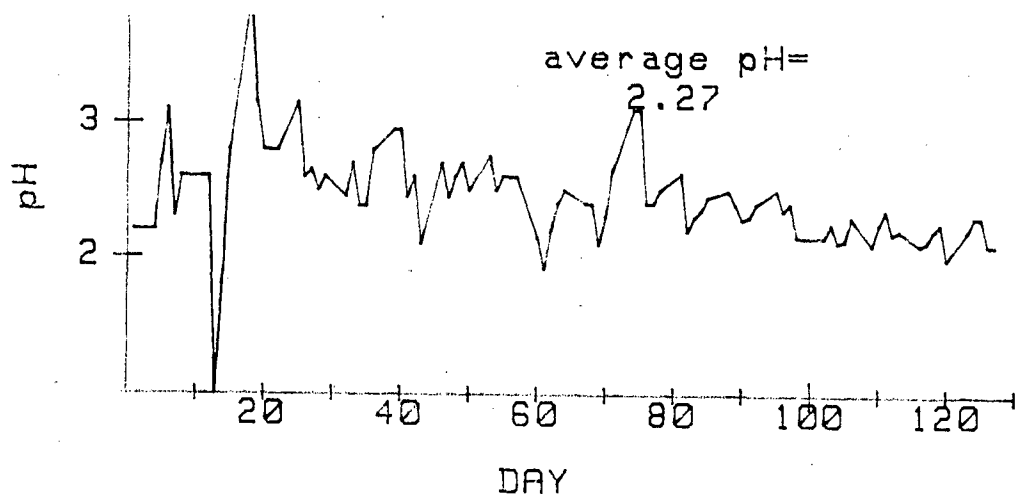
FIGURE C.2. Exposure Conditions for Aging of High Density Polyethylene at 48°C

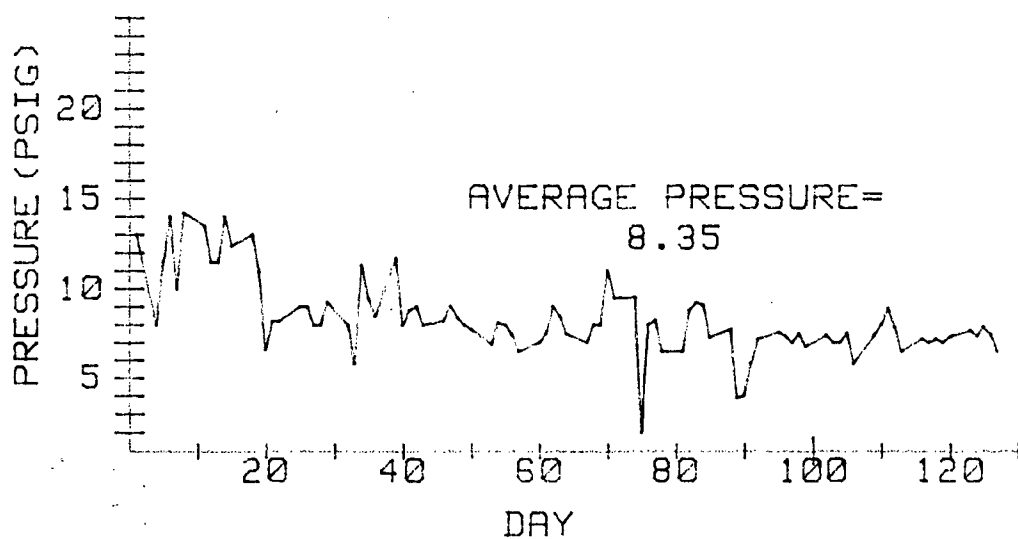
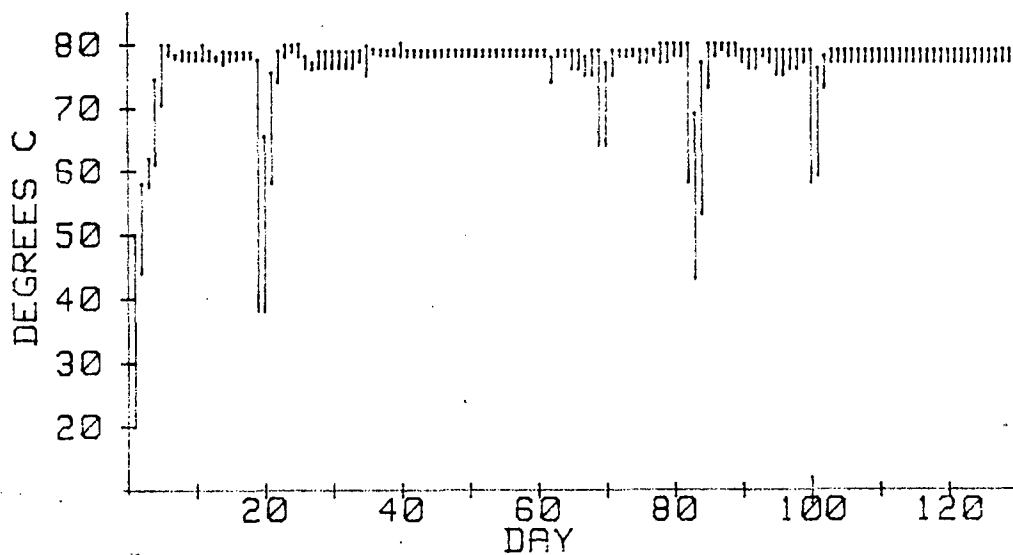
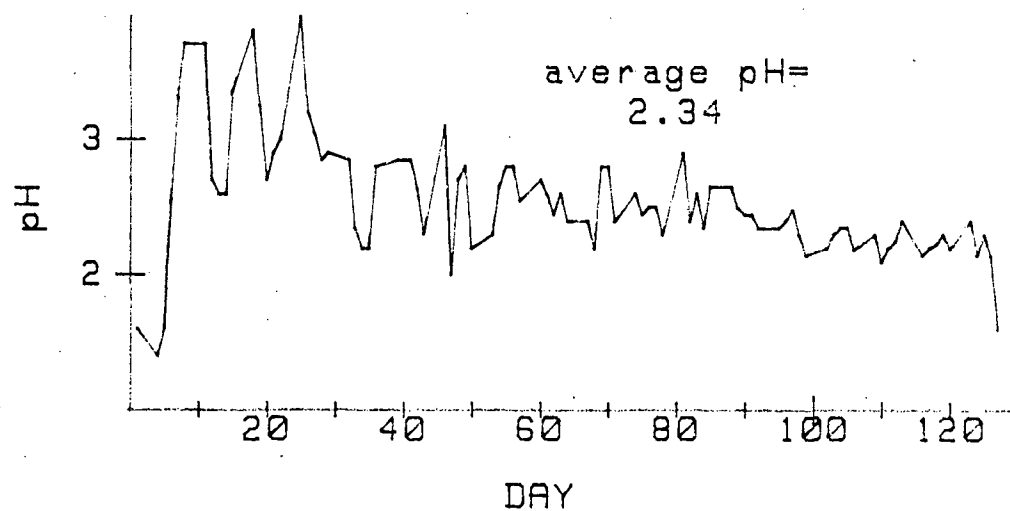
FIGURE C.3. Exposure Conditions for Aging of High Density Polyethylene at 78°C
