**Invensys Response to  
Request for Additional Information (RAI)**  
Ref: Letter dated December 8, 2010, NRC to Invensys

ATTACHMENT 1  
INVENSYS RESPONSE TO RAI No. 1

RAI No. 1: RXM Safety/Non-safety Interface versus Interim Staff Guidance (ISG)-4

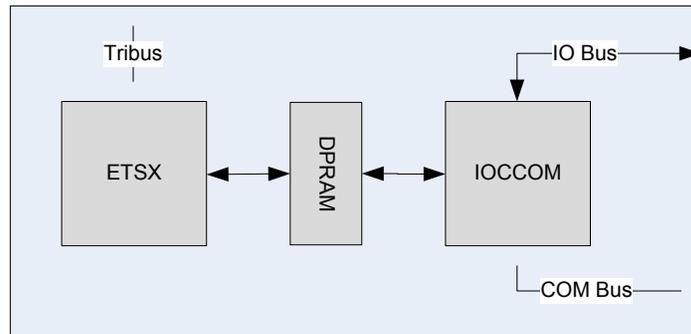
The 3008N Main Processor module consists of three main subsystems as shown in the figure below:

Each subsystem consists of a microprocessor and memory subsystem. The ETSX (Enhanced Triconex System Executive) is responsible for running the user defined application program on the Application Processor. The IOCCOM Processor is responsible for communications with the I/O modules in the system and the Tricon communications modules (TCM). The DPRAM provides the interface between the ETSX and IOCCOM. The DPRAM is divided into several sections:

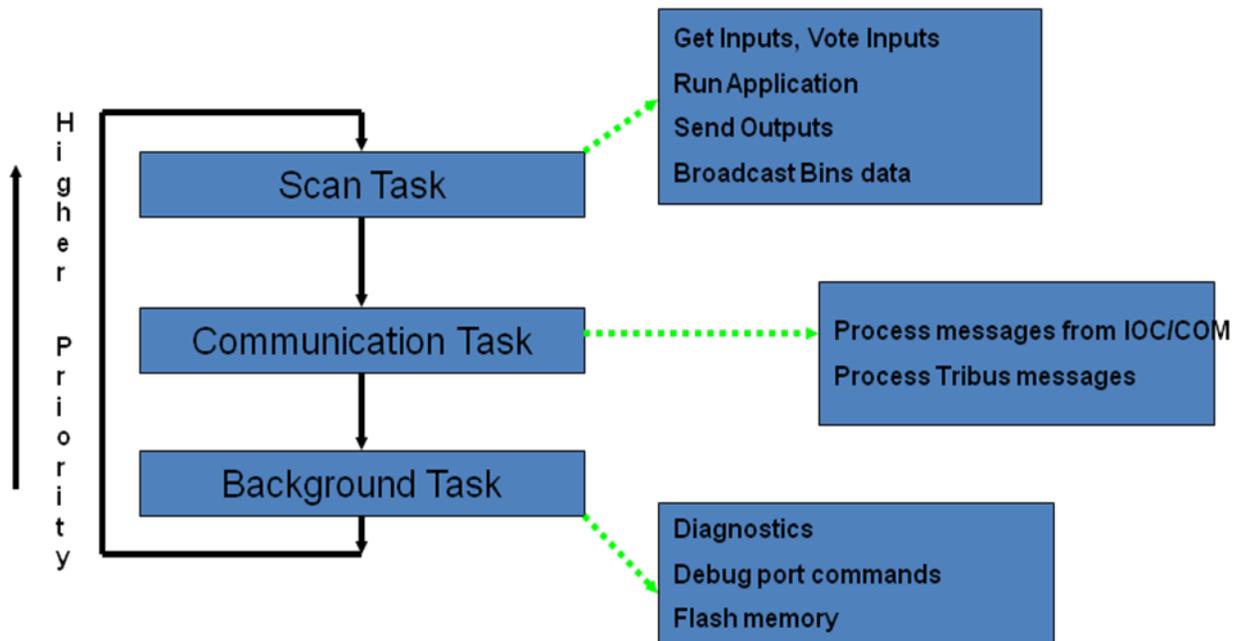
The ETSX is made up of three tasks:

A lower priority task cannot interrupt a higher priority task.

The above scan structure guarantees that the Tricon ETSX scan cycle is predictable and repeatable from scan to scan.

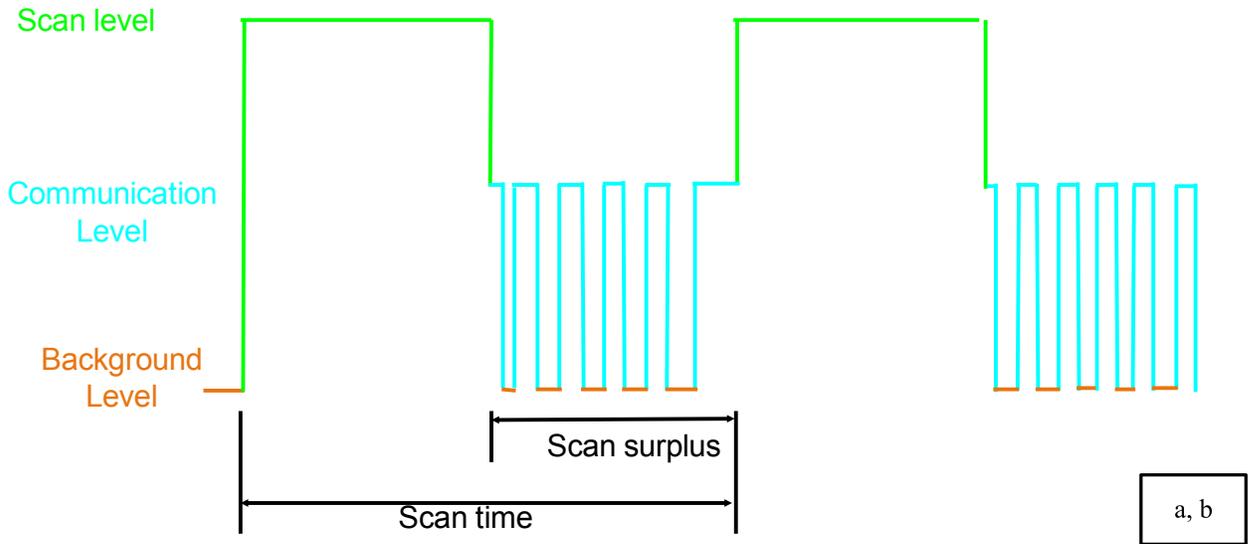
**Task Scheduling**

The following figure shows how the tasks would be scheduled for two application scans.
