**Invensys Response to
Request for Additional Information (RAI)**
Ref: Letter dated December 8, 2010, NRC to Invensys

ATTACHMENT 1
INVENSYS RESPONSE TO RAI No. 1

RAI No. 1: RXM Safety/Non-safety Interface versus Interim Staff Guidance (ISG)-4

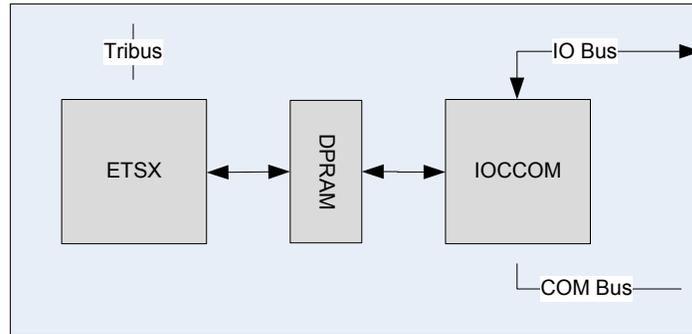
The 3008N Main Processor module consists of three main subsystems as shown in the figure below:

Each subsystem consists of a microprocessor and memory subsystem. The ETSX (Enhanced Triconex System Executive) is responsible for running the user defined application program on the Application Processor. The IOCCOM Processor is responsible for communications with the I/O modules in the system and the Tricon communications modules (TCM). The DPRAM provides the interface between the ETSX and IOCCOM. The DPRAM is divided into several sections:

- Physical Inputs from Input Modules
- Physical Outputs for Output Modules
- Input message queue for I/O Modules
- Output message queue for I/O Modules
- Input message queue for communication modules
- Output message queue for communication modules
- Output Bins for communication modules

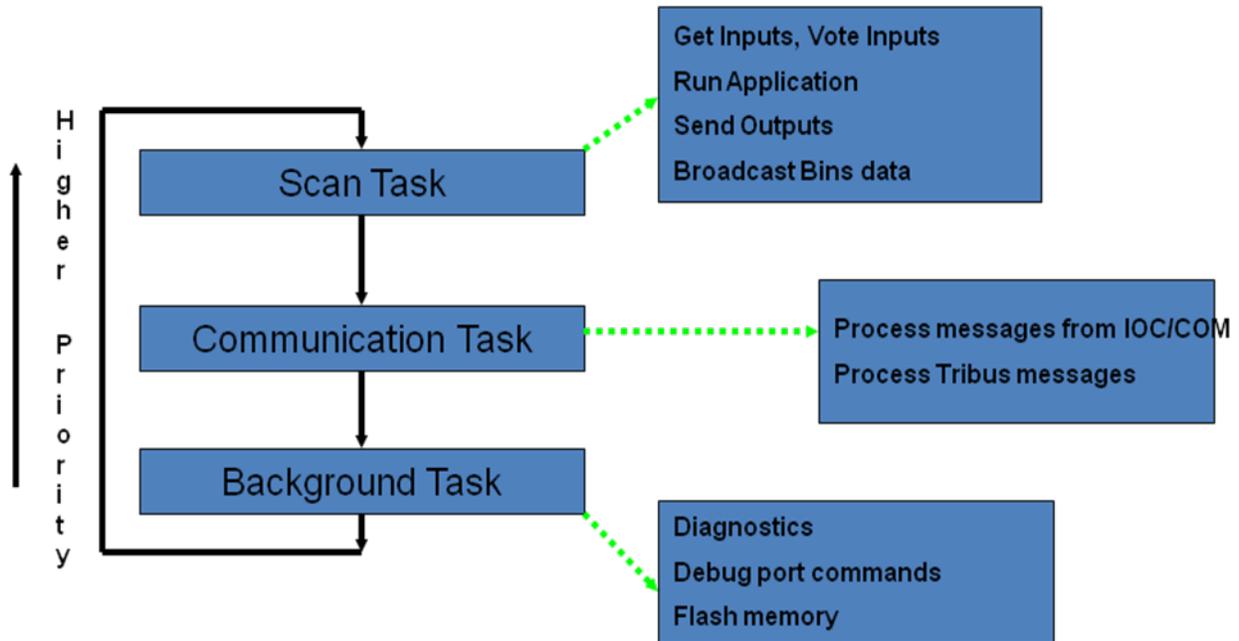
The ETSX is made up of three tasks:

A lower priority task cannot interrupt a higher priority task.

The above scan structure guarantees that the Tricon ETSX scan cycle is predictable and repeatable from scan to scan.
