Site Location Map

United Nuclear Corporation Church Rock Site, Church Rock, New Mexico

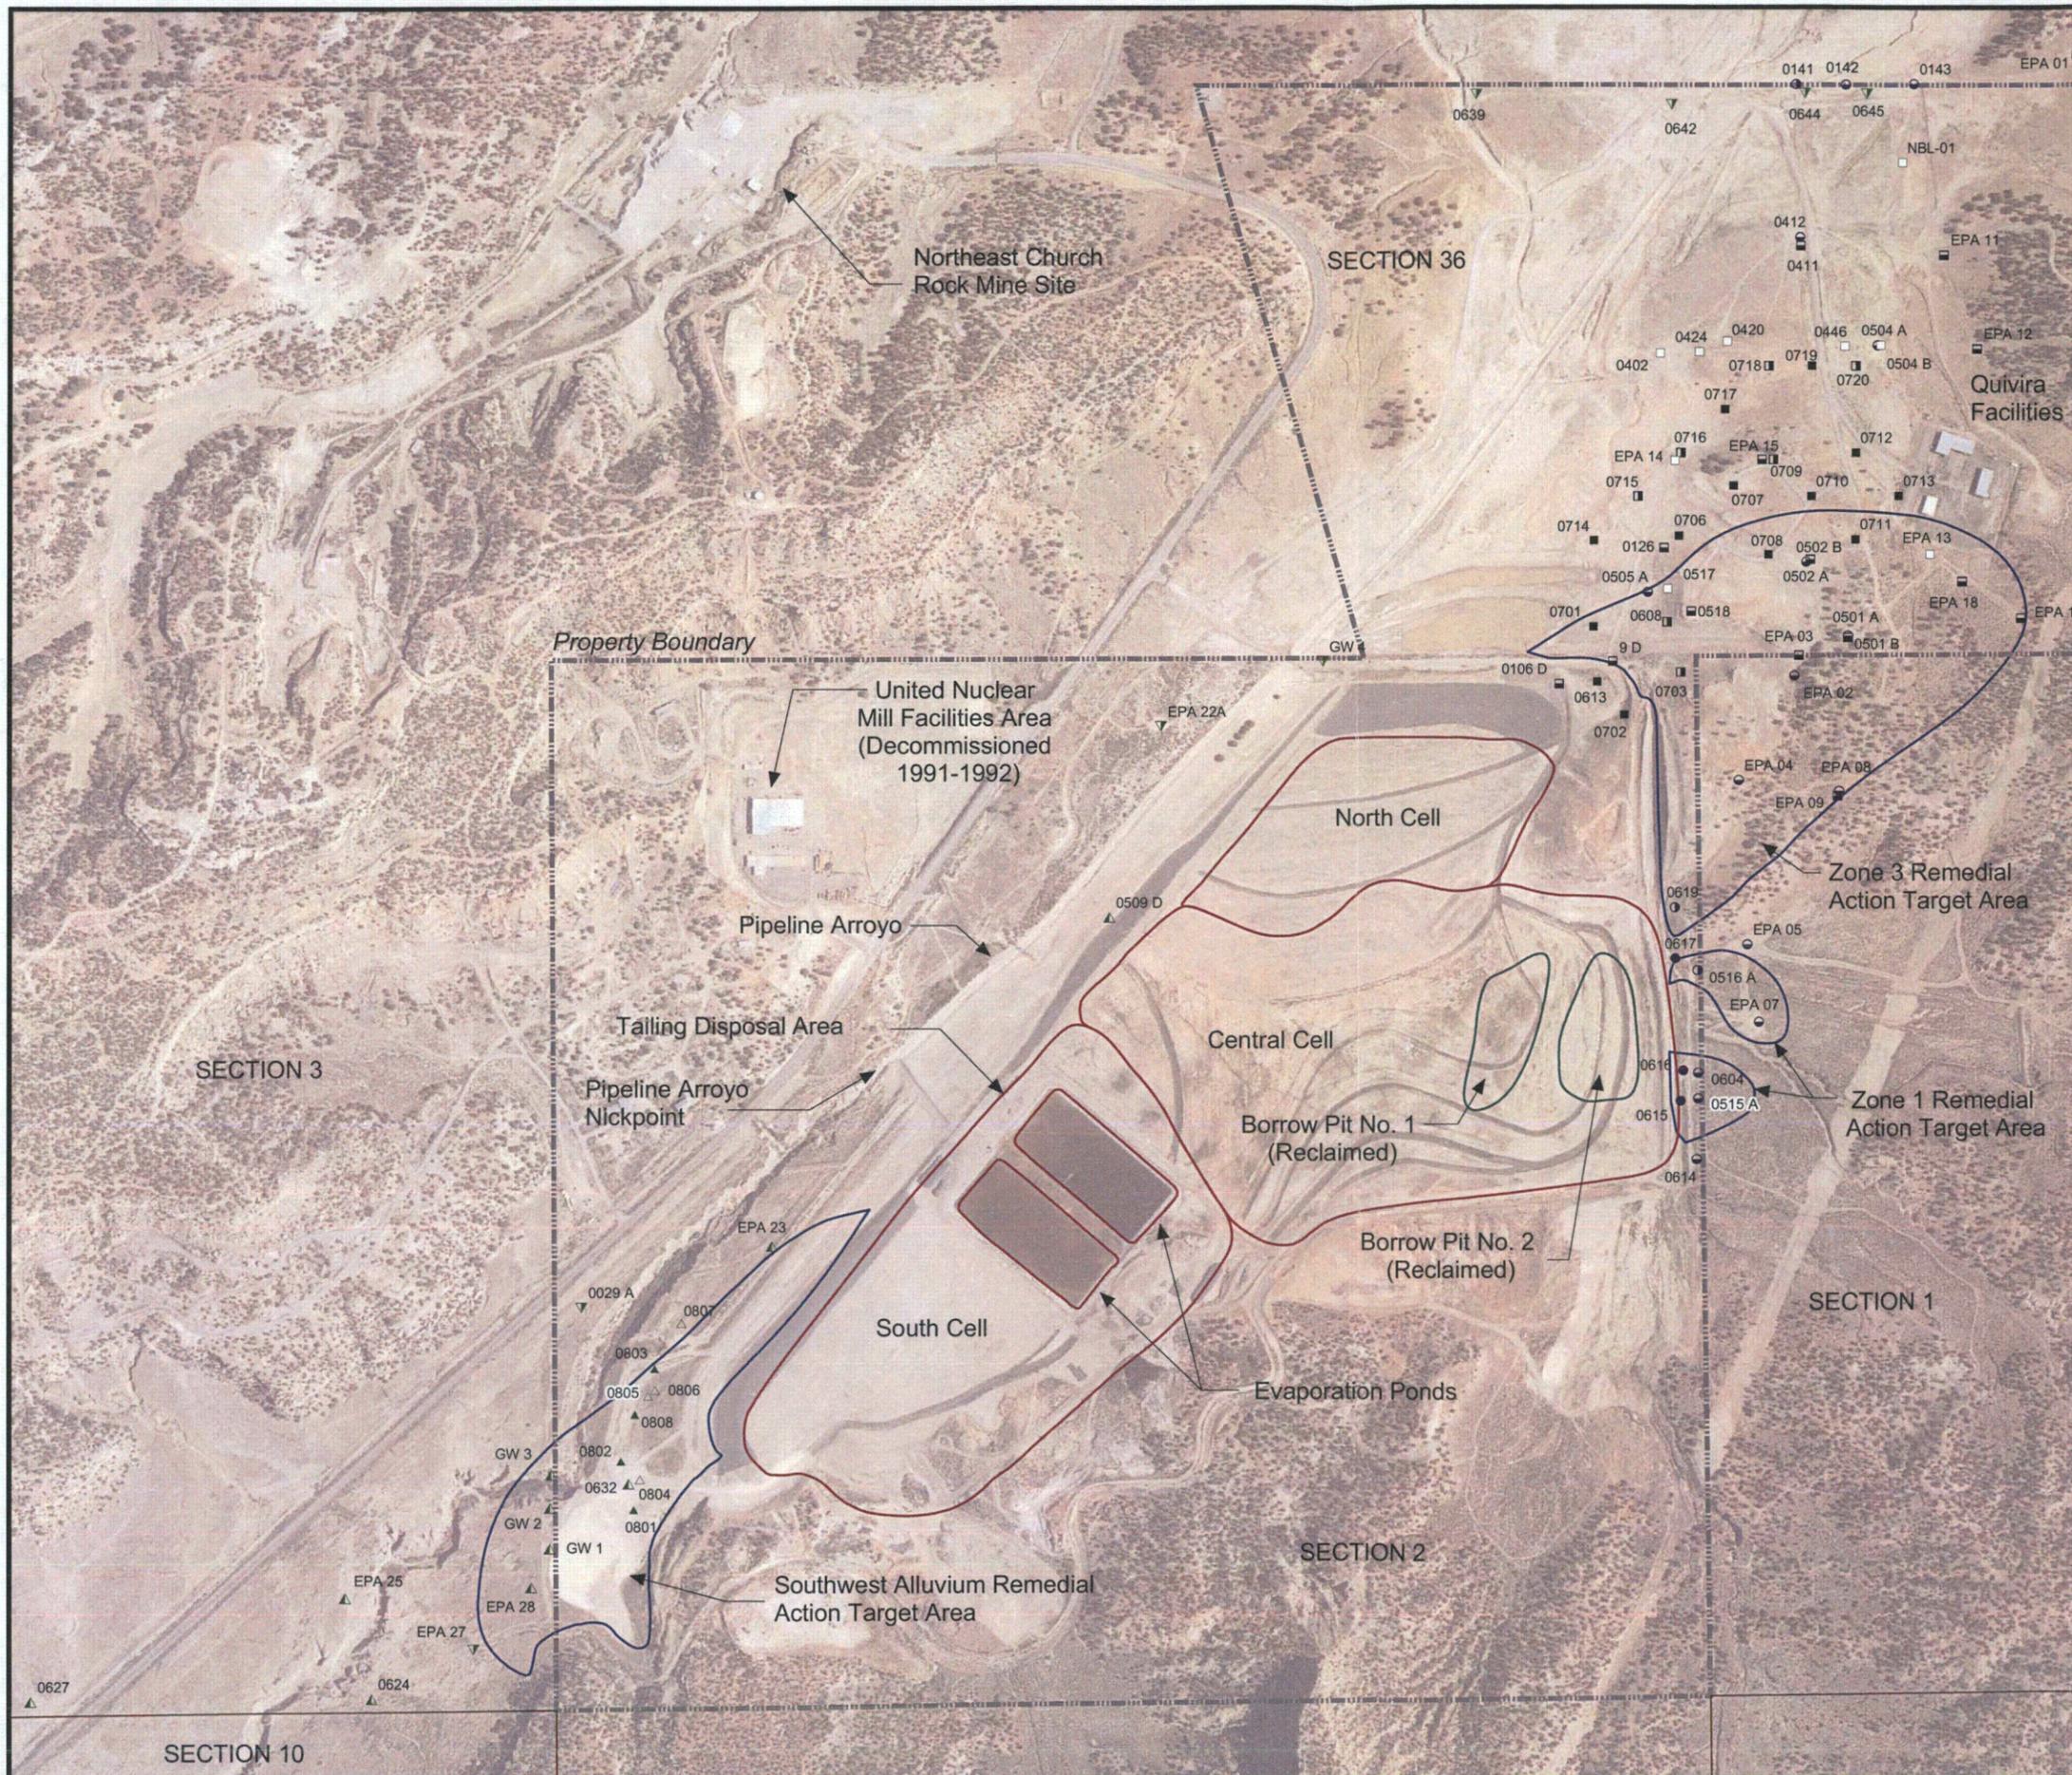
FIGURE 2

Site Layout and Performance
Monitoring Well Locations
2010 Operating Year

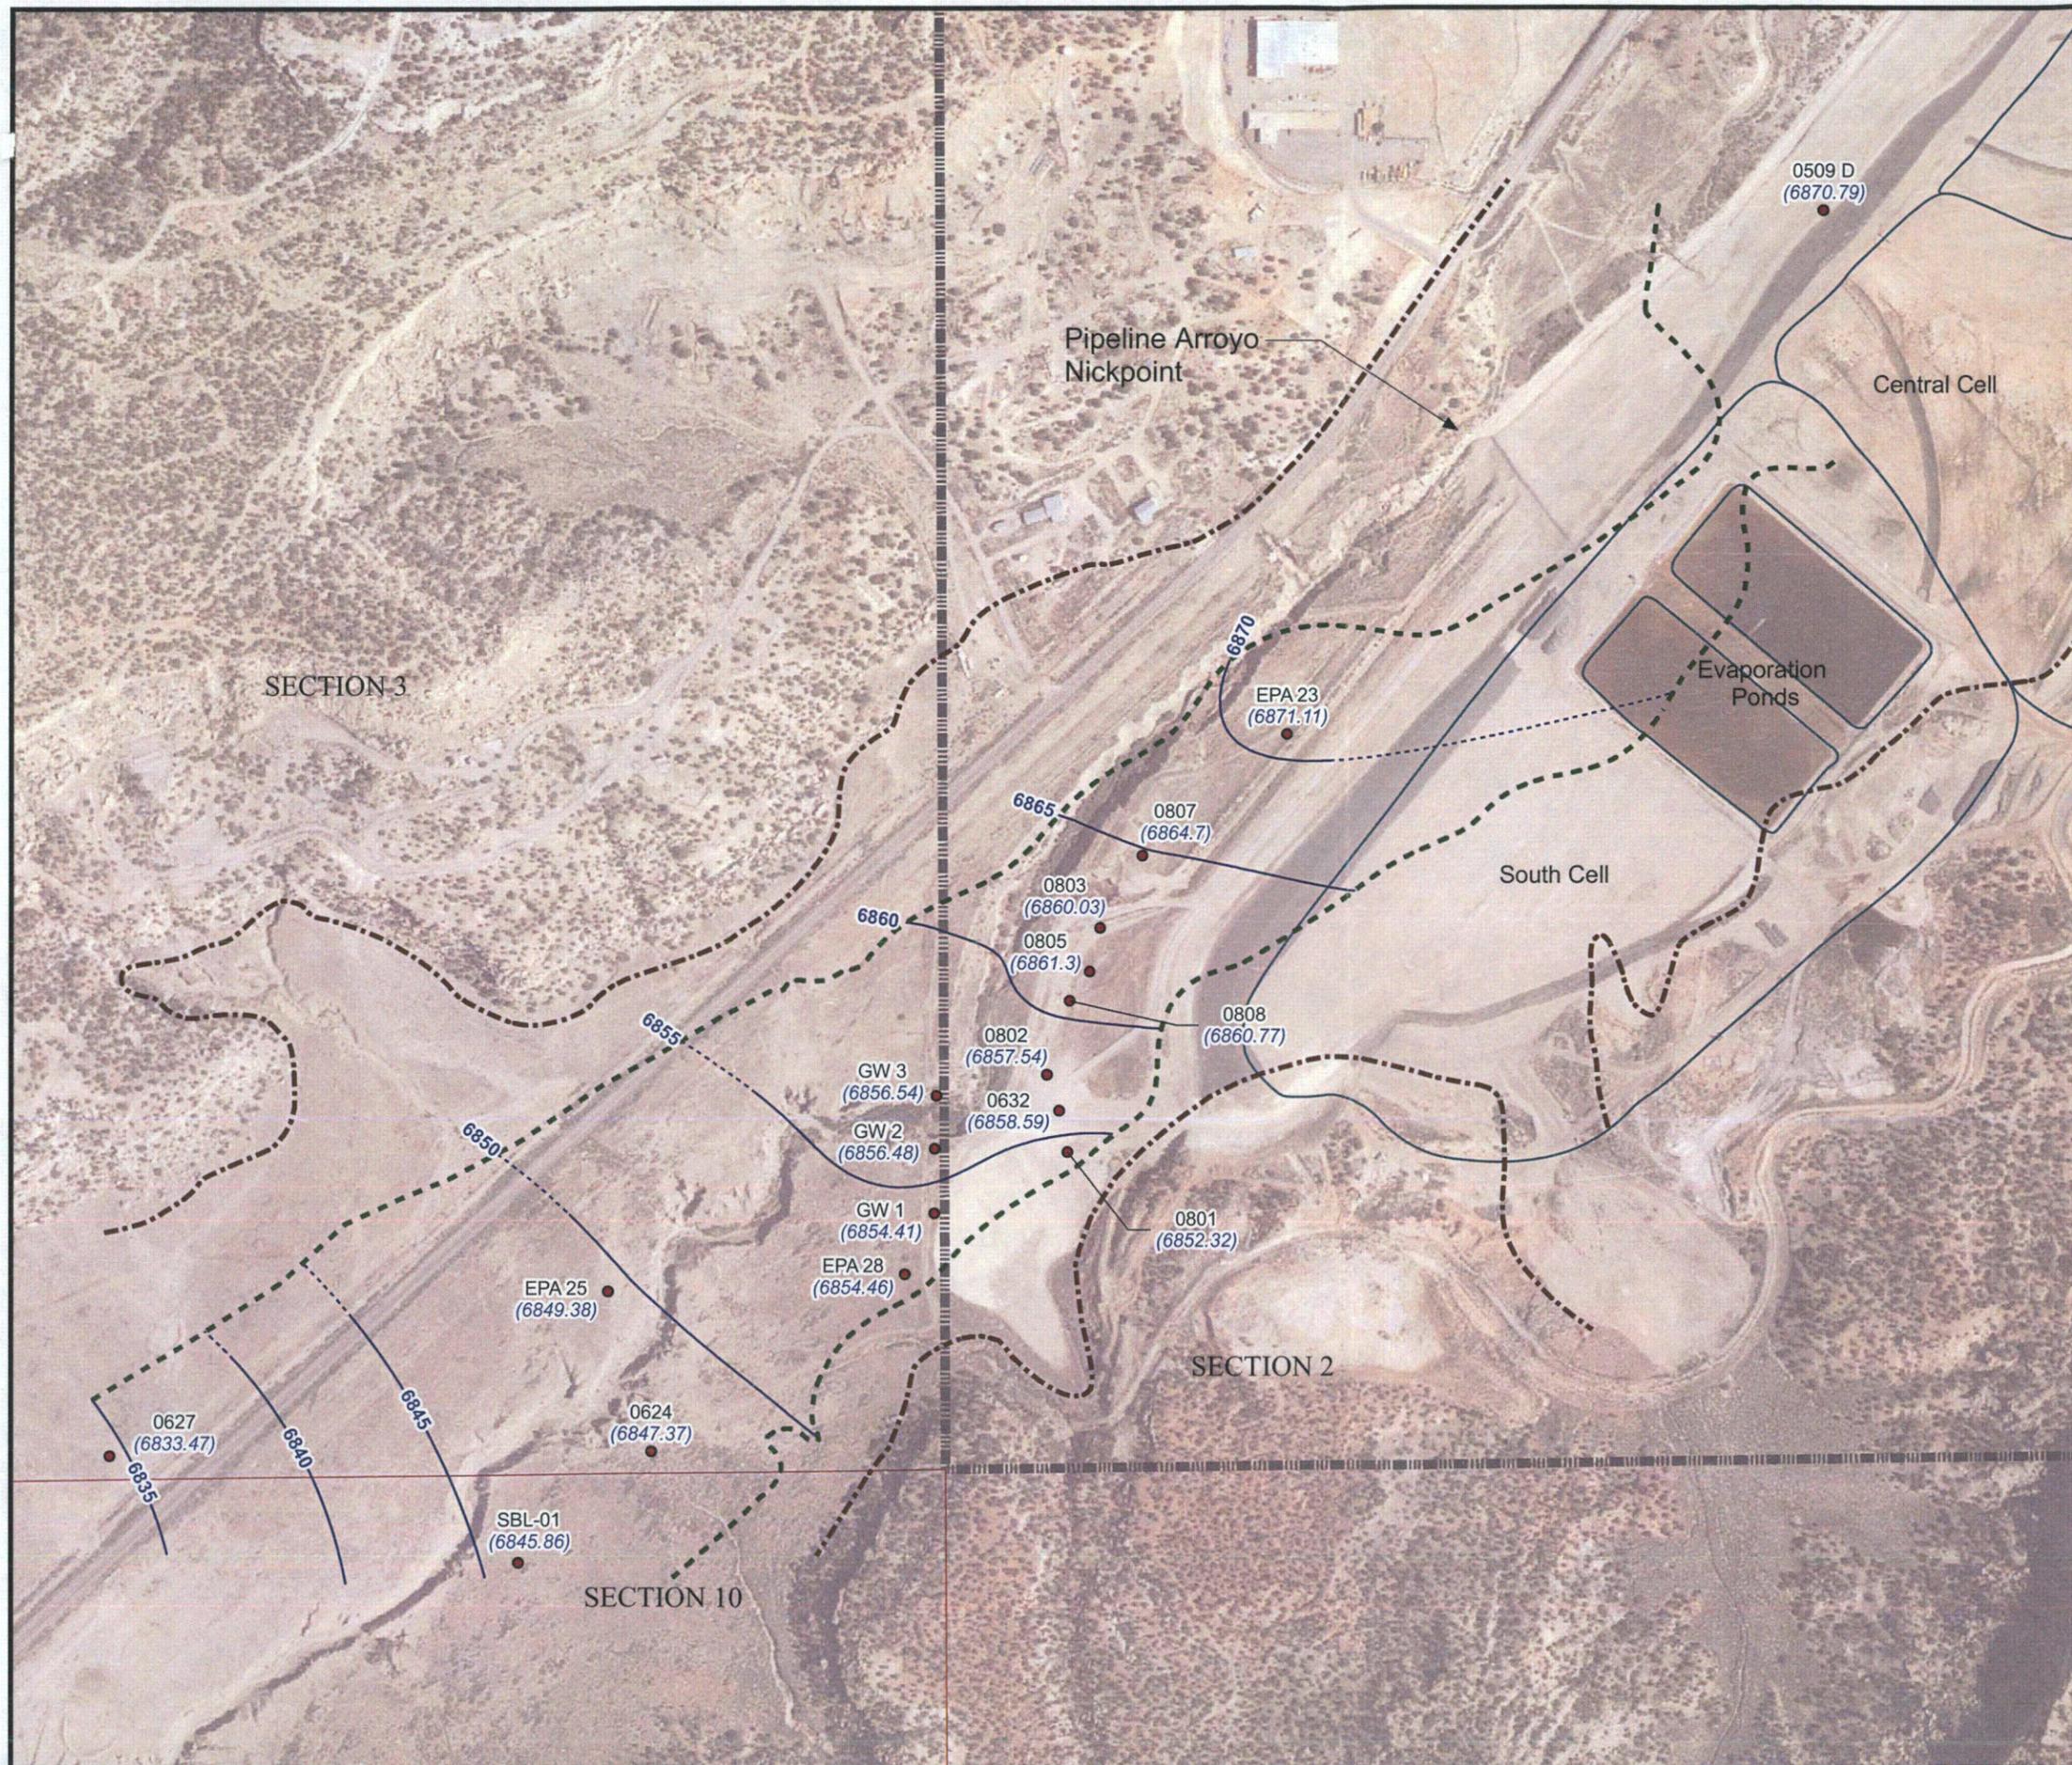
FIGURE 3A

1. Groundwater elevation values are displayed in feet above mean sea level.
2. Well names are displayed with black text.
3. Groundwater elevations are shown with blue text and enclosed in parentheses.
4. Aerial photo taken on August 1, 1996.

Southwest Alluvium
Potentiometric Surface Map
October 2010

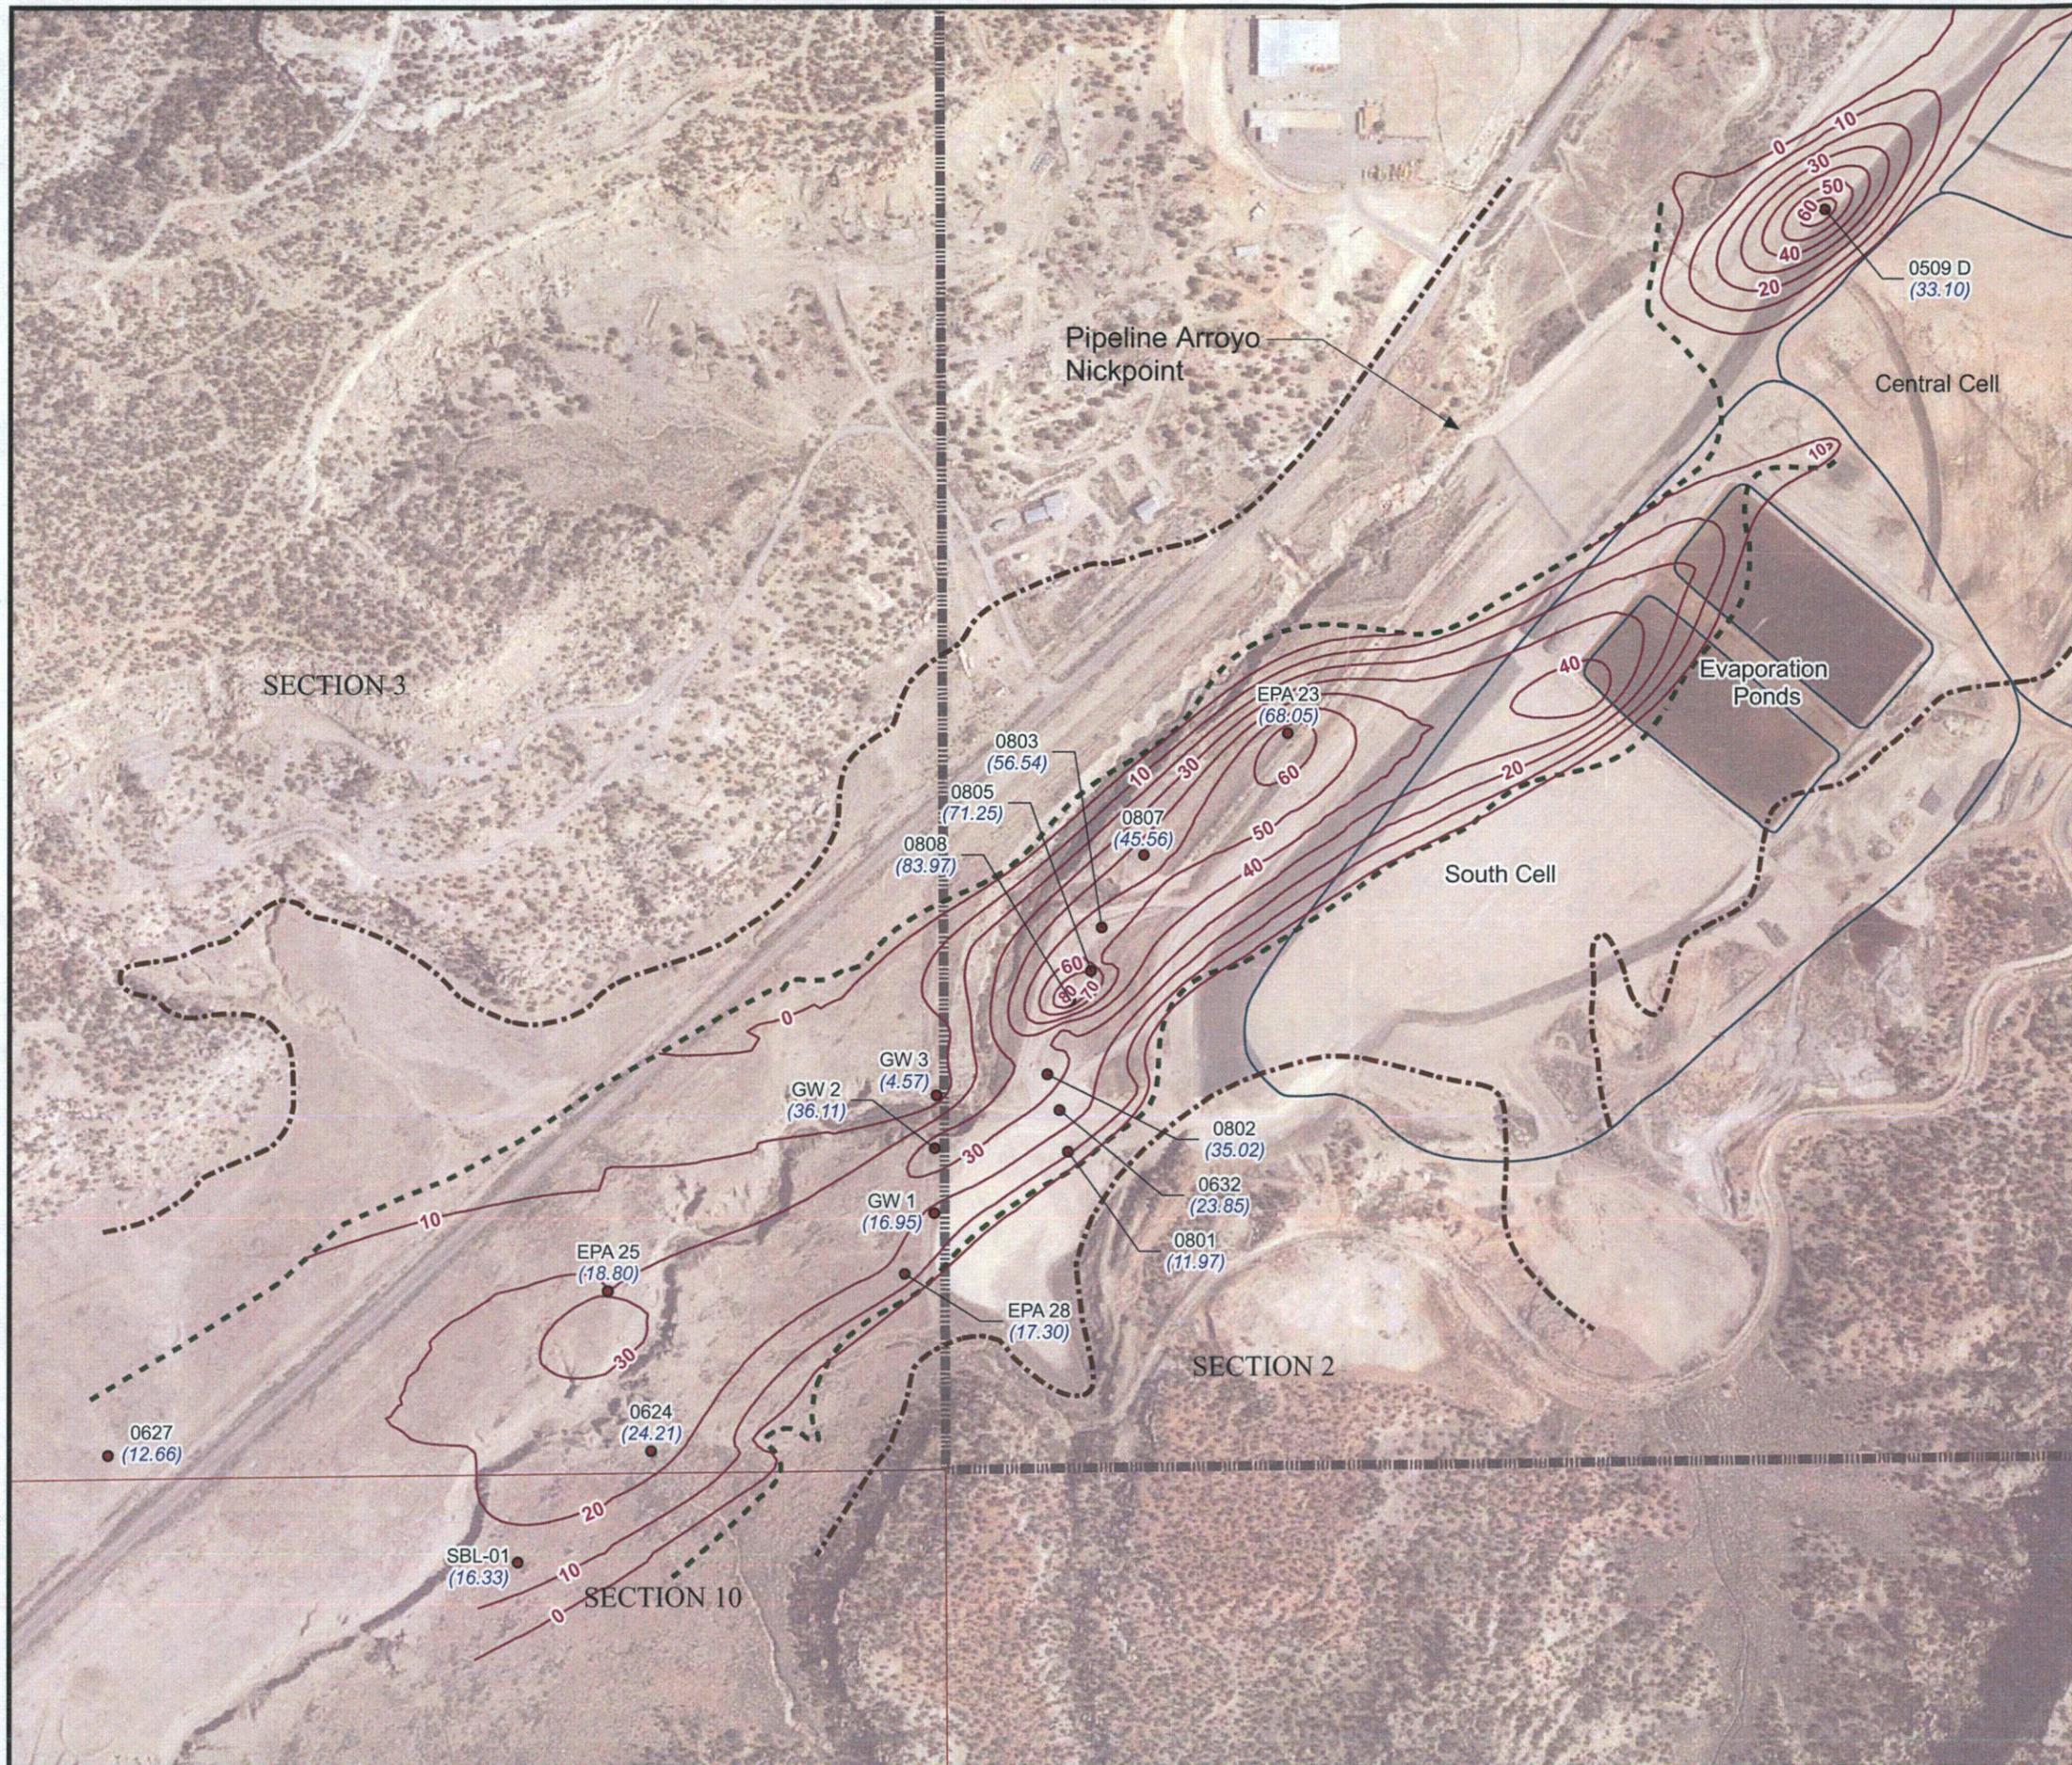
FIGURE 3B

1. Well names are displayed with black text.
2. Saturated thicknesses (feet) are shown with blue text and enclosed in parentheses.
3. Aerial photo taken on August 1, 1996.
4. The posted value of saturated thickness at well 0509 D derives from reference to the screen bottom. The alluvium extends as much as 38 feet below this depth in the vicinity of this well.

Southwest Alluvium
Saturated Thickness Map
October 2010

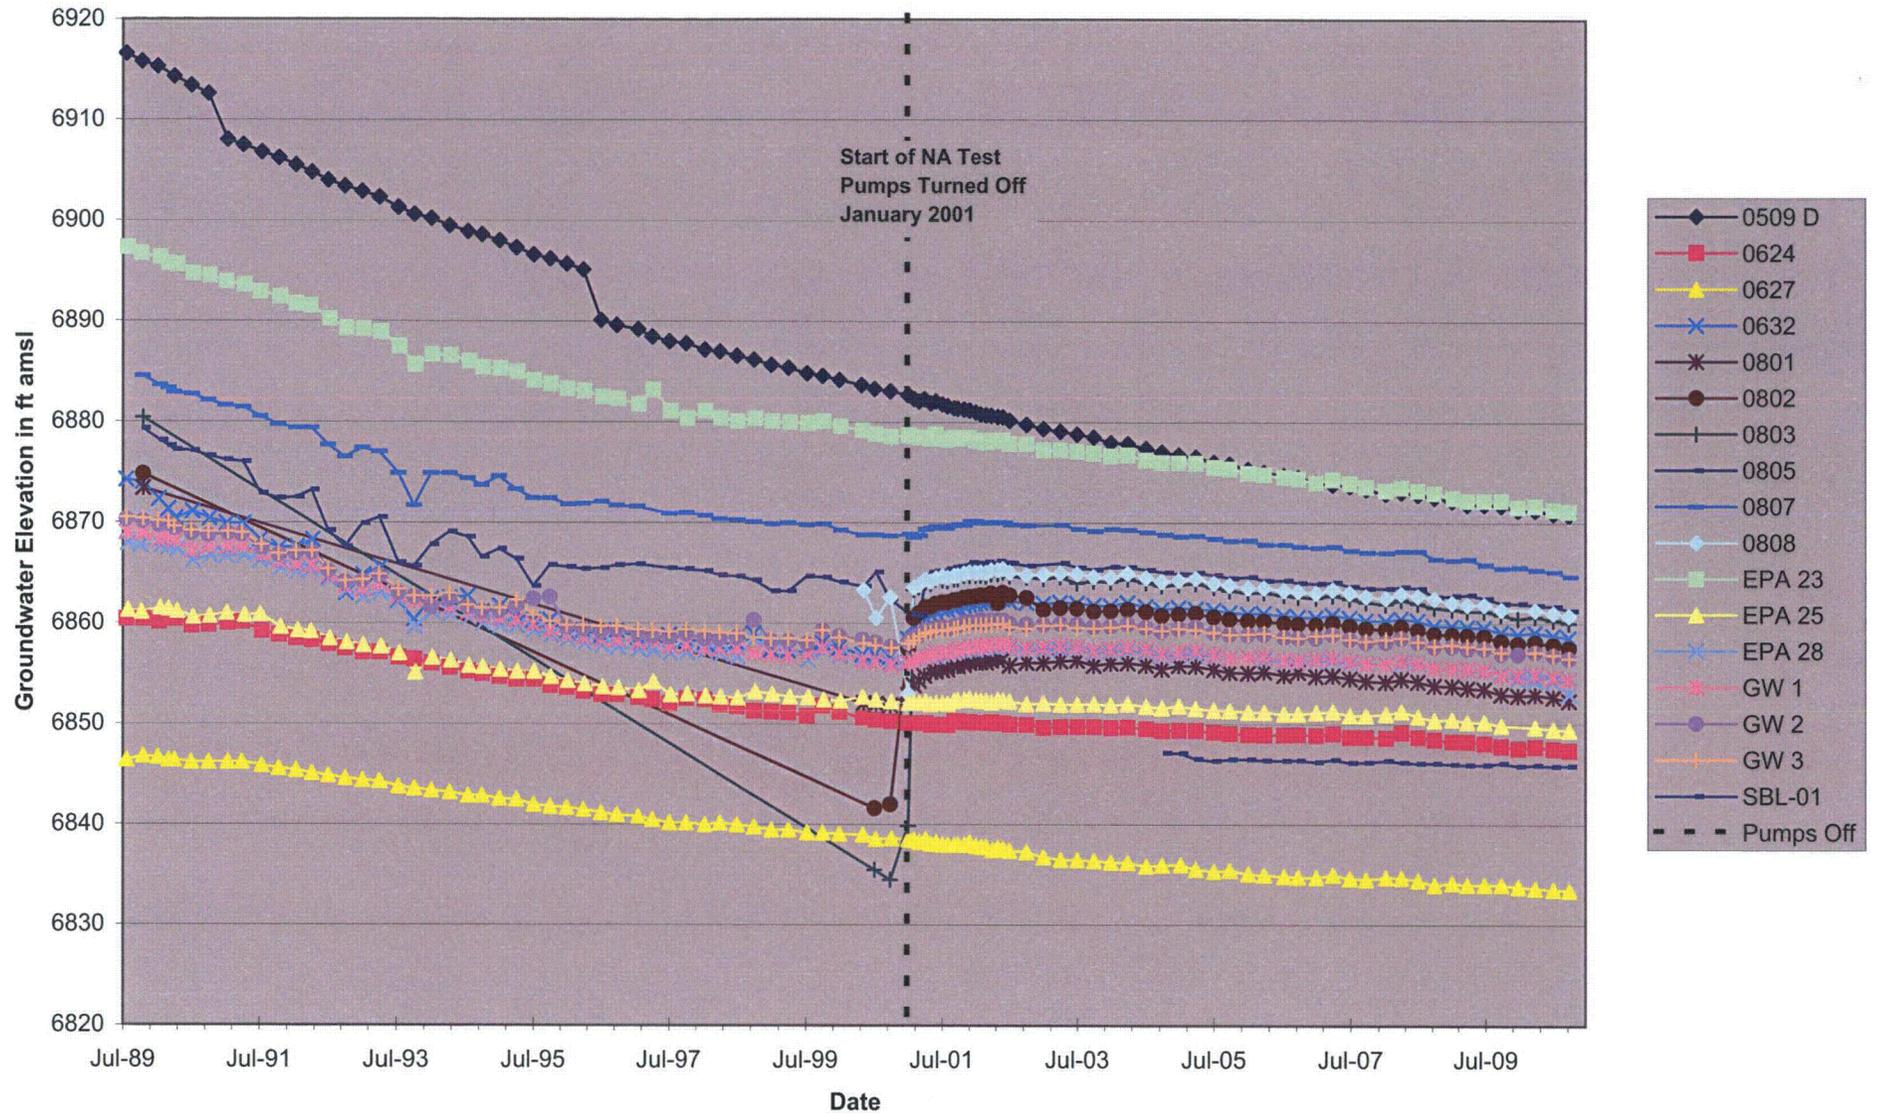
FIGURE 4
 Southwest Alluvium Water Levels Over Time
 United Nuclear Corporation, Church Rock Site, Church Rock New Mexico

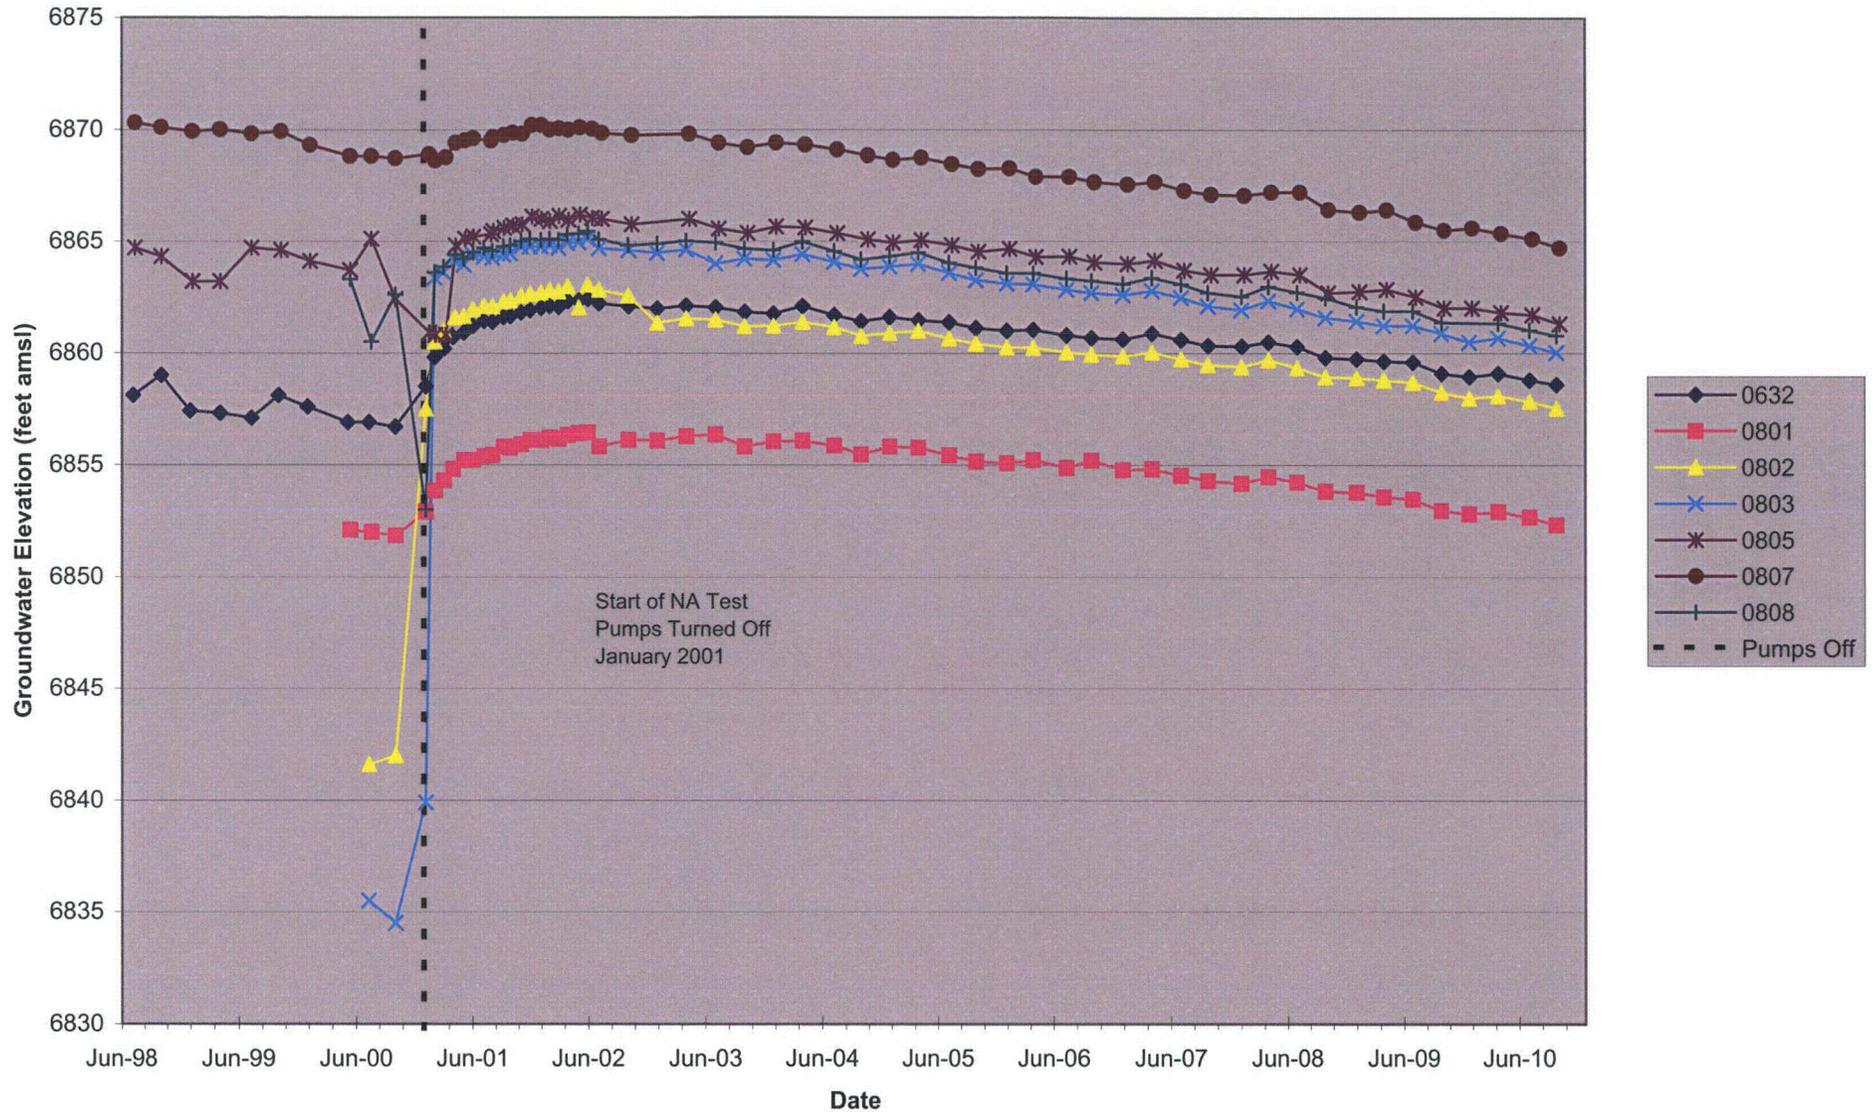
FIGURE 5
 Southwest Alluvium Pumping Well Water Levels Over Time
 United Nuclear Corporation, Church Rock Site, Church Rock New Mexico

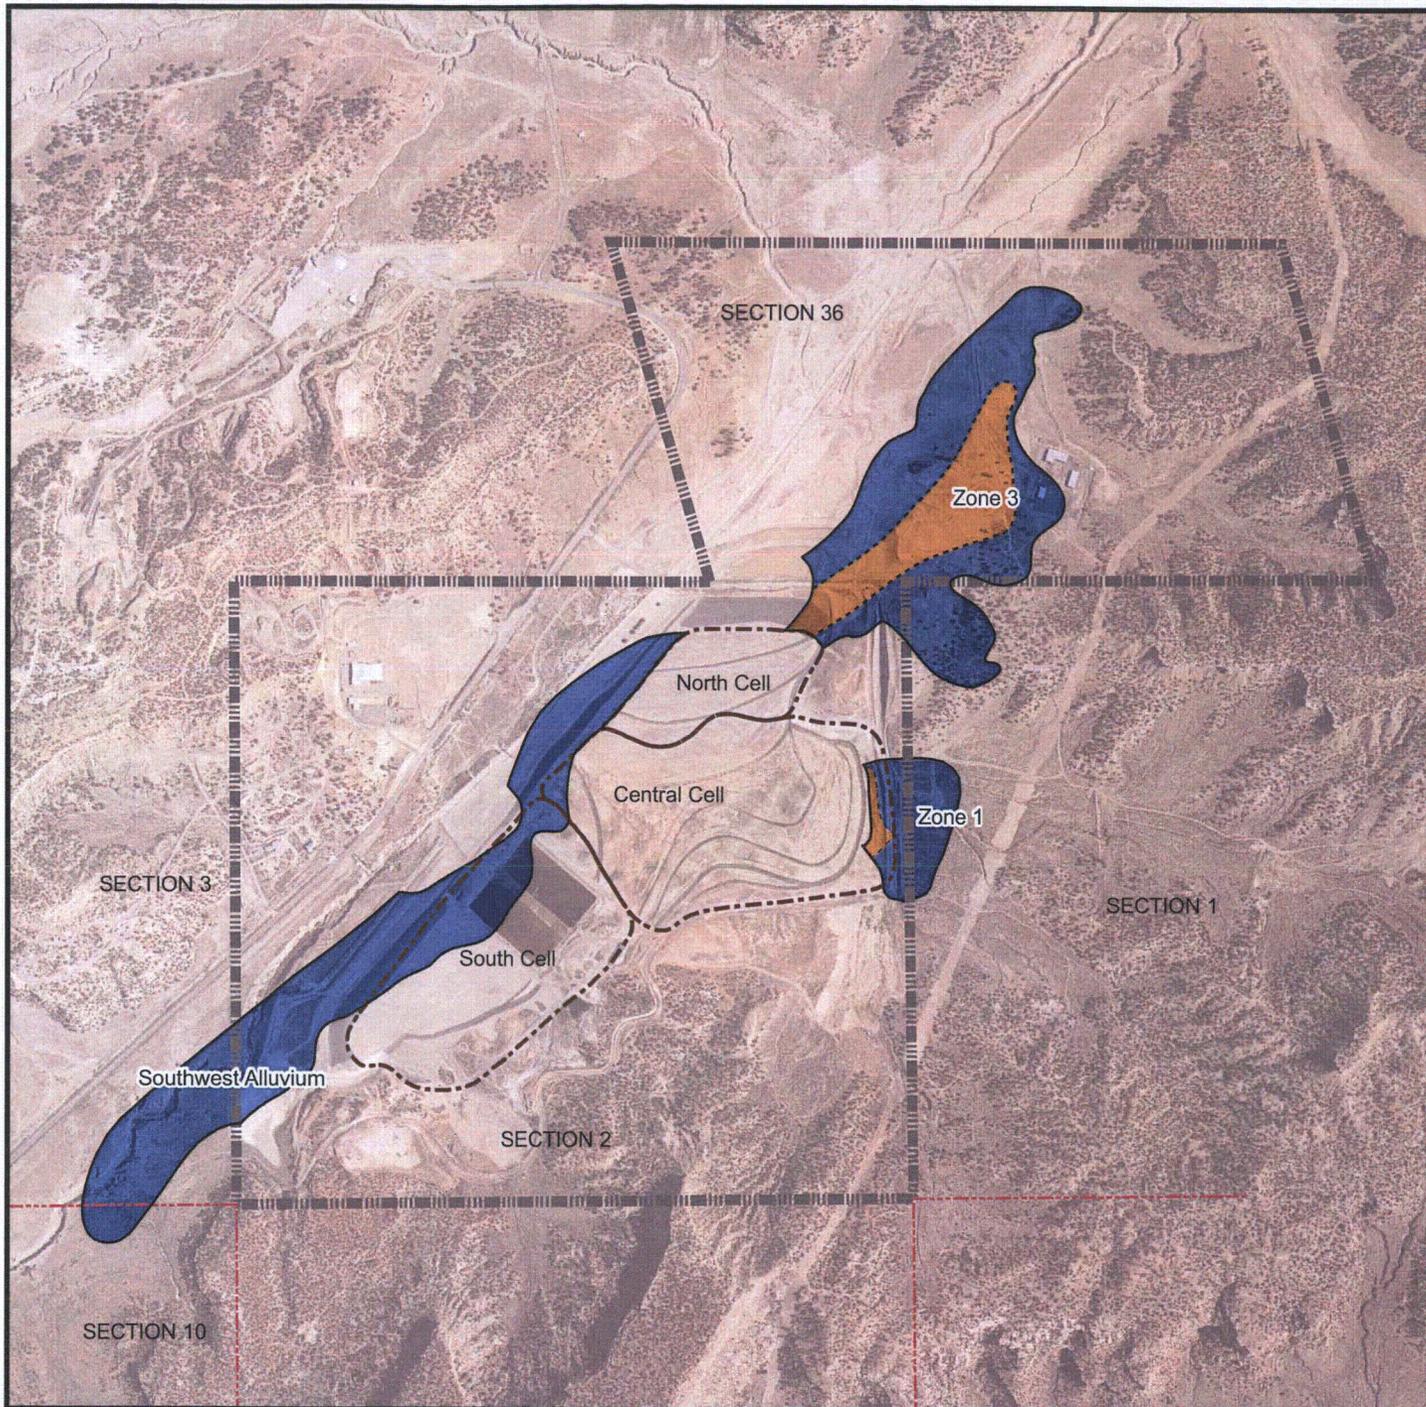
FIGURE 6

Extent of Seepage-Impacted Groundwater, October 2010

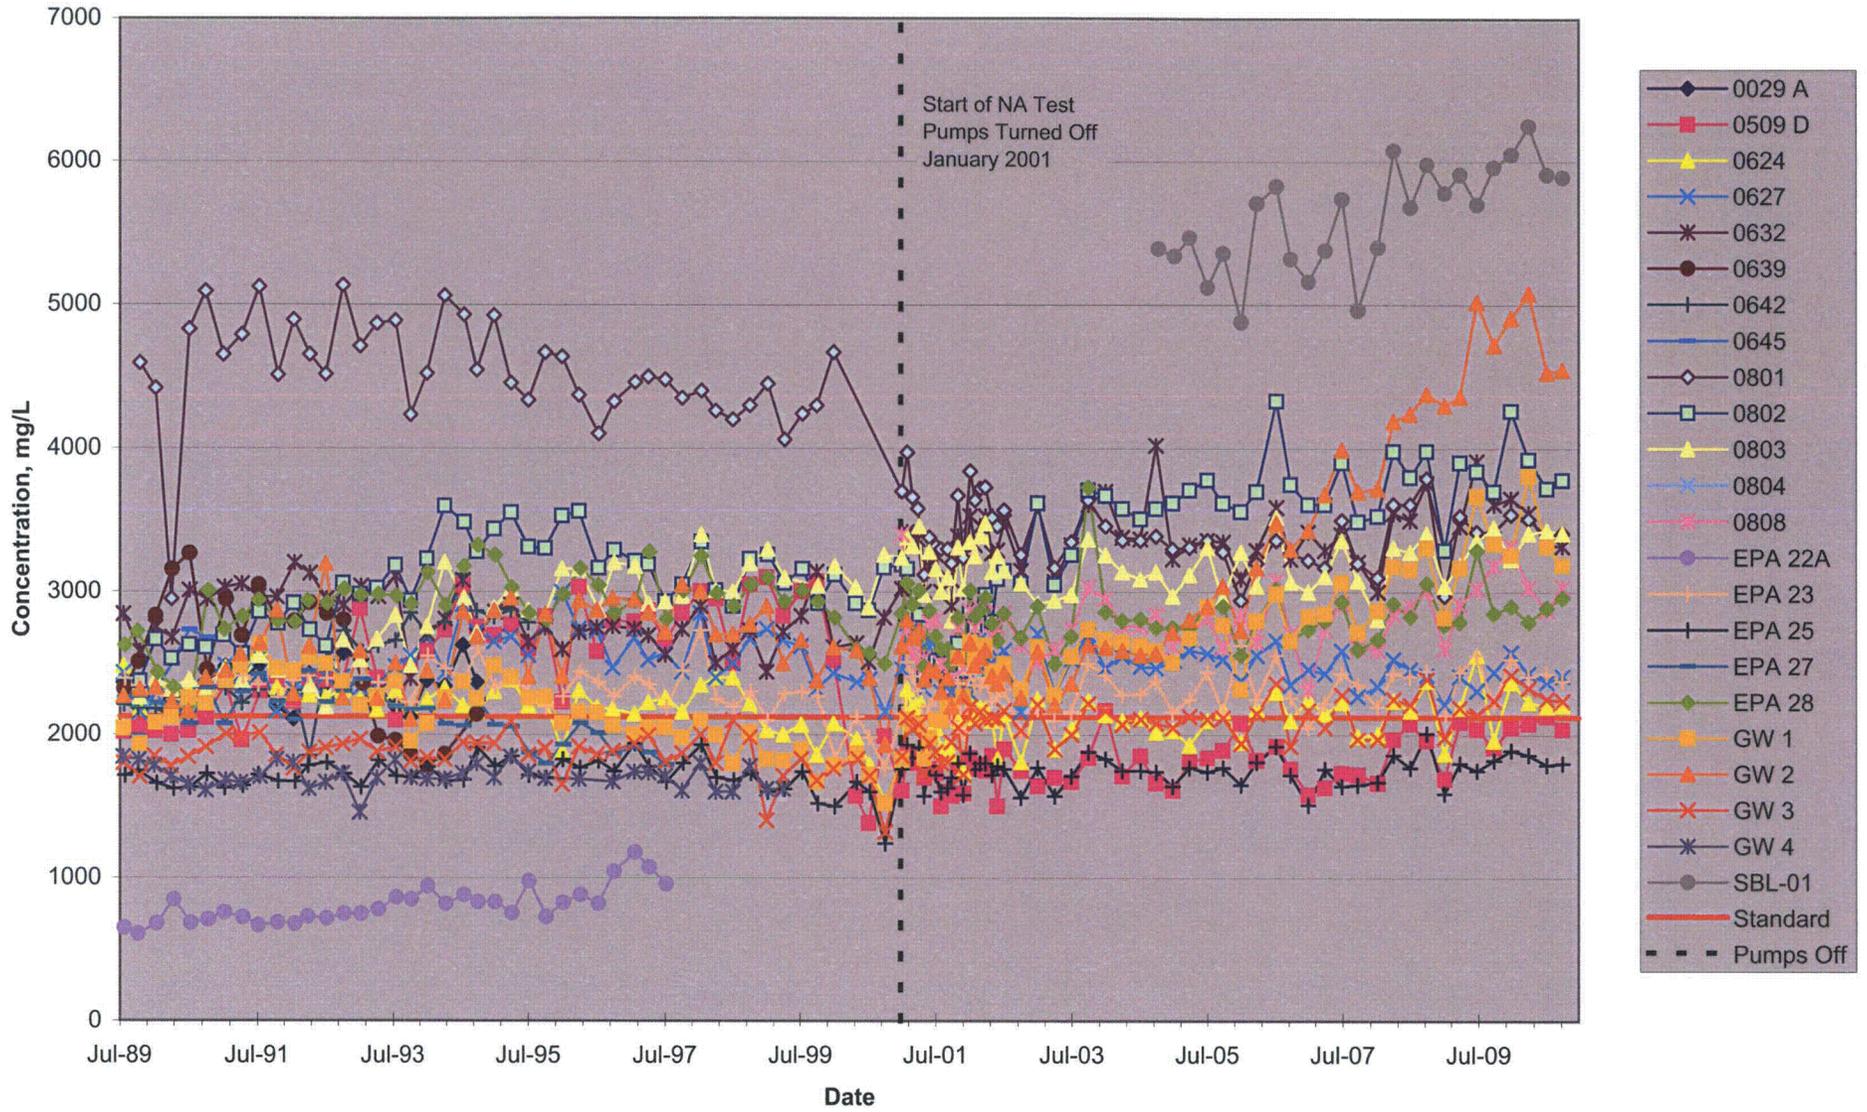
FIGURE 7
 Southwest Alluvium Sulfate Concentraions Over Time
 United Nuclear Corporation, Church Rock Site, Church Rock, New Mexico
