Site Location Map

United Nuclear Corporation Church Rock Site, Church Rock, New Mexico

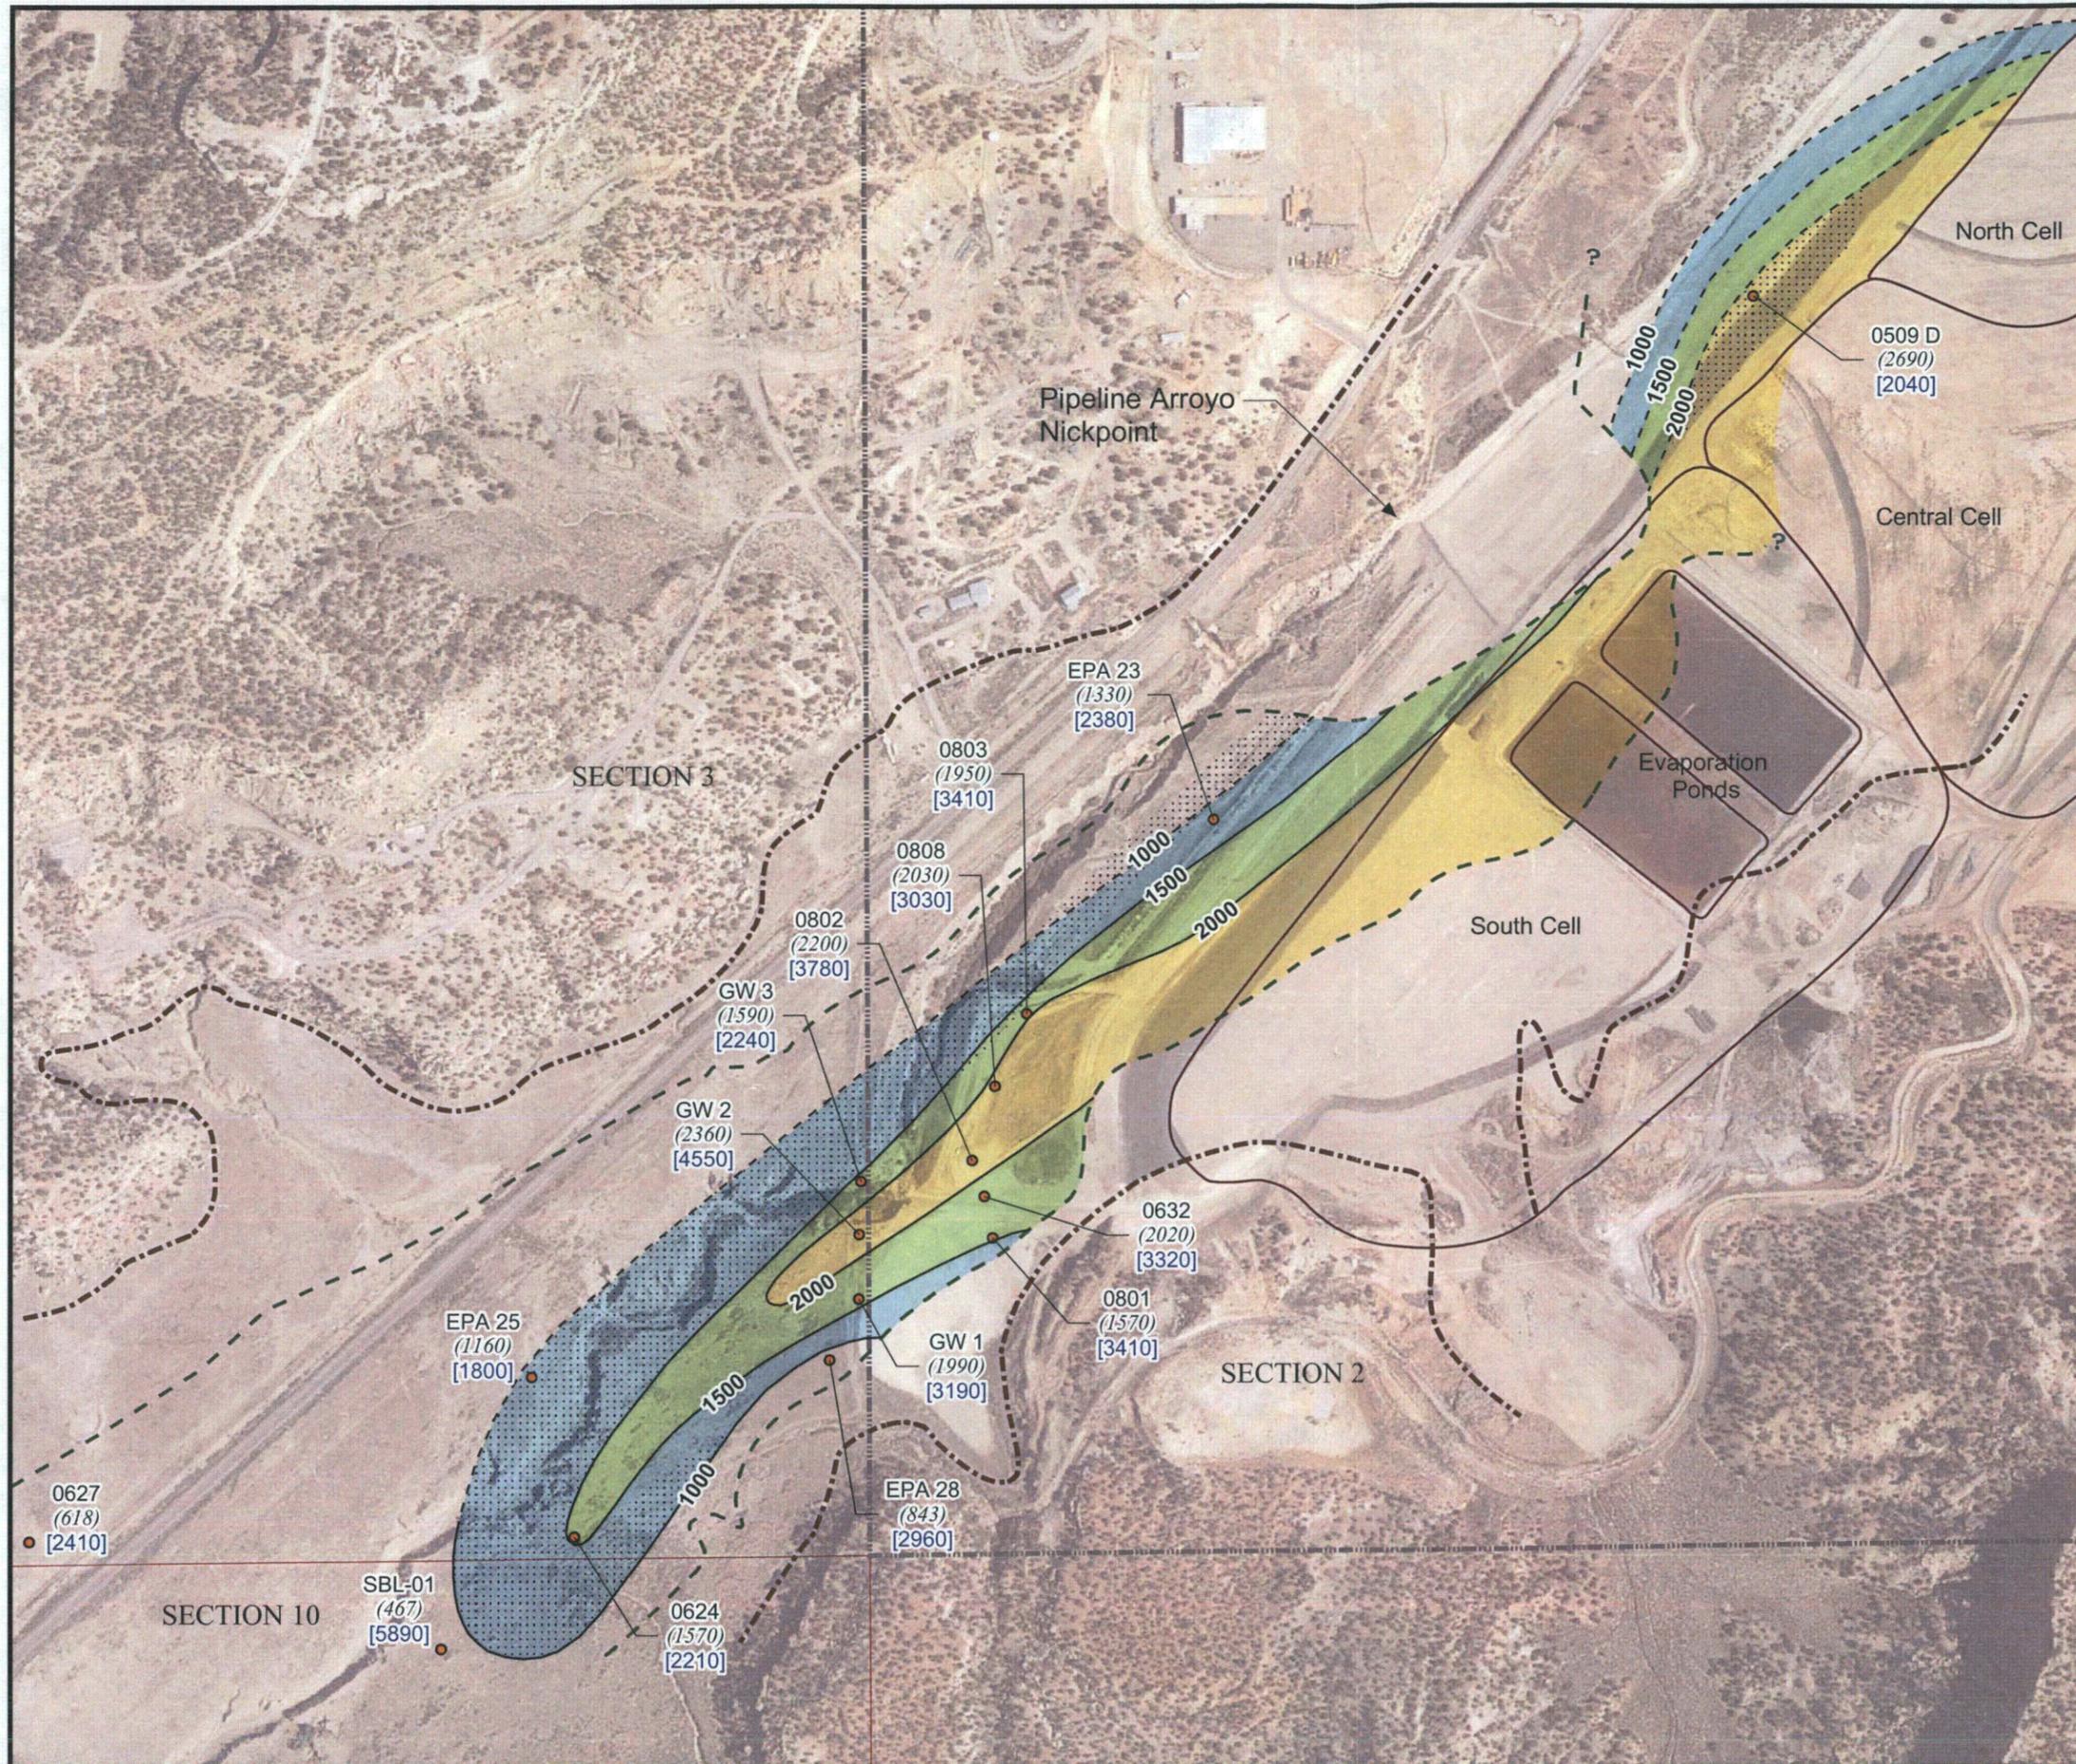
FIGURE 8

Southwest Alluvium Bicarbonate Isoconcentration Map and Distribution of Sulfate Below 2125 mg/L, October 2010

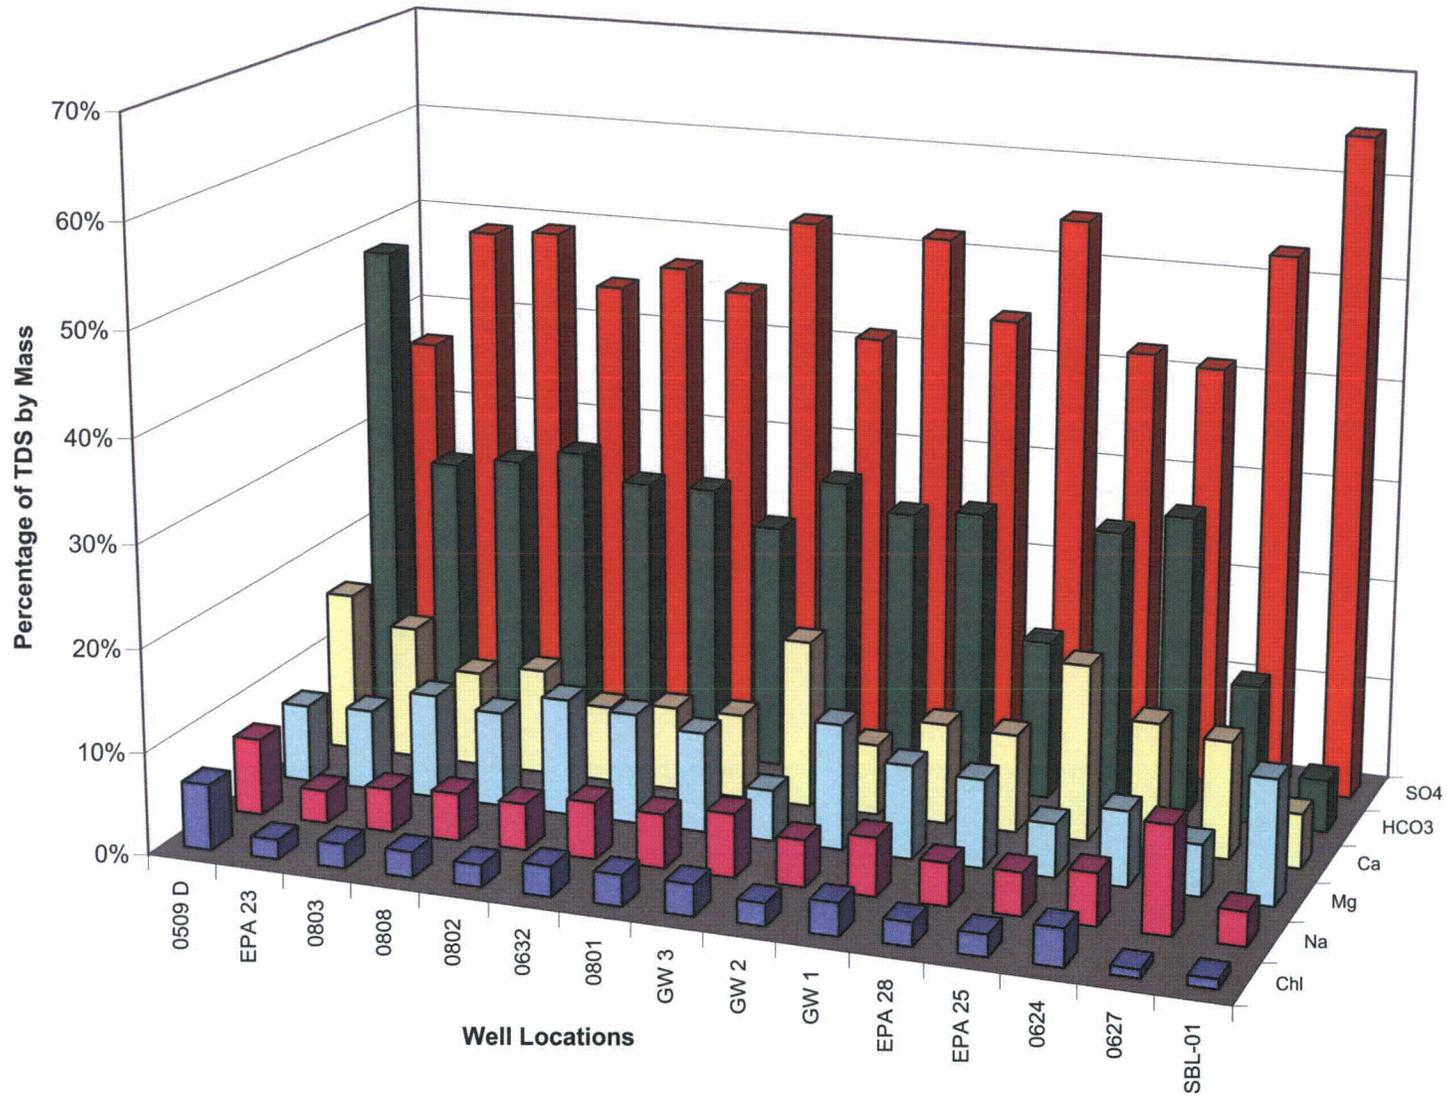
FIGURE 9

Primary Components of Total Dissolved Solids in the Southwest Alluvium, October 2010
United Nuclear Corporation, Church Rock Site, Church Rock, New Mexico

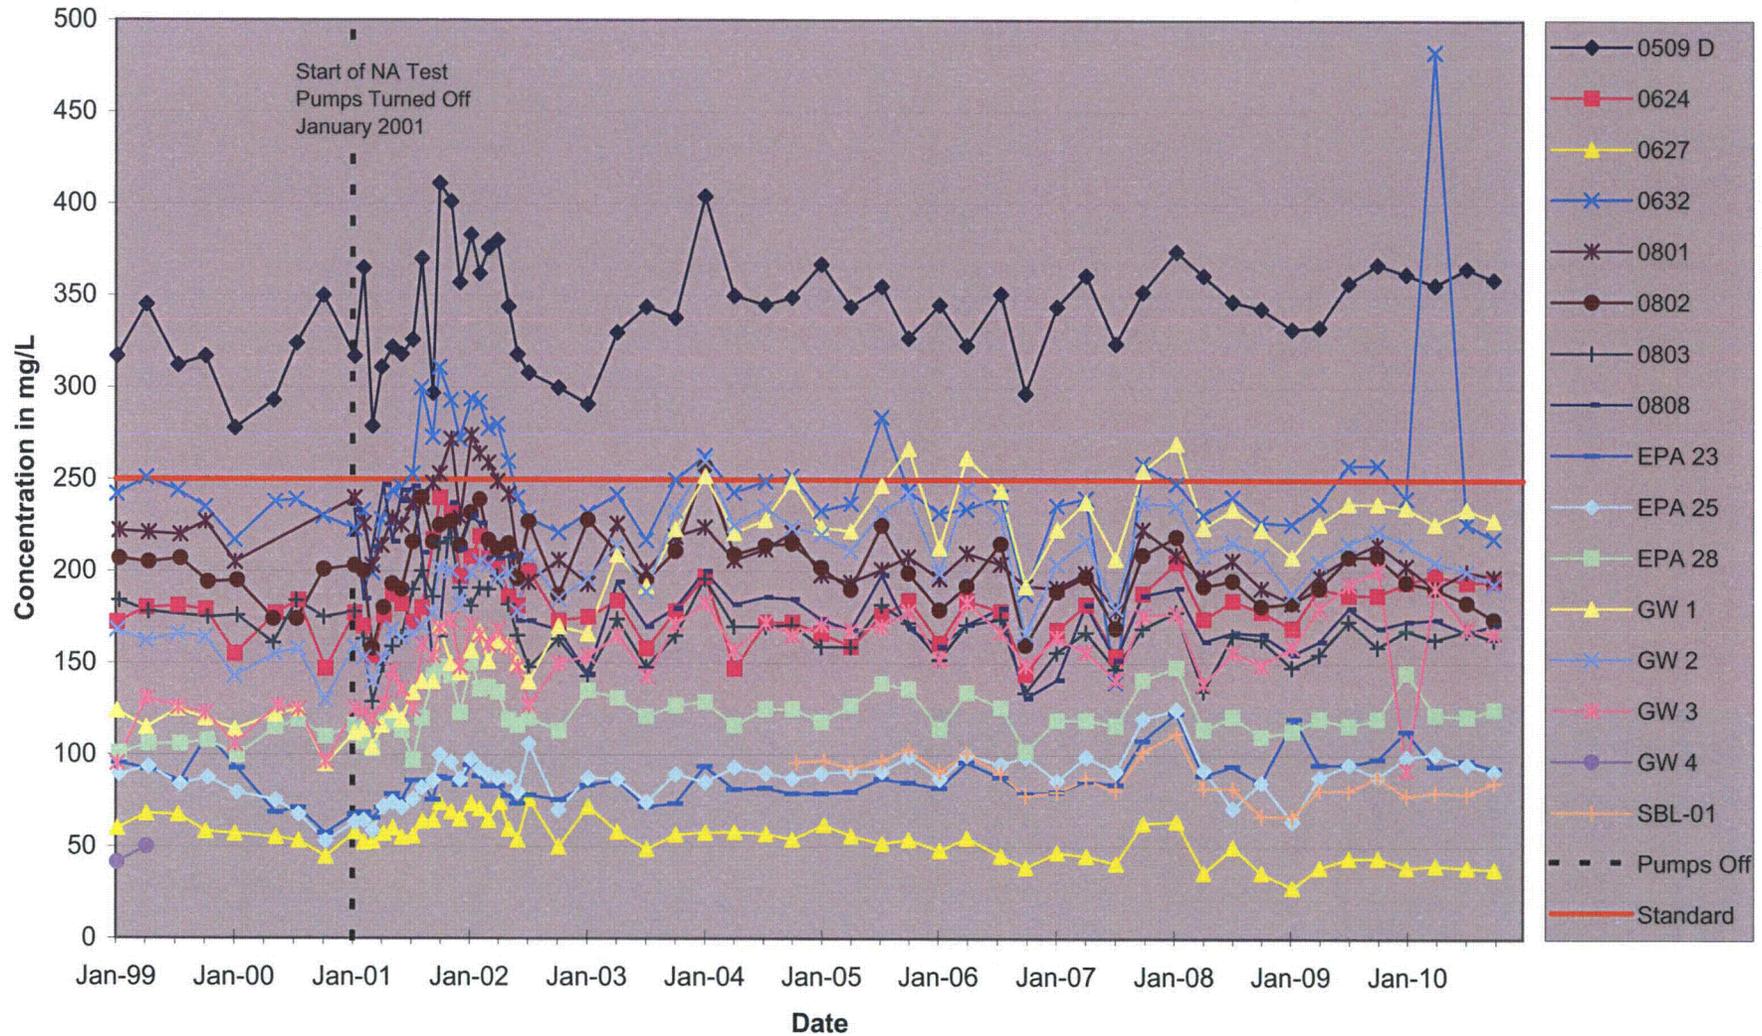
FIGURE 10
 Southwest Alluvium Chloride Concentrations From 1999 Through October 2010
 United Nuclear Corporation, Church Rock Site, Church Rock, New Mexico

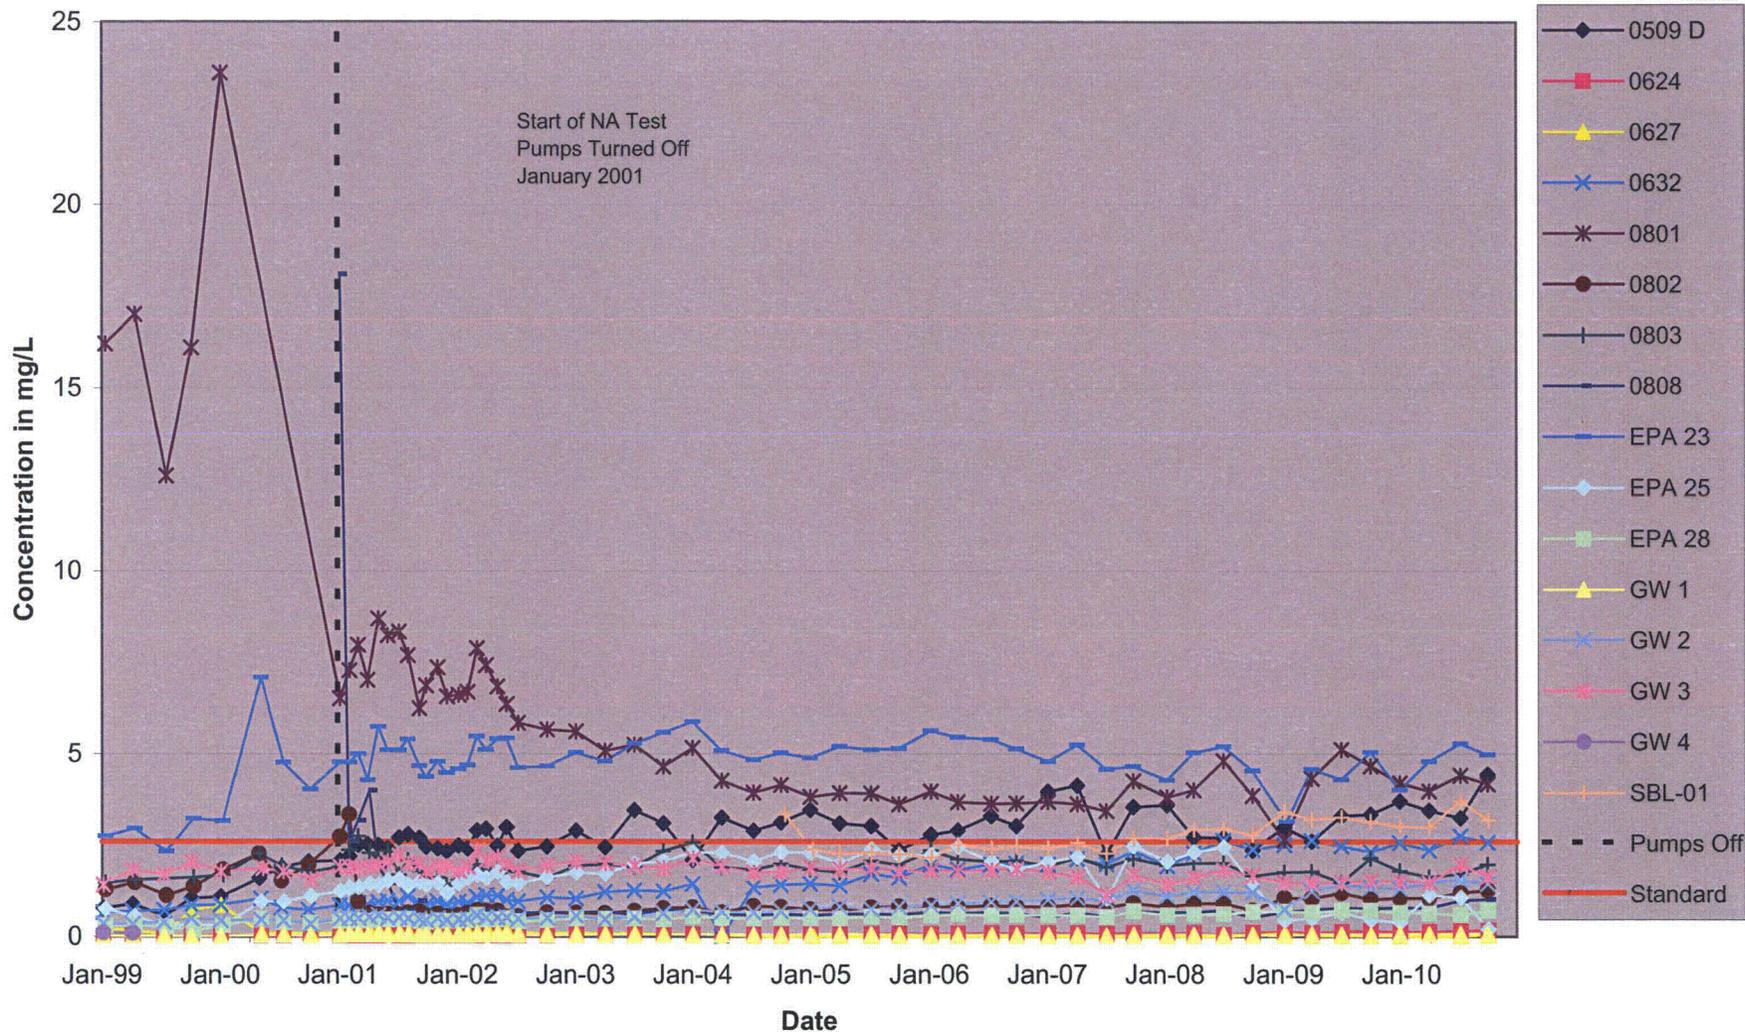
FIGURE 11
 Southwest Alluvium Manganese Concentrations From 1999 Through October 2010
 United Nuclear Corporation, Church Rock Site, Church Rock, New Mexico

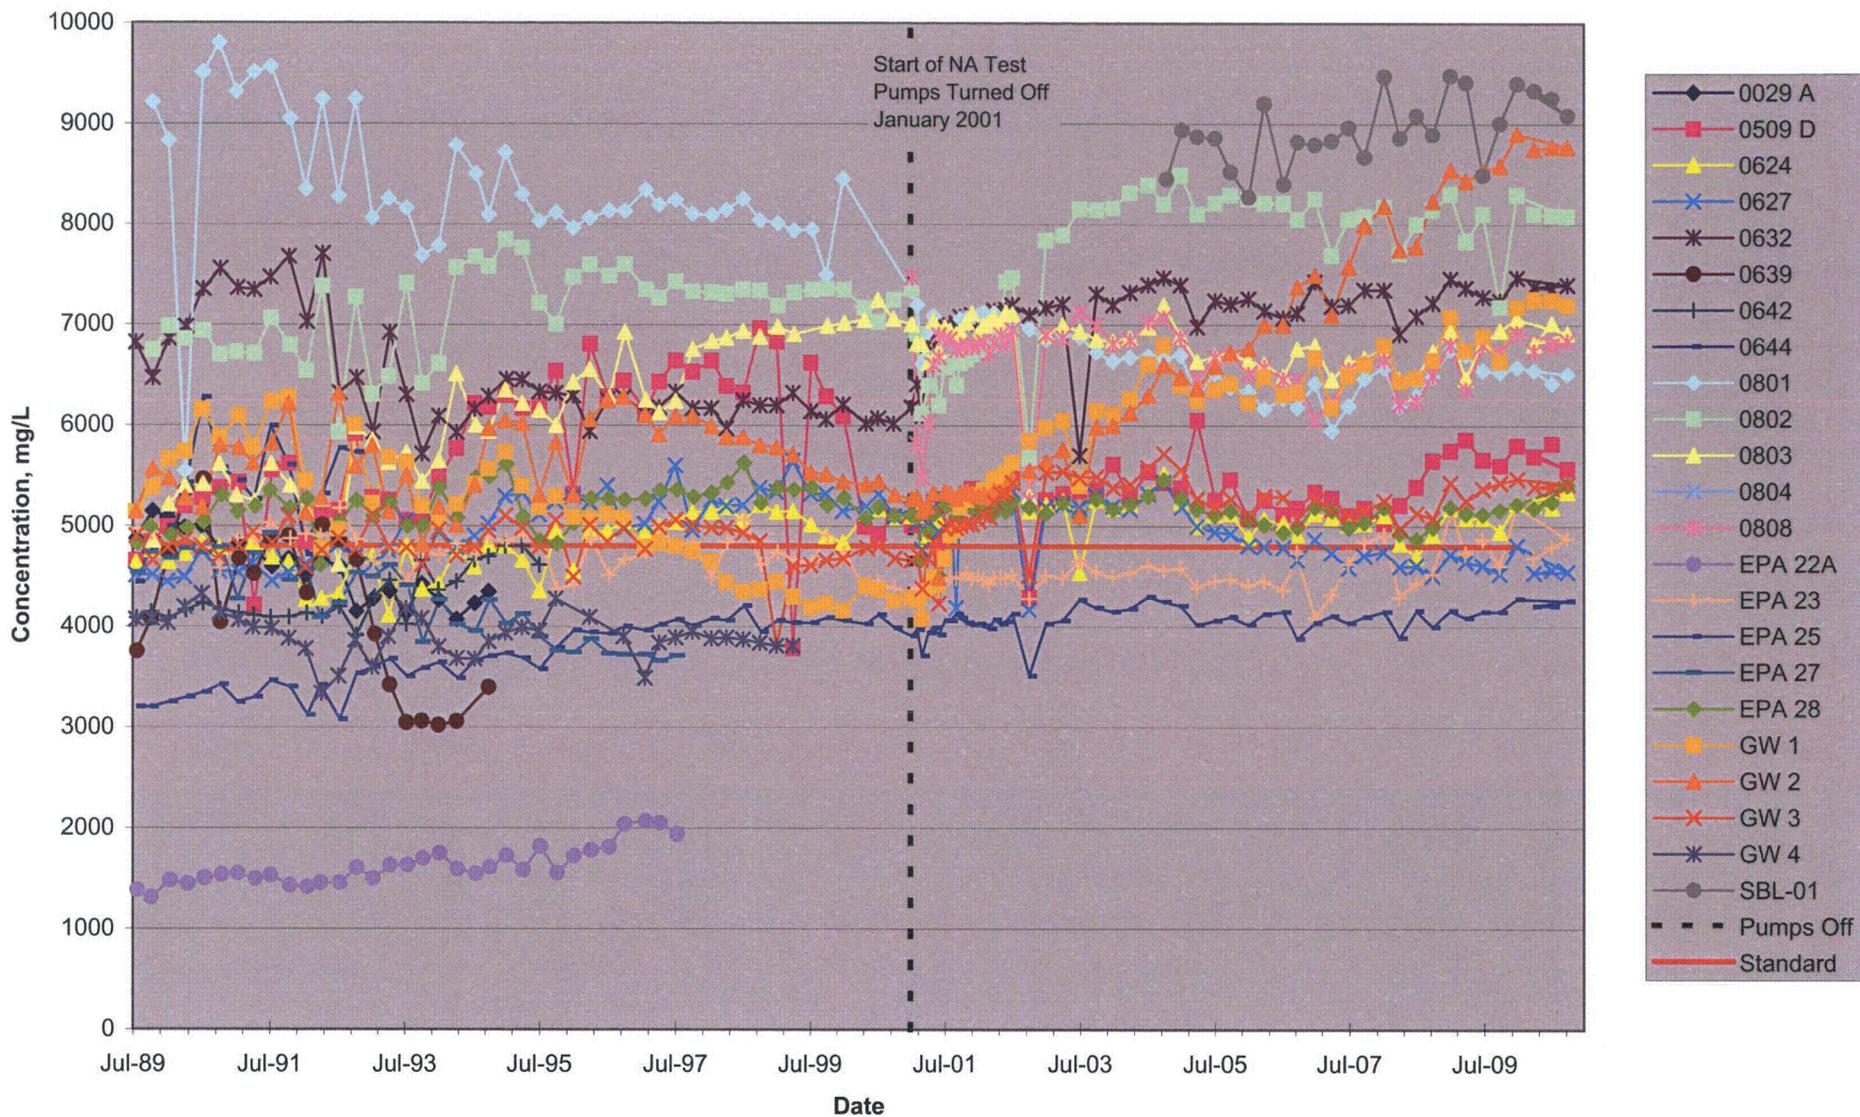
FIGURE 12
 Southwest Alluvium Total Dissolved Solids Concentrations Over Time
 United Nuclear Corporation, Church Rock Site, Church Rock, New Mexico

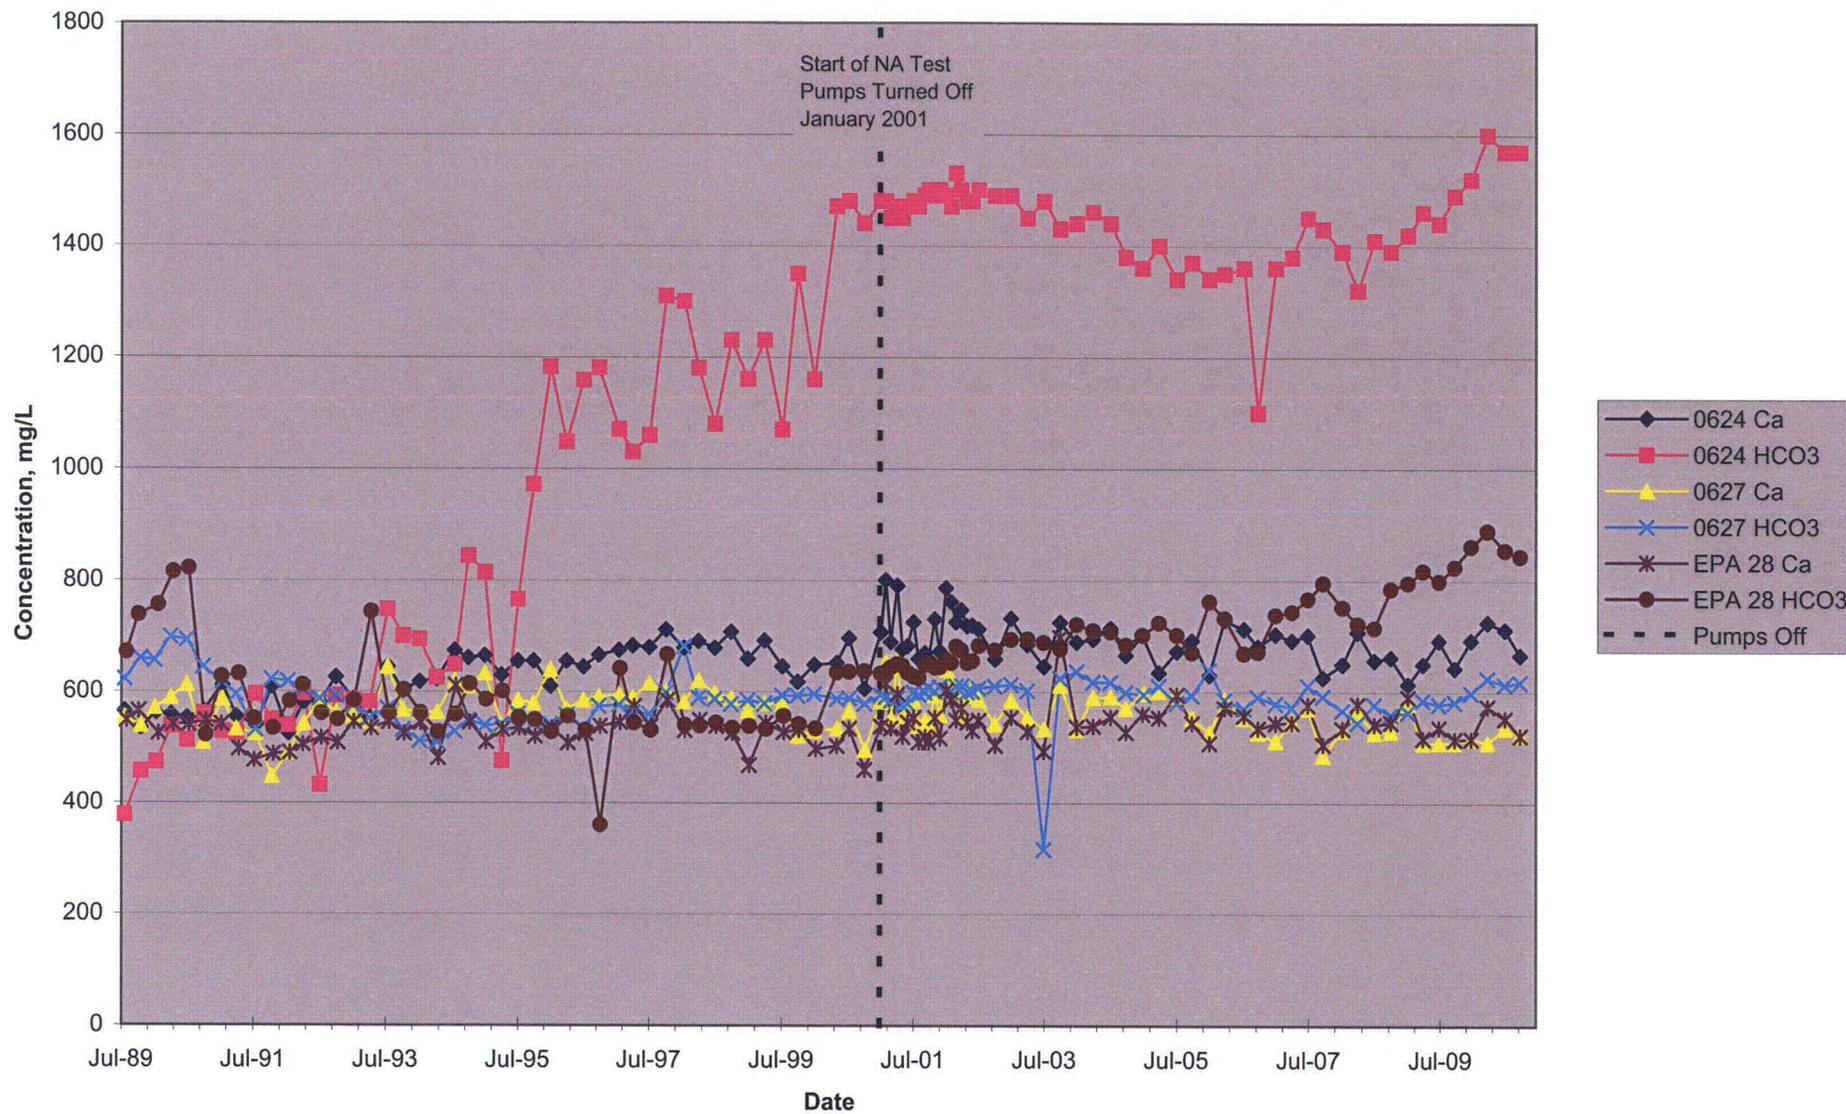
FIGURE 13
 Calcium and Bicarbonate Concentrations in Selected Background and Seepage-Impacted Wells
 United Nuclear Corporation Church Rock site, Church Rock, New Mexico

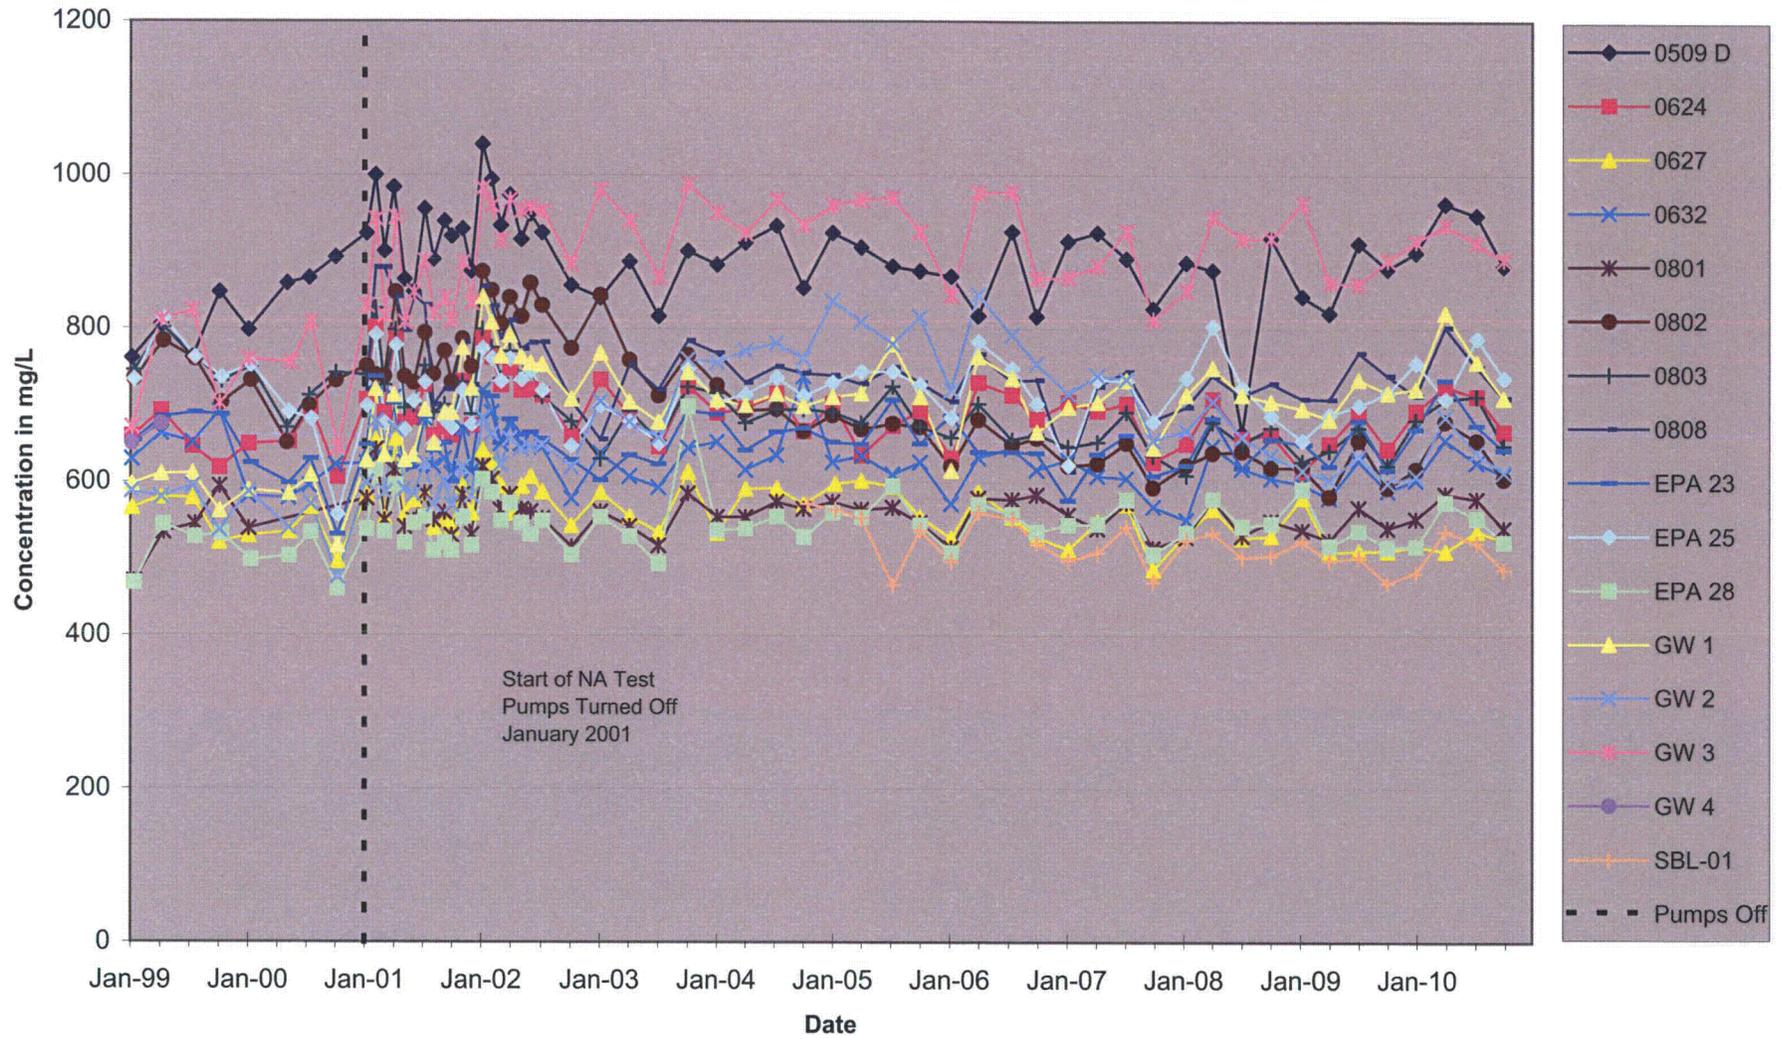
FIGURE 14
 Southwest Alluvium Calcium Concentrations From 1999 Through October 2010
 United Nuclear Corporation, Church Rock Site, Church Rock, New Mexico

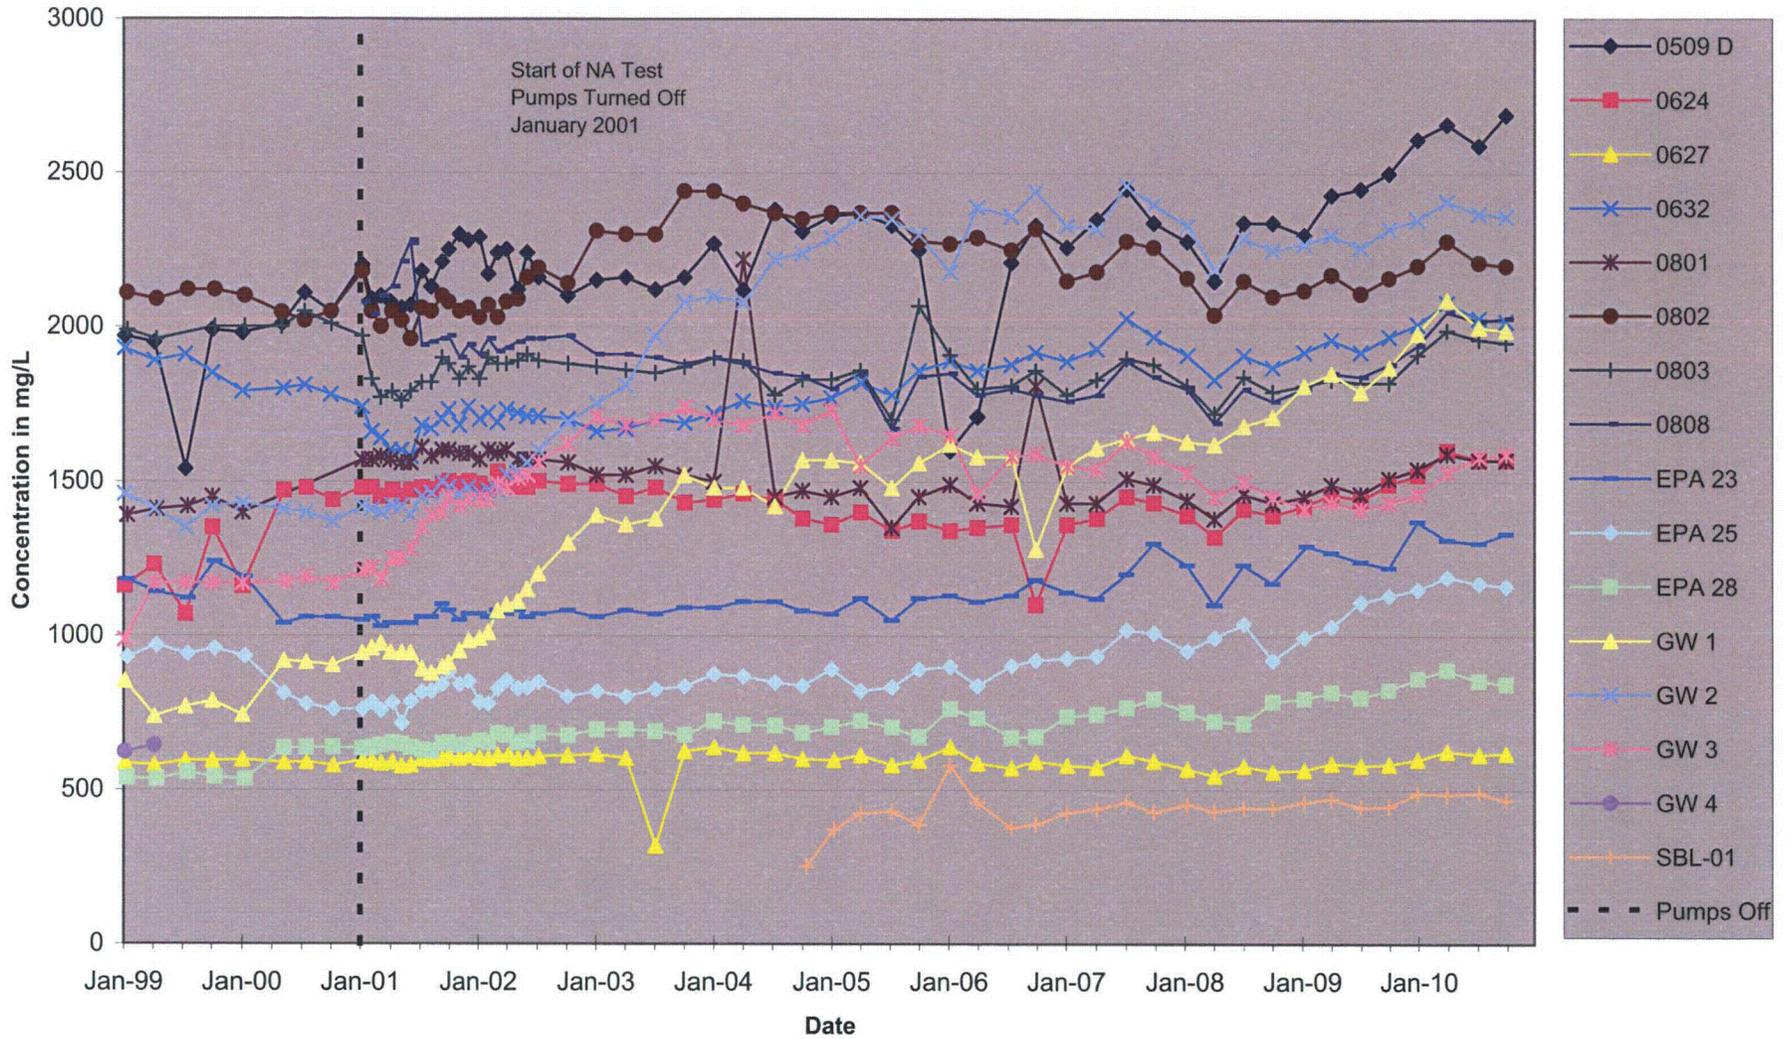
FIGURE 15

Southwest Alluvium Bicarbonate Concentrations From 1999 Through October 2010
United Nuclear Corporation, Church Rock Site, Church Rock, New Mexico

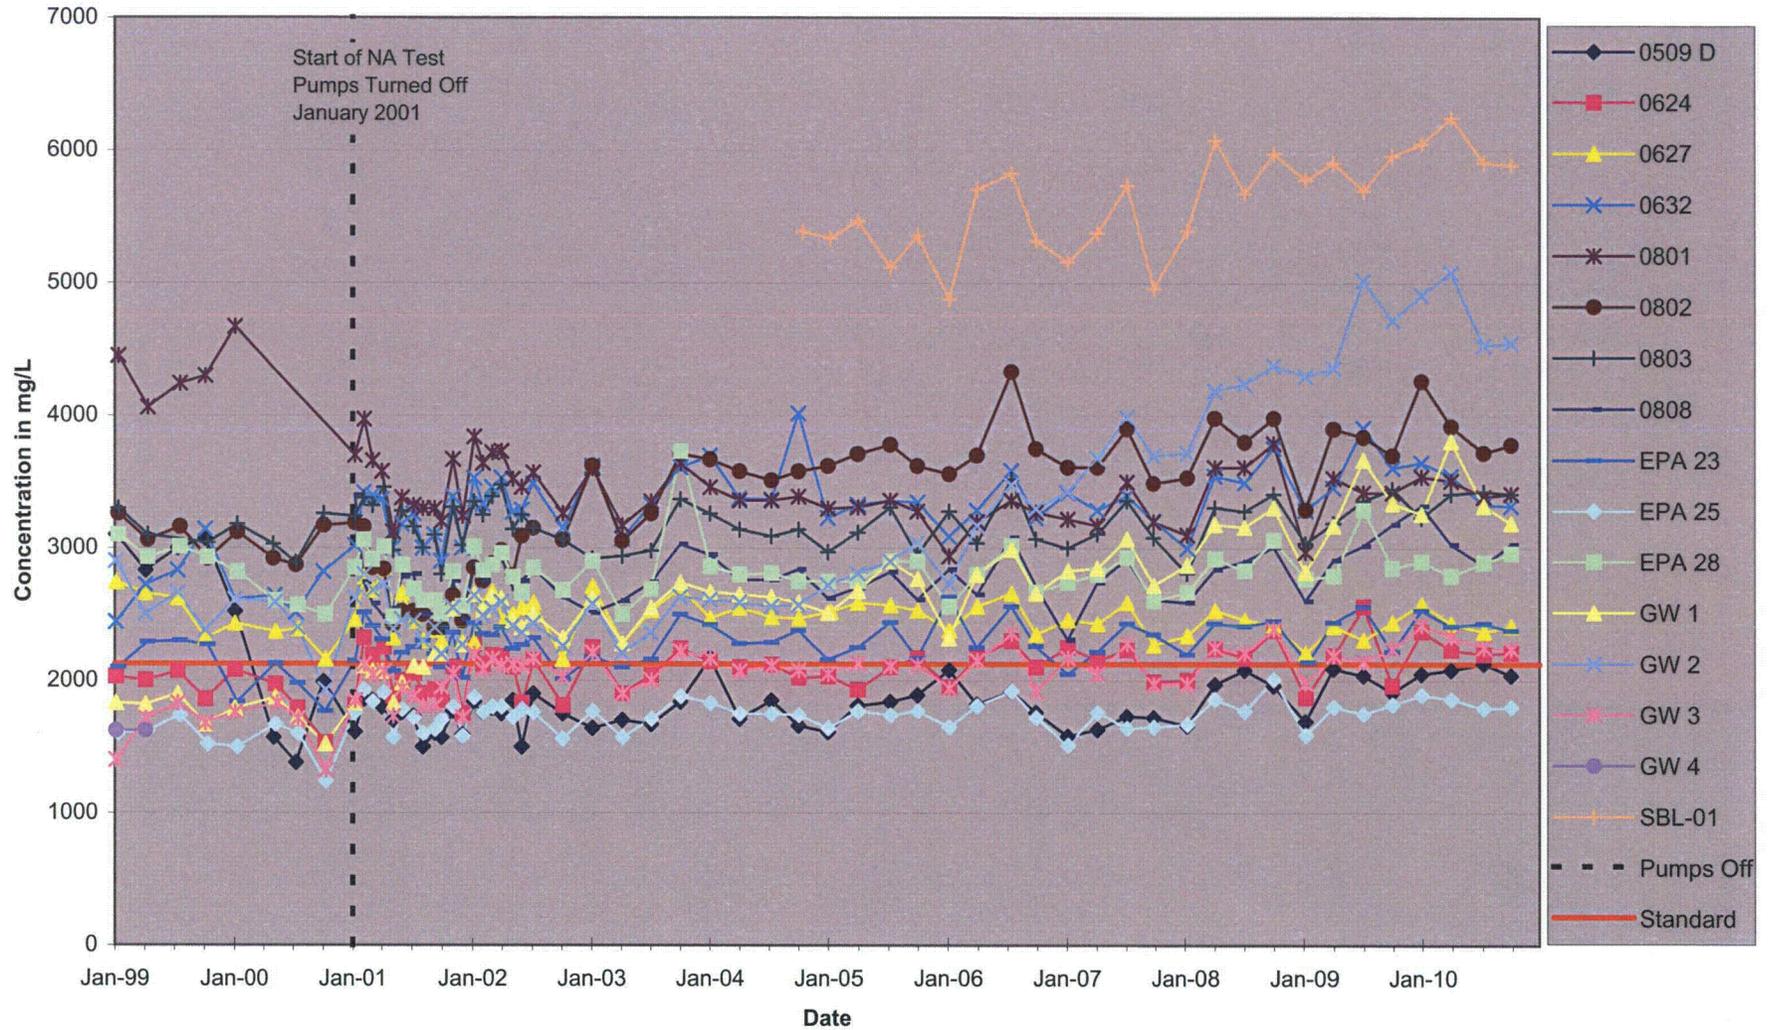
FIGURE 16
 Southwest Alluvium Sulfate Concentrations From 1999 Through October 2010
 United Nuclear Corporation, Church Rock Site, Church Rock, New Mexico

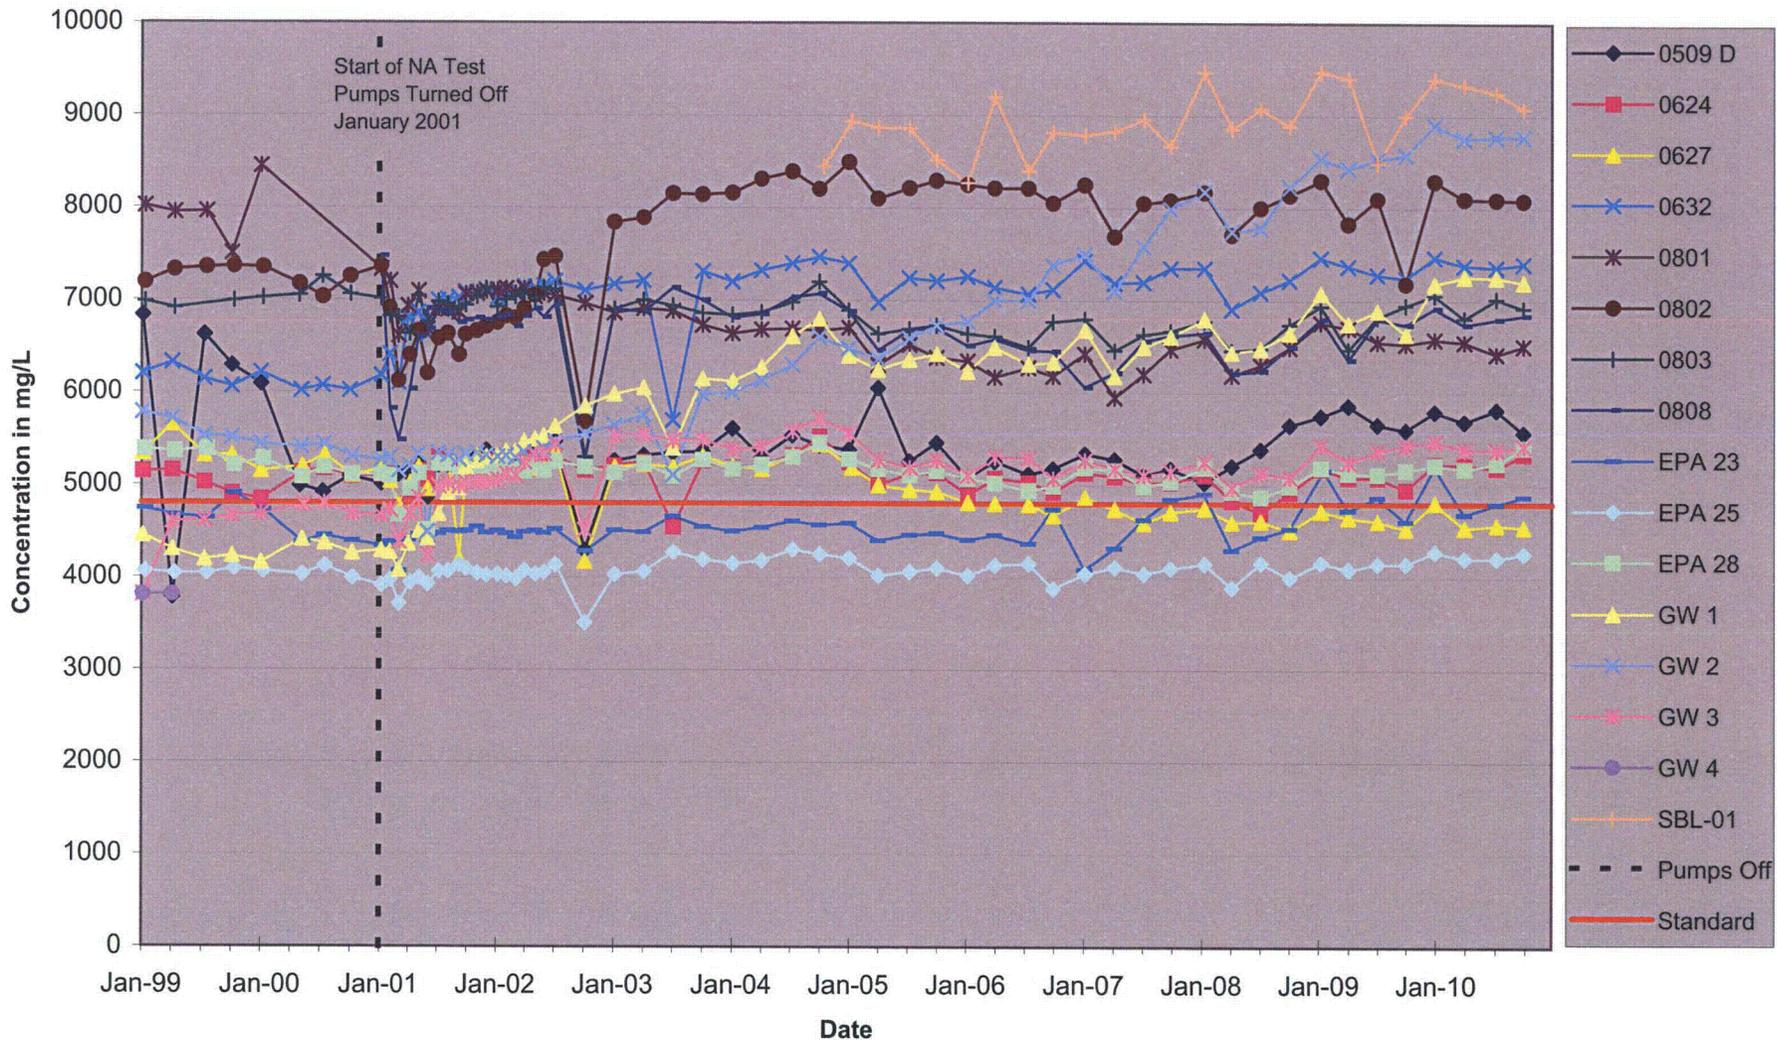
FIGURE 17
 Southwest Alluvium Total Dissolved Solids Concentrations From 1999 Through October 2010
 United Nuclear Corporation, Church Rock Site, Church Rock, New Mexico

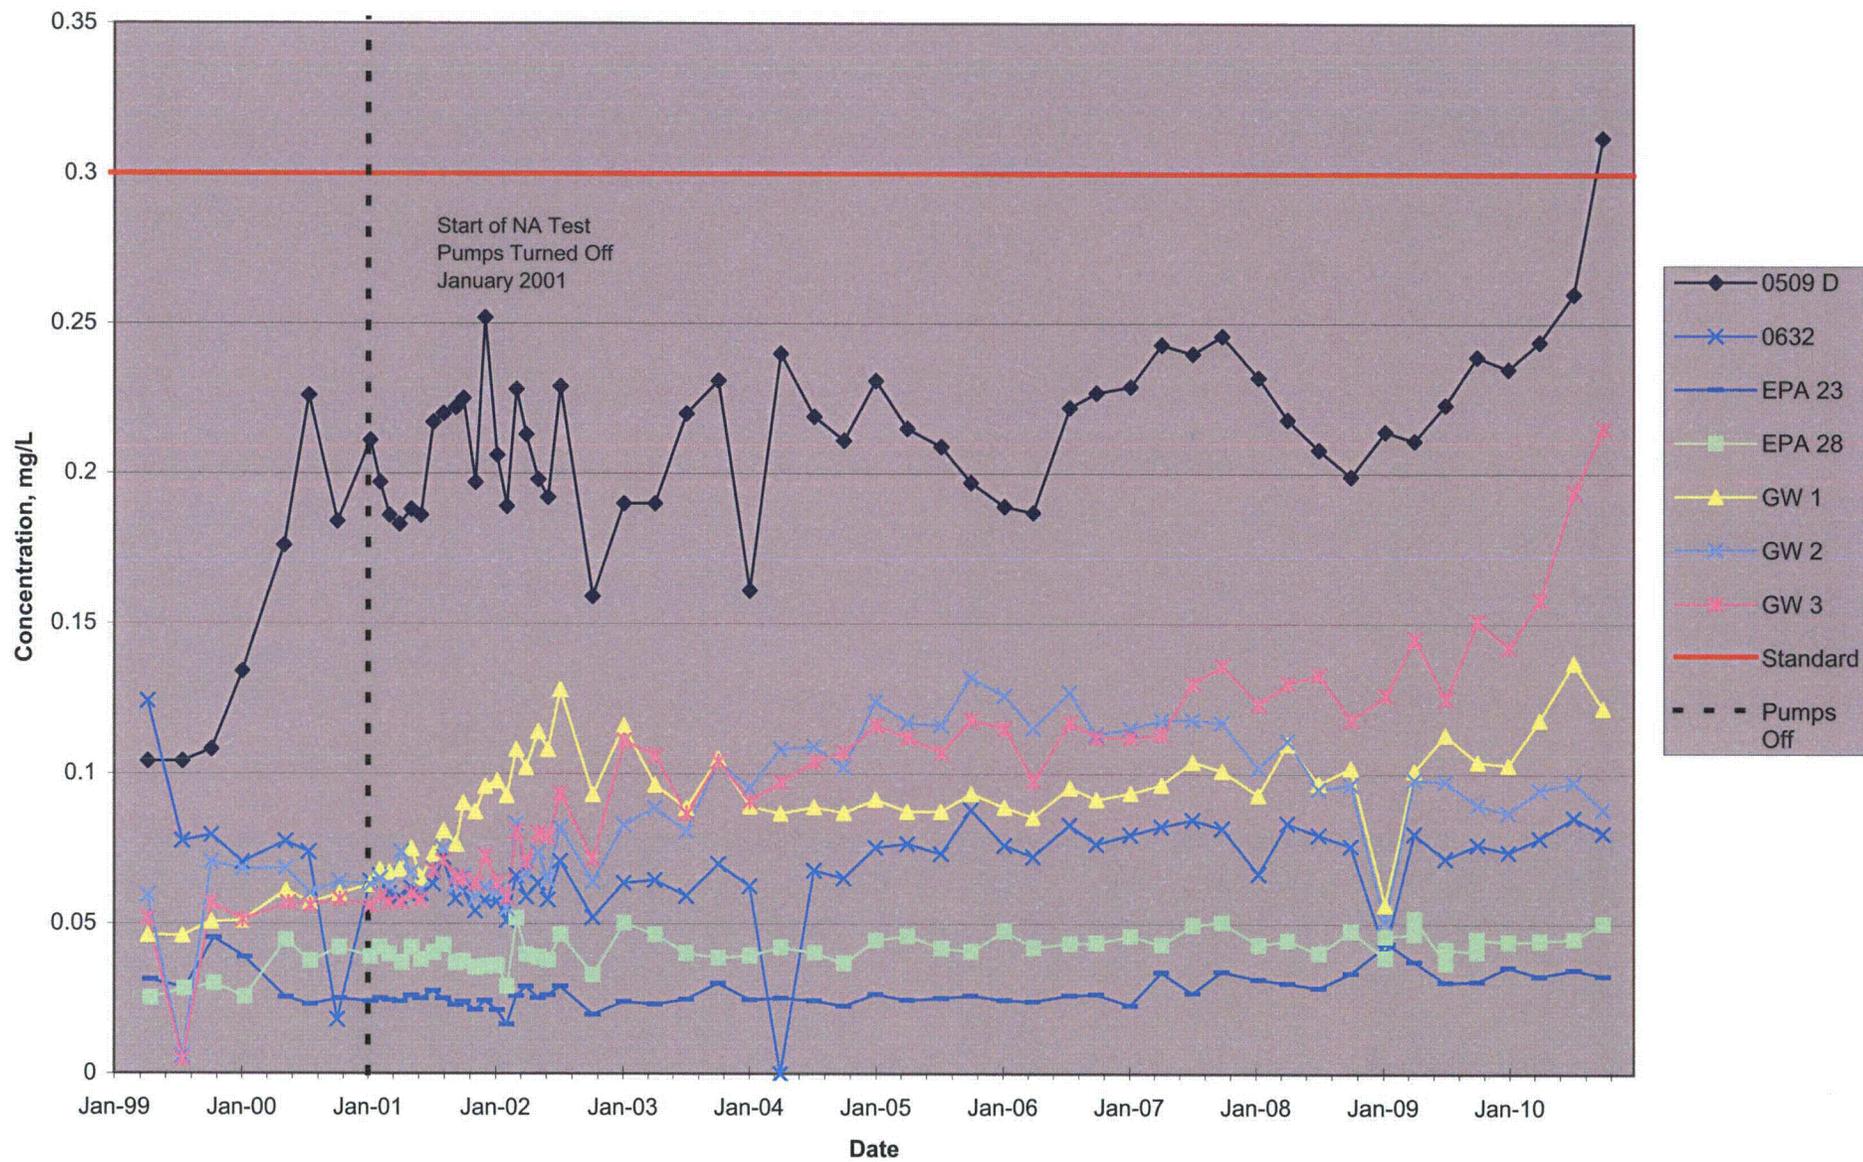
FIGURE 18
 Uranium Concentrations in Selected Southwest Alluvium Wells
 United Nuclear Corporation, Church Rock Site, Church Rock, New Mexico
