Site Location Map

United Nuclear Corporation Church Rock Site, Church Rock, New Mexico

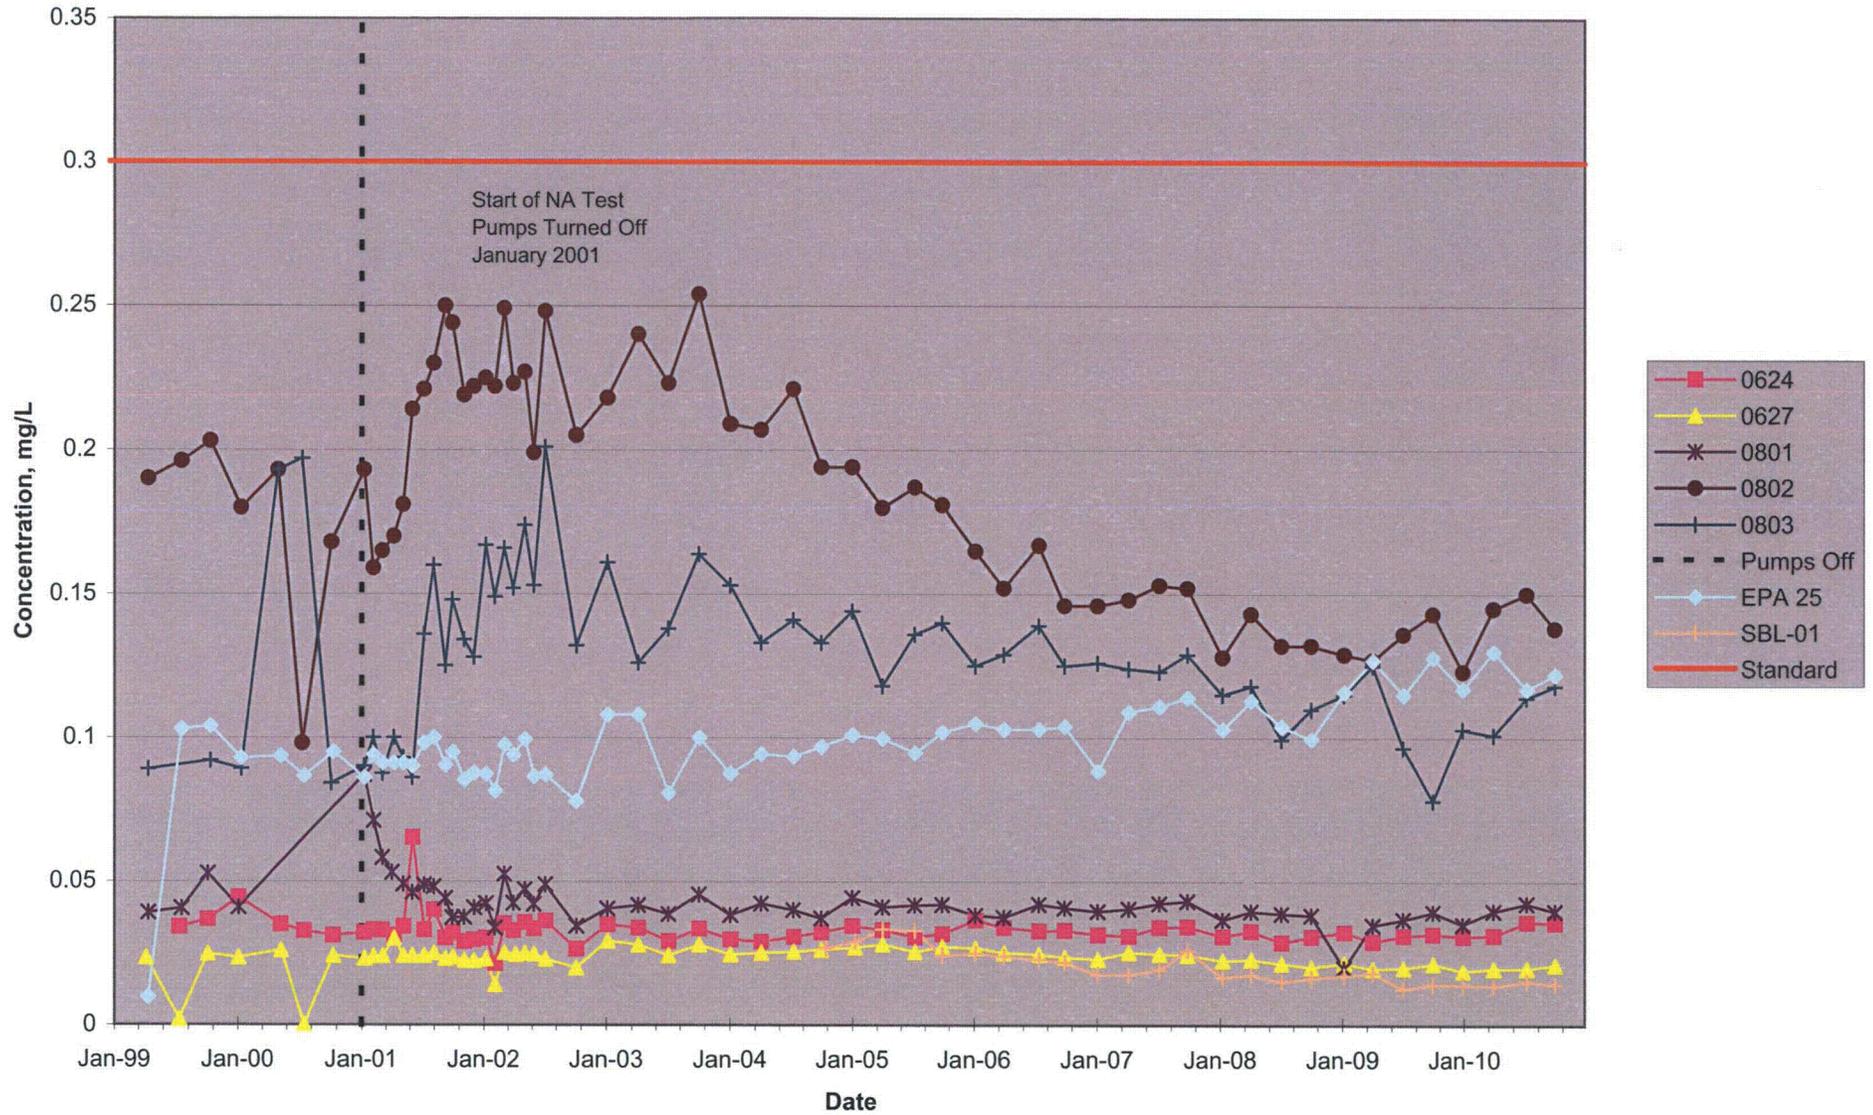
FIGURE 19
 Uranium Concentrations in Selected Southwest Alluvium Wells
 United Nuclear Corporation, Church Rock Site, Church Rock, New Mexico

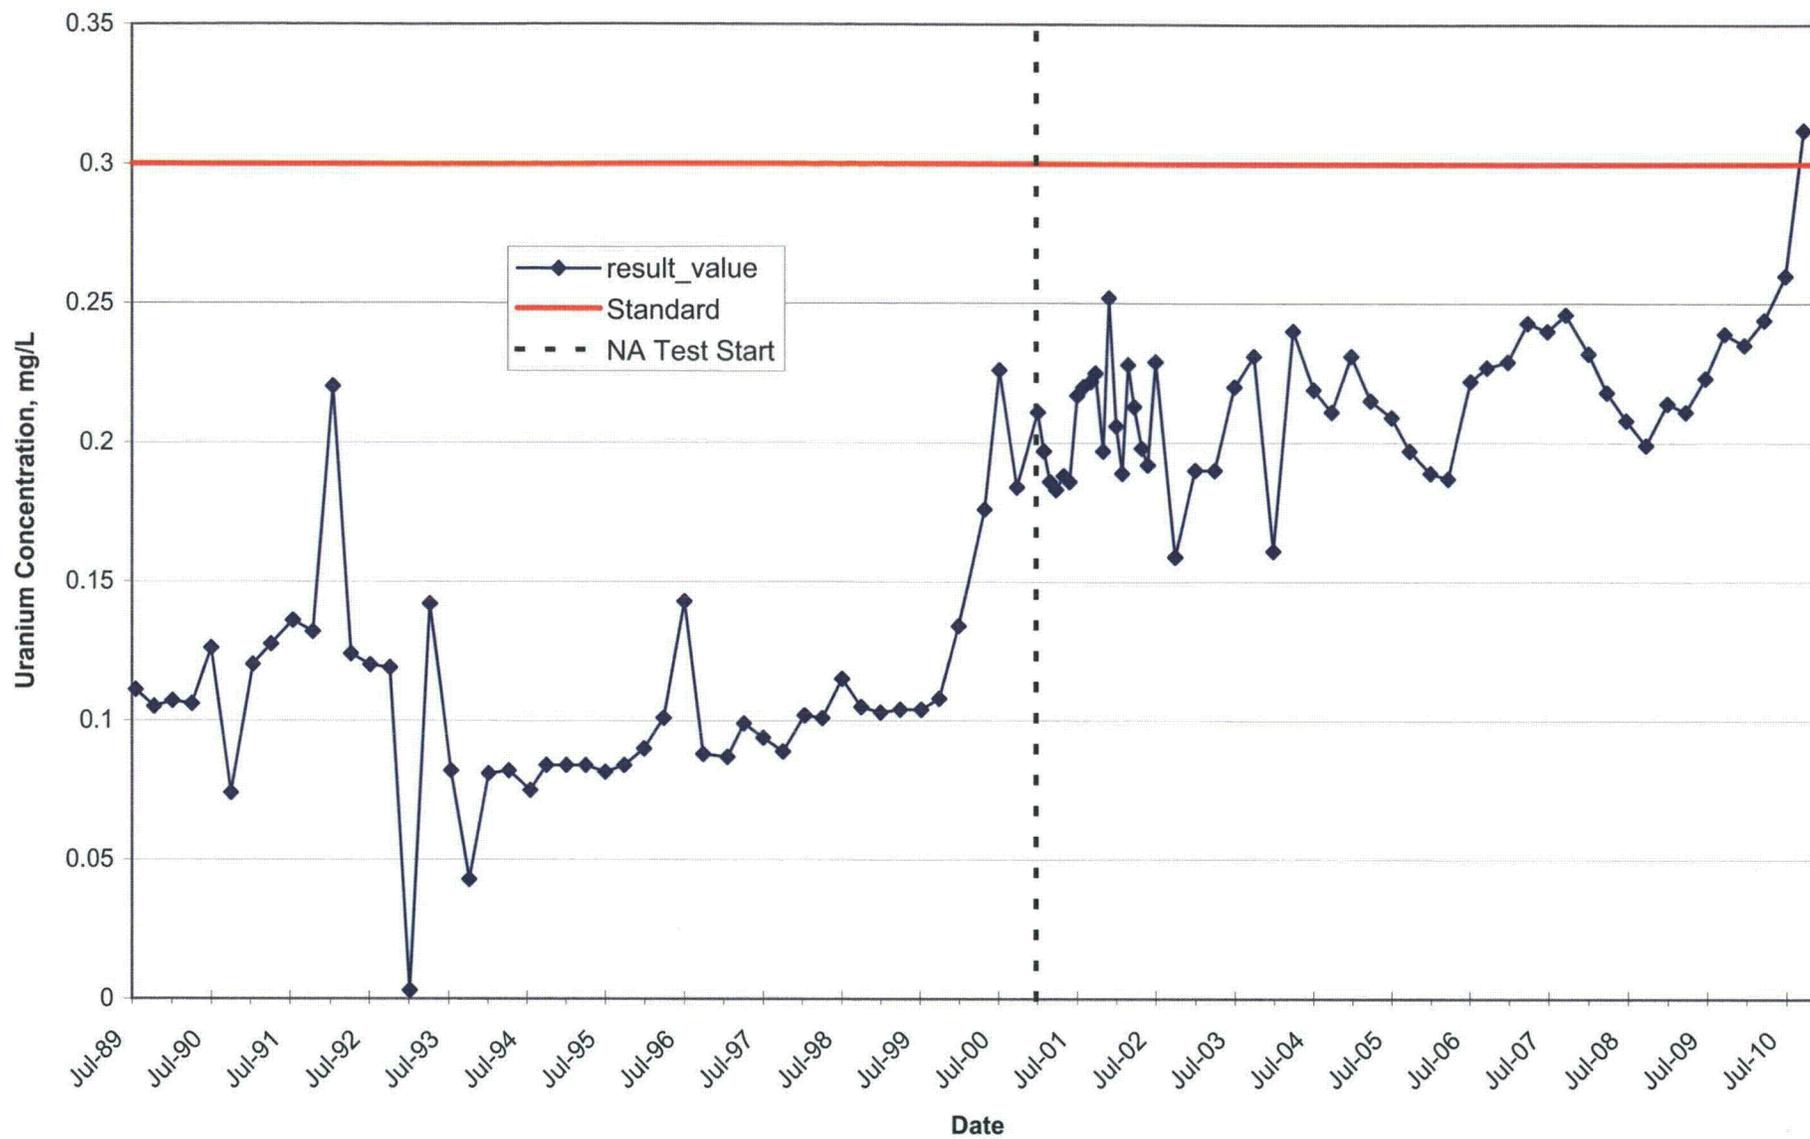
FIGURE 20
Uranium Concentration in Well 0509 D
United Nuclear Corporation Church Rock Site, Church Rock, New Mexico

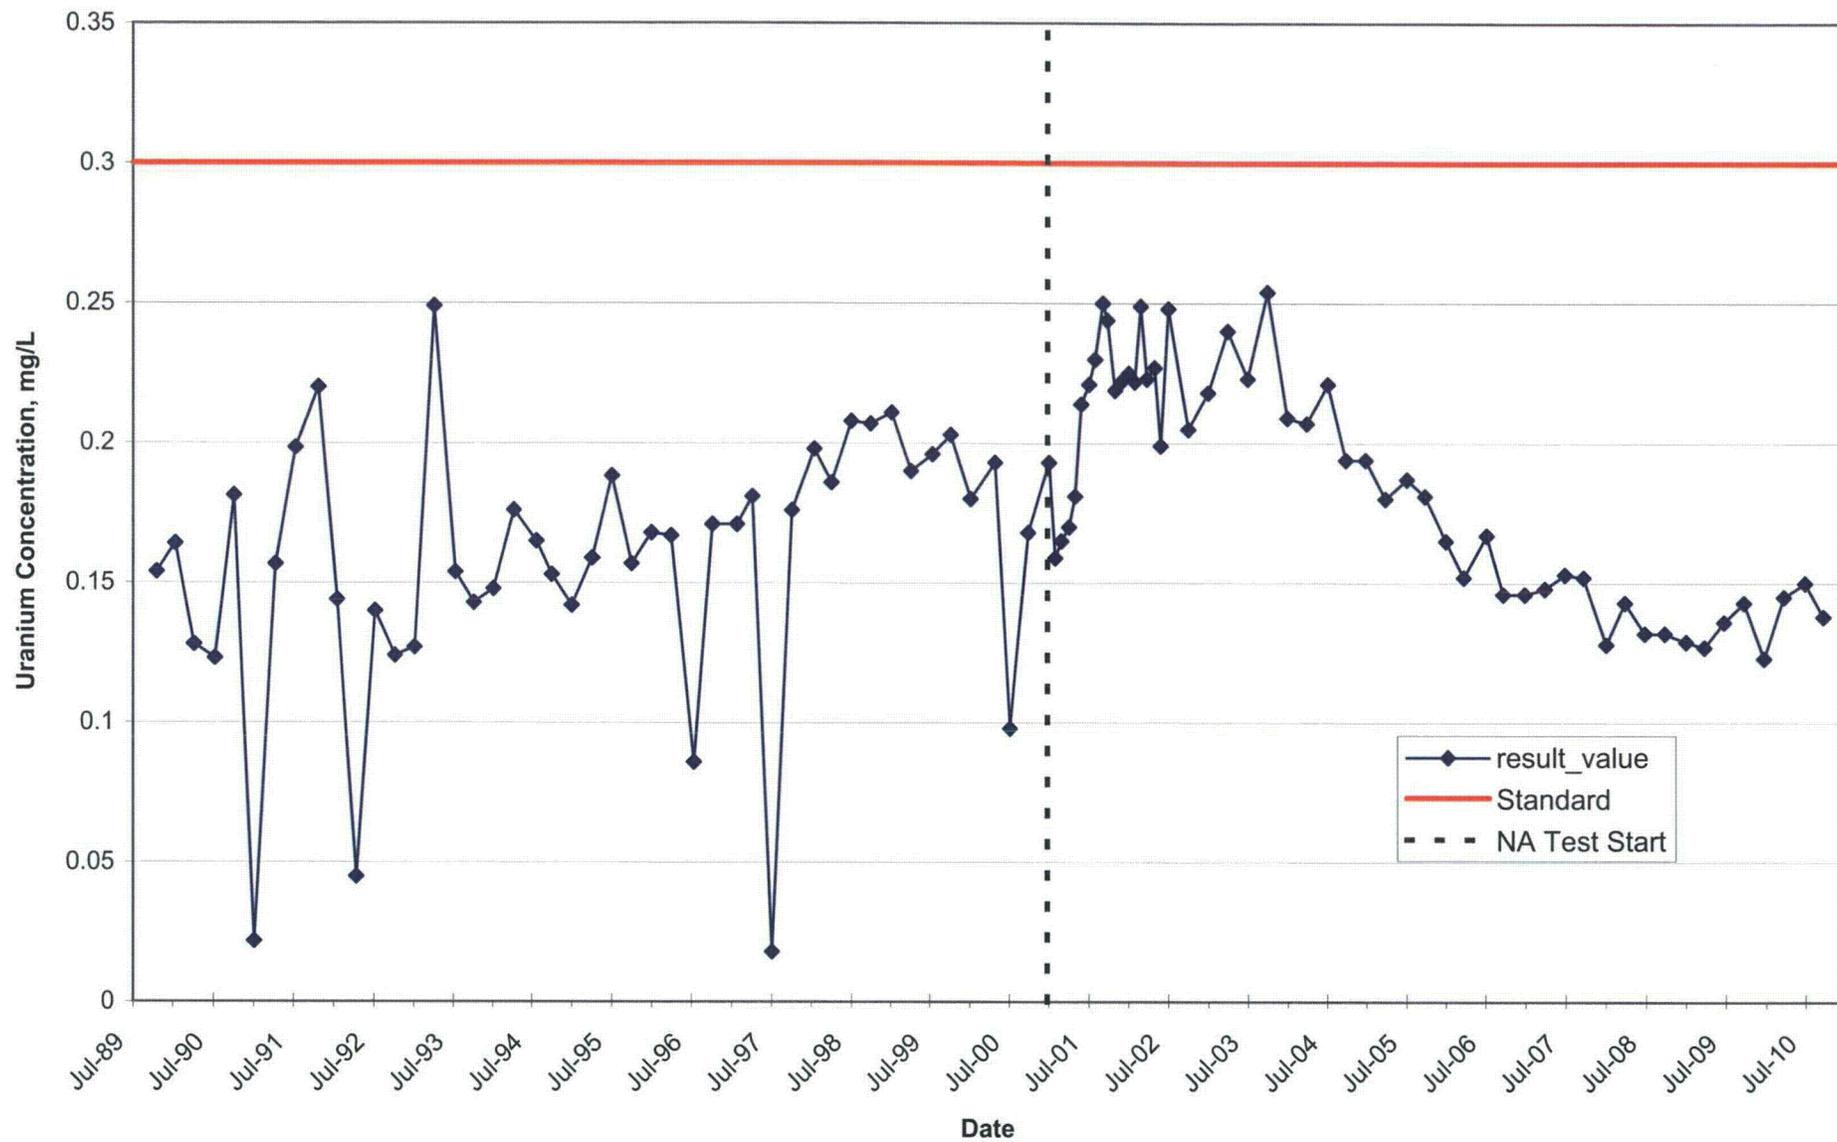
FIGURE 22
Uranium Concentration in Well 0802
United Nuclear Corporation Church Rock Site, Church Rock, New Mexico

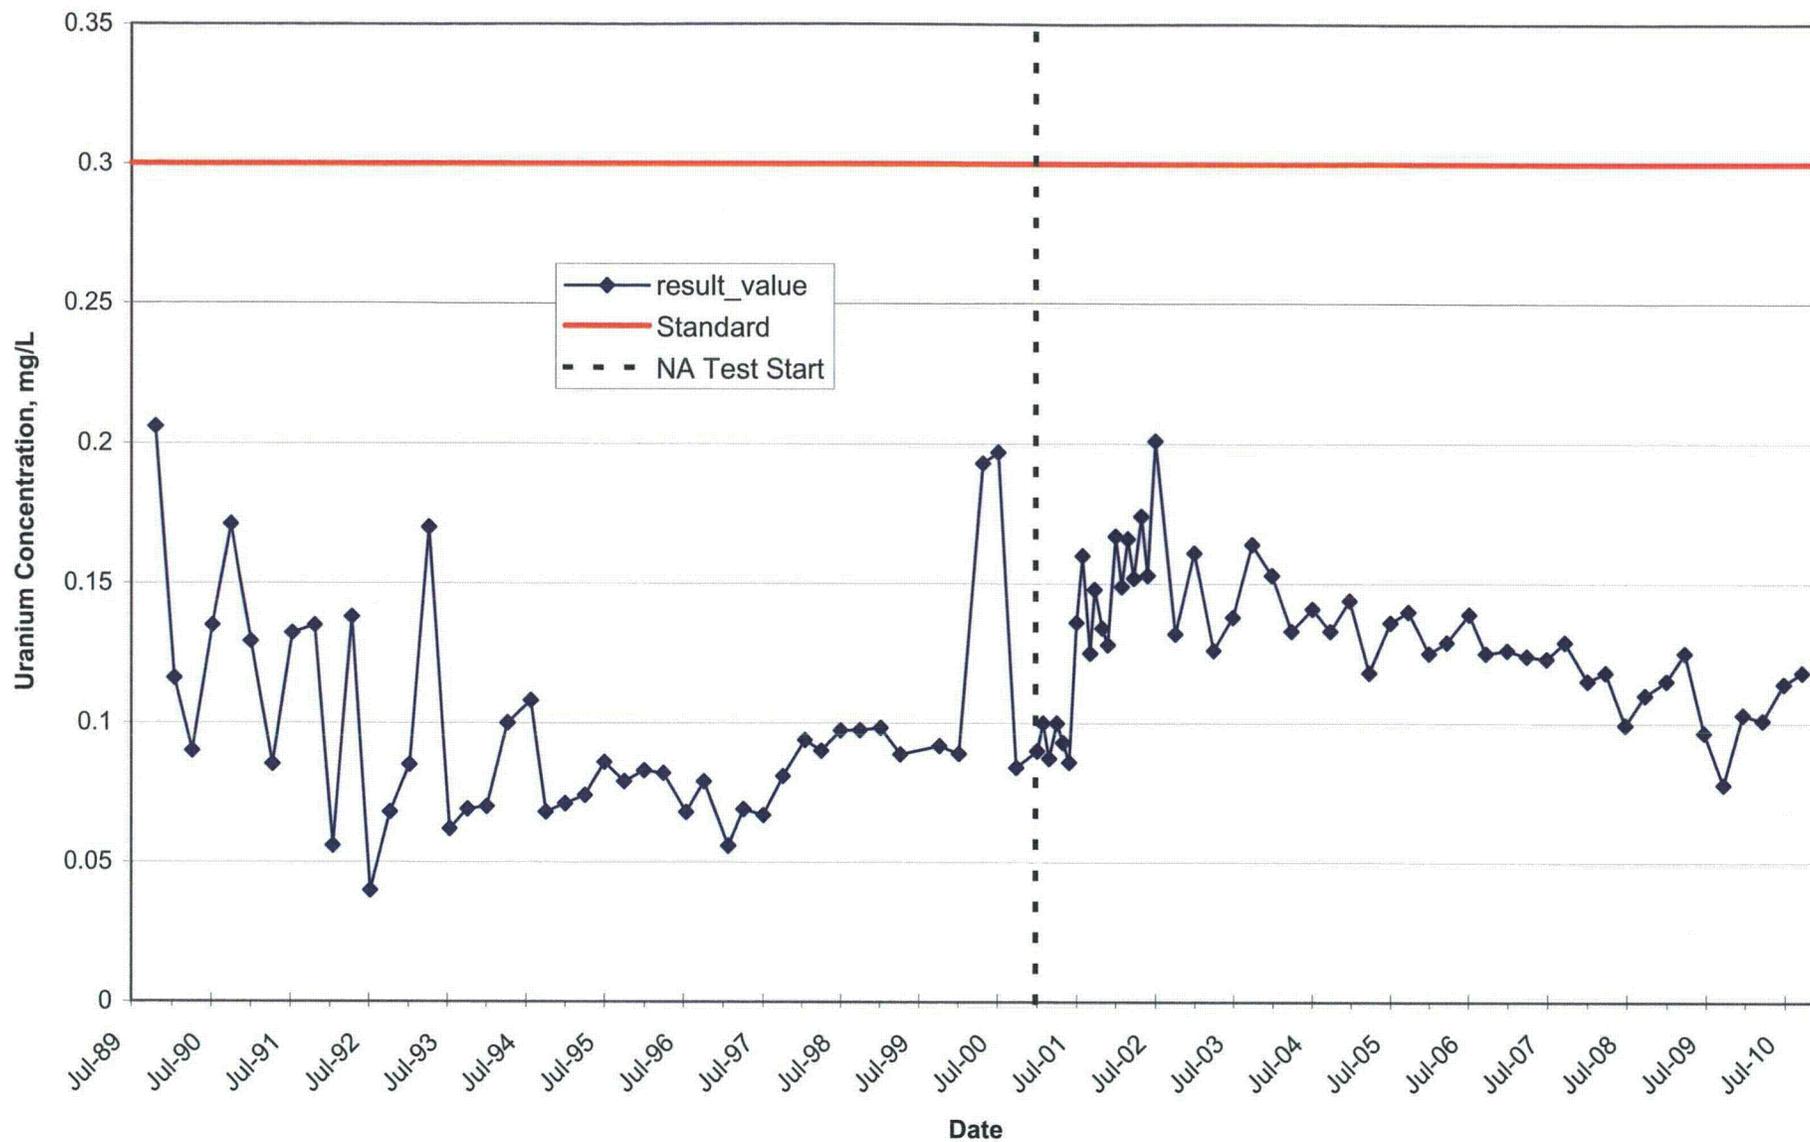
FIGURE 23
Uranium Concentration in Well 0803
United Nuclear Corporation Church Rock Site, Church Rock, New Mexico

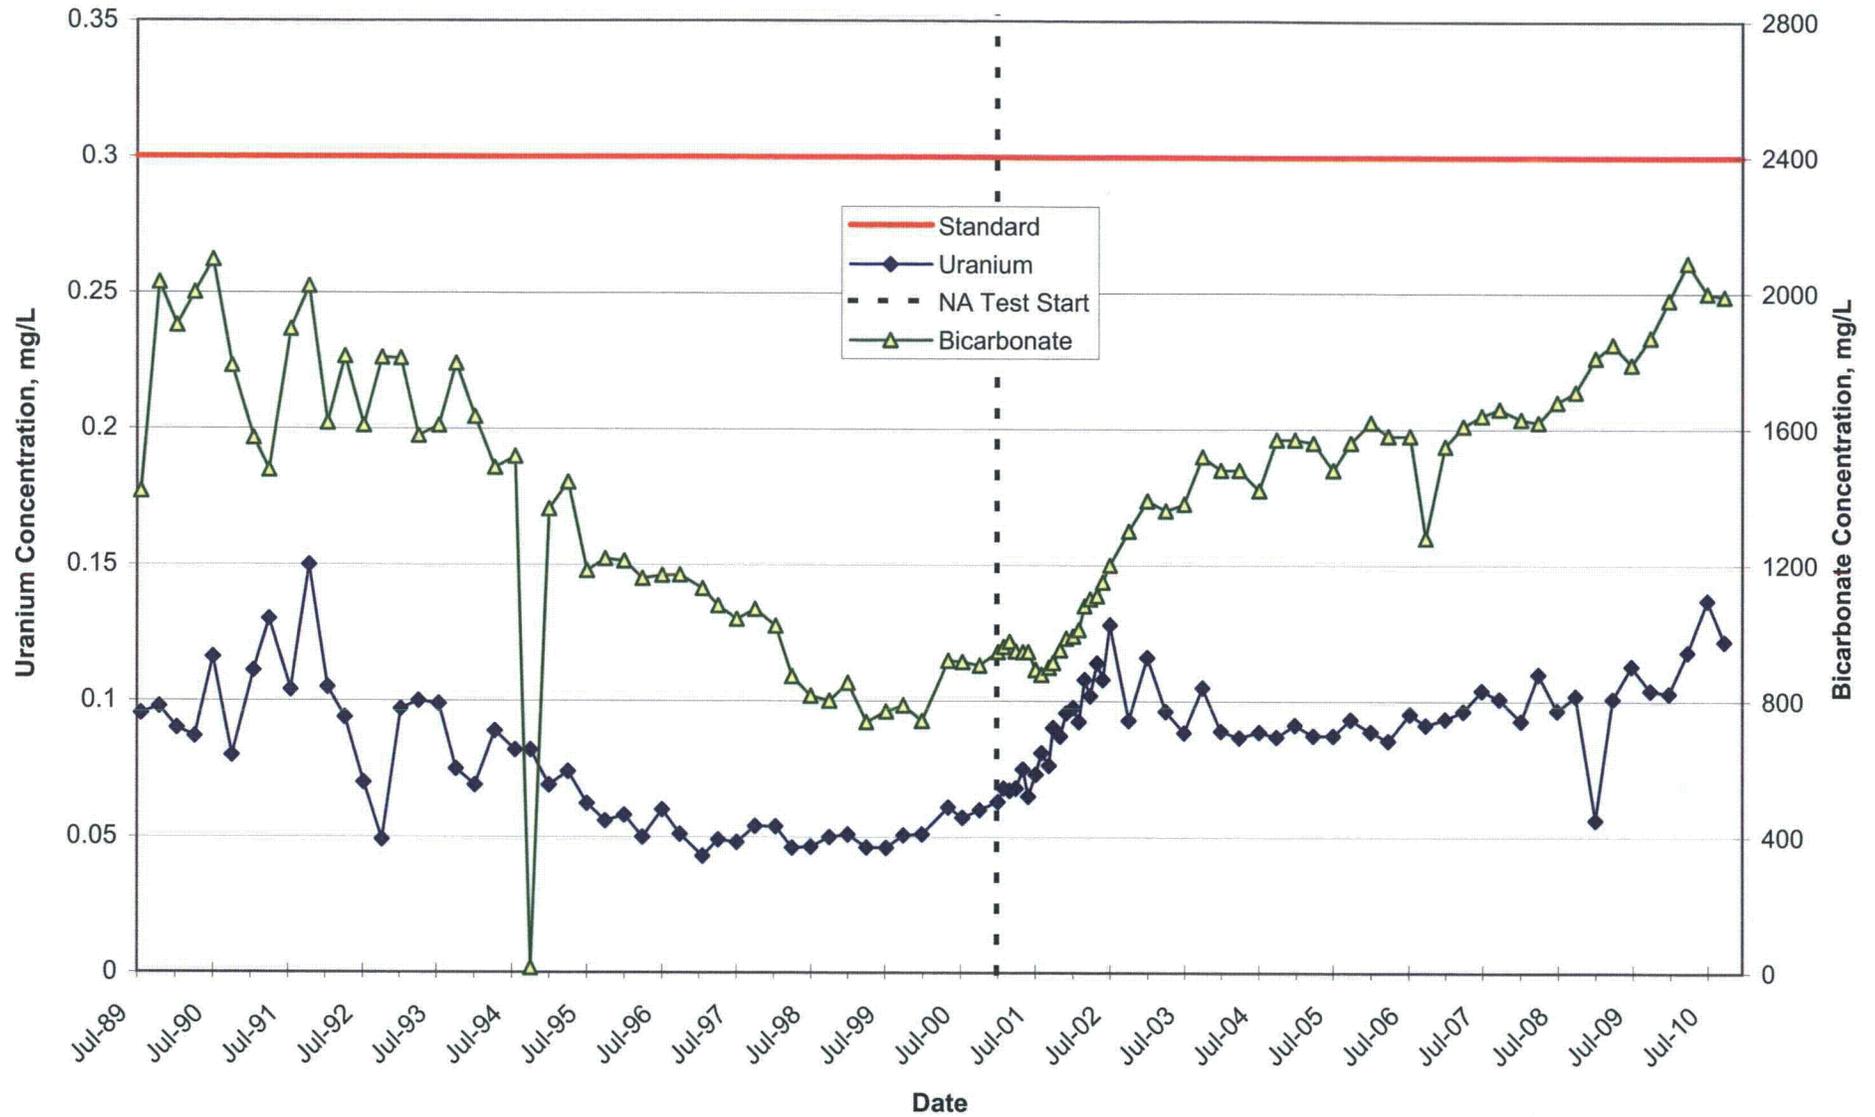
FIGURE 24
 Uranium and Bicarbonate Concentrations in Well GW 1
 United Nuclear Corporation Church Rock Site, Church Rock, New Mexico

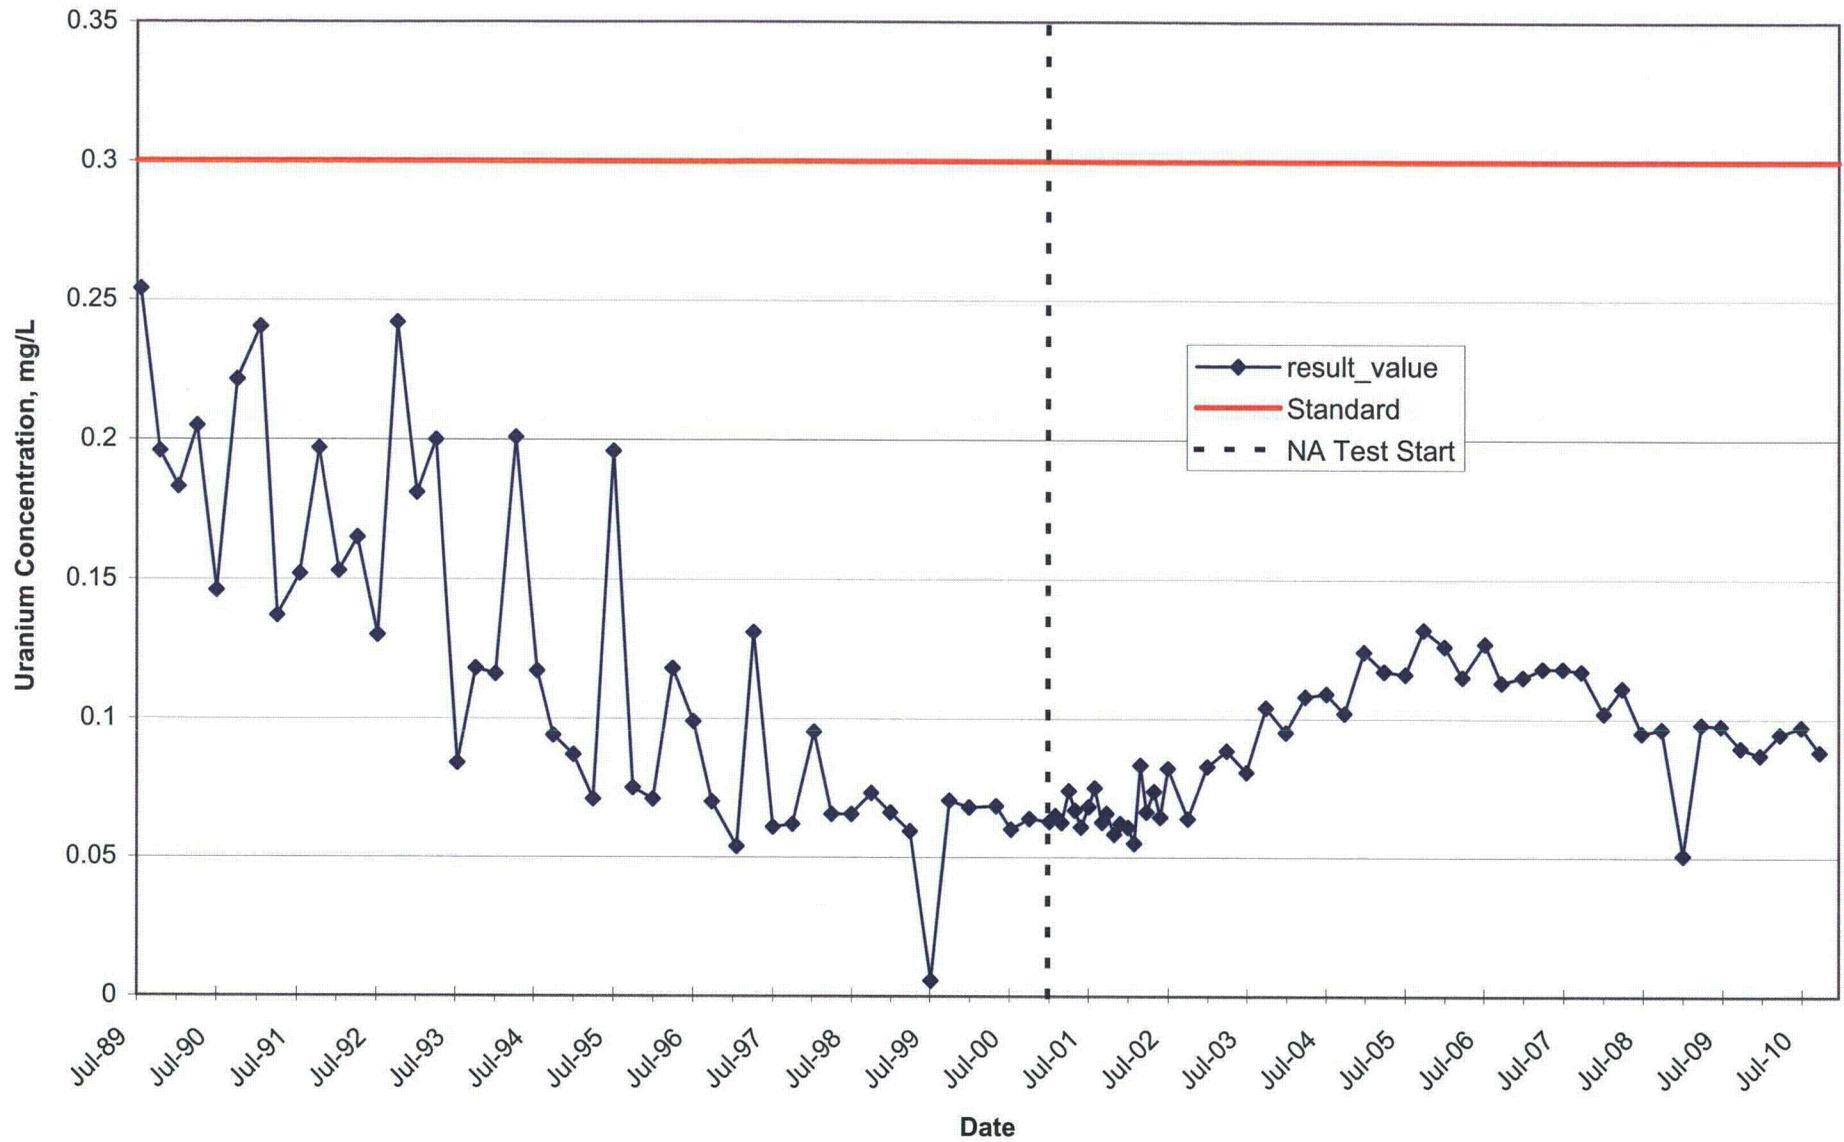
FIGURE 25
Uranium Concentration in Well GW 2
United Nuclear Corporation Church Rock Site, Church Rock, New Mexico

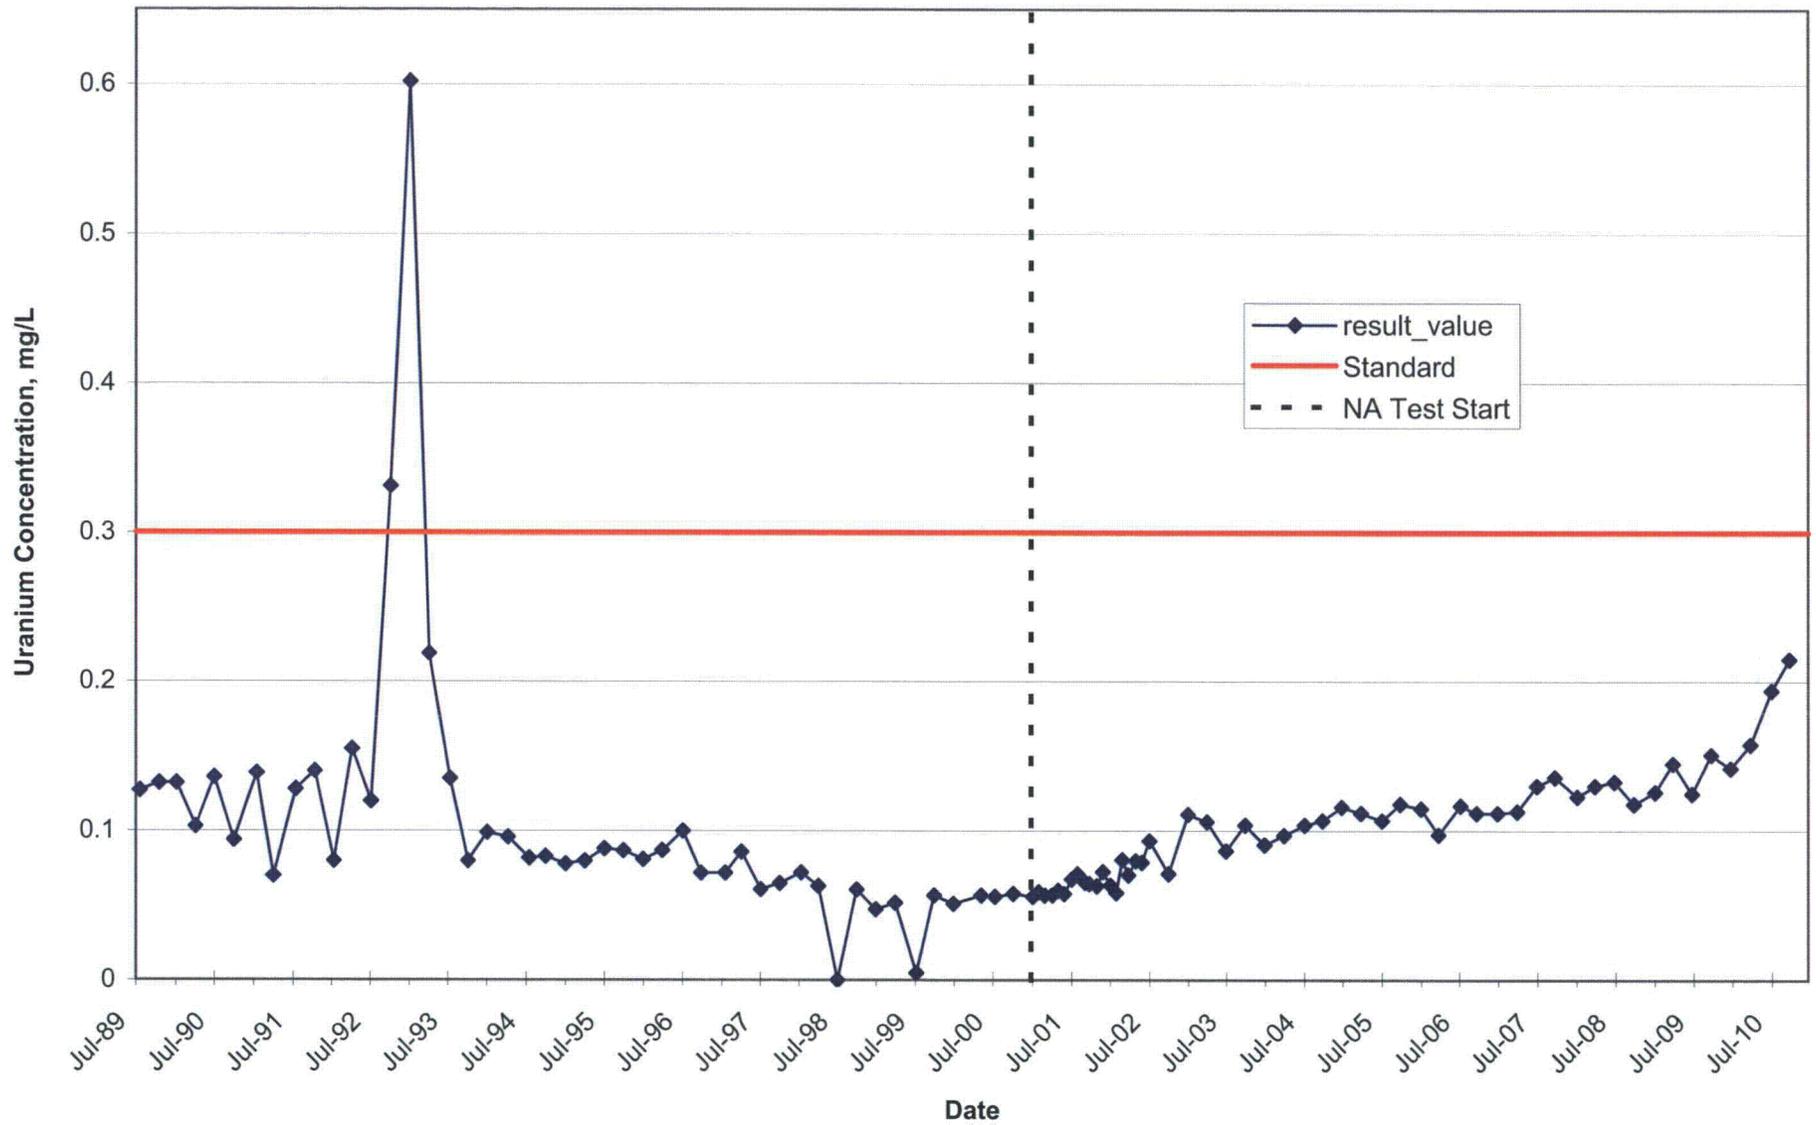
FIGURE 26
Uranium Concentration in Well GW 3
United Nuclear Corporation Church Rock Site, Church Rock, New Mexico

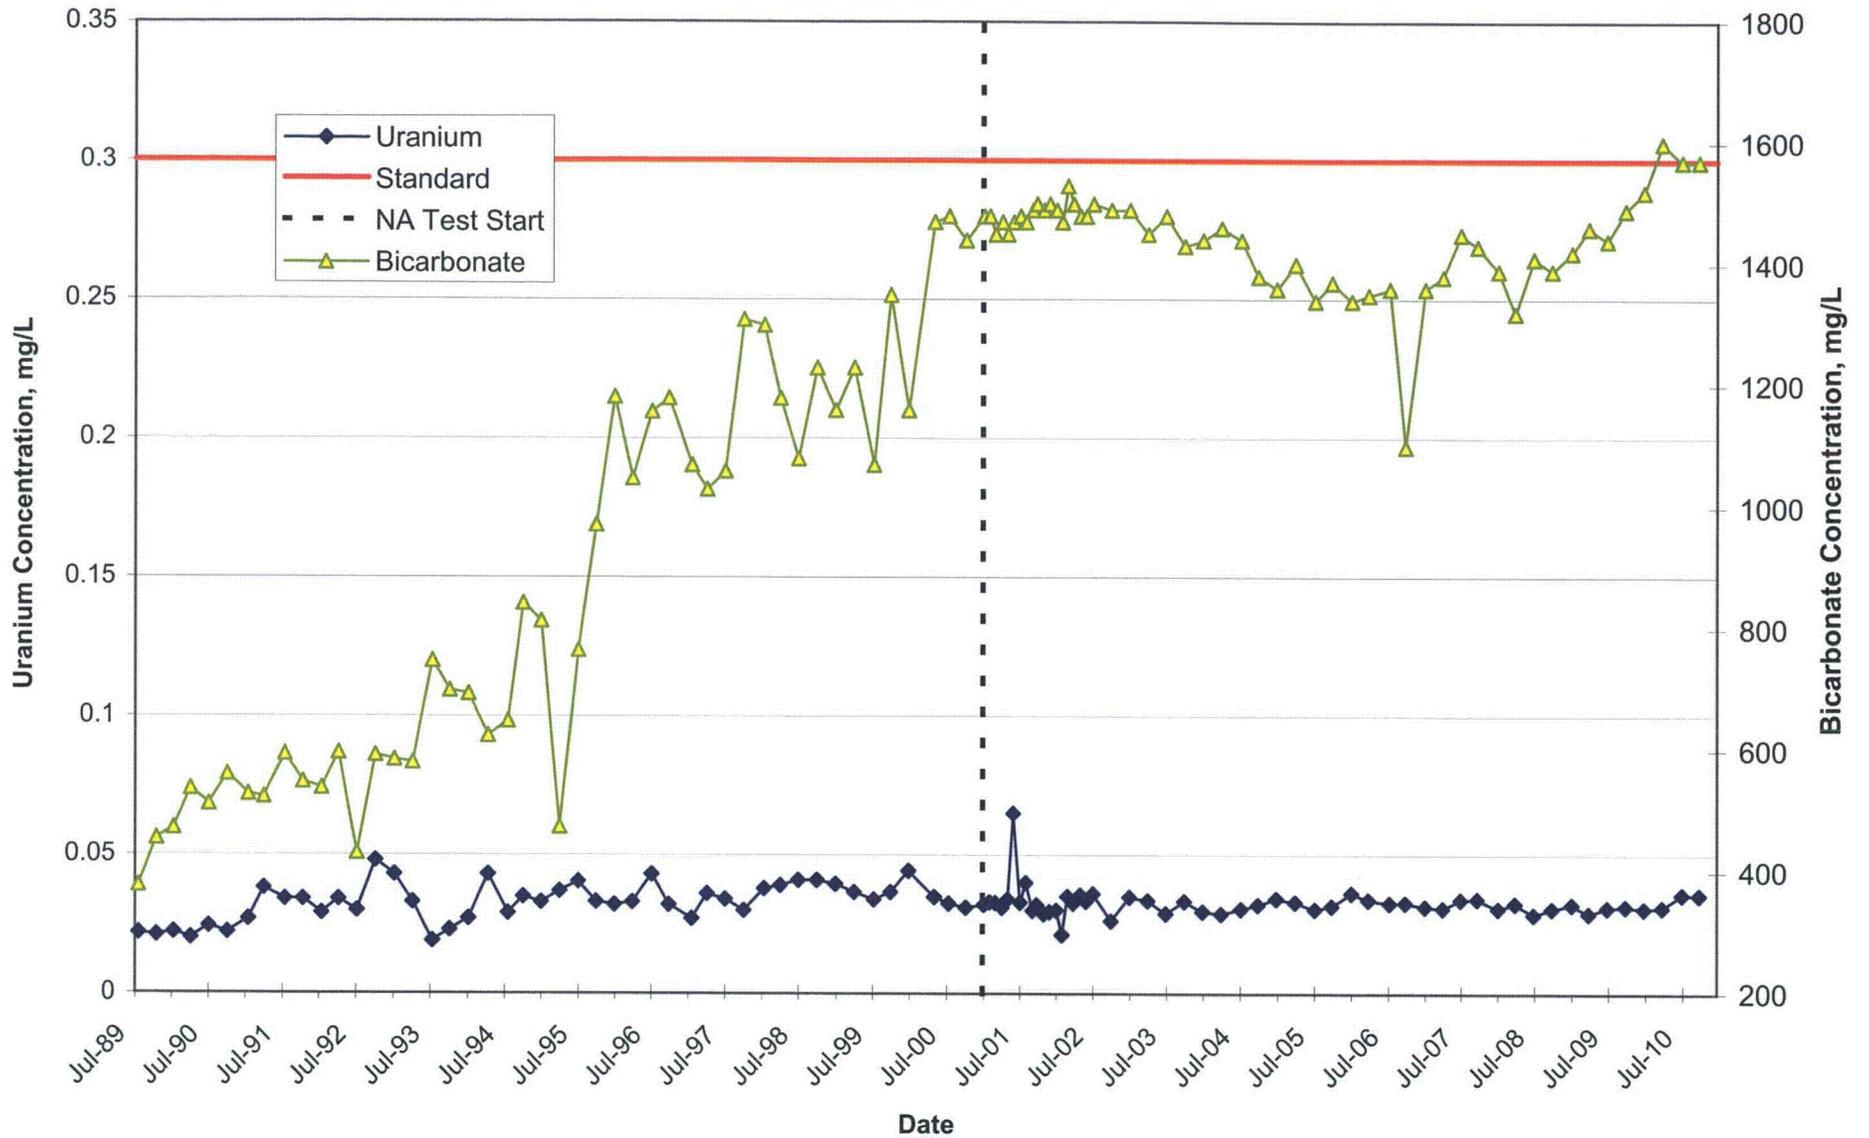
FIGURE 27
 Uranium and Bicarbonate Concentrations in Well 0624
 United Nuclear Corporation Church Rock Site, Church Rock, New Mexico

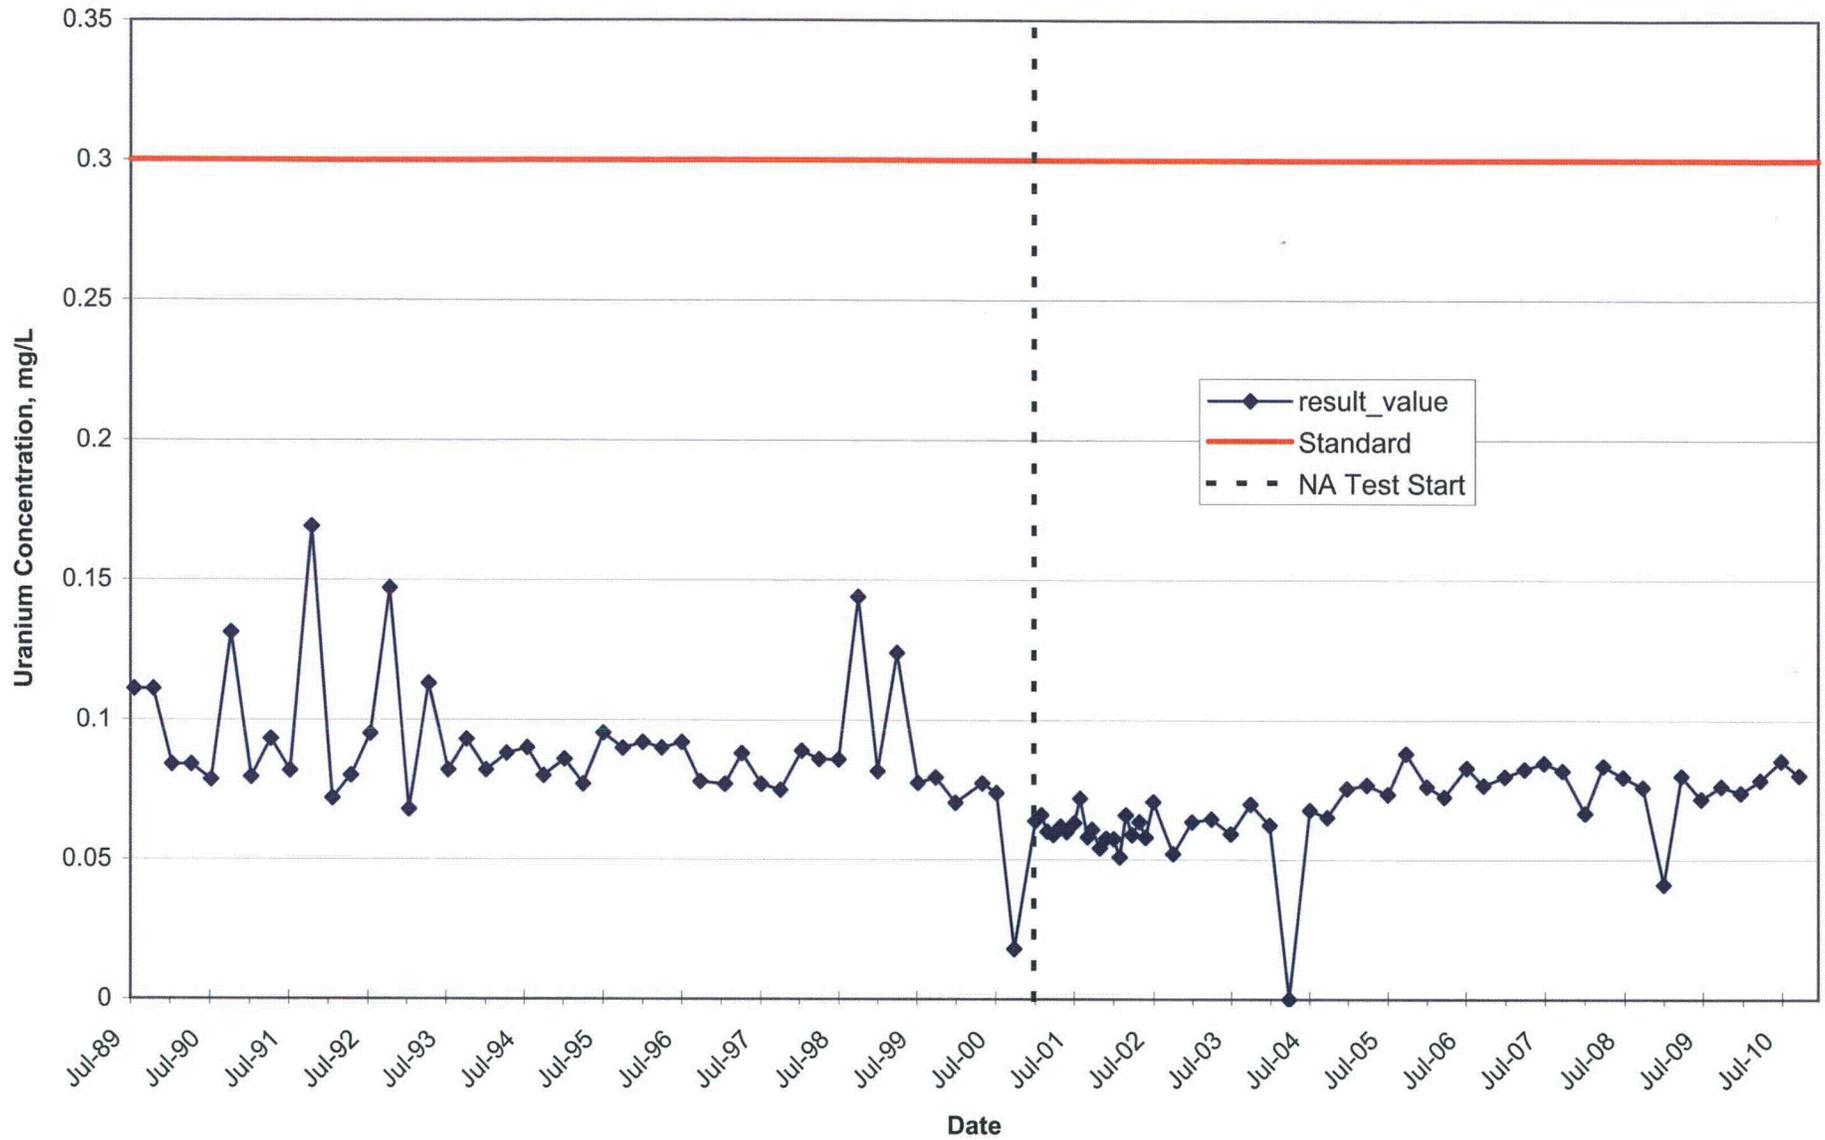
FIGURE 28
Uranium Concentration in Well 0632
United Nuclear Corporation Church Rock Site, Church Rock, New Mexico

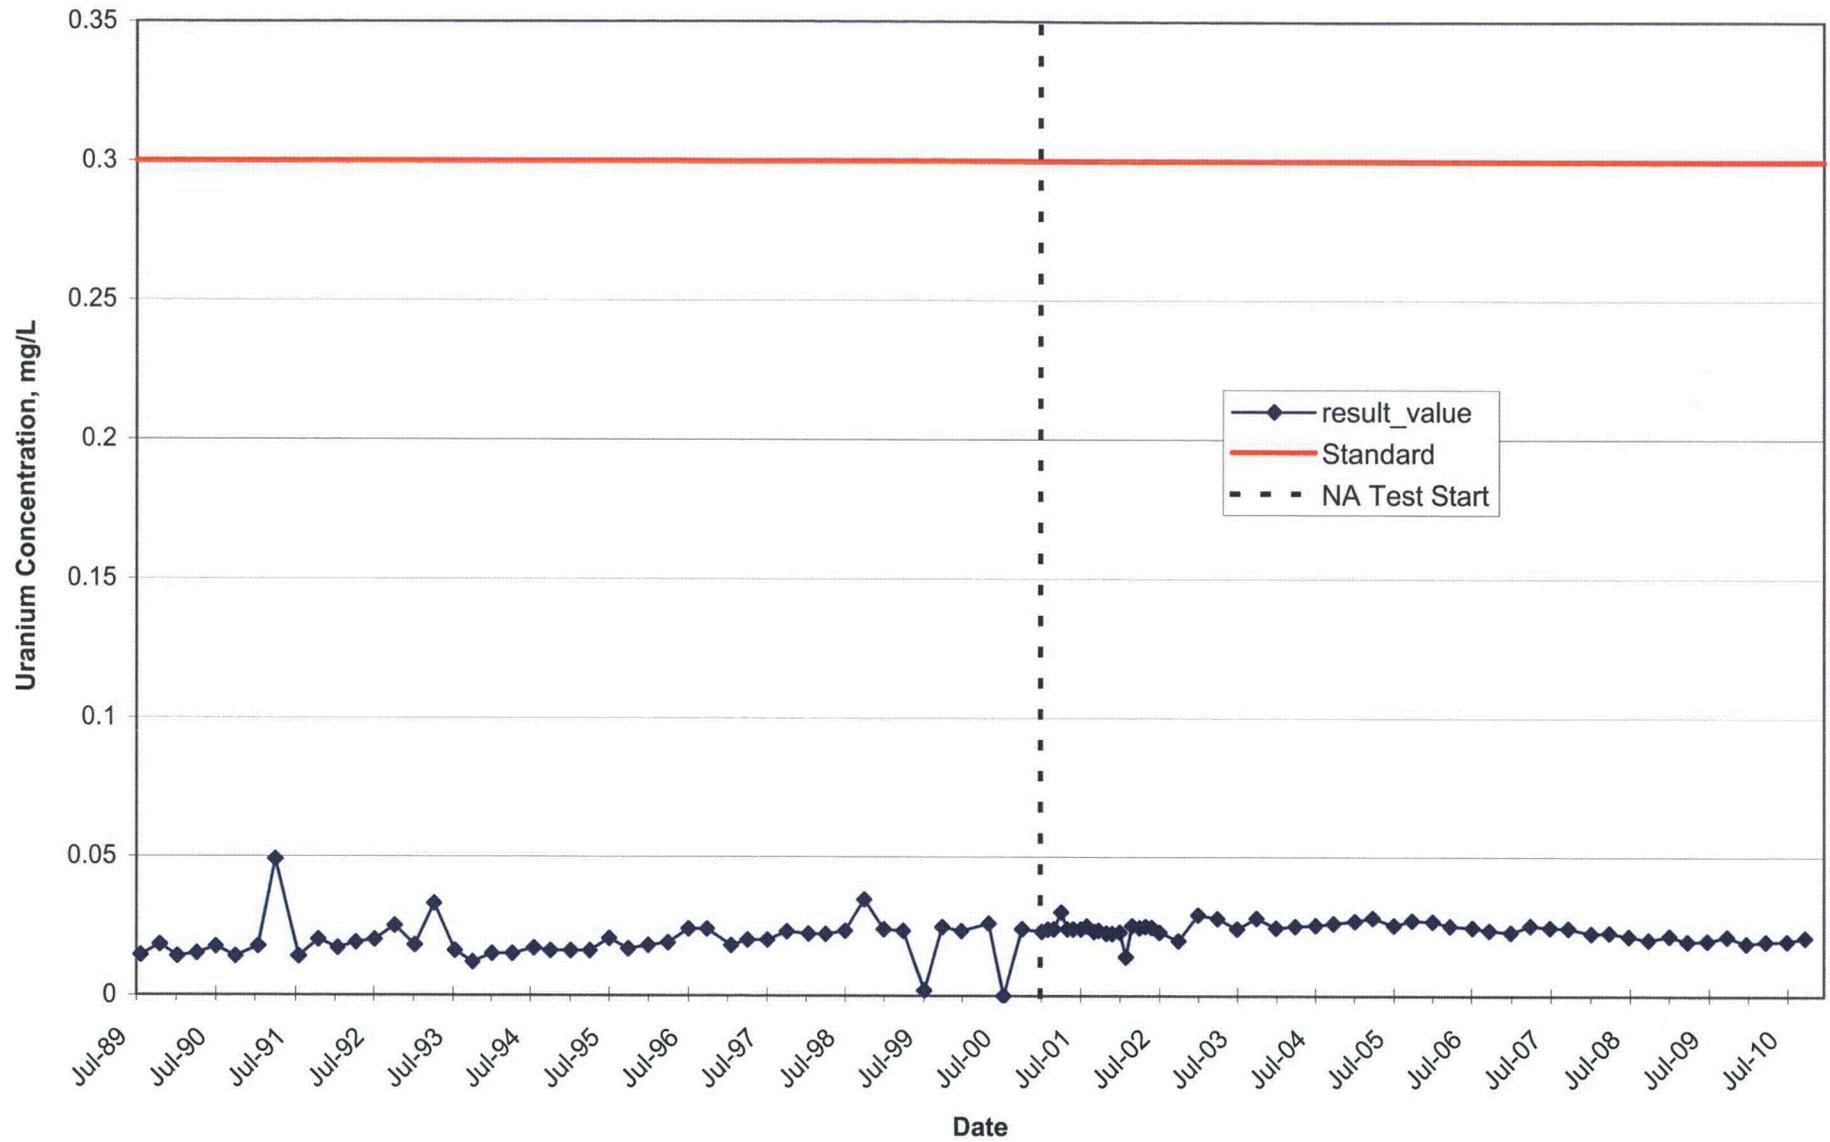
FIGURE 29
Uranium Concentration in Well 0627
United Nuclear Corporation Church Rock Site, Church Rock, New Mexico

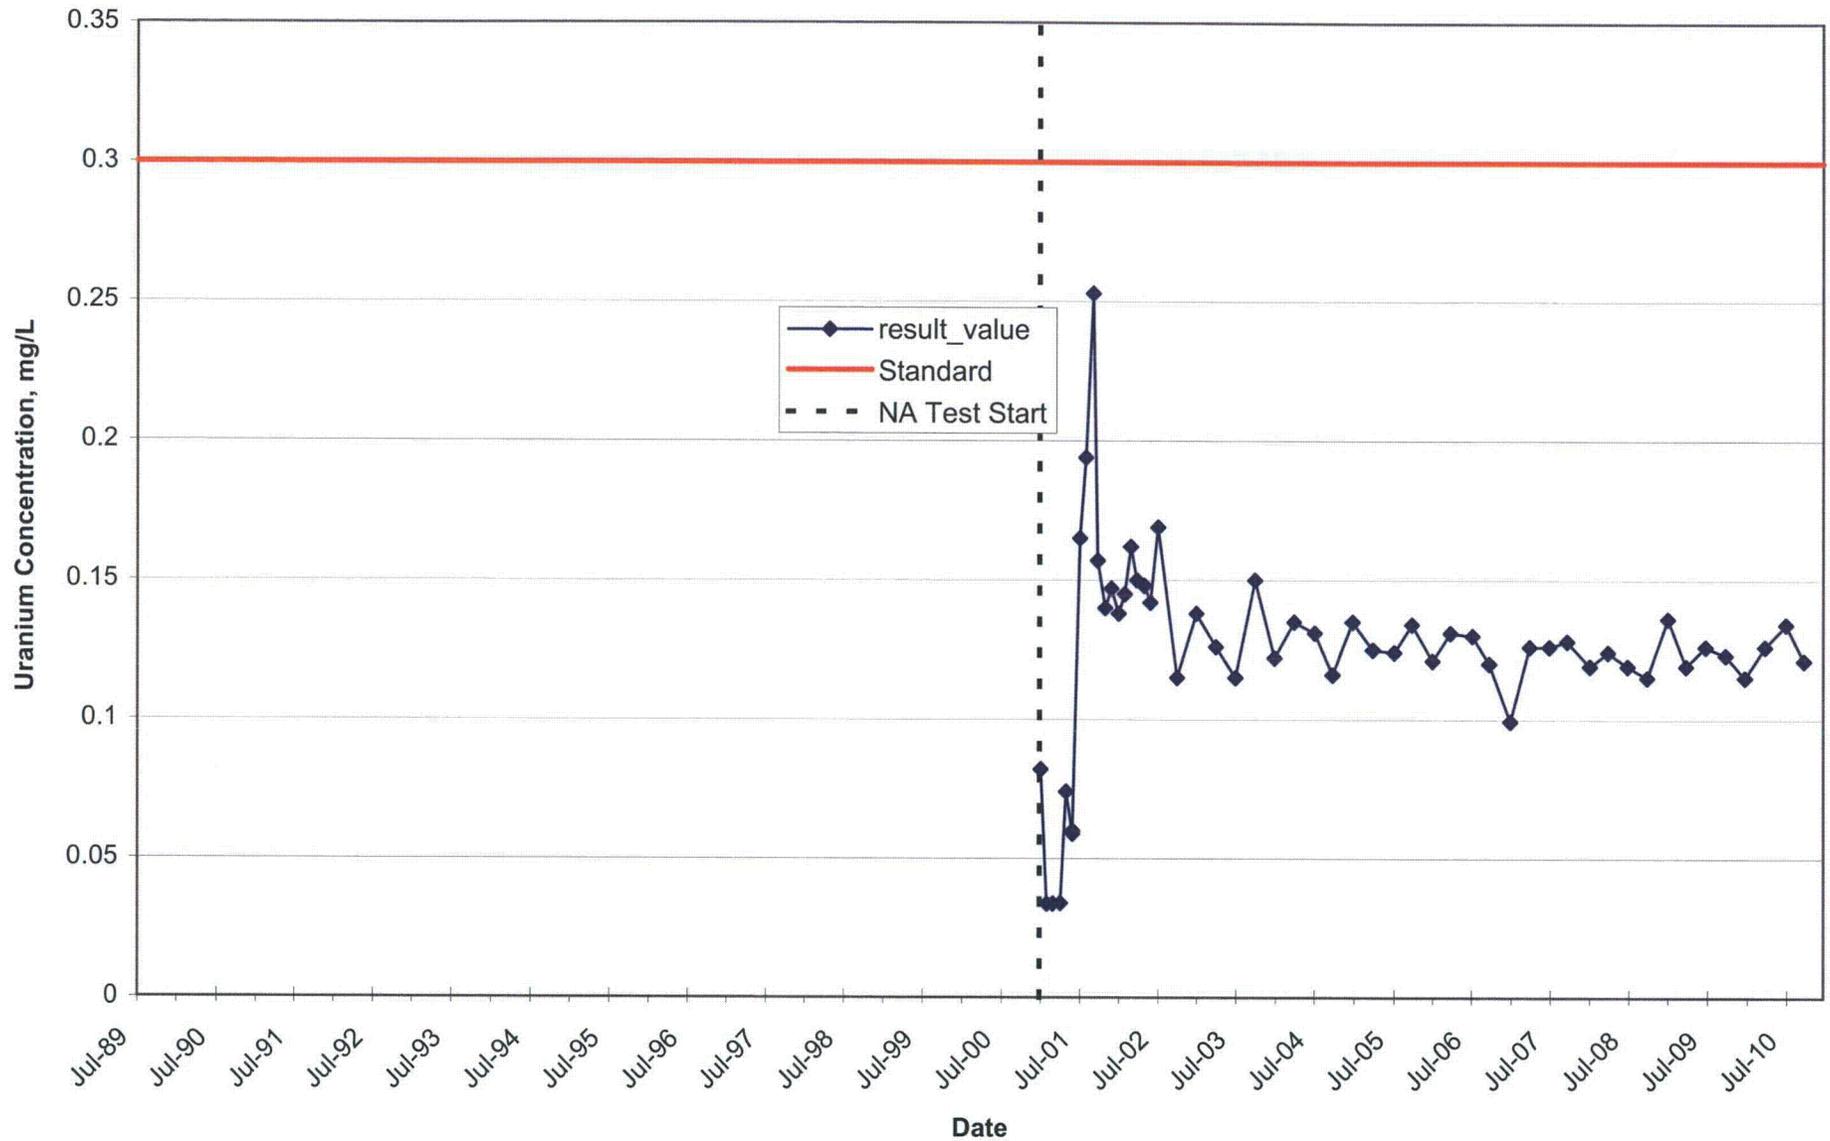
FIGURE 30
Uranium Concentration in Well 0808
United Nuclear Corporation Church Rock Site, Church Rock, New Mexico
