Site Location Map

United Nuclear Corporation Church Rock Site, Church Rock, New Mexico

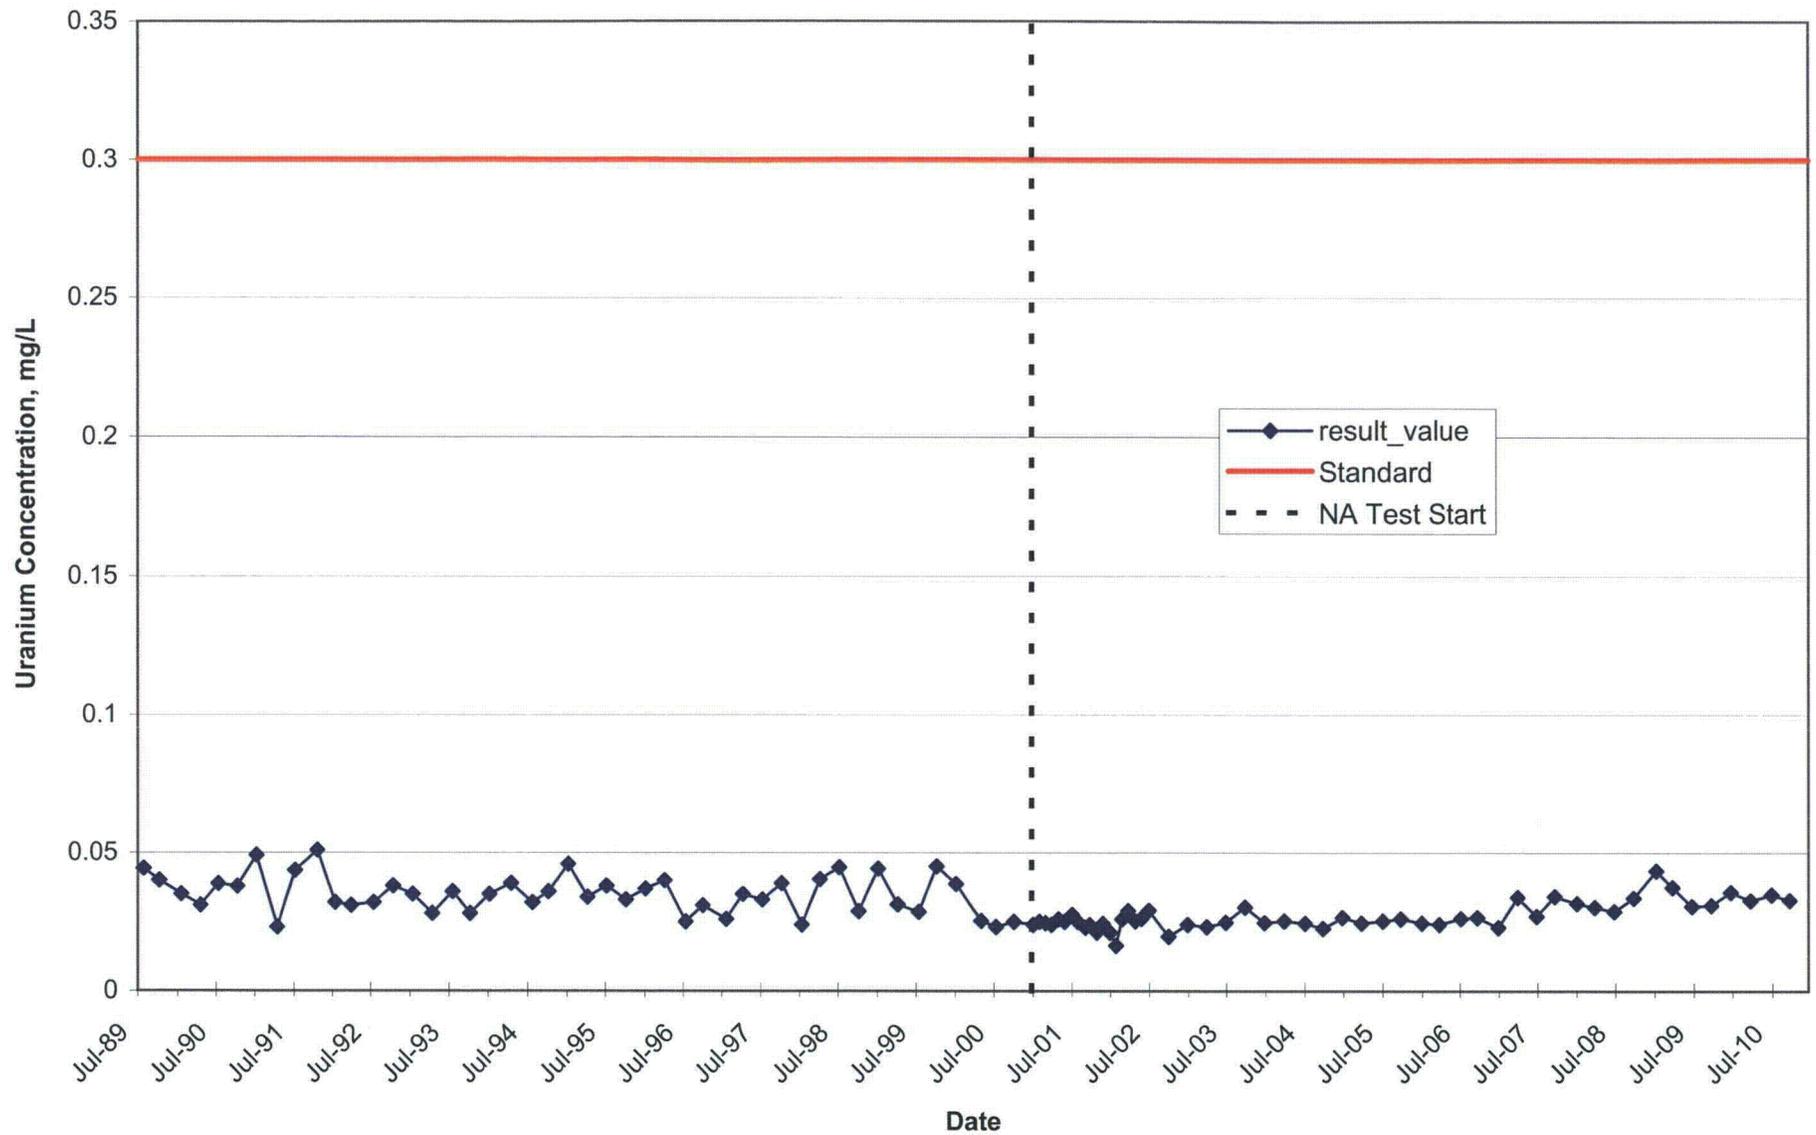
FIGURE 31
Uranium Concentration in Well EPA 23
United Nuclear Corporation Church Rock Site, Church Rock, New Mexico

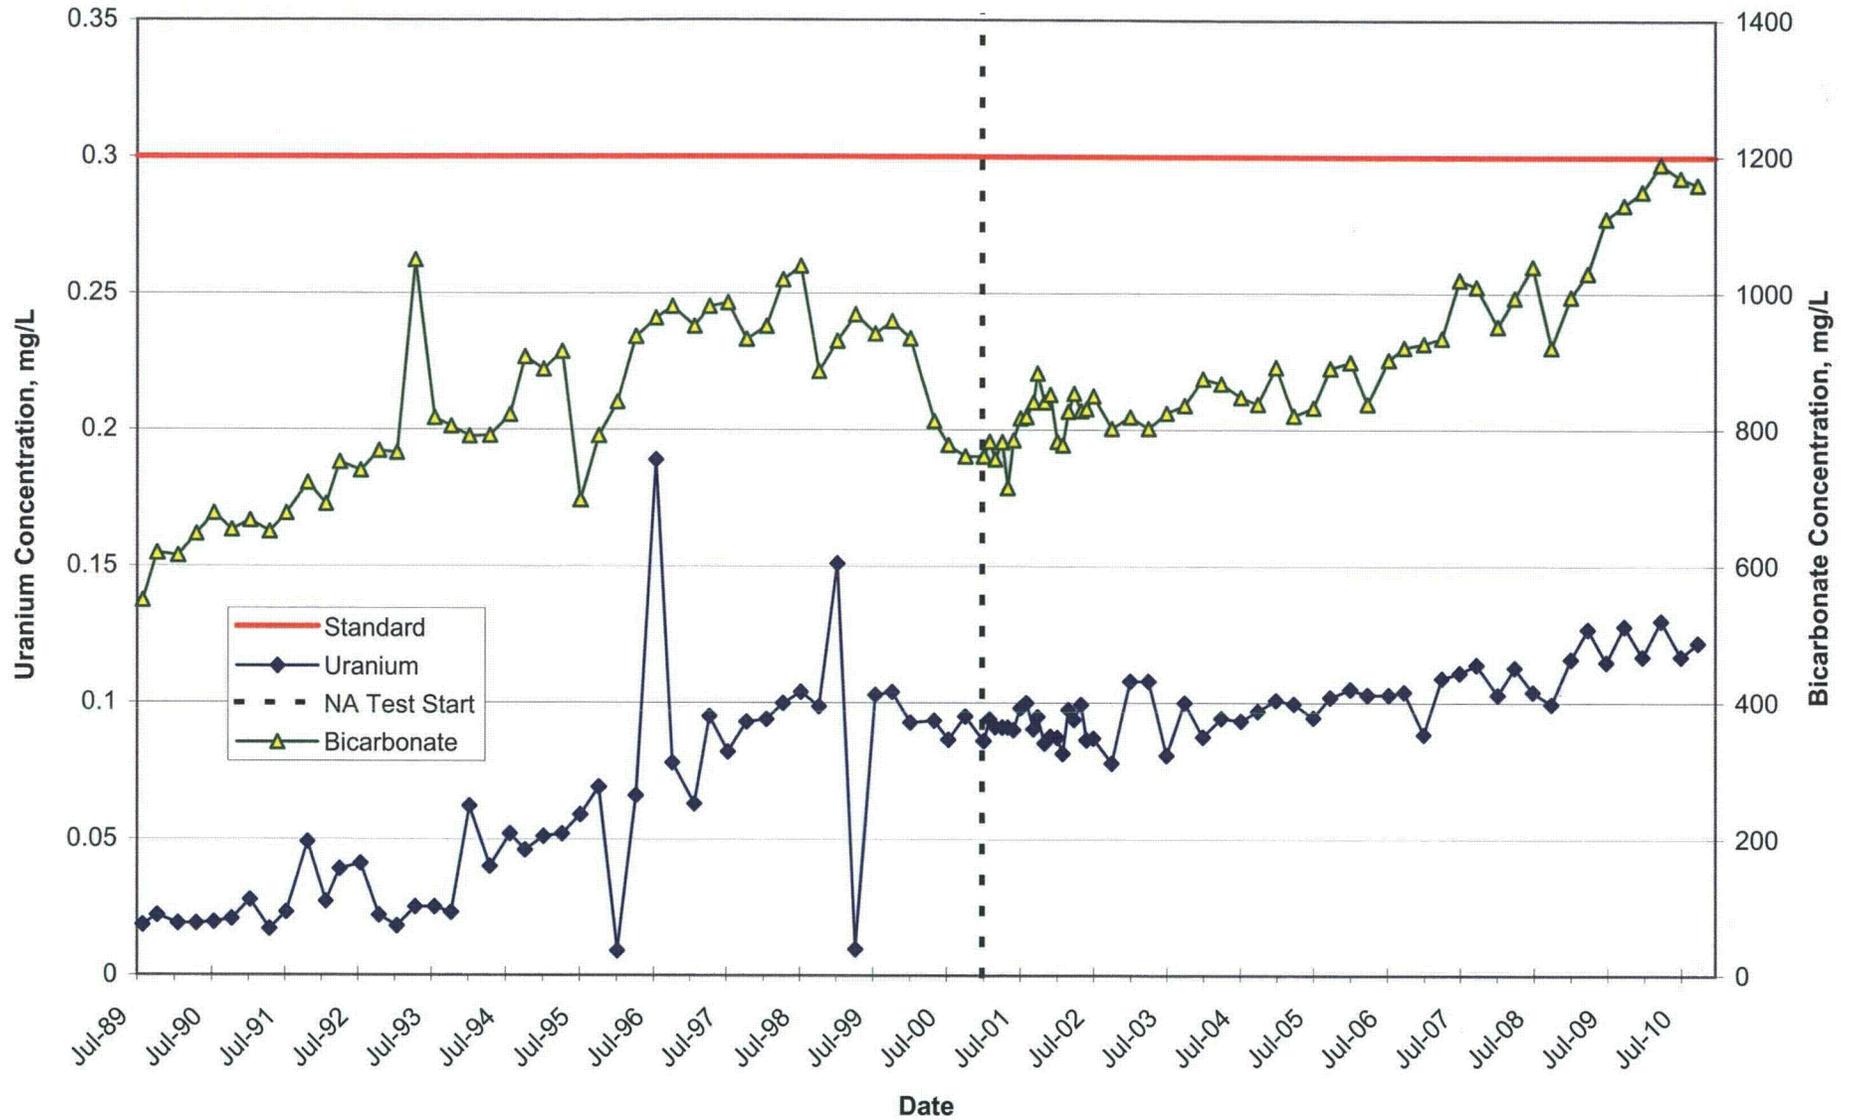
FIGURE 32
 Uranium and Bicarbonate Concentrations in Well EPA 25
 United Nuclear Corporation Church Rock Site, Church Rock, New Mexico

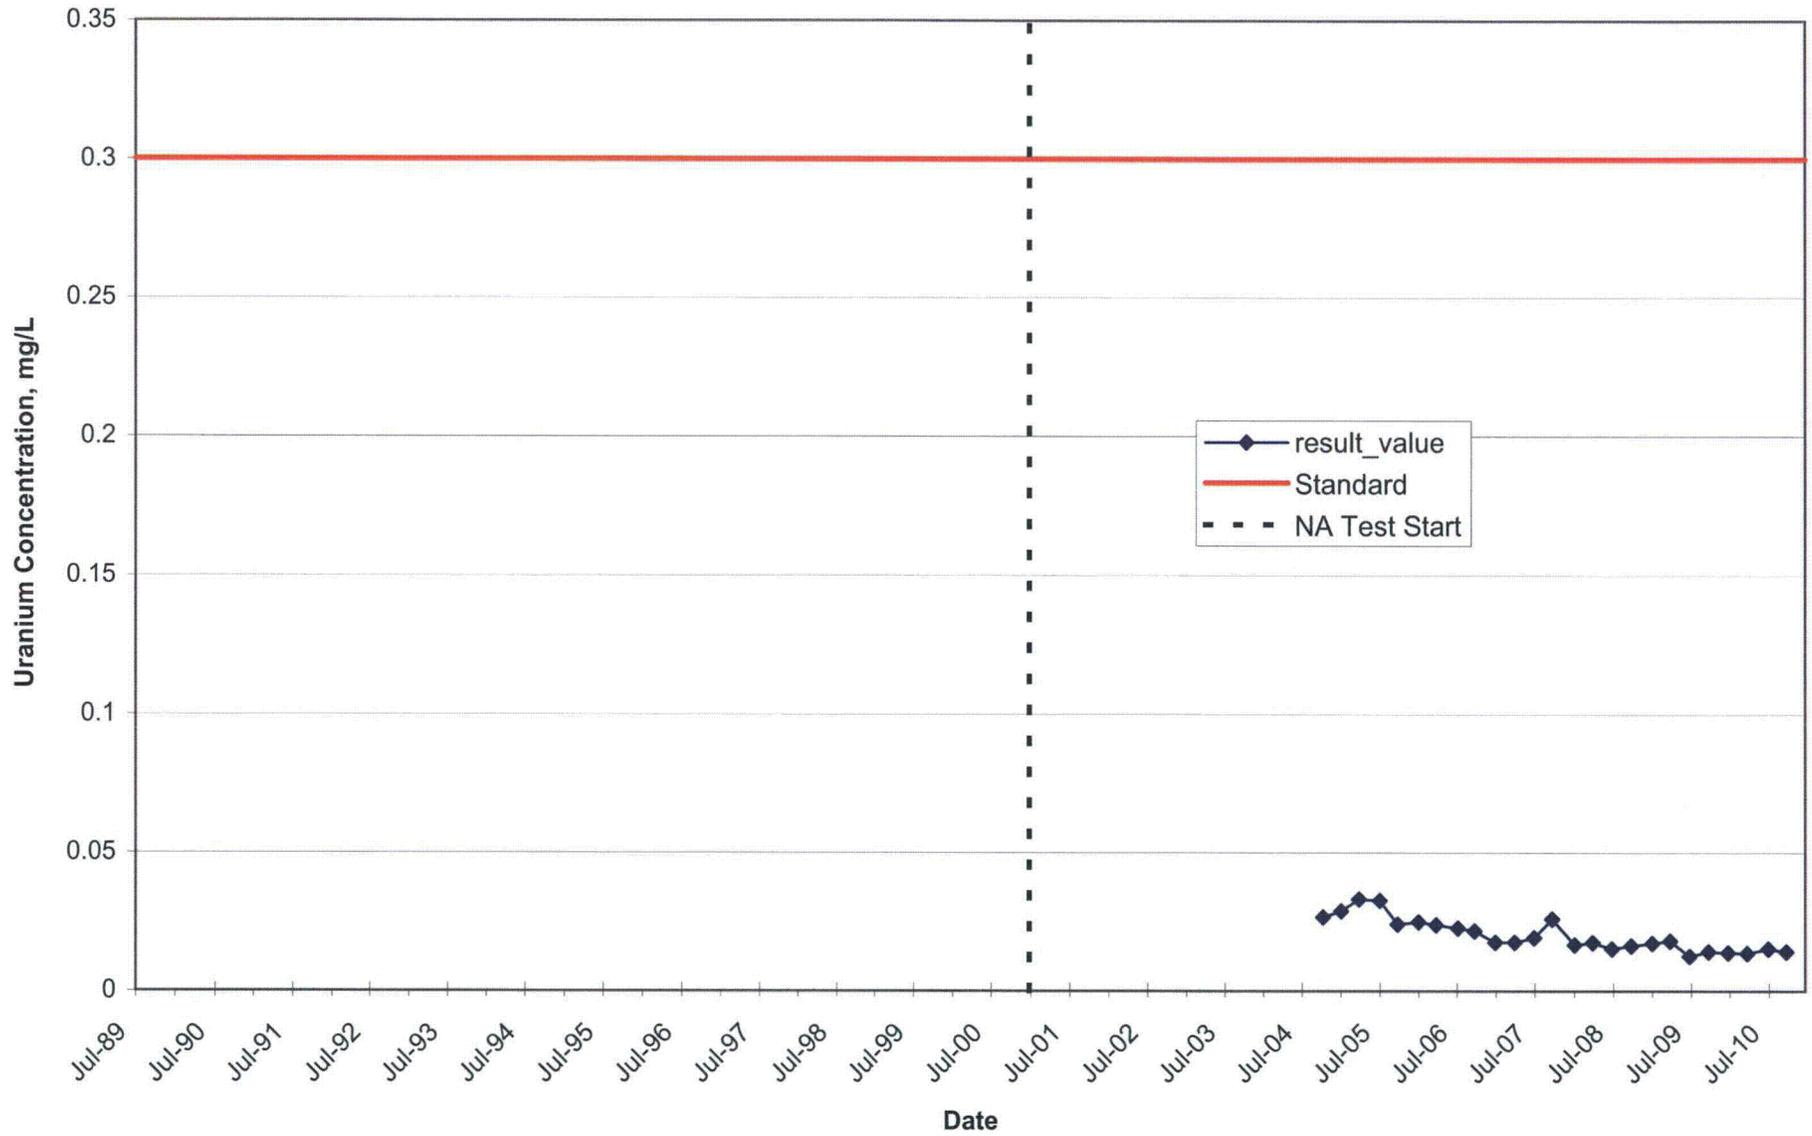
FIGURE 34
Uranium Concentration in Well SBL-01
United Nuclear Corporation Church Rock Site, Church Rock, New Mexico

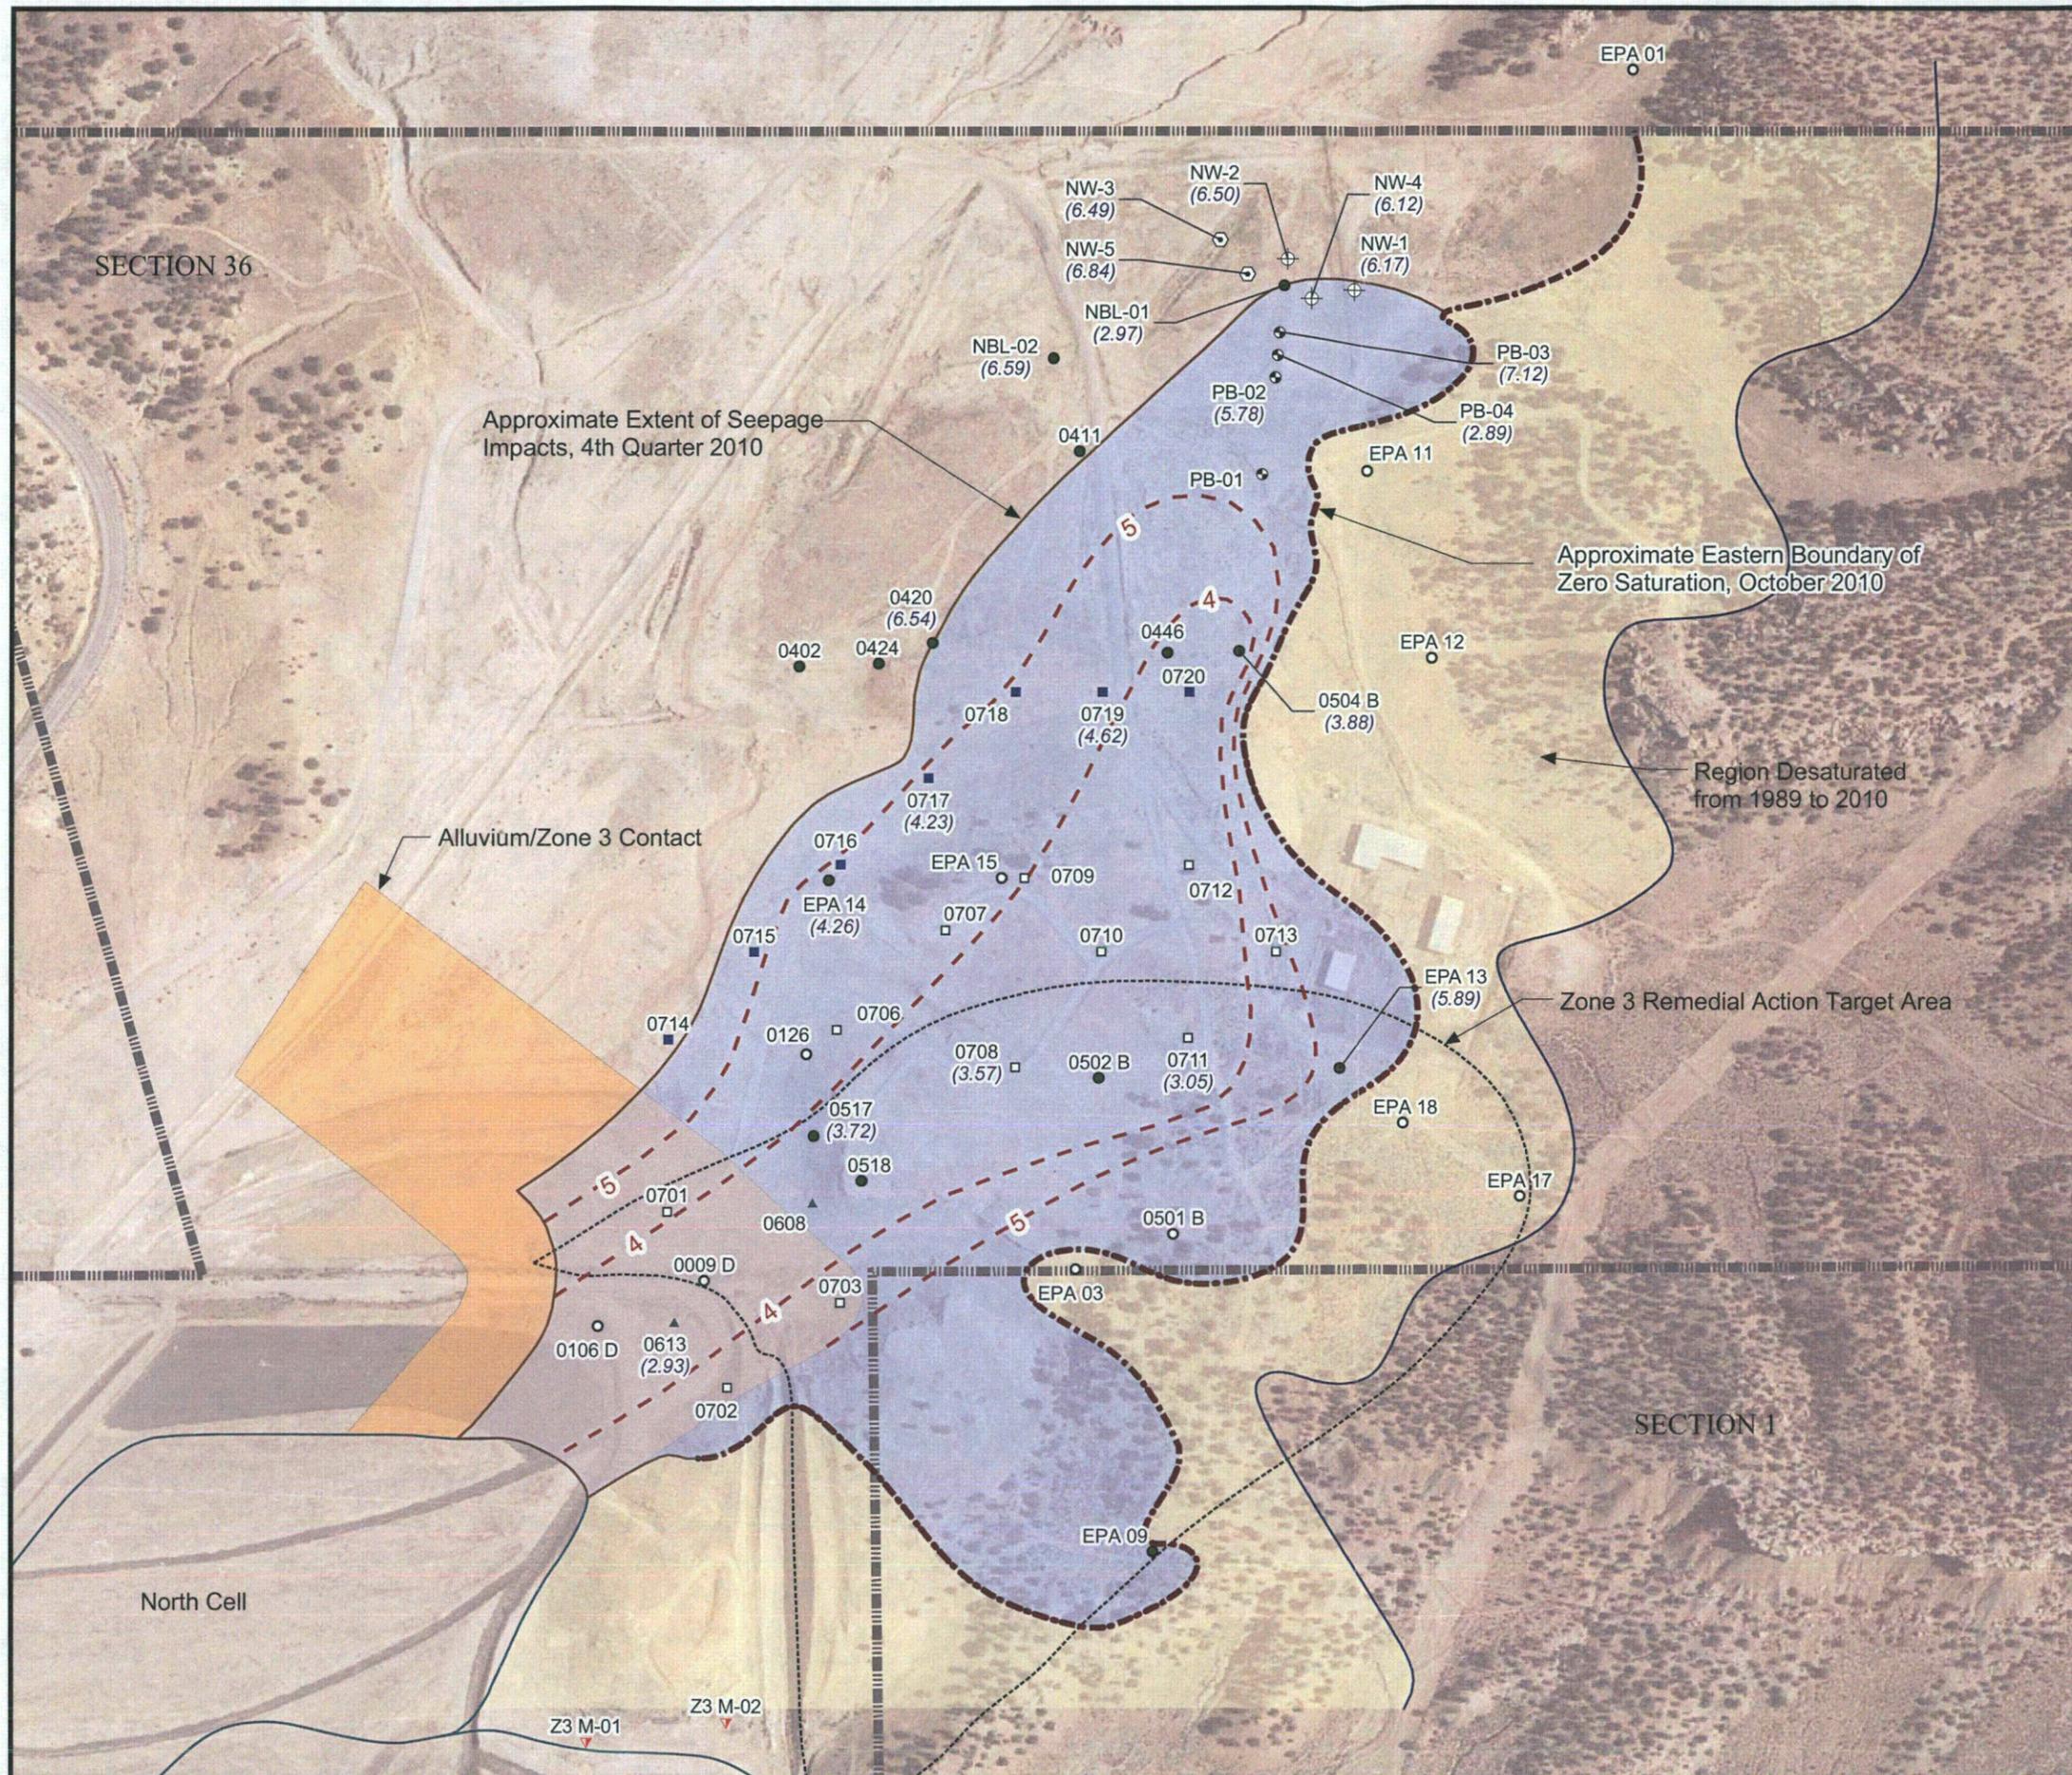
FIGURE 35

1. Well names are displayed with black text.
2. Values for field measured pH are shown with purple text and enclosed in parentheses.
3. Aerial photo taken on August 1, 1996.

Zone 3 Approximate Extent of Seepage Impacts, October 2010

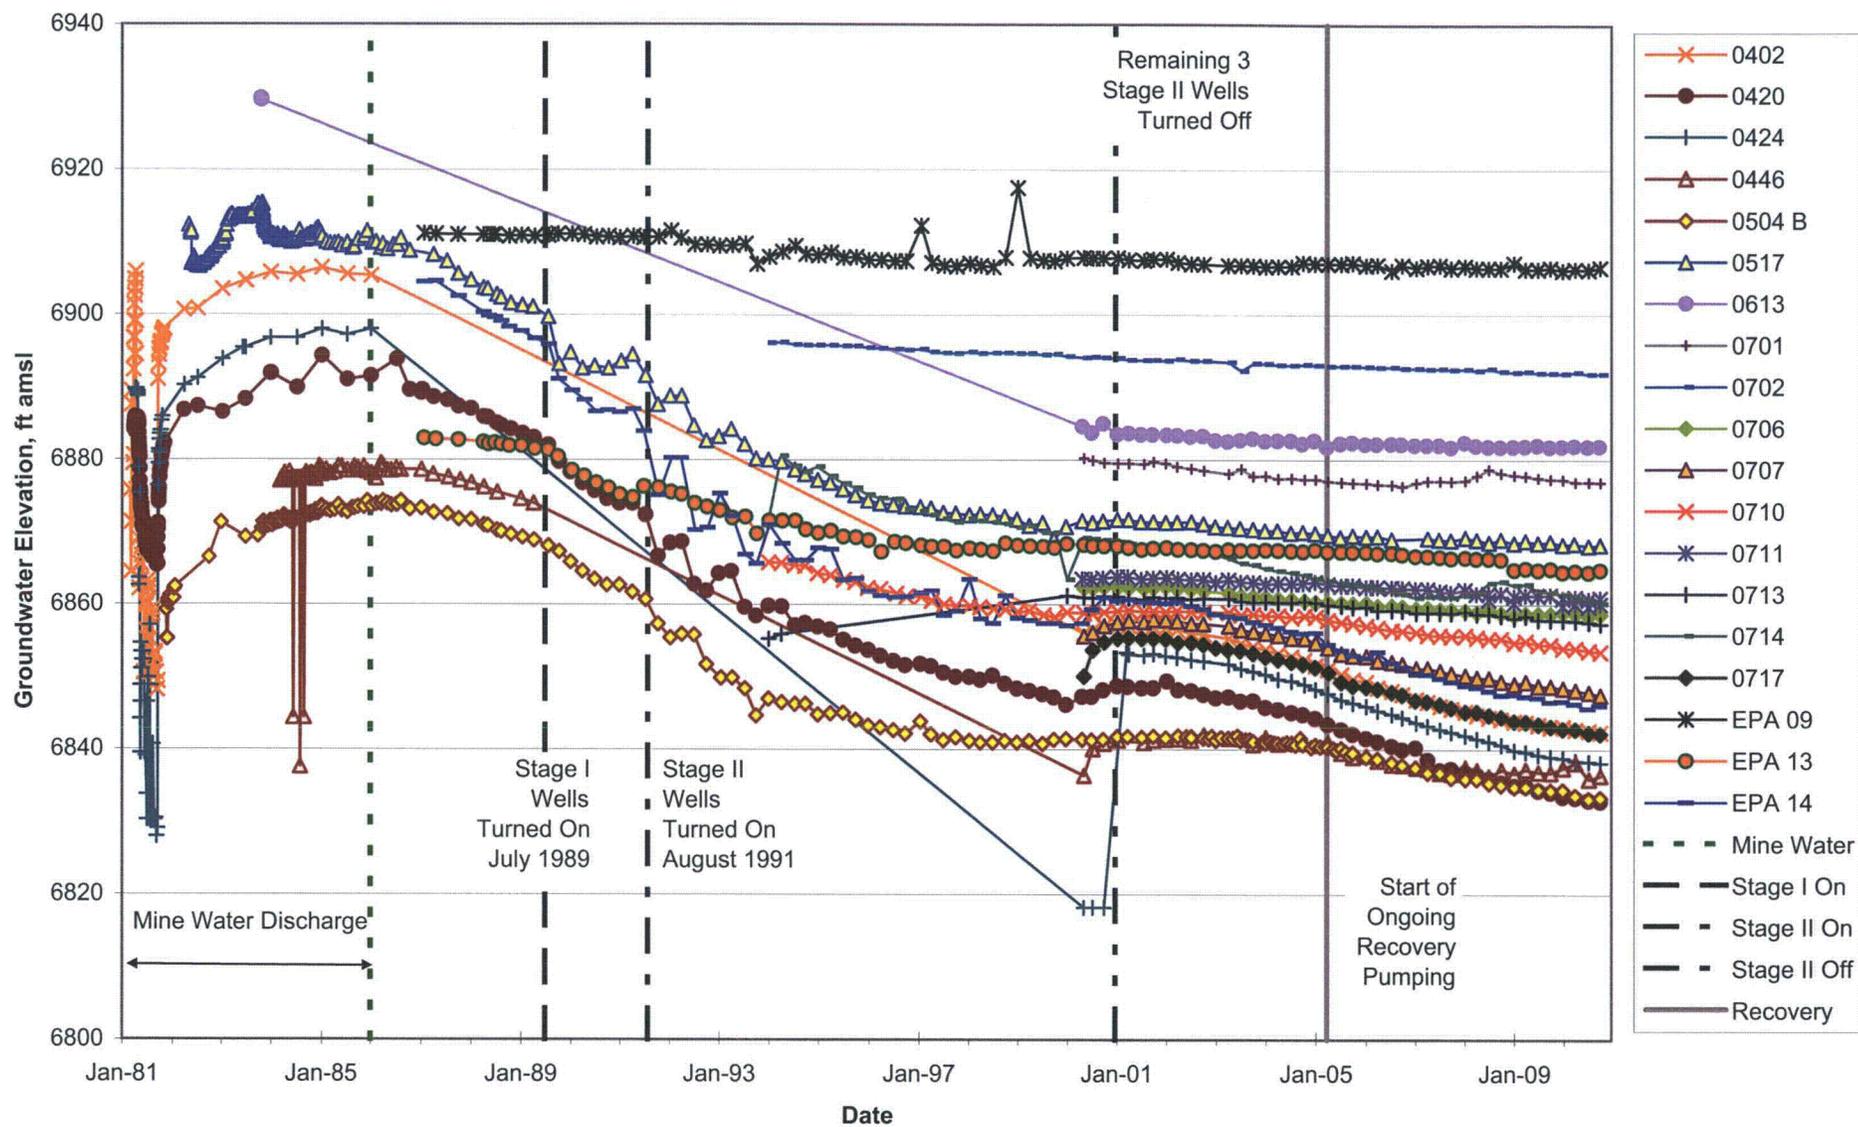
FIGURE 36
 Effects of Past and Current Pumping to Dewater Zone 3
 United Nuclear Corporation, Church Rock Site, Church Rock, New Mexico

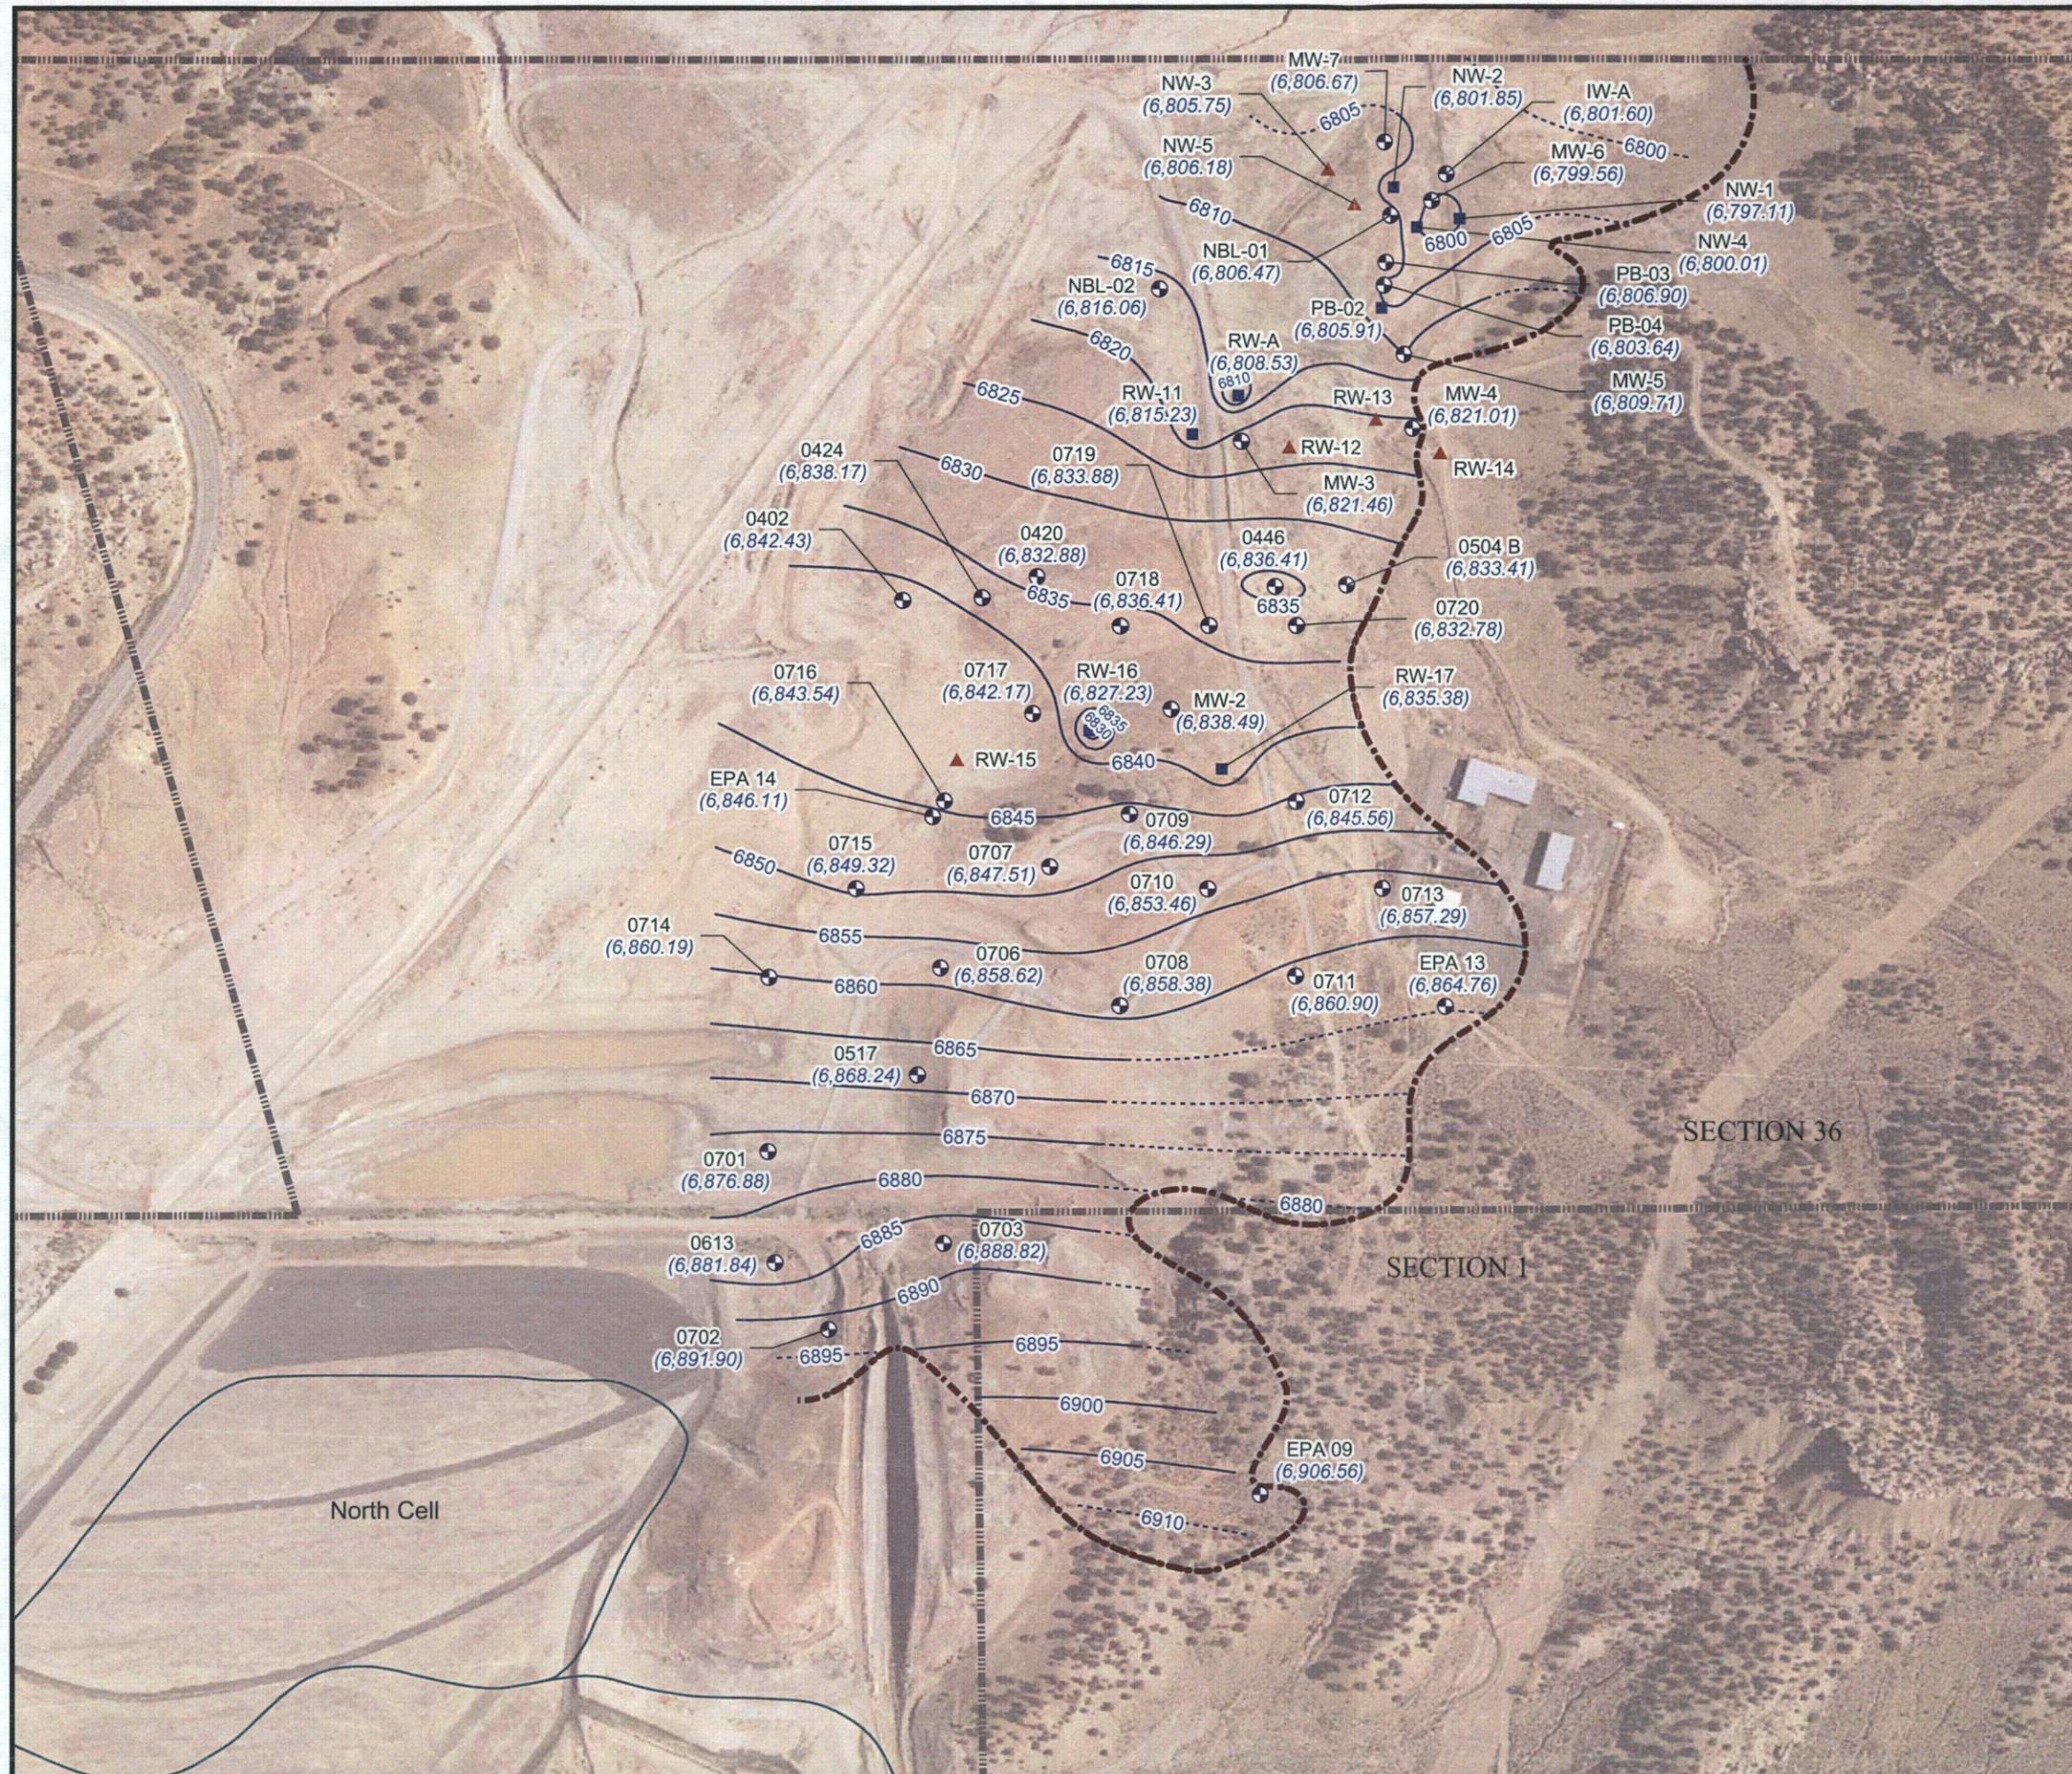
- Notes:**
1. Groundwater elevation values are displayed in feet above mean sea level.
 2. Well names are displayed with black text.
 3. Aerial photo taken on August 1, 1996.

FIGURE 37
 Zone 3 Potentiometric Surface Map
 October 2010
