# Long-Term Surveillance Plan for the Durango Disposal Site, Durango, Colorado

January 2011

Legacy  
Management

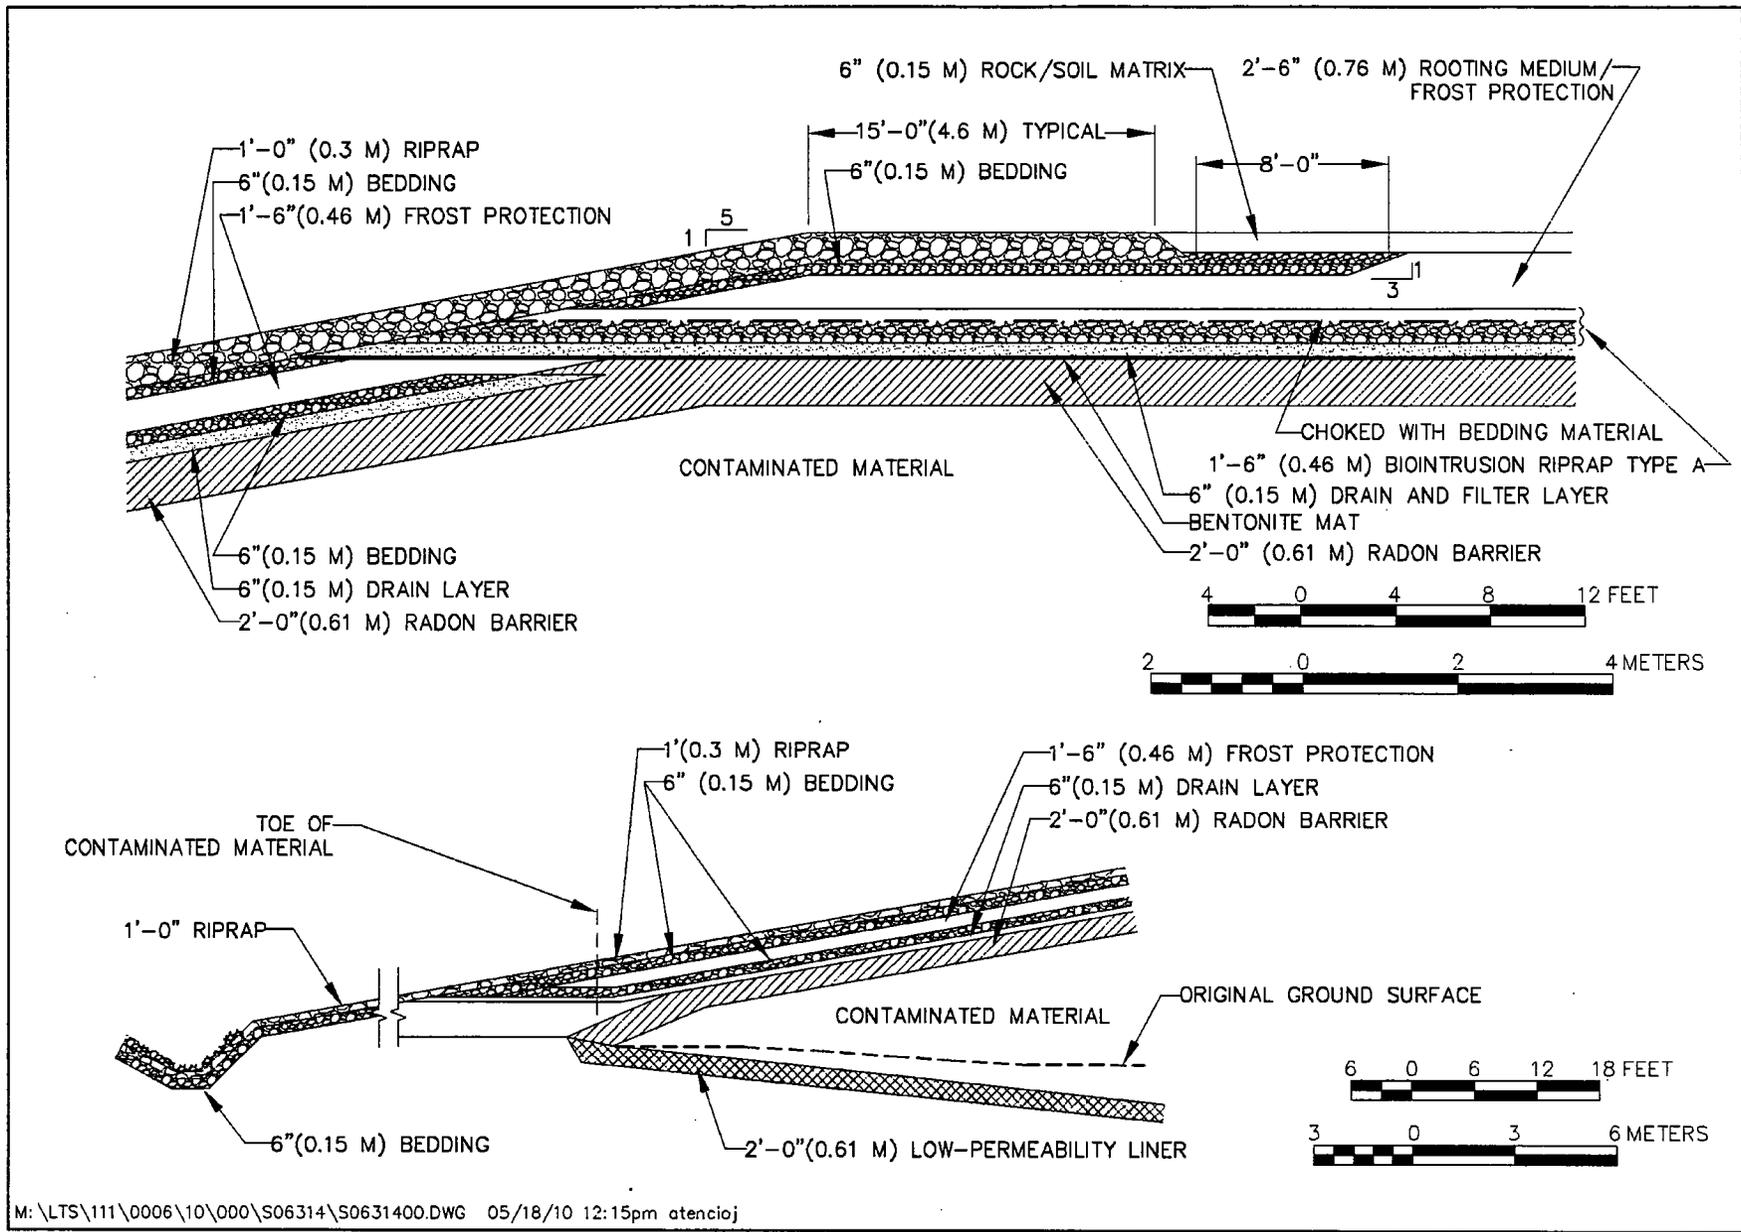
Figure 2-3. As-Built Cross Section of Cover System, Durango, Colorado, Disposal Cell

The top slope was completed with a 1.5-ft (0.5-m)-thick biointrusion layer, a 2.5-ft (0.8-m)-thick frost-protection layer of compacted soil, and a 6-inch (15-cm)-thick rock/soil matrix. The matrix has a 1.5 to 2.0 percent grade away from a drainage divide at the center of the cell. The cell top slope is covered with native grasses. The cover system for the embankment top slope is illustrated in Figure 2-3 and Figure 2-4.

- A low-permeability liner on the sides and beneath the contaminated tailings (Figure 2-3).
- A compacted clay radon/infiltration barrier (with bentonite mat on top slope and bentonite amended clay on side slopes) above the tailings material (Figure 2-4).
- A high-conductivity sand drain/filter layer placed on the top of the radon barrier (Figure 2-4).

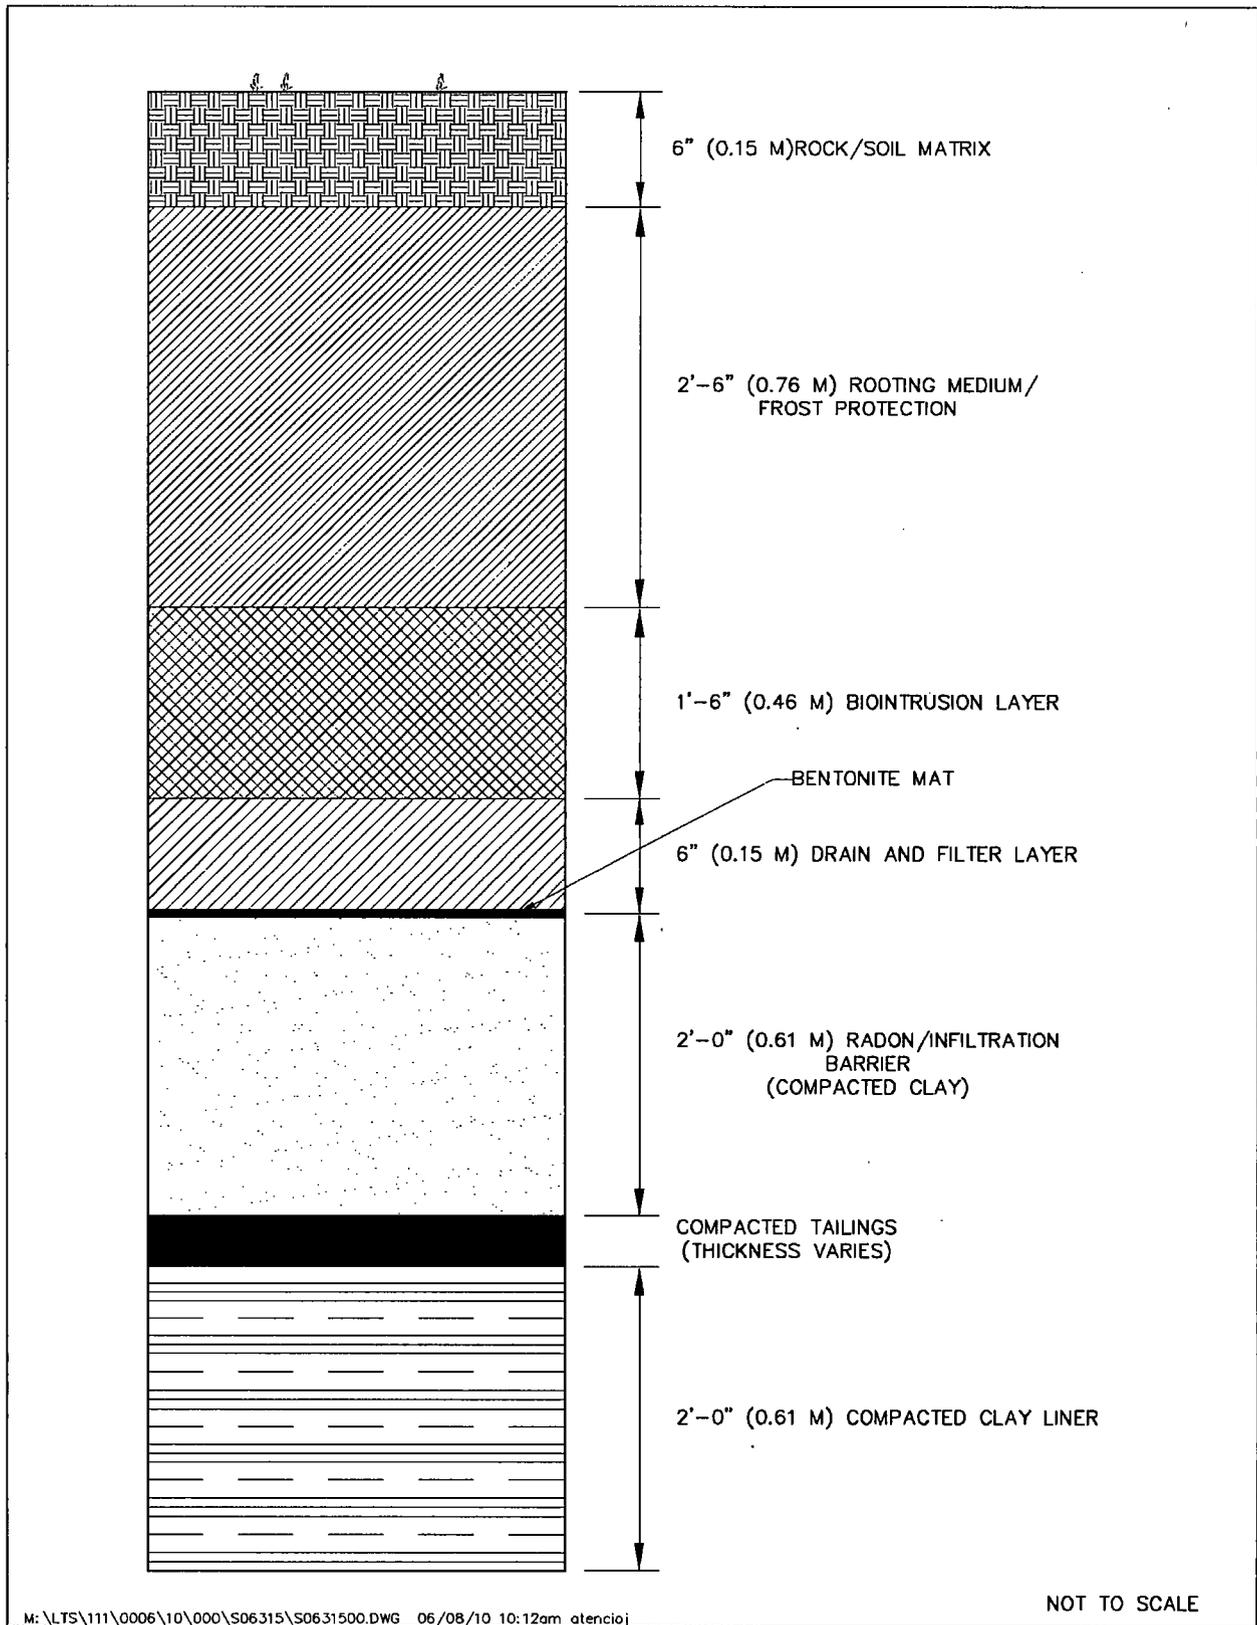
Figure 2-4. Top Slope Cover System, Durango, Colorado, Disposal Cell

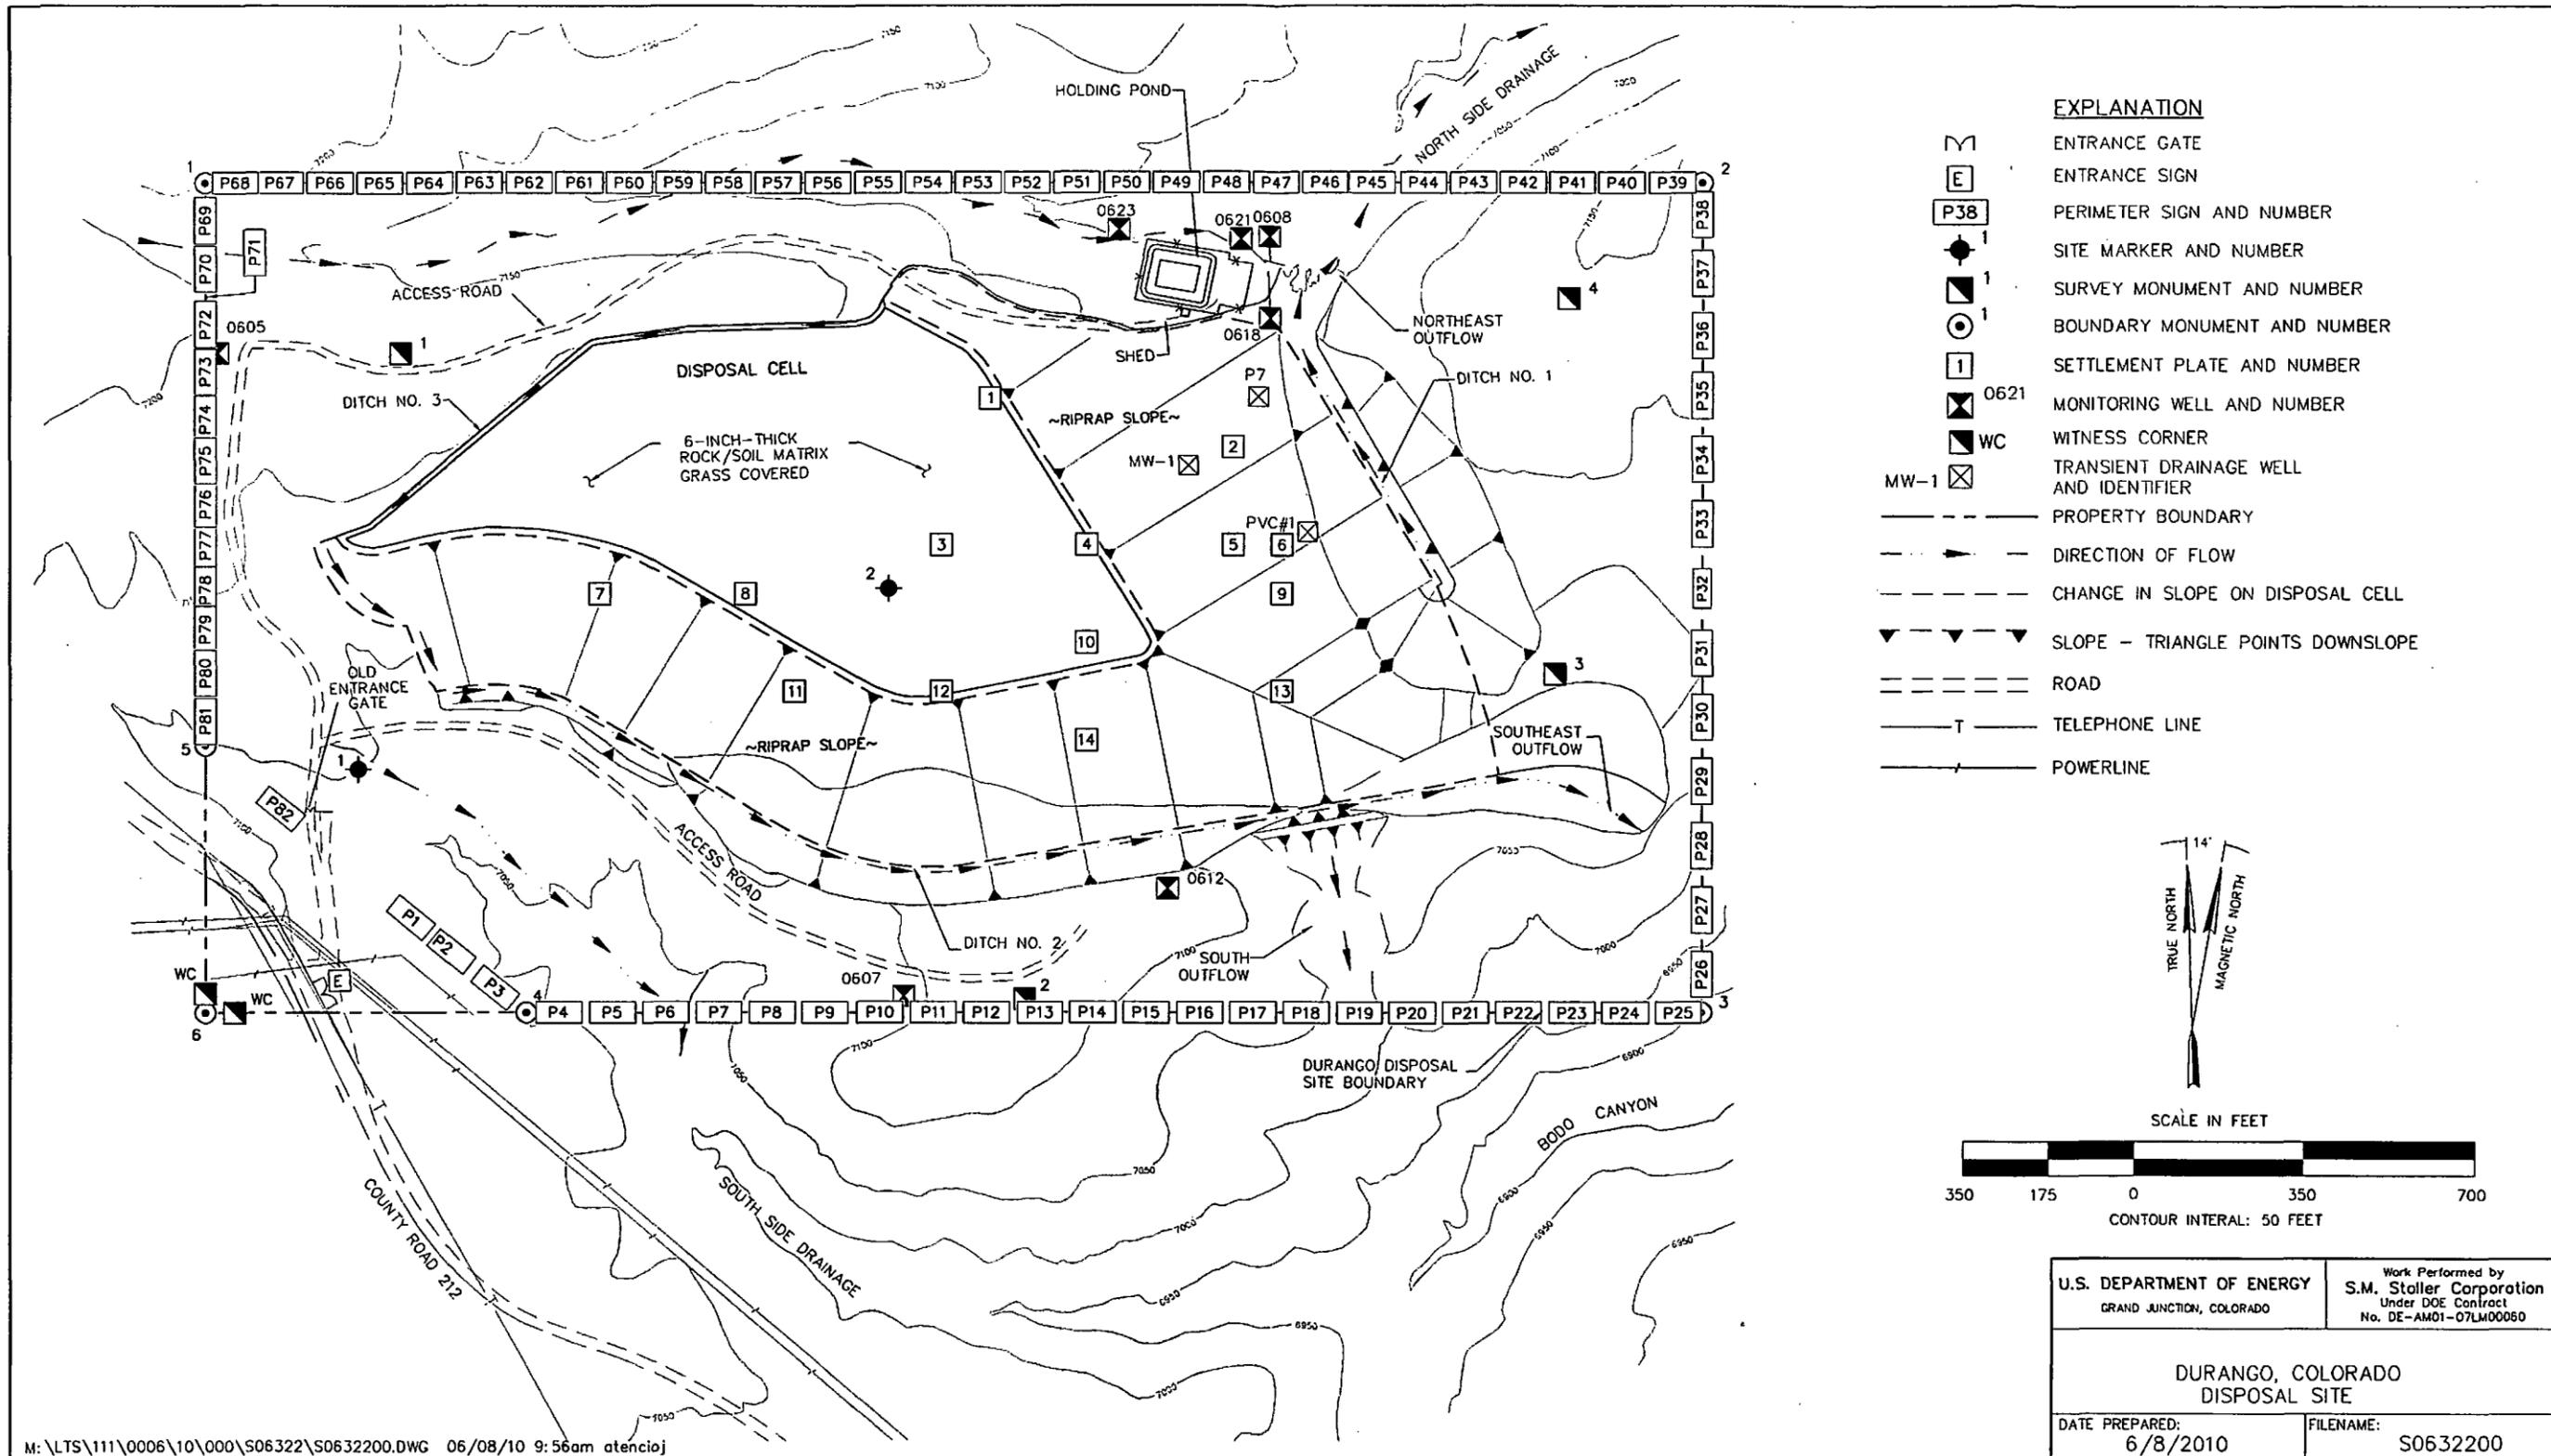
Figure 2-6. Map of the Durango, Colorado, Disposal Site

Survey monuments (SM), boundary monuments (BM), site markers (SMK), and entrance and perimeter signs are the permanent surveillance features at the disposal site. Five boundary monuments define the corners of the unfenced perimeter of the disposal site. Eighty-two warning signs are placed around the perimeter of the disposal site (Figure 2-6).

**Survey Monuments**—SM-1 is in the northwest part of the site, SM-2 is south of the disposal cell, and SM-3 and SM-4 are to the east (Table 2-1 and Figure 2-6). The monuments, Berntsen RT-1 metal markers, were set into the top of a truncated cone of reinforced concrete set in concrete (DOE 2001).

**Boundary Monuments**—Five Berntsen federal aluminum survey monuments, Model A-1 (DOE 2001), were used for the site boundary monuments (BM-1 through BM-6) (Table 2-1 and Figure 2-6). BM-1, BM-2, and BM-3 mark the northwest, northeast, and southeast corners, respectively, of the site. BM-4 is at the west end of the proposed truncated south boundary, and BM-5 is at the south end of the truncated west boundary, however DOE retained the full area that is marked by BM-6 in the southwest corner (MK-F 1991).

**Entrance and Perimeter Signs**—The site entrance sign (Figure 2-8) is at the entrance gate. In addition to the entrance sign, 82 perimeter signs (Figure 2-9) mark the boundary around most of the site (Table 2-1 and Figure 2-6). These signs display the international trefoil symbol indicating the presence of radioactive materials. They also state that the disposal site is U.S. Government property and that trespassing is forbidden. The entrance sign has the same information as the perimeter signs, plus the name of the site and the telephone numbers of DOE and CDPHE offices (Figure 2-8).

**Settlement Plates**—Fourteen settlement plates (DOE 2001) are located on the disposal cell, primarily on the south and east side slopes of the cell (Table 2-1 and Figure 2-6). The total long-term settlement of the disposal cell could be measured using the 14 settlement plates. The plates were installed after the disposal cell was completed.

A new site inspection map will be prepared after each annual inspection using the disposal site map (Figure 2-6) as a base. This map will include at a minimum the following:

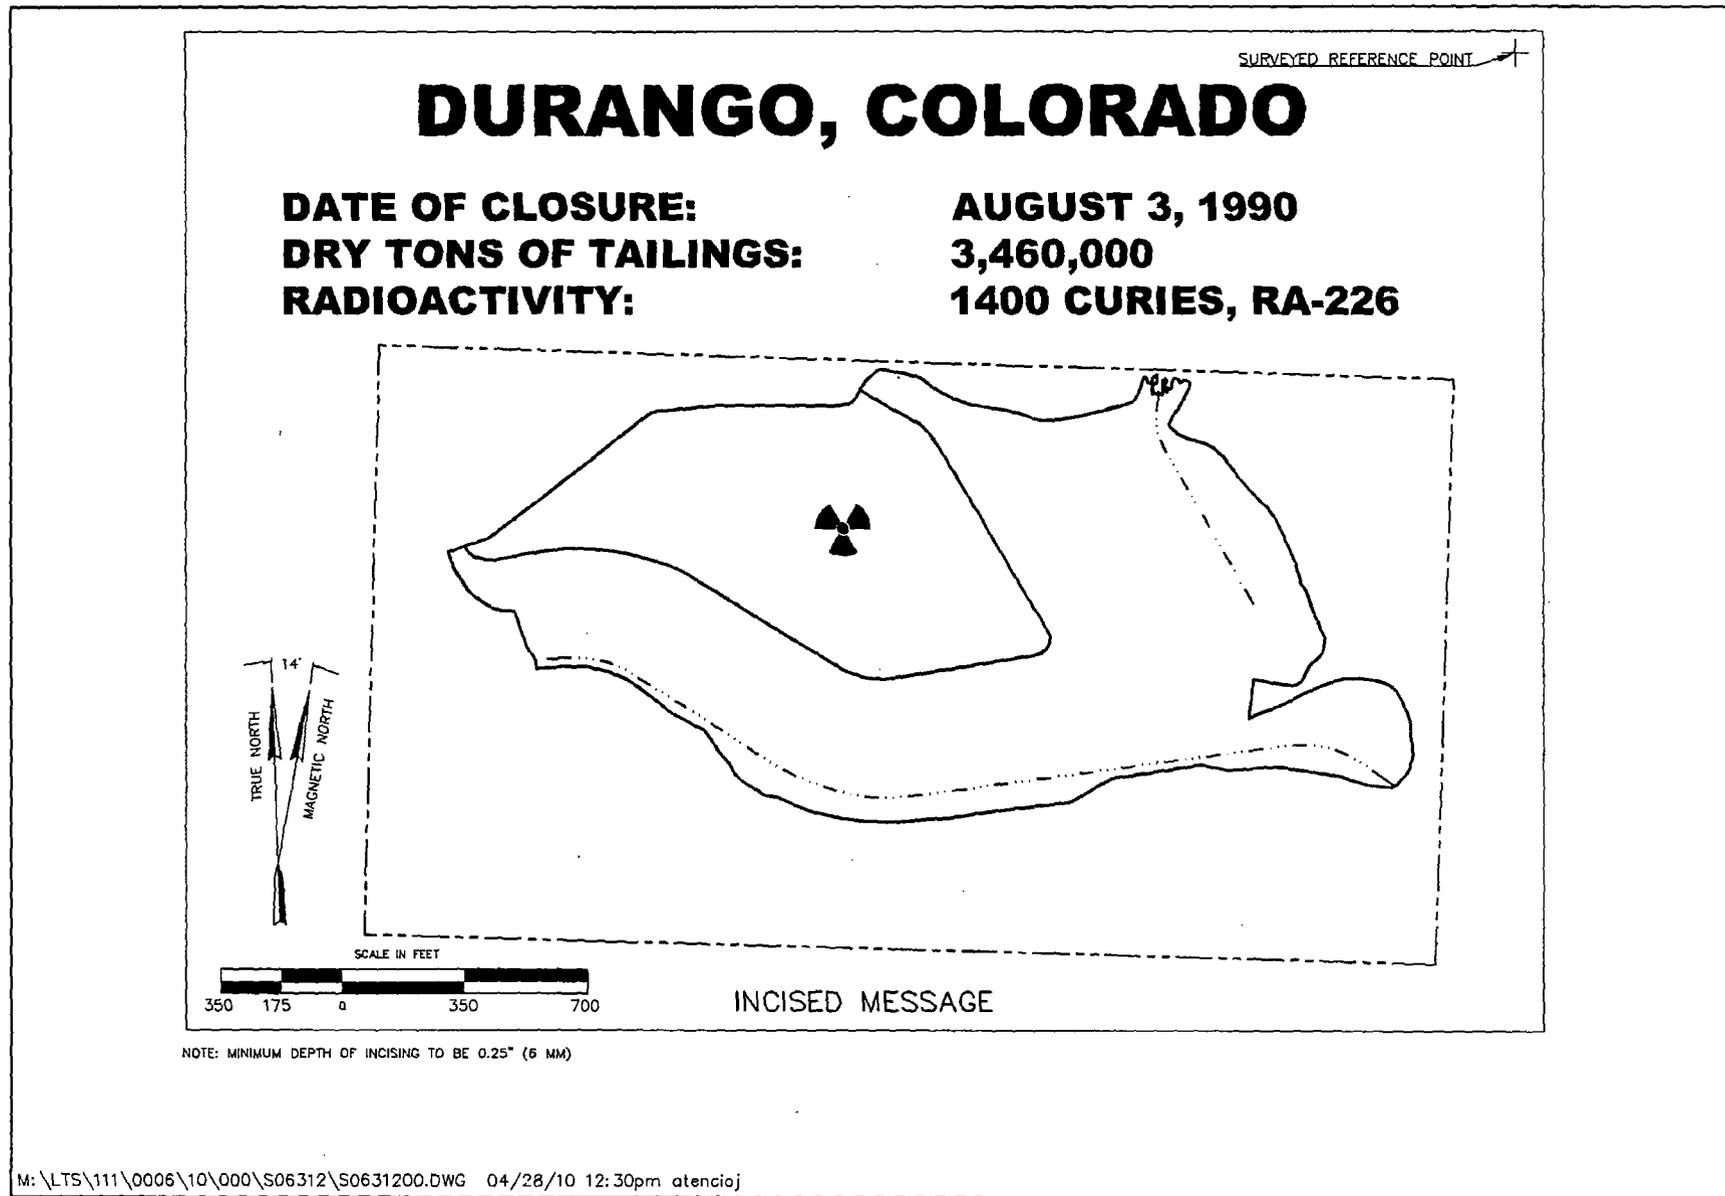
Figure 2-7. Site Marker, Durango, Colorado, Disposal Site

**Site Markers**—Two unpolished granite site markers (SMK-1 and SMK-2) are within the restricted site boundary. SMK-1 is just inside the entrance gate, and SMK-2 is on top of the disposal cell revegetated area (DOE 2001). The markers identify the disposal site, the general location of the disposal cell, the date of closure (August 3, 1990), the mass of residual radioactive materials (3,460,000 dry tons [3,140,000 tonnes]), and the radioactivity (1,400 curies, radium-226) (Figure 2-7).

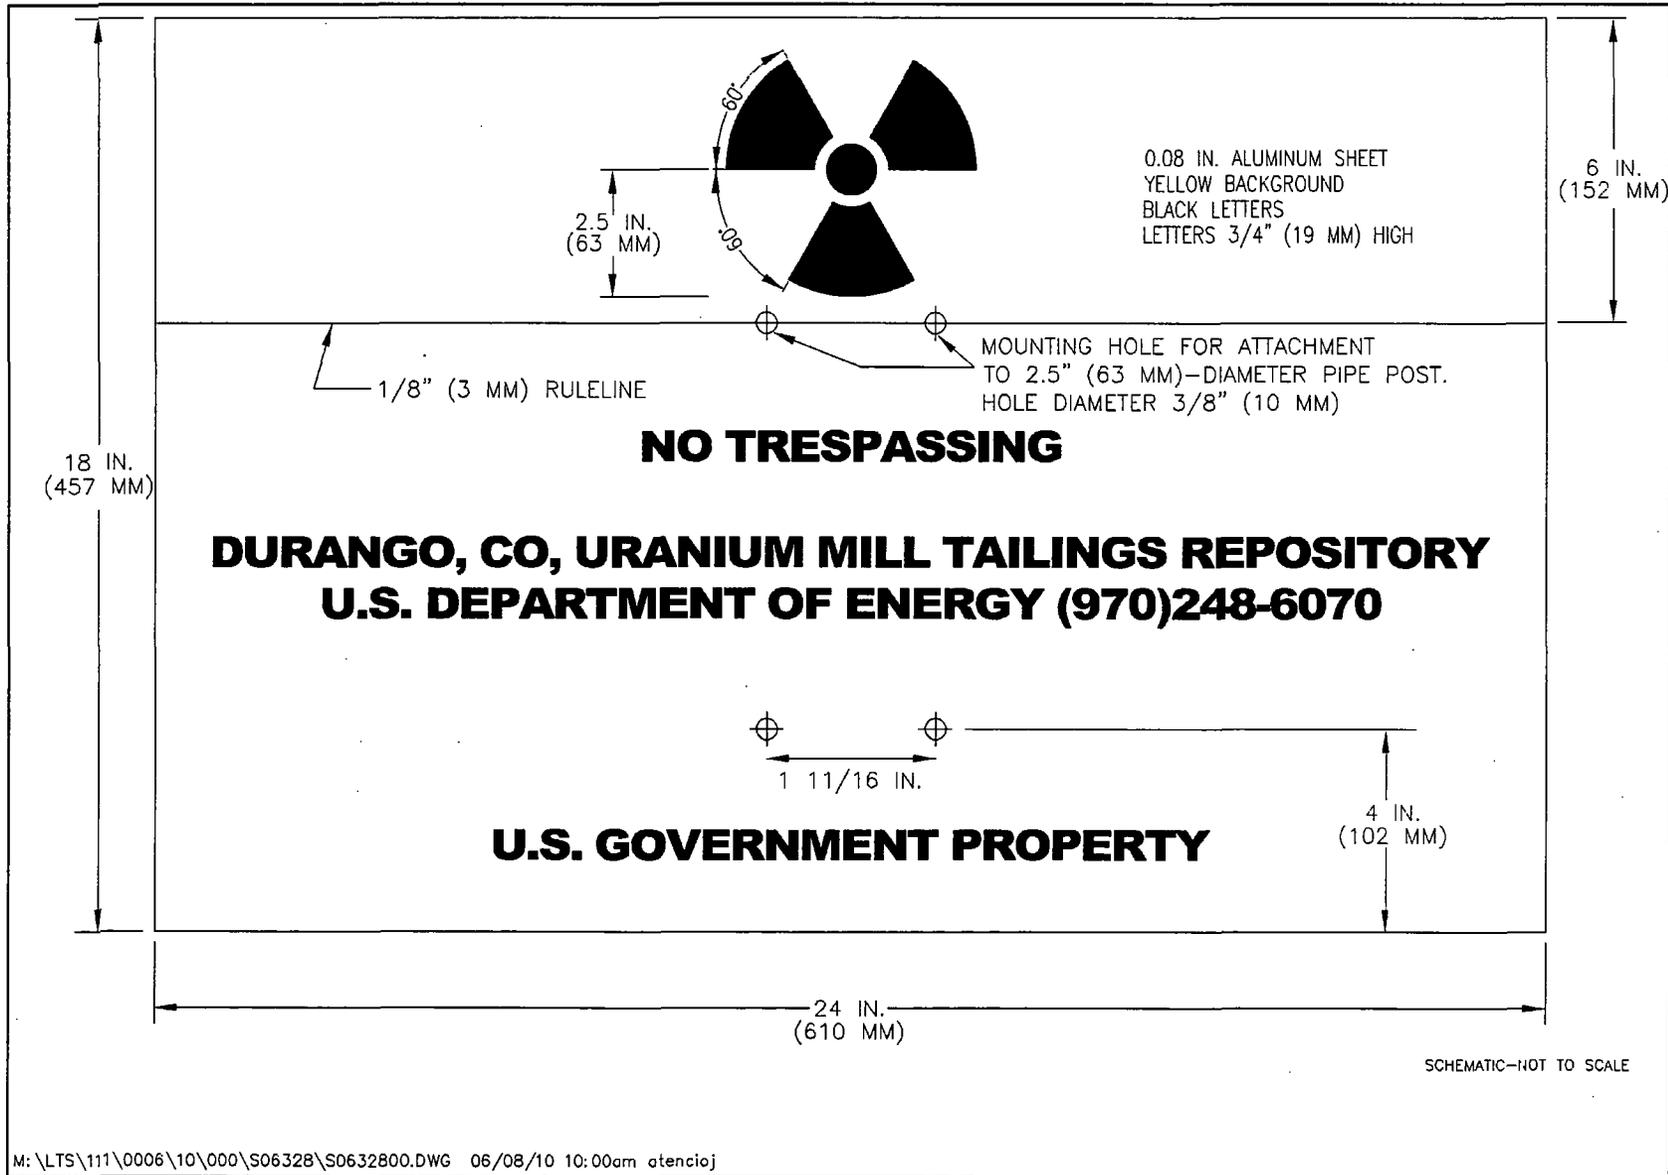
Figure 2-8. Entrance Sign, Durango, Colorado, Disposal Site

The public may use the 24-hour DOE telephone number posted on the entrance sign to request information or to report a problem at the site (Figure 2-8).

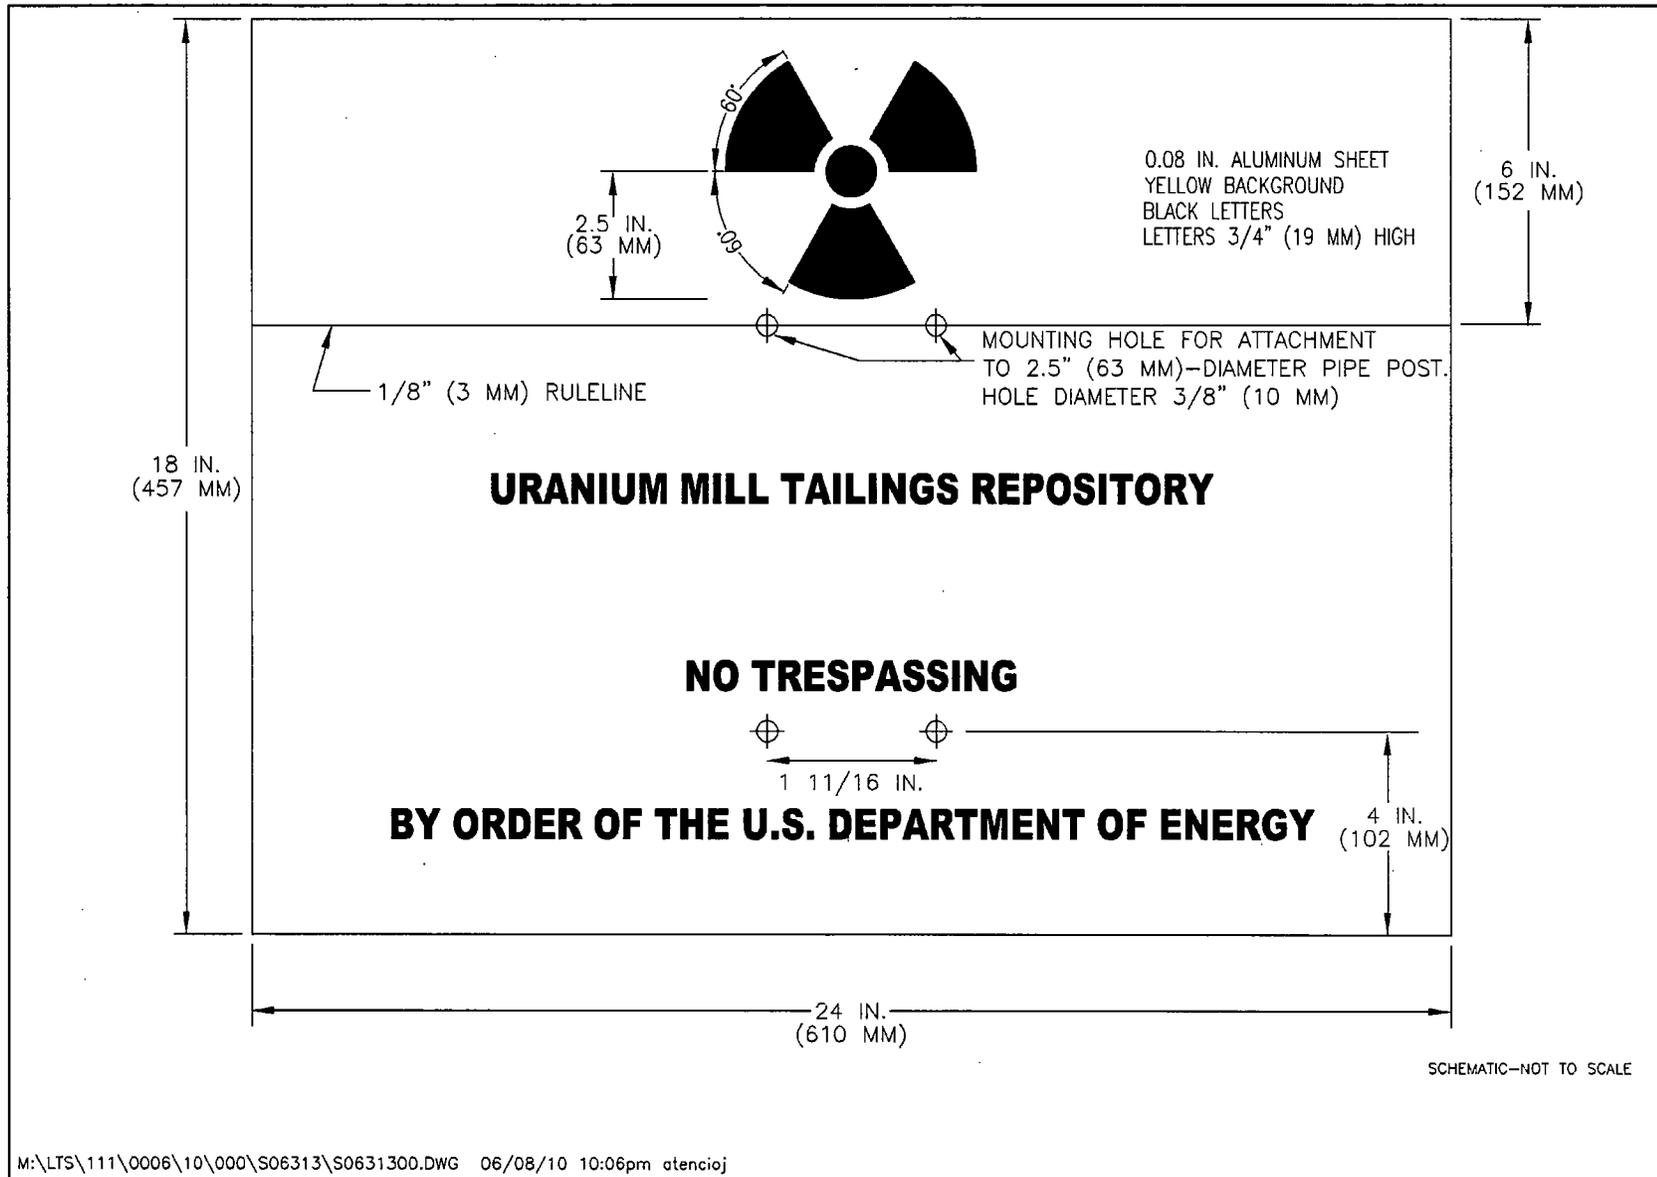
Figure 2-9. Perimeter Sign, Durango, Colorado, Disposal Site

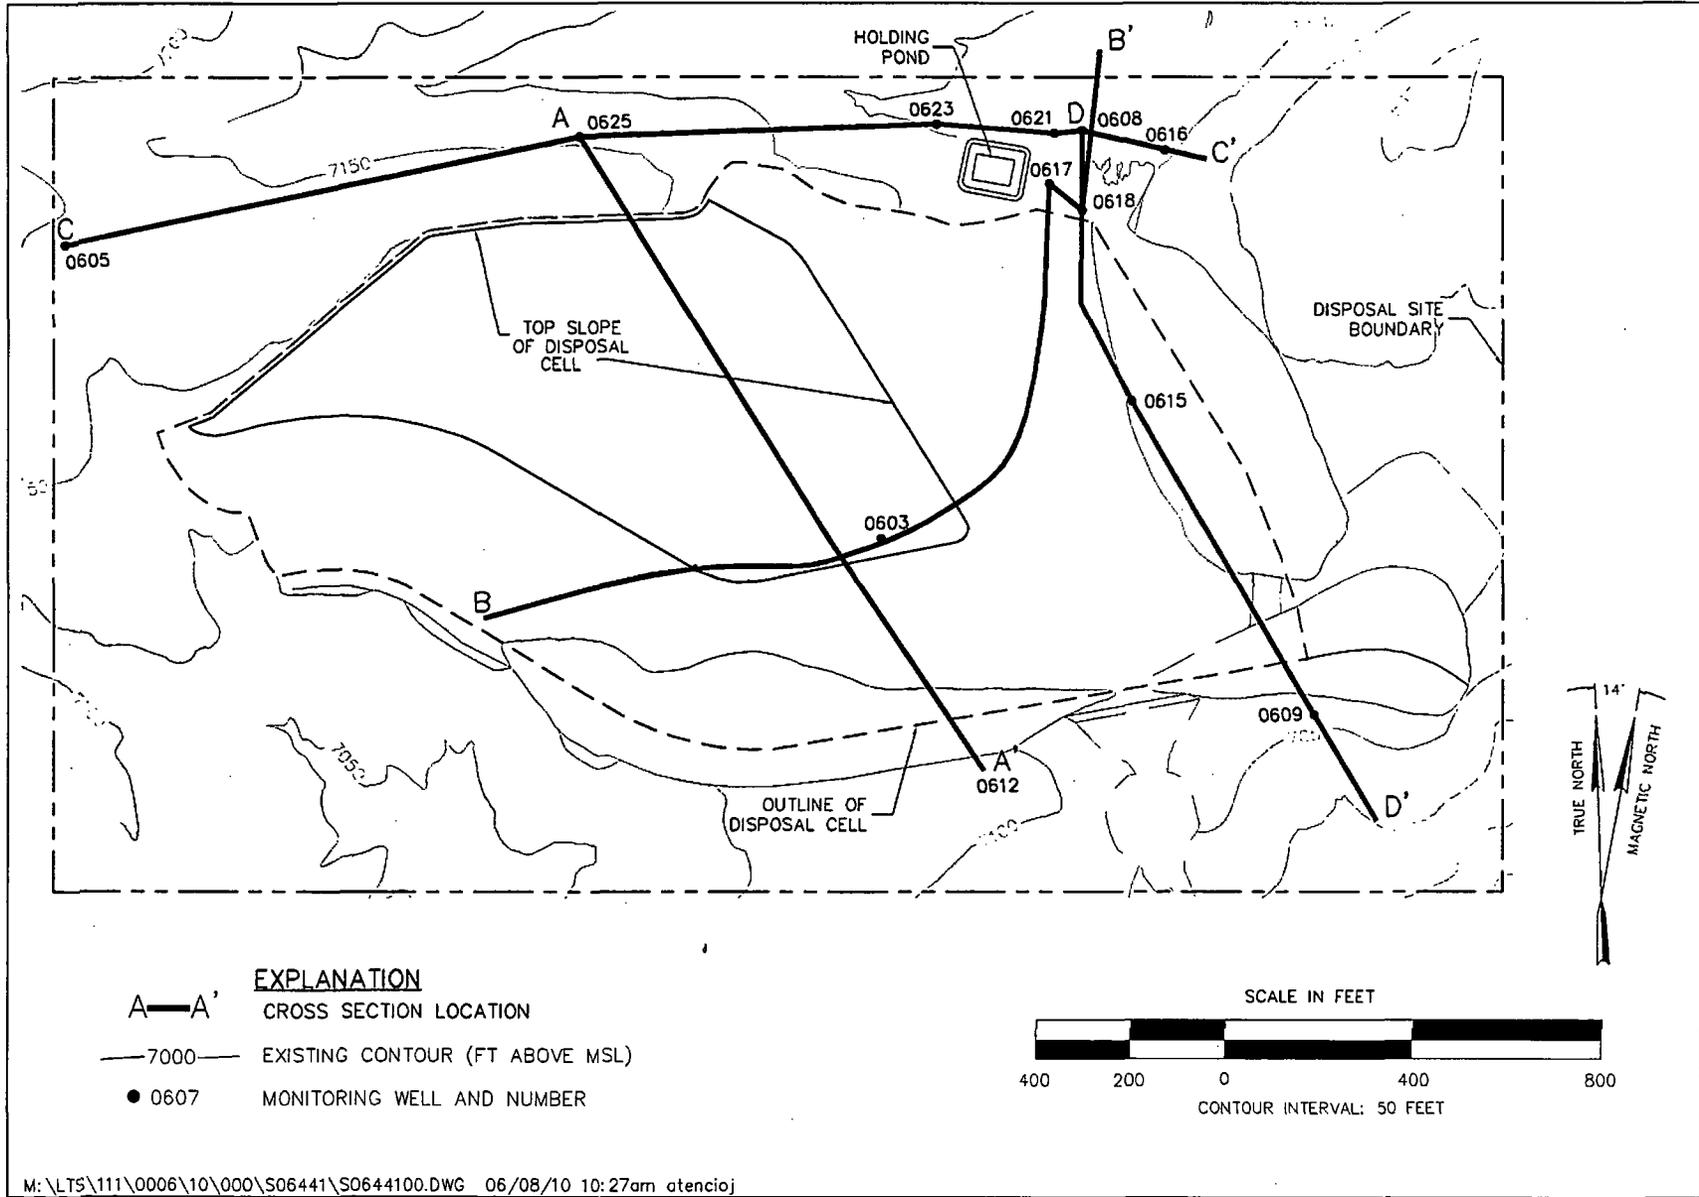
Figure 2-10. Locations of Monitoring Wells and Cross Sections, Durango, Colorado, Disposal Site

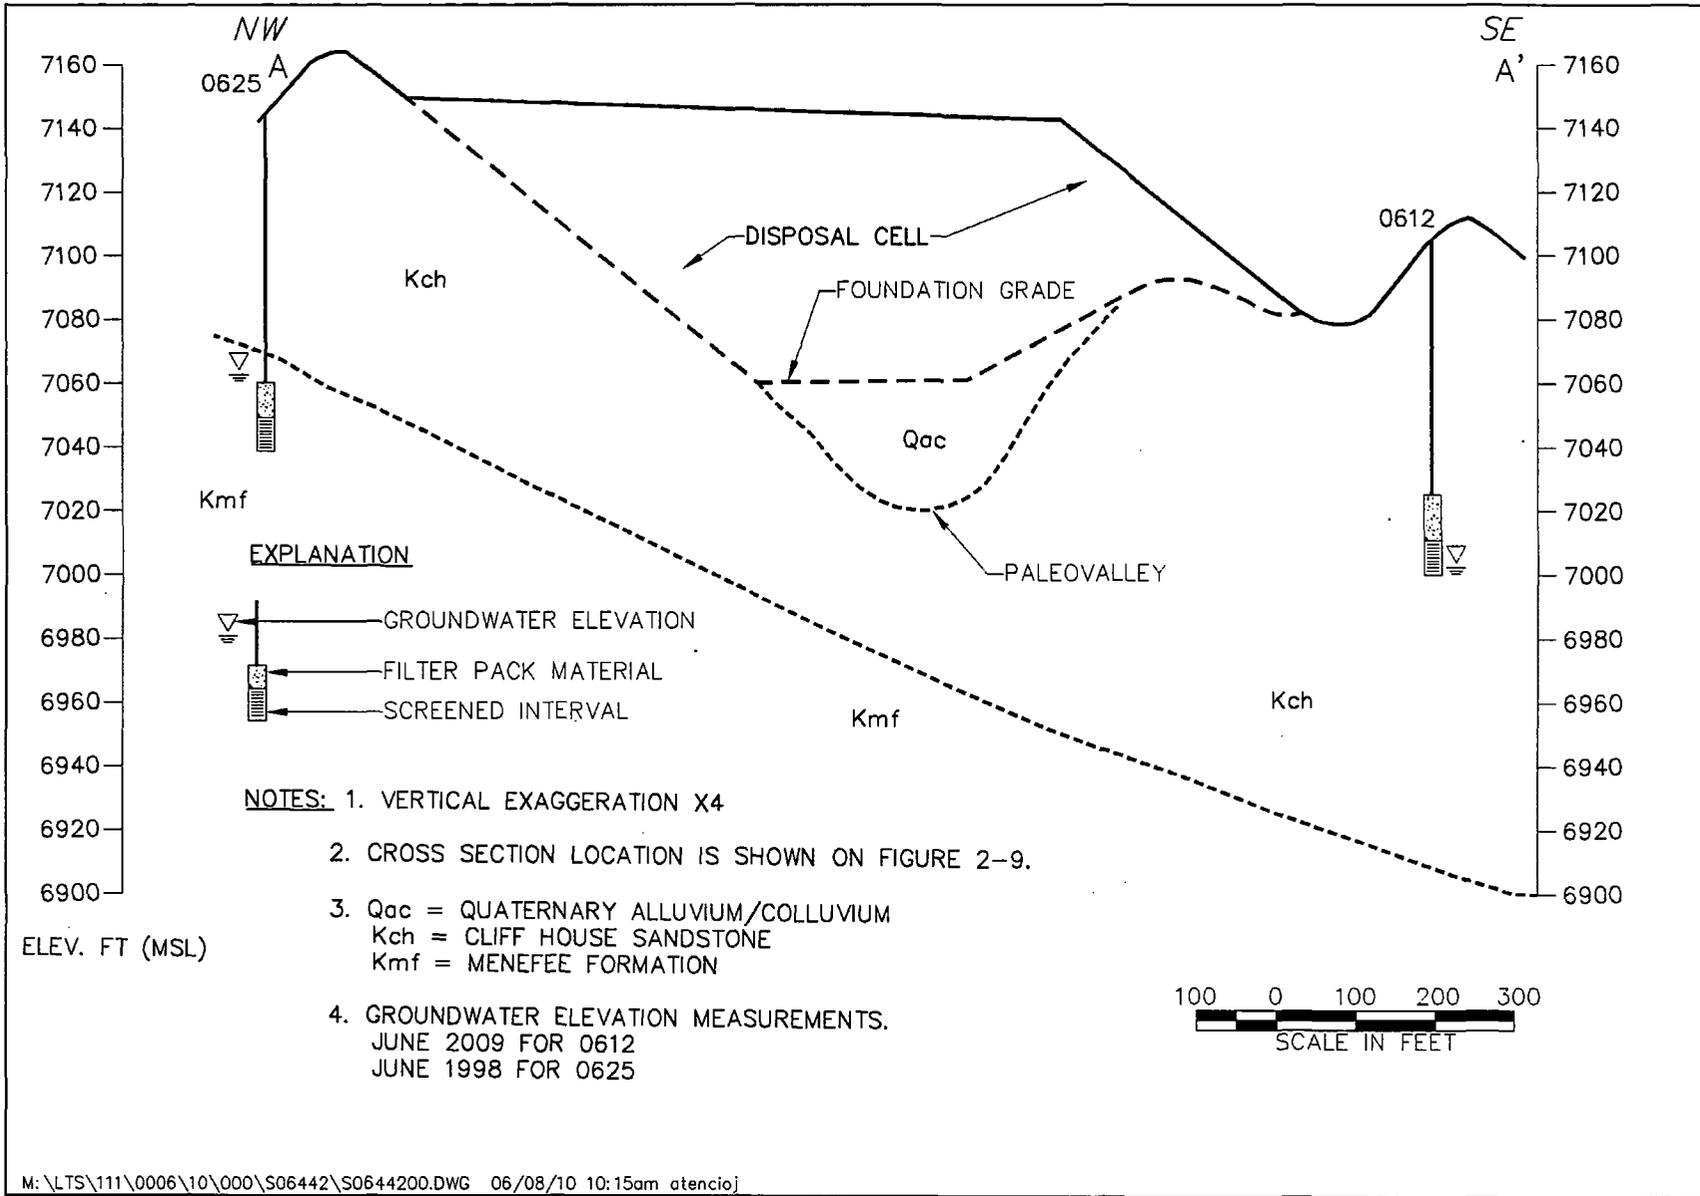
Figure 2-11. Cross Section A-A', Durango, Colorado, Disposal Site

Based on lithologic differences, the Cliff House Sandstone may be roughly divided into two informal units, lower and upper, which are approximately the same thickness. The lower unit consists mainly of interbedded siltstone and sandstone beds that range up to 3 ft (1 m) in thickness. The ridge just north of the disposal cell is supported by resistant sandstone beds in the lower unit (Figure 2-11). The upper unit contains more shale beds and fewer and thinner sandstone beds than the lower unit. Less resistant than the lower unit, beds of sandy siltstone in the upper unit support the ridge just south of the disposal cell (Figure 2-11).

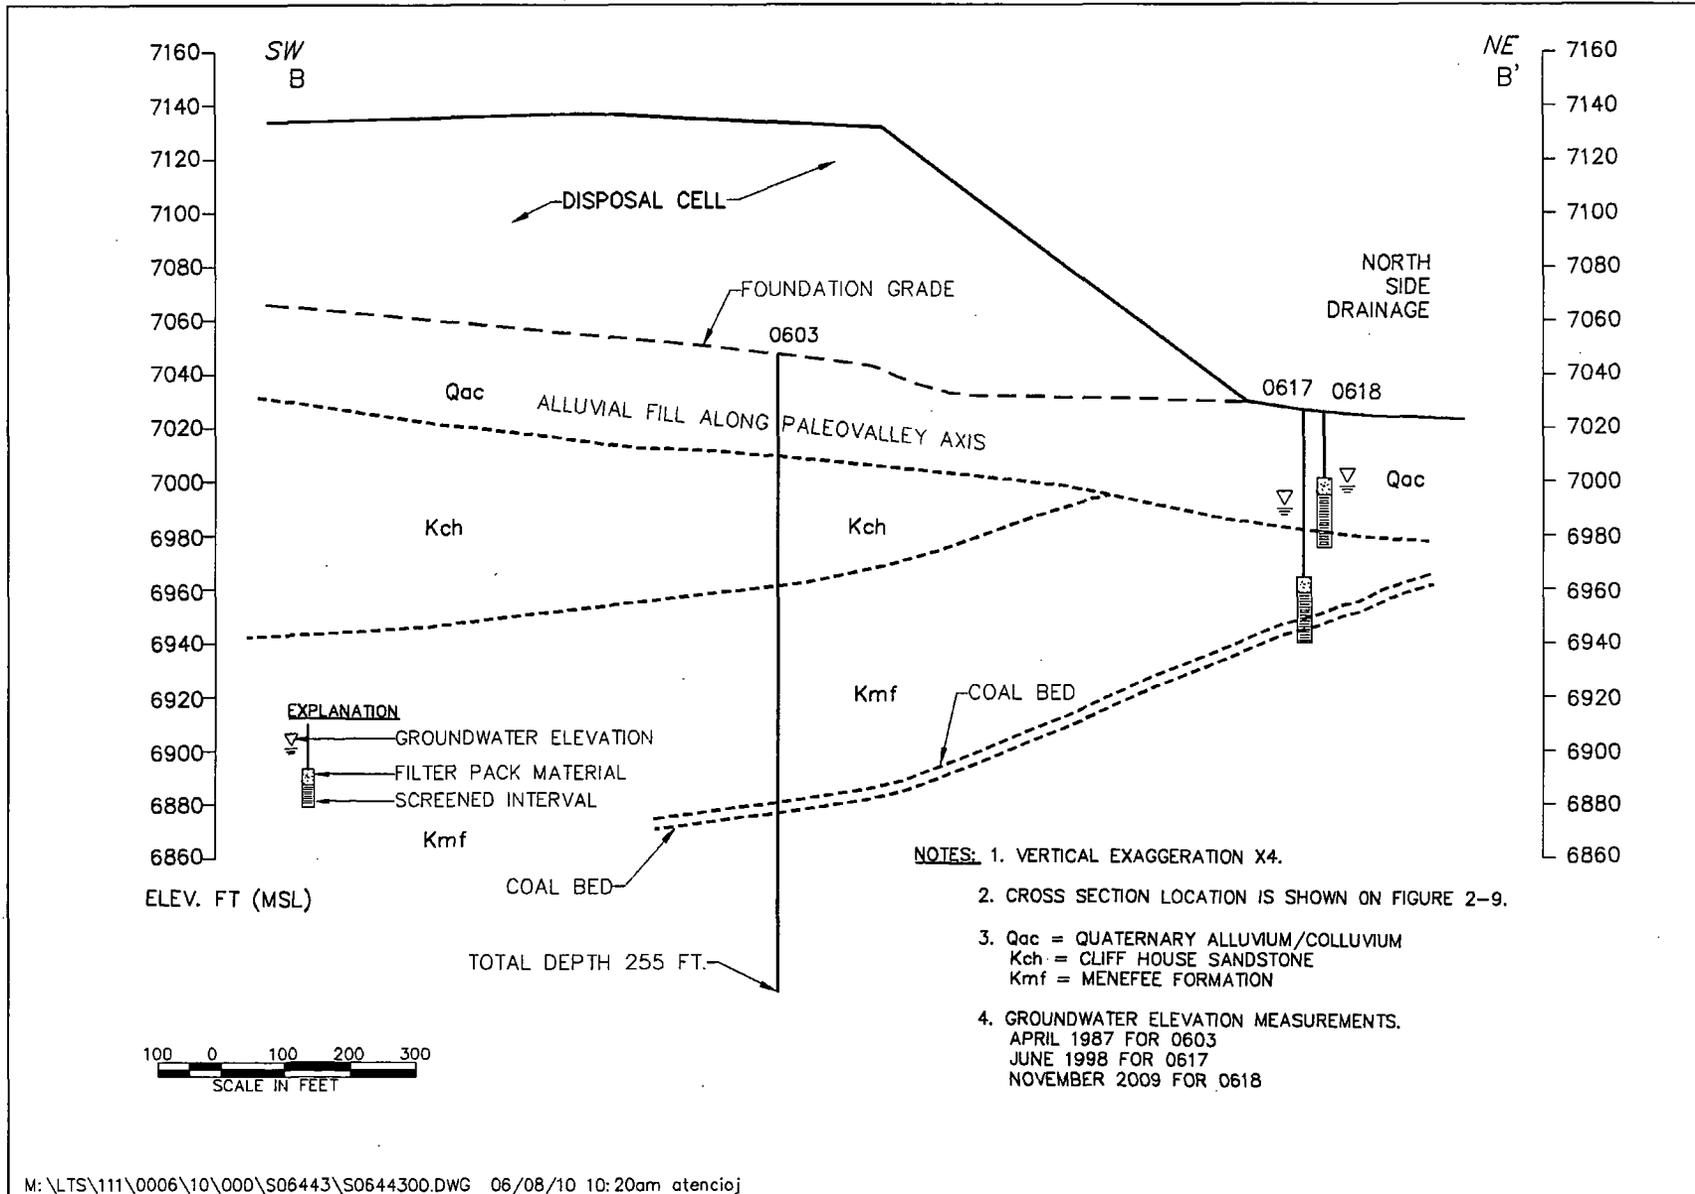
Figure 2-12. Cross Section B-B', Durango, Colorado, Disposal Site
