# Long-Term Surveillance Plan for the Durango Disposal Site, Durango, Colorado

January 2011

Legacy  
Management

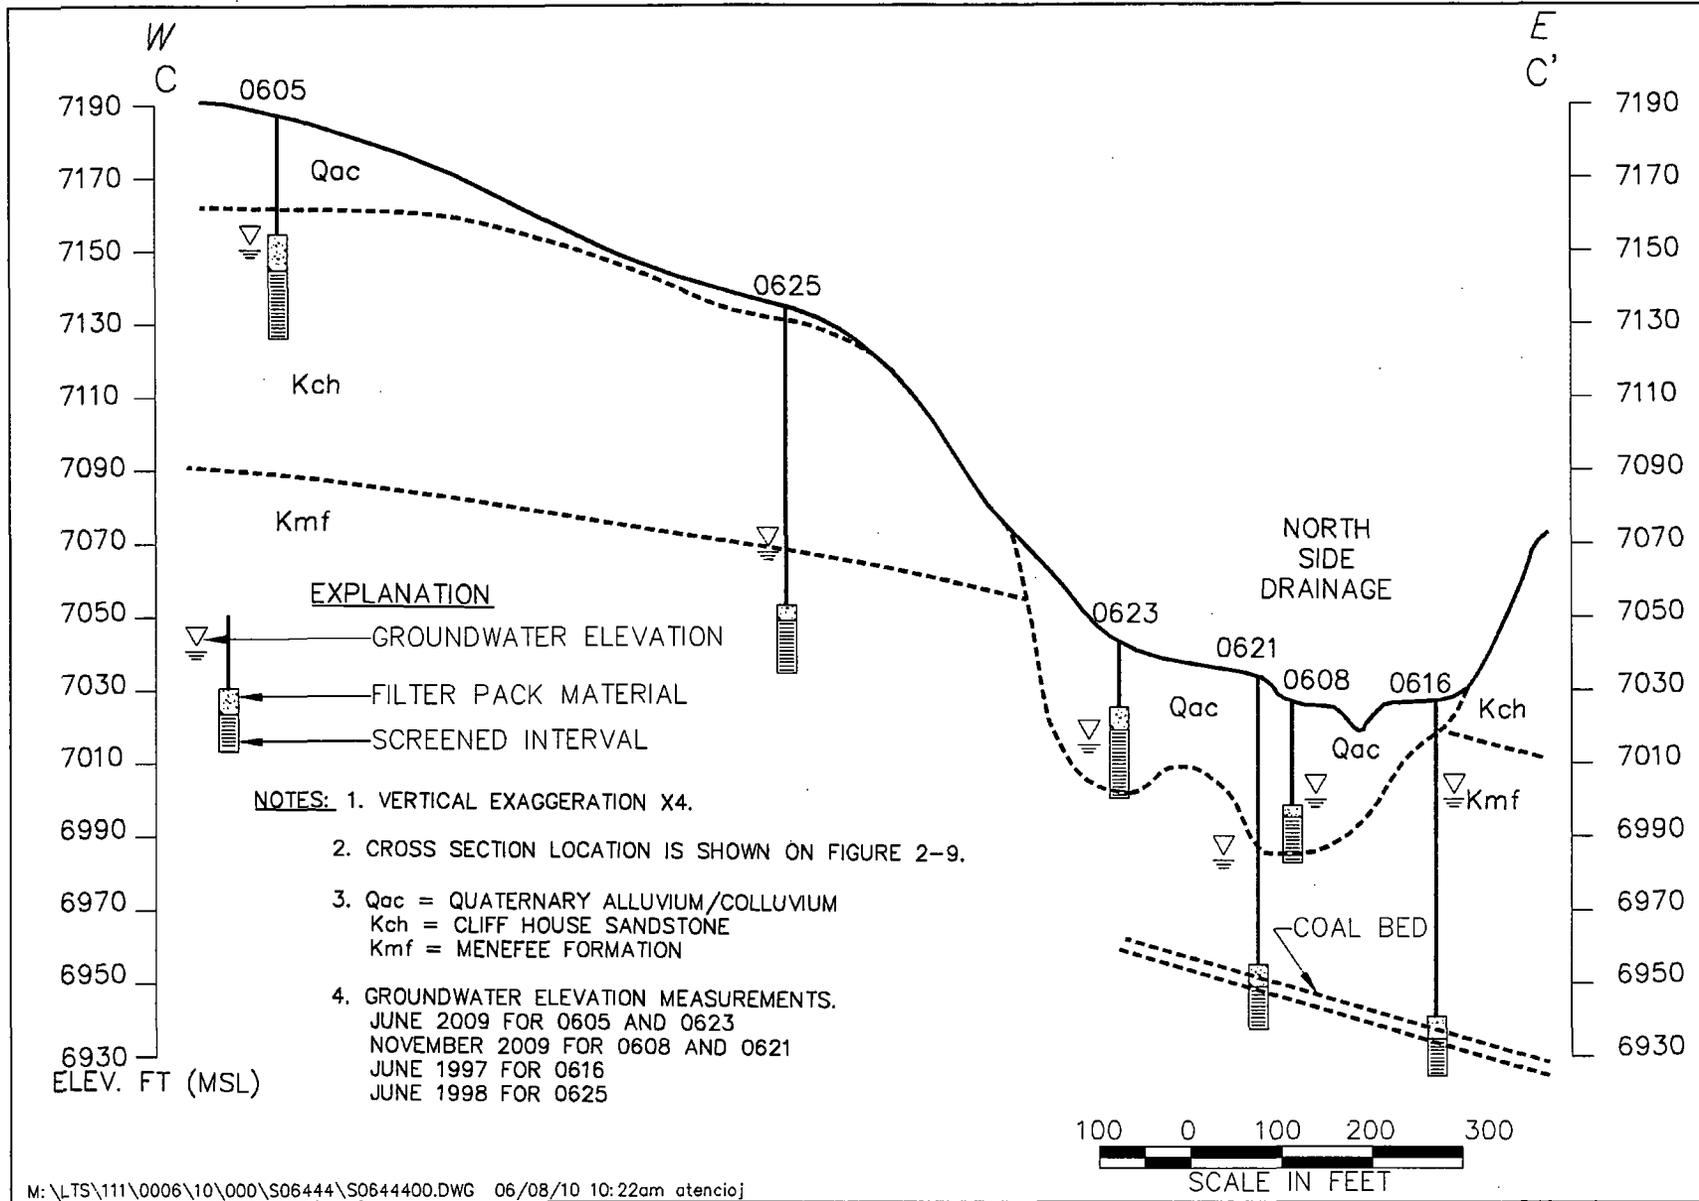
Figure 2-13. Cross Section C-C', Durango, Colorado, Disposal Site

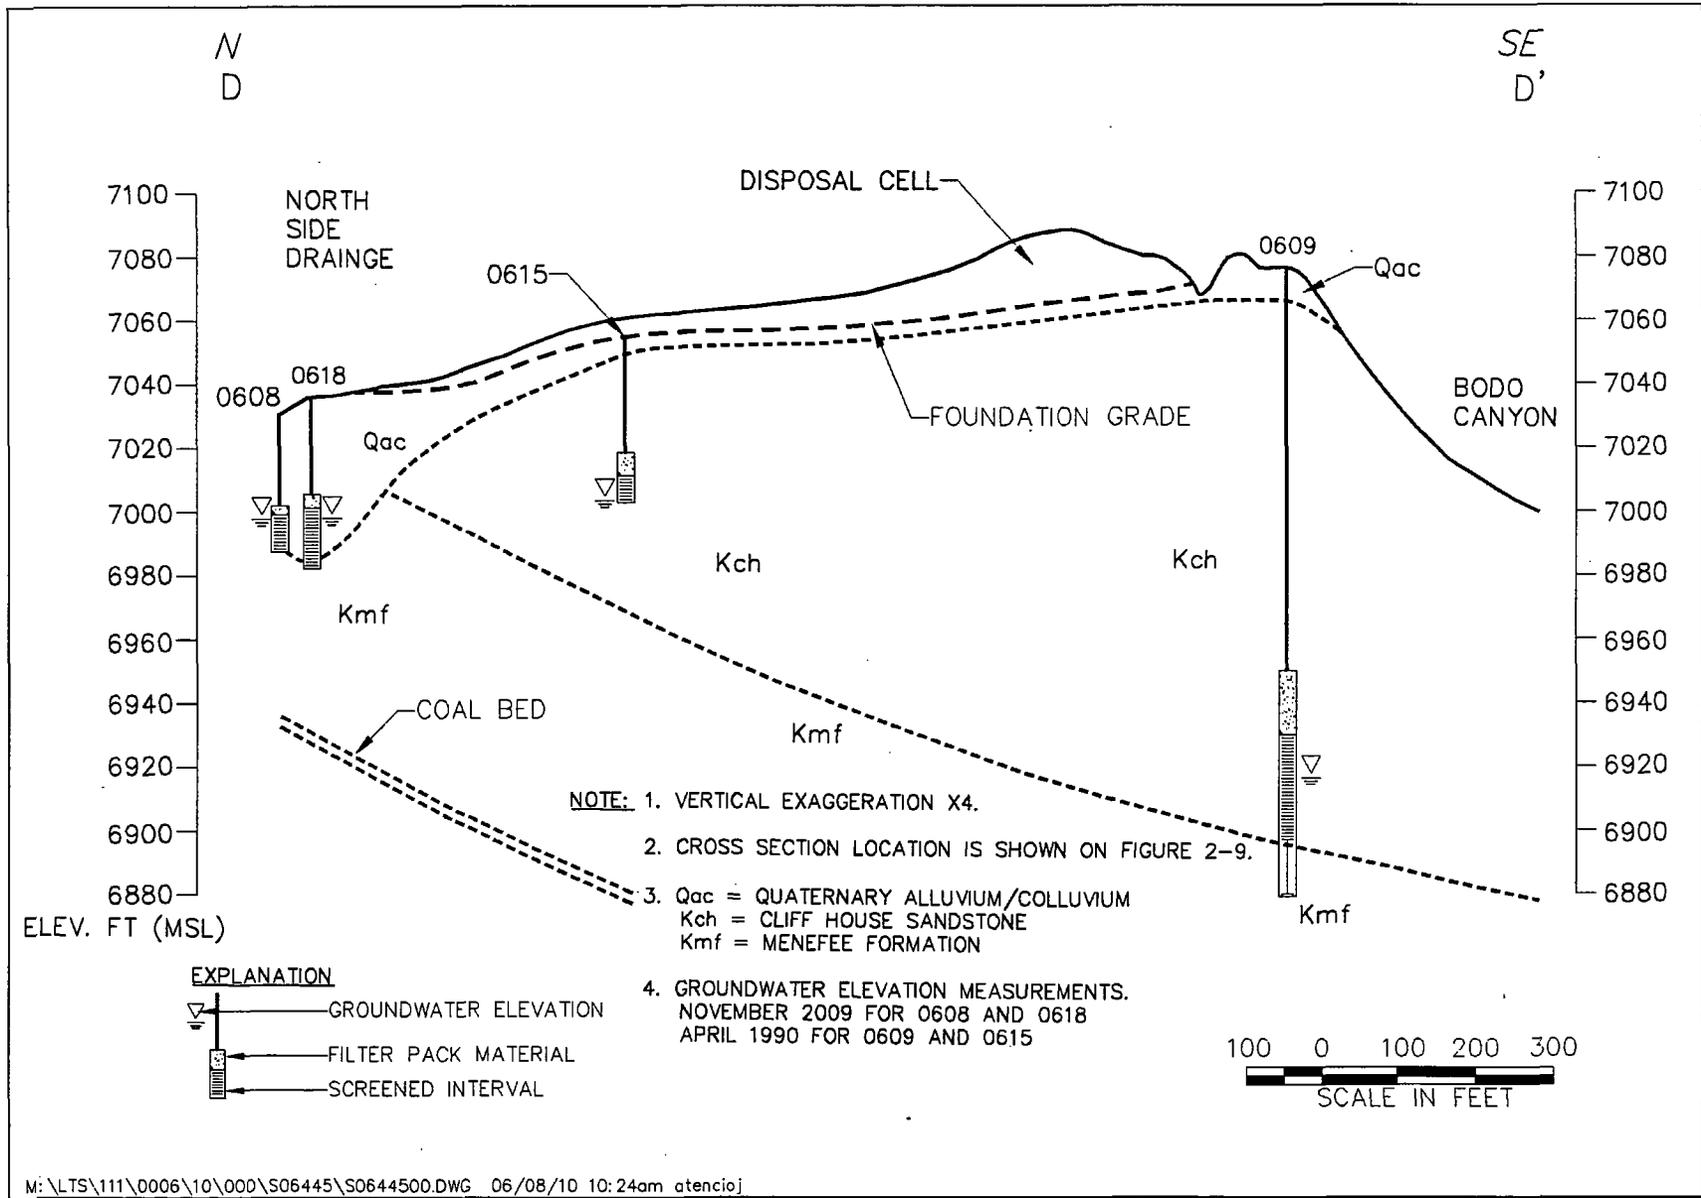
Figure 2-14. Cross Section D-D', Durango, Colorado, Disposal Site

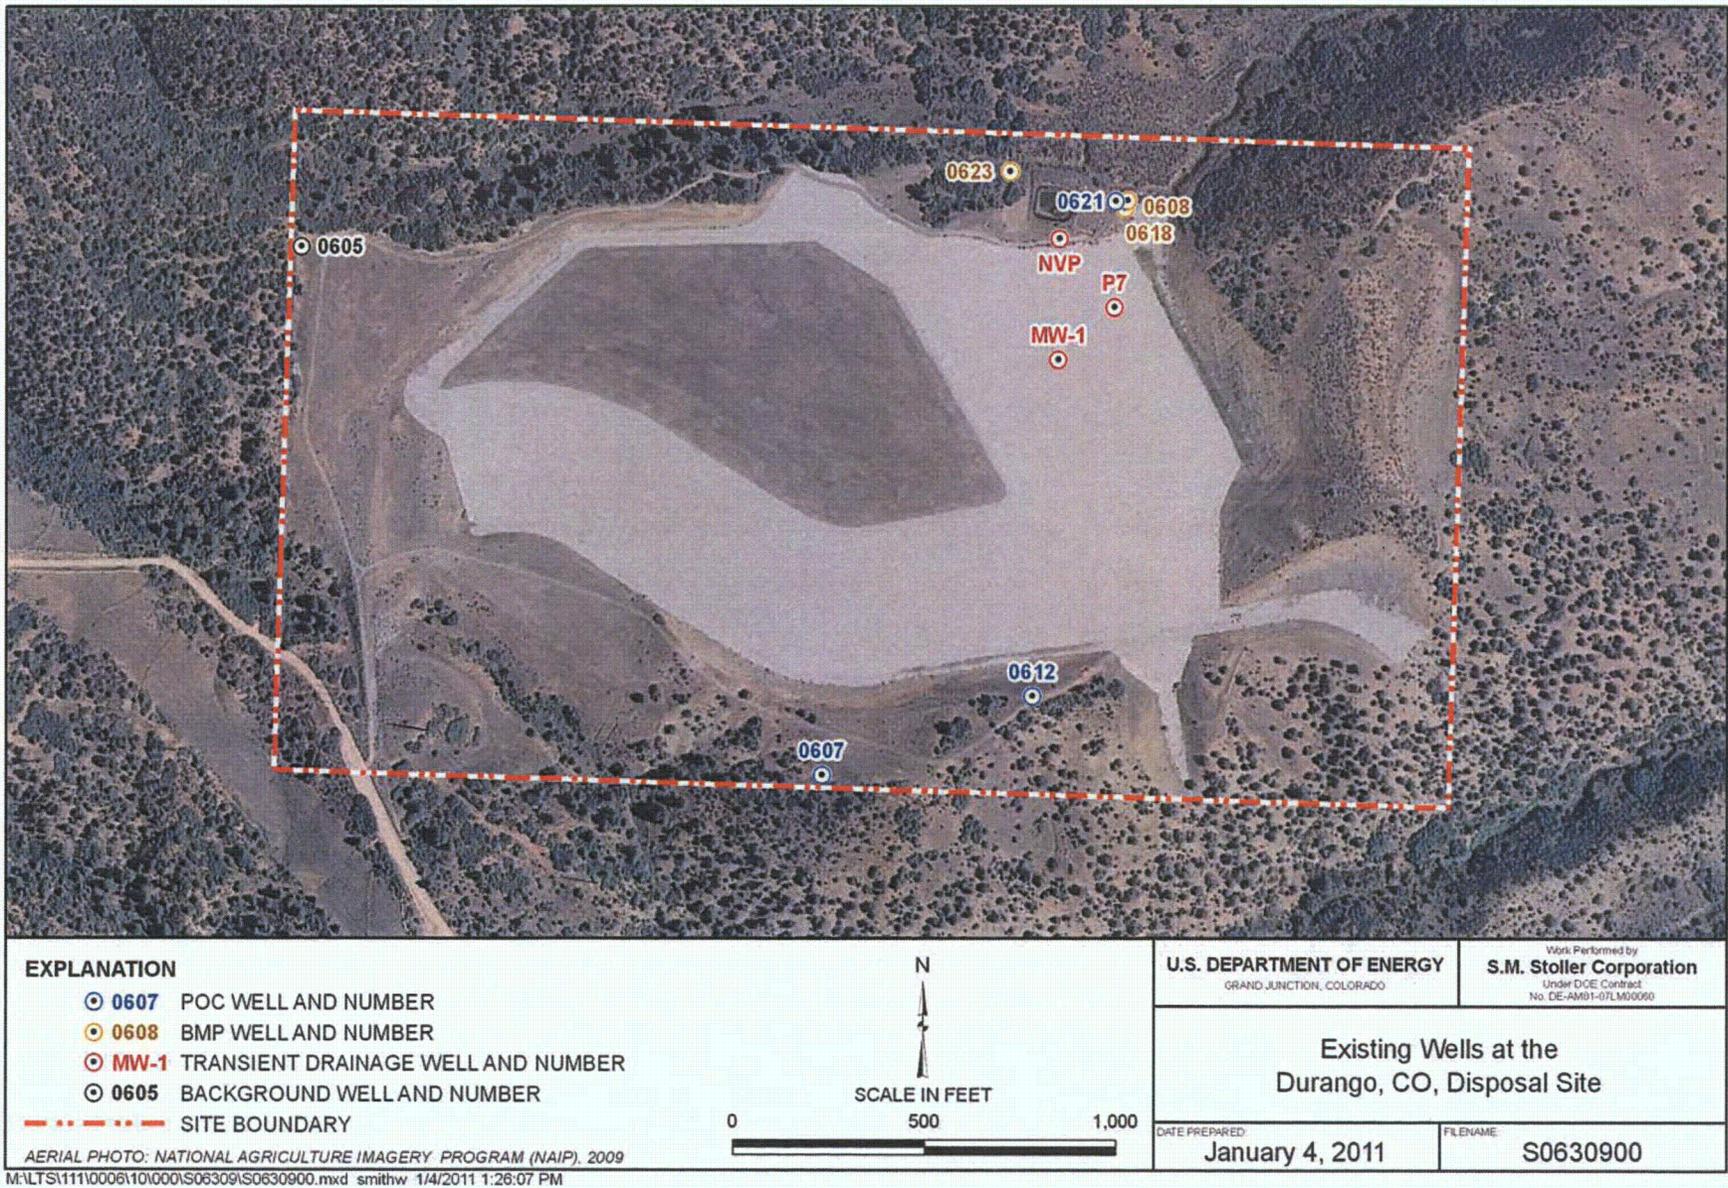
Figure 3-1. Existing Wells at the Durango, Colorado, Disposal Site

Groundwater is monitored at the Durango disposal site to verify the initial performance of the disposal cell. The monitoring network consists of seven wells (Table 3-4 and Figure 3-1). Four wells are completed in the uppermost aquifer (bedrock of the Cliff House Sandstone and the Menefee Formation), including one upgradient background well (0605) and three downgradient point-of-compliance wells (0607, 0612, and 0621). Wells 0607 and 0612 are downdip of the disposal cell in the direction of bedrock groundwater flow. Well 0621 is installed in the bedrock in the vicinity of the paleochannel alluvium in the direction of surface water flow. It monitors bedrock that could be affected by infiltration of groundwater from the alluvium.
