**UNITED STATES OF AMERICA**  
**NUCLEAR REGULATORY COMMISSION**  
**BEFORE THE ATOMIC SAFETY AND LICENSING BOARD**

Pilgrim Nuclear Power Station

License Renewal Application

**Pilgrim Watch Reply to Entergy's and the NRC Staff's Oppositions to  
Pilgrim Watch's Request for Hearing on a New Contention.**

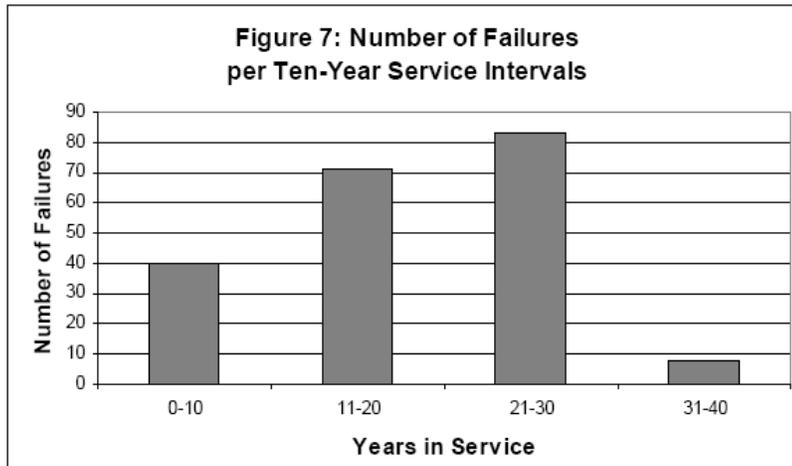
¶60. As said earlier, It may appear that the number of failure decreases after 30 years, but this is misleading. Very few plants have been operating for more than 30 years; and the number of failures per plants of various age is not stated. There is no reason to suspect that the likelihood of failure will magically decrease after age 30 unless NRC assures the requirements of 10 CFR 50.49 are put in place. It is recognized that many inaccessible cables are being subjected to design basis events that include conditions of normal operation defined by 10 CFR 50.49. (Blanch Decl., 48 )

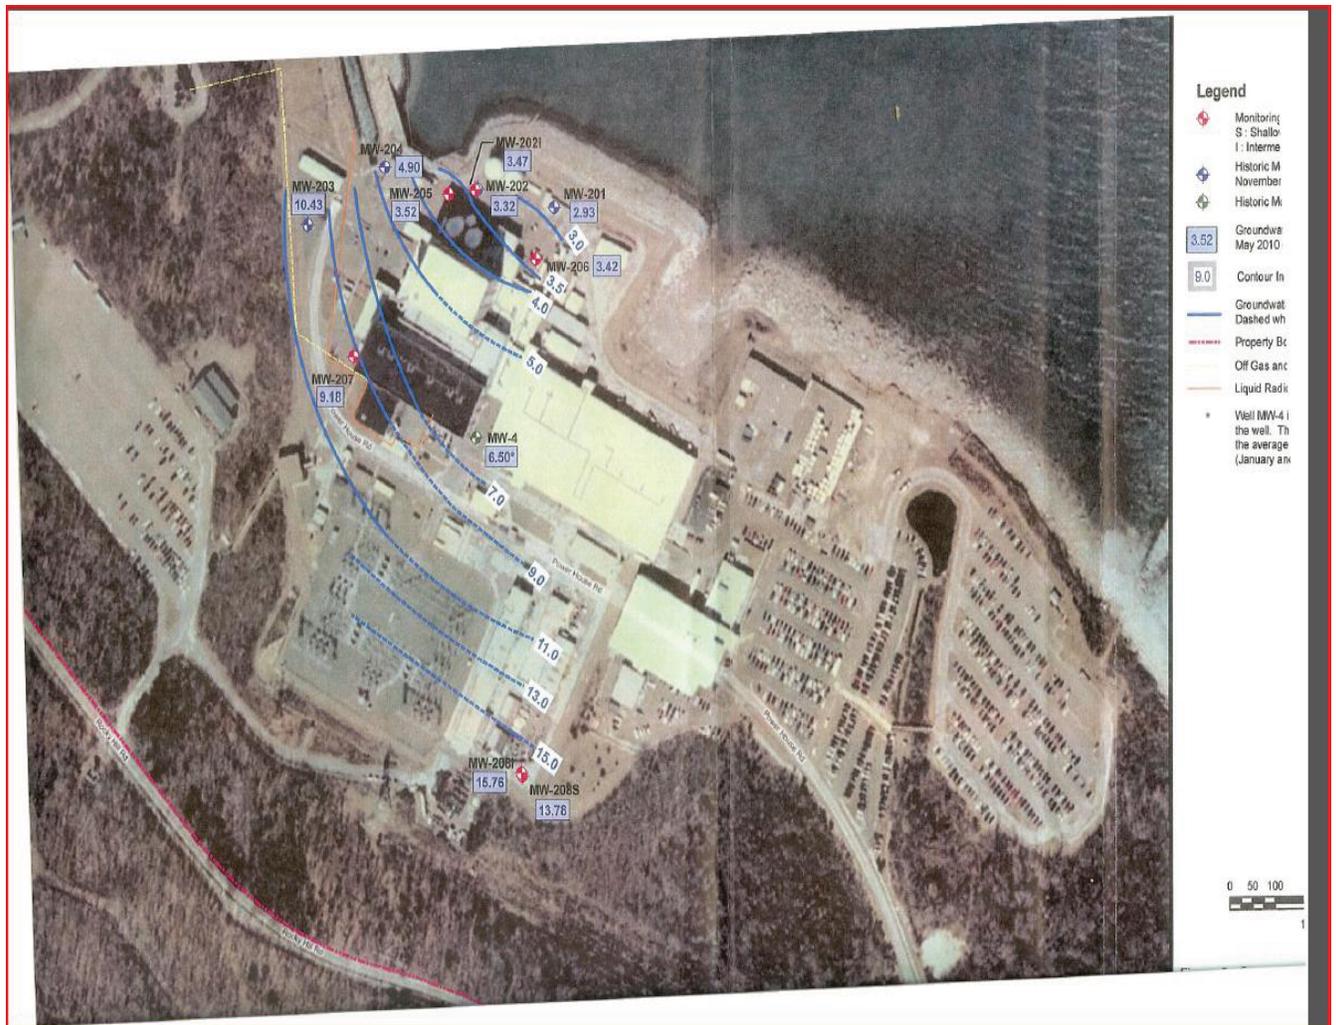
Consistent with U.S. Coast Geological Survey maps, Entergy’s document shows that near the Bay the constour line is 3.5 feet; proximate to the main reactor building, 7-9 feet; and up the hill to Rocky Hill Road distant from PNPS’ site structures, the lines range from 13-15 feet.

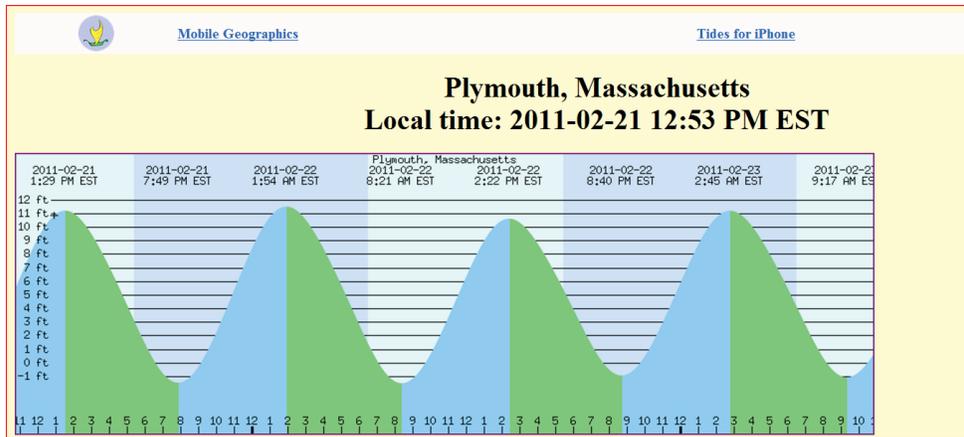
Entergy’s ERM Report (November 1, 2010 4.0 Key Findings, 29) said that with one exception that, “all wells monitored exhibit changes in groundwater elevation that reflect the effects of tidal fluctuations. In general, the amplitude of the elevation fluctuation at each well decreases with distance from the shoreline.

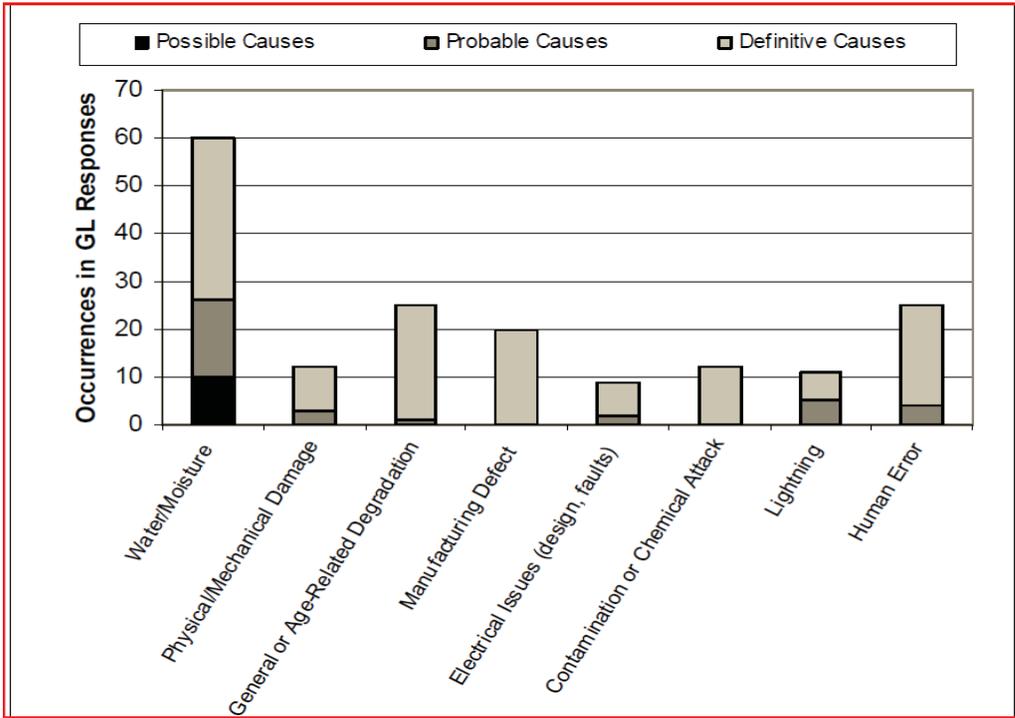
**Figure 22: Causes and Causal Factors for All Cable Failures**

Although water and aging are the top factors causing degradation impurities can play a contributing role. For example, Generic Letter 2007-01, “Inaccessible or Underground Power Cable Failures That Disable Accident Mitigation Systems or Cause Plant Transients”: Summary Report (MI082760385) asked licensees to identify causes of cable failures. Figure 22 summarizes their findings.

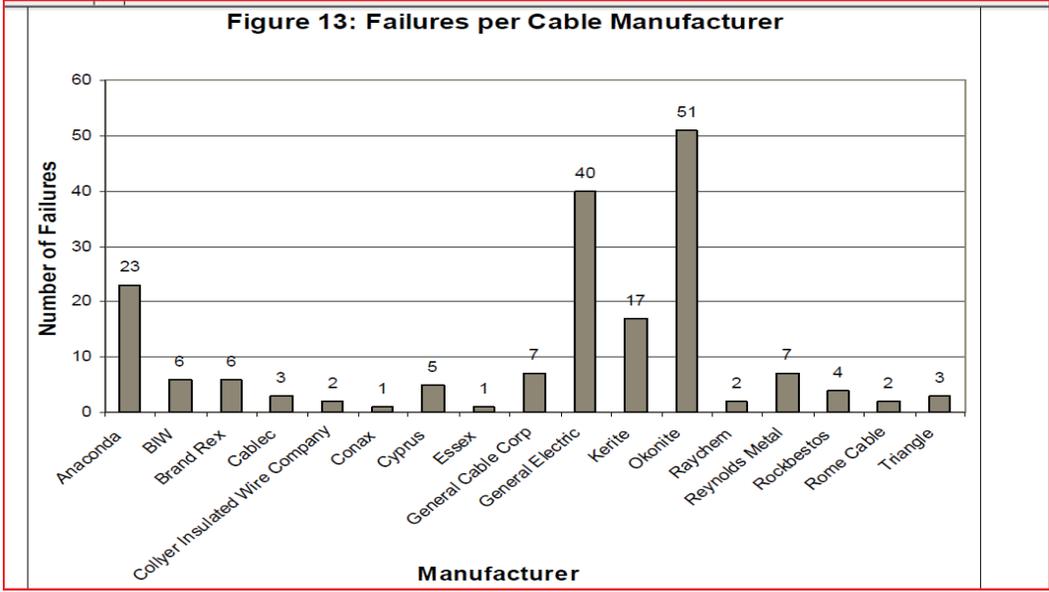
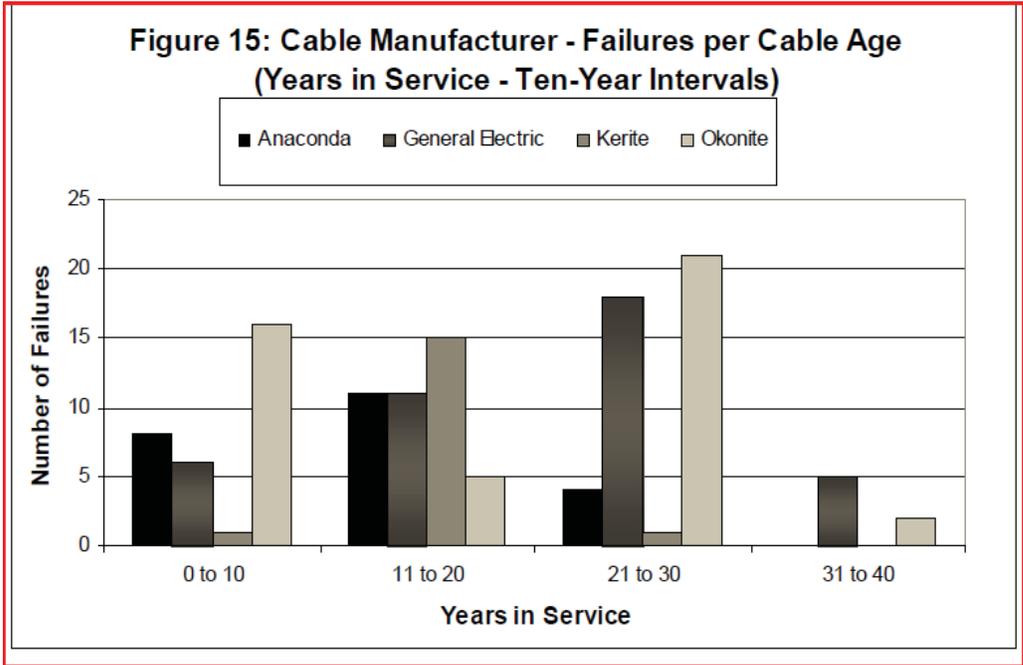
<sup>19</sup> The GL asked licensees to identify the manufacturers of the failed cables. The relative percentage of cables from a given manufacturer that experienced failures is unknown. Thus, if one manufacturer had twice as many failures as the next higher example but had 10 times the total cable-feet of exposure, a report of the raw number of failures by manufacturer may be misleading. In this context, the following figures show the number of cable failures per cable manufacturer. Licensees did not identify the manufacturer for 89 of the cable failures. This number includes cables for which the licensee provided a list of possible manufacturers of the cables. From these data, the NRR staff noted that a variety of manufacturers’ cables were susceptible to failure. Figure 13 shows that **Anaconda, General Electric, Kerite, and Okonite cables appeared to have the most failures;** however, as stated above, the relative percentage of cables from a given manufacturer that experienced failures is unknown. The data in Figures 14 and 15 show that

the majority of failures of these manufacturers' cables appears to be occurring in the range of 11 to 30 years of service, although there was some inconsistency among manufacturers.
