UNITED STATES OF AMERICA
NUCLEAR REGULATORY COMMISSION
BEFORE THE ATOMIC SAFETY AND LICENSING BOARD

Pilgrim Nuclear Power Station

License Renewal Application

**Pilgrim Watch Reply to Entergy's and the NRC Staff's Oppositions to
Pilgrim Watch's Request for Hearing on a New Contention.**

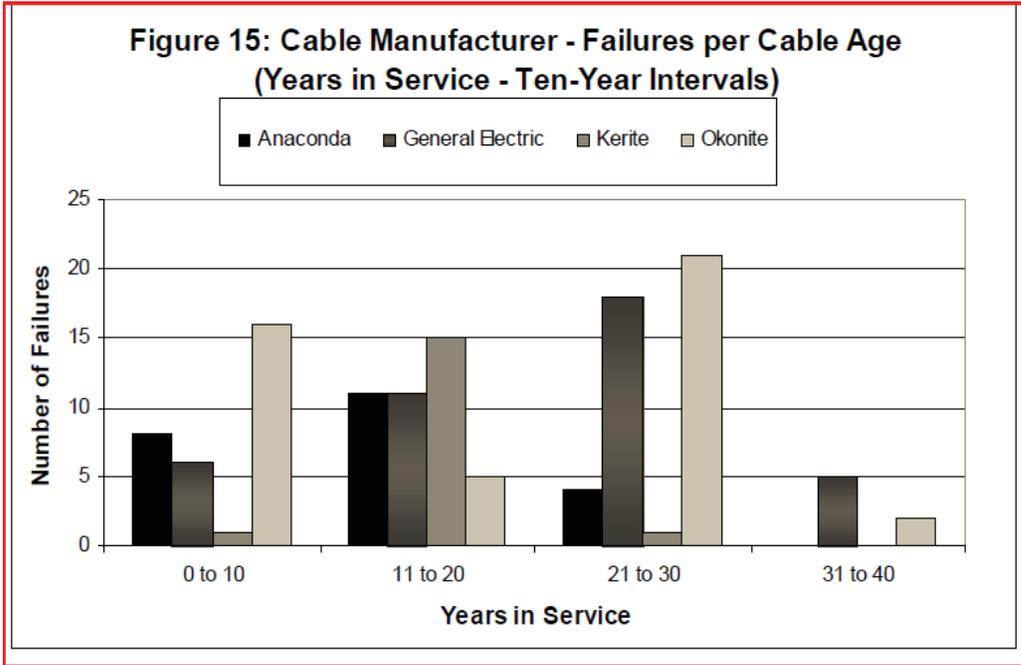
¹⁹ The GL asked licensees to identify the manufacturers of the failed cables. The relative percentage of cables from a given manufacturer that experienced failures is unknown. Thus, if one manufacturer had twice as many failures as the next higher example but had 10 times the total cable-feet of exposure, a report of the raw number of failures by manufacturer may be misleading. In this context, the following figures show the number of cable failures per cable manufacturer. Licensees did not identify the manufacturer for 89 of the cable failures. This number includes cables for which the licensee provided a list of possible manufacturers of the cables. From these data, the NRR staff noted that a variety of manufacturers’ cables were susceptible to failure. Figure 13 shows that **Anaconda, General Electric, Kerite, and Okonite cables appeared to have the most failures;** however, as stated above, the relative percentage of cables from a given manufacturer that experienced failures is unknown. The data in Figures 14 and 15 show that

the majority of failures of these manufacturers' cables appears to be occurring in the range of 11 to 30 years of service, although there was some inconsistency among manufacturers.

Pilgrim Watch finds Entergy’s claims truly remarkable. Based on Generic Letter 2007-01, “Inaccessible Or Underground Power Cable Failures That Disable Accident Mitigation Systems Or Cause Plant Transients”: Summary Report (M1082760385) that summarized the number of failures per cable manufacturer and found that Kerite were among the top four cables to have the most failures, Figure 13; and the data in Figures 14 and 15 show that the majority of failures of these manufacturers’ cables appears to be occurring in the range of 11 to 30 years of service, although there was some inconsistency among manufacturers.¹⁹
