Omaha Public Power District

Subject: Licensee Event Report 2011-005, Revision 0, for the Fort Calhoun Station

LICENSEE EVENT REPORT (LER)

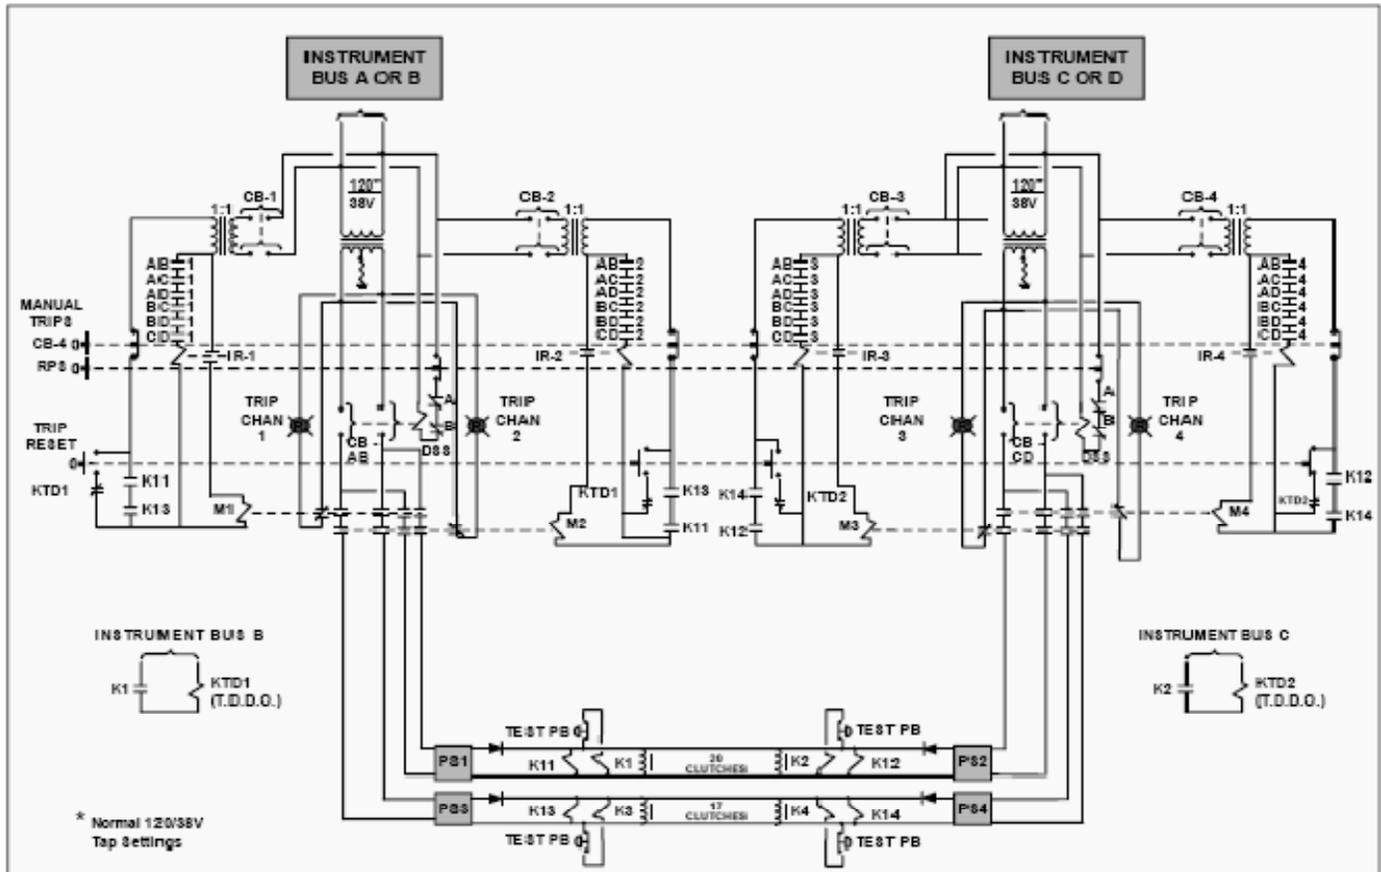
RPS TRIP PATHS

The Fort Calhoun Station (FCS) Reactor Protective System (RPS) is designed to rapidly shut down the nuclear chain reaction prior to reaching a condition that could damage the reactor core. The RPS generates a reactor trip signal, which releases the control element assemblies and allows the control rods to fall into the core. The Diverse Scram System (DSS) is a backup system, which augments the RPS by using diverse, independent components to initiate a reactor trip on high pressure in the Reactor Coolant System (RCS). The RPS continuously monitors critical parameters and compares them to setpoints to ensure that design limits are not exceeded.

The Diverse Scram System (DSS) provides the design function of augmenting the RPS. Should an anticipated operational occurrence result in the over pressurization of the Reactor Coolant System, and the reactor fail to trip, the DSS functions to trip the reactor.

On June 14, 2010, the reactor protective system (RPS) M2 contactor (similar to the RPS breakers) failed to open during periodic surveillance testing. Operations declared the RPS M2 contactor inoperable and entered Technical Specification (TS) Limiting Condition for Operation (LCO) action 2.15(1) because the RPS M2 contactor did not have a specifically defined LCO. Subsequent reviews determined that the station continued to operate in a condition not allowed by TS on June 14 and 15 for a period of approximately 20.5 hours. TS 2.0.1 should have been invoked. (Section 2.0.1, similar to standard TS 3.0.3.)

On June 14, 2010, the RPS M2 contactor failed to open during periodic surveillance testing. Operations declared the RPS M2 contactor inoperable, and entered Technical Specification (TS) Limiting Condition for Operation (LCO) action 2.15(1), because the RPS M2 contactor did not have a clearly defined LCO.
