**IOEB Analysis Team Study on Recent Operating Experience  
Ineffective Use of Vendor Technical Recommendations**  
(public version)

**Summary:**

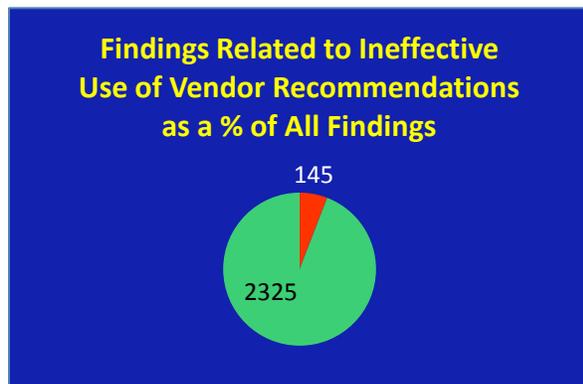
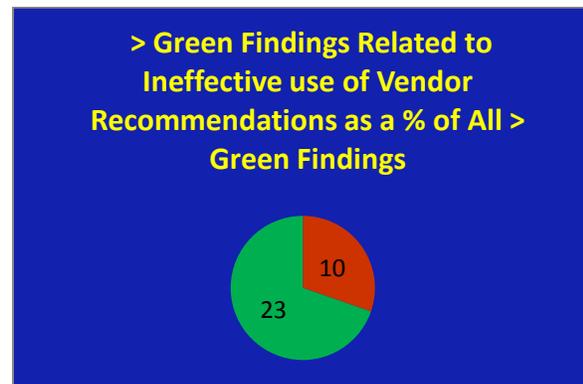
In an effort to categorize and trend the performance deficiencies and related findings that were considered, the staff observed the following characteristics of failures from the inspection data:

- Ineffective use of vendor recommendations has caused or contributed to the complexity of reactor trips/transients and failures in safety-related components,
- Their numbers appear to be relatively consistent in frequency and in severity,
- They are not limited to any particular component, system, or reactor type,
- They are typically accompanied by a cross cutting aspect,
- They have caused or contributed to performance indicators crossing the green-white Operformance threshold, and
- They have occurred at plants with good over performance.
