AUGUST 1, 1973 MEETING WITH NORTHERN STATES POWER CORPORATION RE PRAIRIE ISLAND (50-282) AND WISCONSIN PUBLIC SERVICE CORPORATION RE KEWAUNEE (50-305)

The purpose of the meeting was to discuss the redesign of the main steam check and isolation valves for the Kewaunee plant and the Prairie Island plant. An attendance list is enclosed.

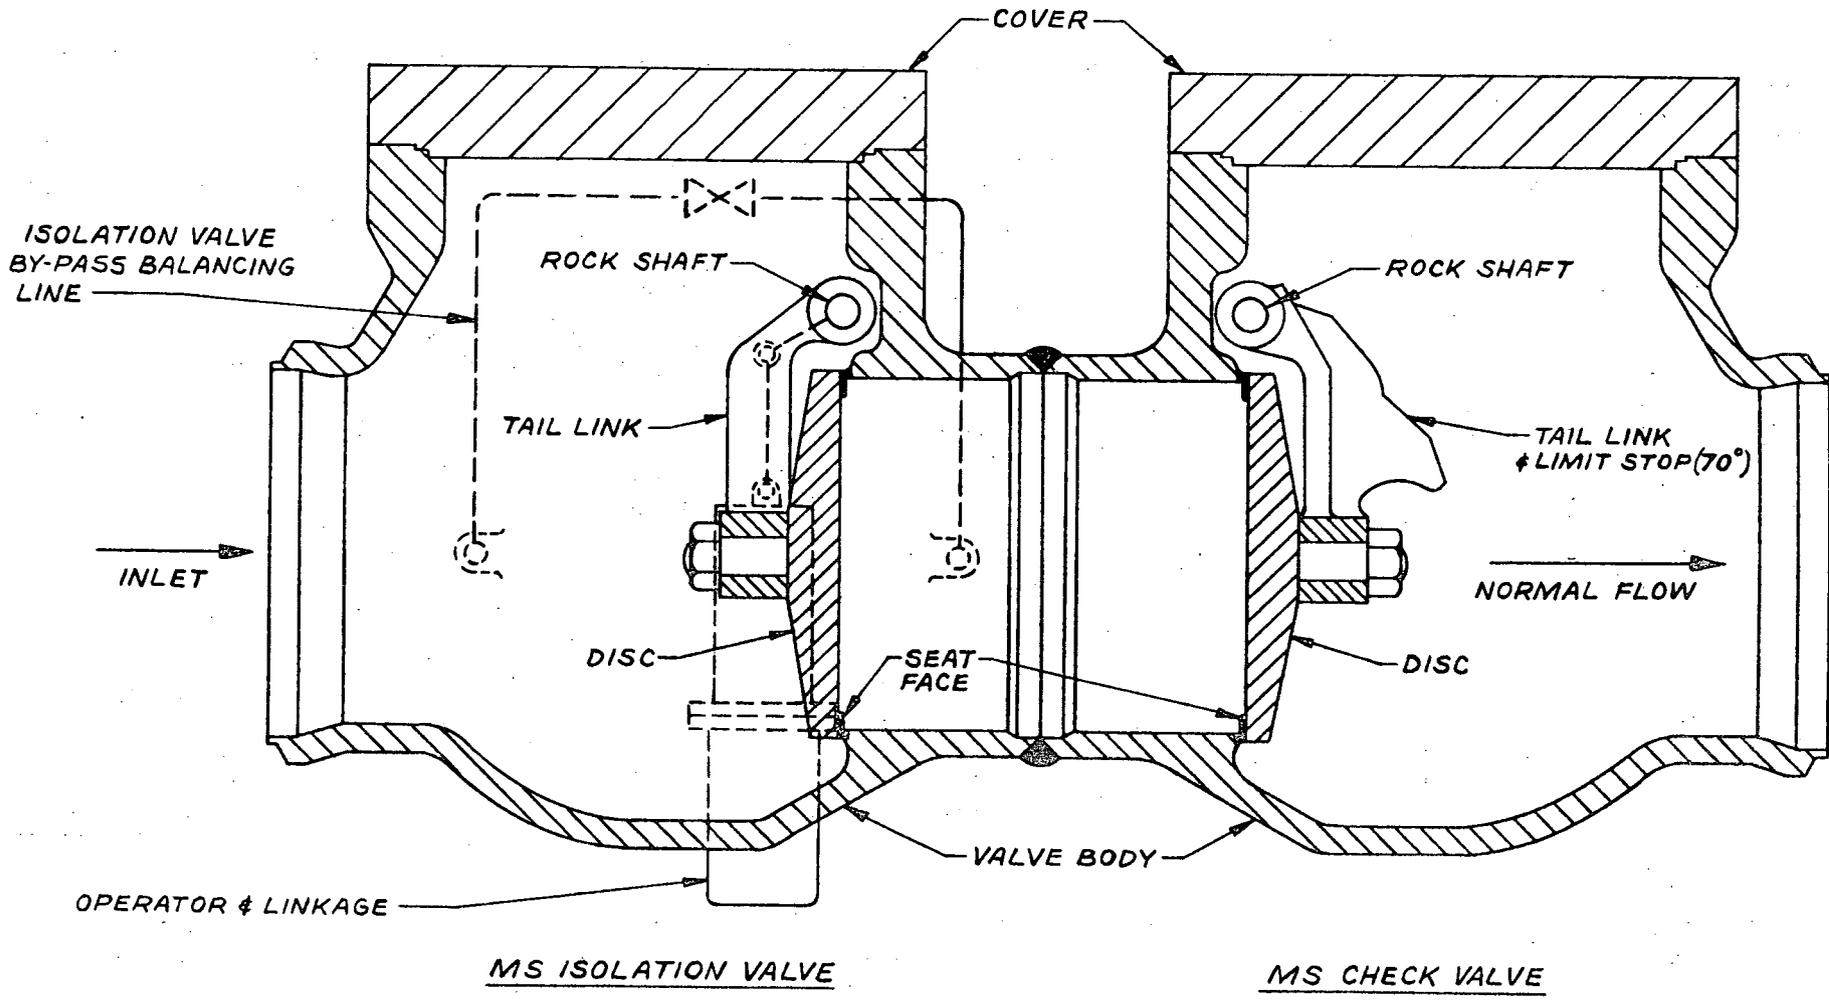
The main steam check and isolation valves for the Prairie Island plant and the Kewaunee plant are identical valves manufactured by Schutte Koerting. A sketch of the valve is enclosed. The redesign includes changing the material of the discs for both the isolation valve and the check valve from the 250 maraging steel used in the original design to 410 stainless steel used in the design of turbine stop valves. The original discs in the Kewaunee plant had been found to contain cracks after preoperational tests.

The maximum energy following pipe rupture was calculated to result in plastic deformation in the disc, tail link, body, and body seat and elastic deformation in the rock shaft and disc pin. A finite element stress analysis code was used in this analysis and a summary of results is presented in the enclosed table. Maximum strains were less than 50% of the ultimate strain. The maximum energy following a spurious closing at rated power was calculated to result in plastic deformation of a lesser amount in the disc, body and body seat and elastic deformation in the tail link, rock shaft and disc pin.
