**THE GREAT EAST JAPAN EARTHQUAKE
EXPERT MISSION**

**IAEA INTERNATIONAL FACT FINDING
EXPERT MISSION OF THE
FUKUSHIMA DAI-ICHI NPP ACCIDENT
FOLLOWING THE GREAT EAST JAPAN
EARTHQUAKE AND TSUNAMI**

**Tokyo, Fukushima Dai-ichi NPP, Fukushima Dai-ni NPP and
Tokai Dai-ni NPP, Japan**

24 May – 2 June 2011

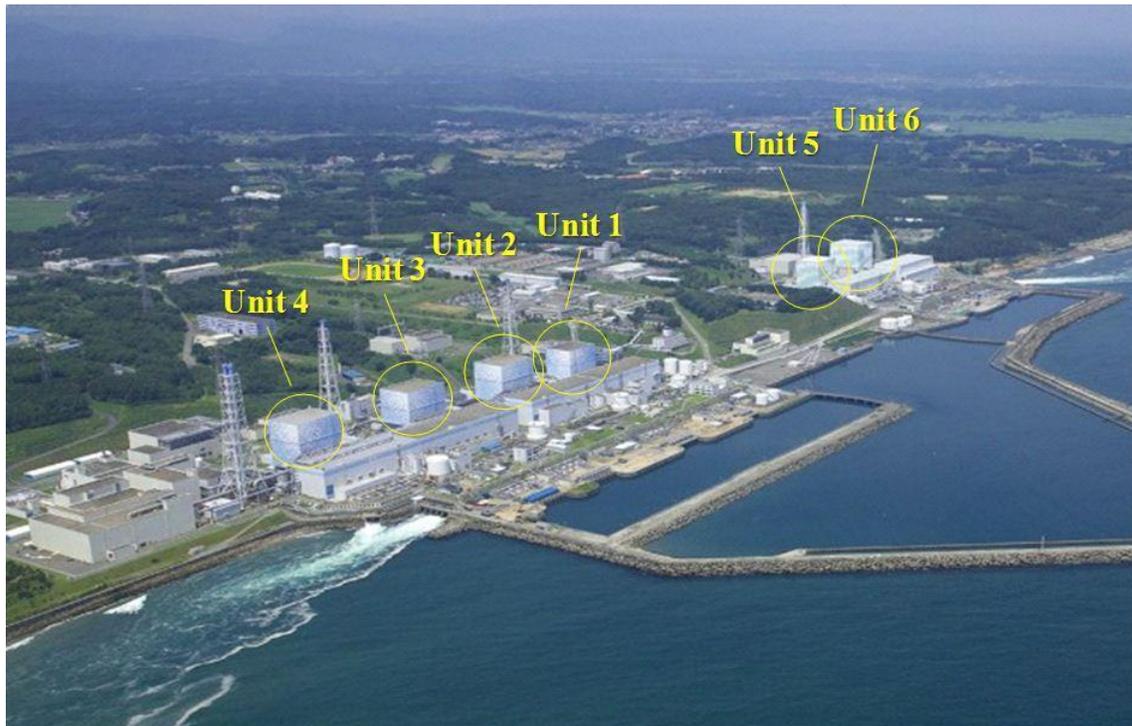
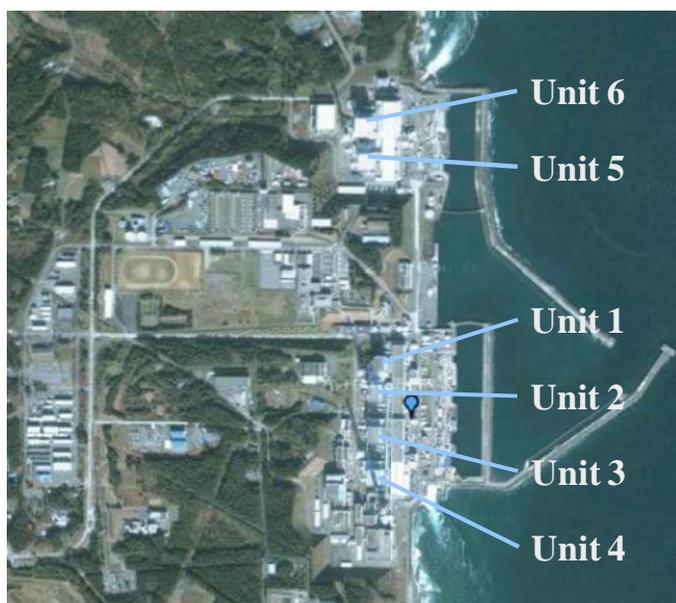
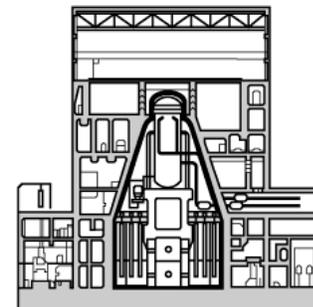
FIG. 1.2. Fukushima Dai-ichi NPP.

a) Pictorial view

**BWR Mark I (Unit 1~5)**

**BWR Mark II (Unit 6)**

b) Layout

Dai-ni site. Tokai Dai-ni has one operating BWR-5 unit of 1100 MW(e) capacity. Pictorial views of Fukushima Dai-ichi NPP, Fukushima Dai-ni NPP and Tokai Dai-ni NPP are given in Figs 1.2, 1.3 and 1.4 respectively.

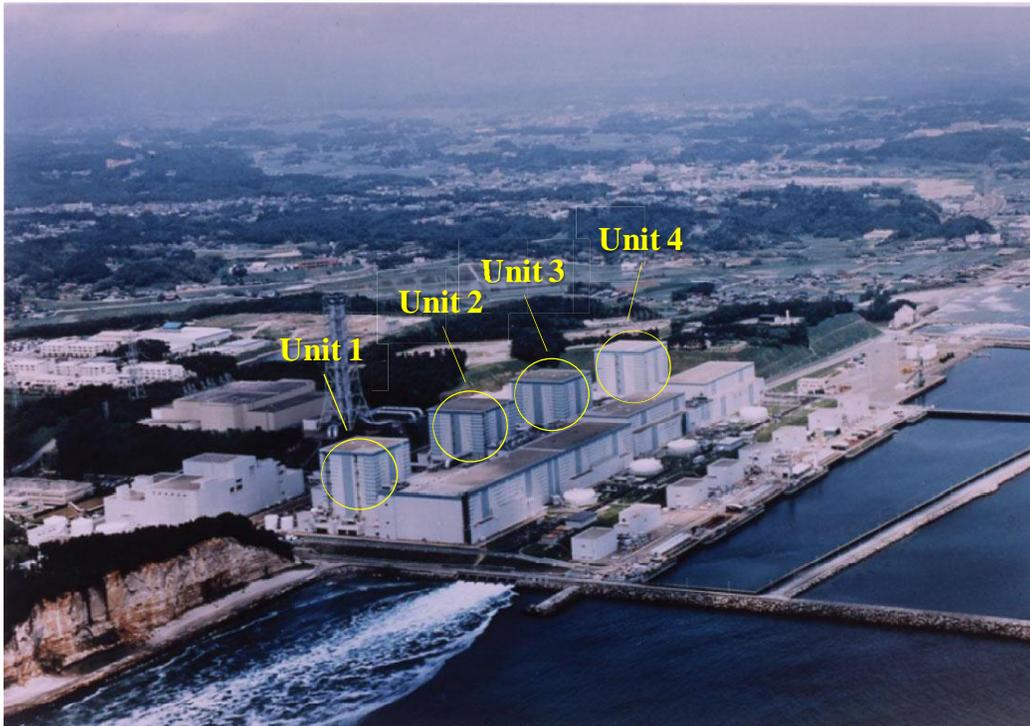
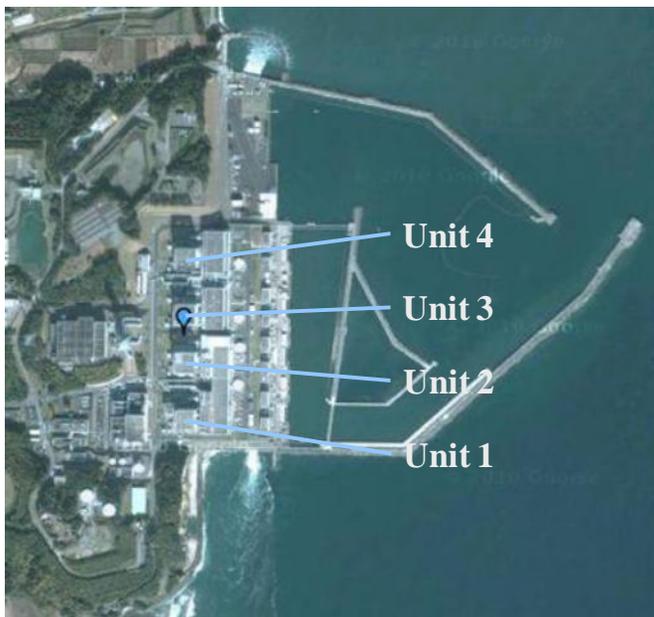
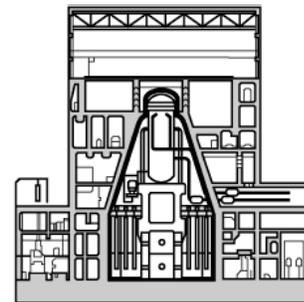
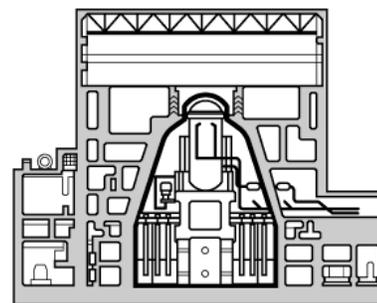
FIG. 1.3. Fukushima Dai-ichi NPP.

a) Pictorial view

b) Layout

**BWR Mark II (Unit 1)**

**BWR Mark II R (Unit 2~4)**

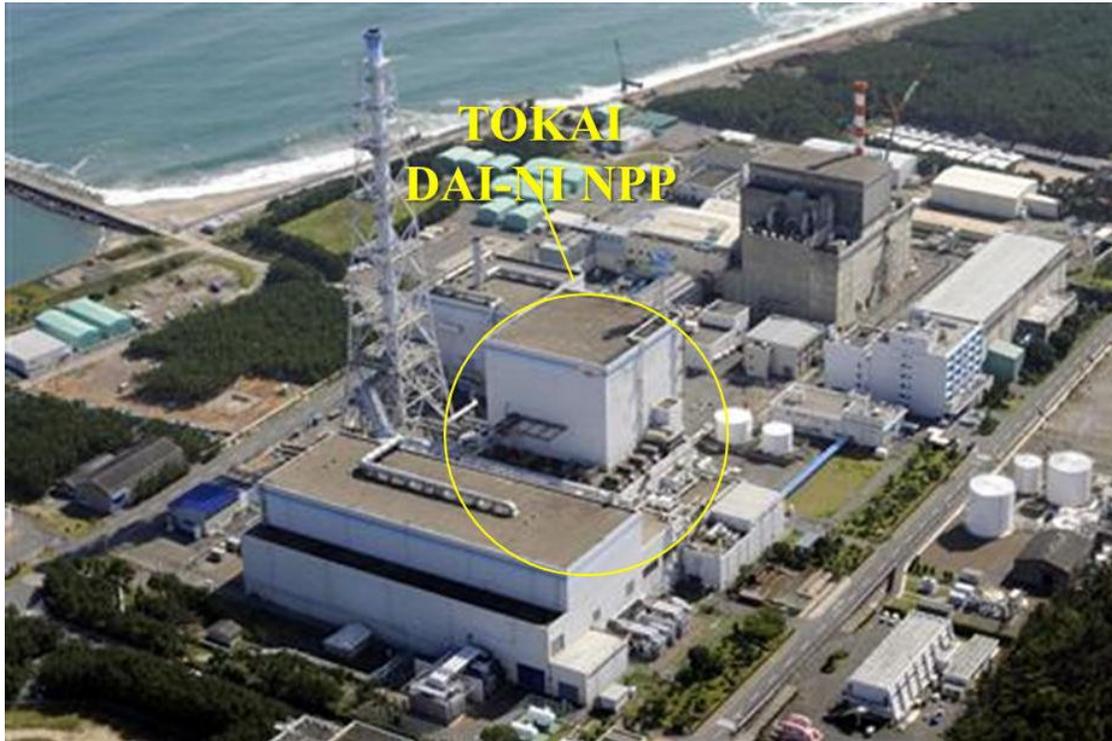
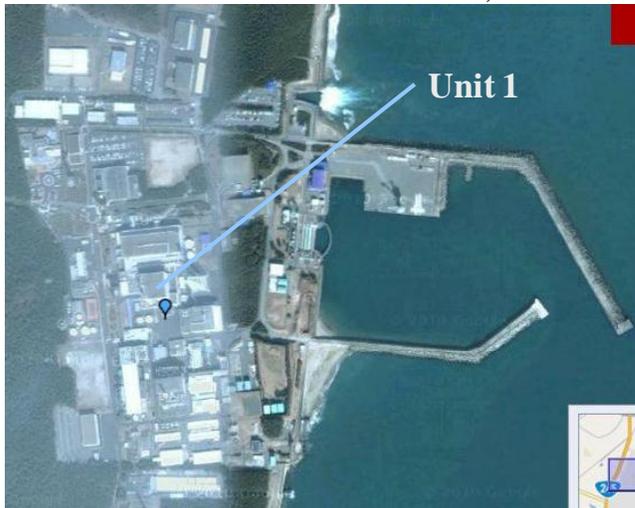
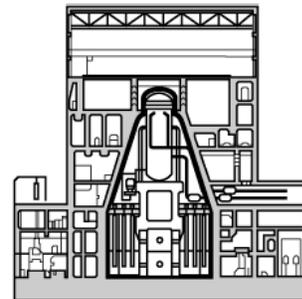
a) Pictorial view

b) Layout

**BWR Mark II (Unit 1)***FIG. 1.4. Tokai Dai-ni NPP.*
