Irradiation Microstructure of Austenitic Steels and Cast Steels Irradiated in the BOR-60 Reactor at 320°C

Keywords: Neutron irradiation, BOR-60, PWR, and Dislocation loops

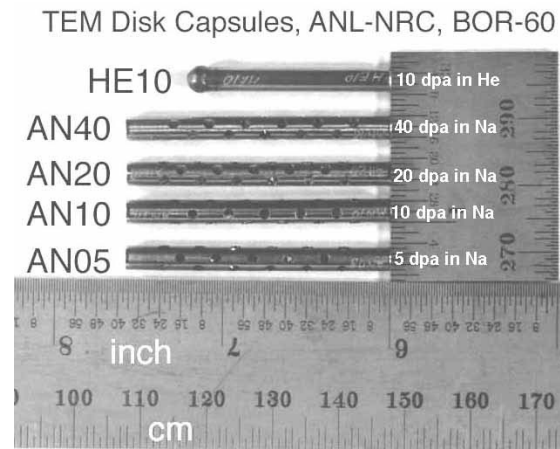
Figure 1. TEM capsules irradiated in the BOR-60 reactor (the dpa numbers in the figure are targeted irradiation doses).

Neutron irradiations were carried out in the BOR-60 reactor, a sodium-cooled fast breeder reactor located in the Research Institute of Atomic Reactors (RIAR), Dimitrovgrad, Russia. The TEM disks were loaded in four perforated capsules and one helium-tight capsule, as shown in Figure 1. The dpa values shown in the figure were targeted irradiation doses and the examined specimens in this paper were loaded in tube AN40, and the disks were in direct contact with sodium coolant during irradiation. The experiment included eight irradiation sub-cycles and several maintenance shut-down periods and the irradiation experiment was conducted in the fifth row of the core of the BOR-60 reactor. Neutron fluence was monitored by five dosimeters loaded in the central channel of the irradiation rig and in baskets with the specimens. The analyses of dosimeters were carried out by RIAR after irradiation. The irradiation temperature was controlled by monitoring the inlet and outlet sodium temperatures, which were kept at ≈ 315 and 325°C , respectively. Mg-Zn eutectic thermal monitors were also placed among specimens in several baskets during irradiation. Post-irradiation examination of these thermal monitors indicated that the irradiation temperature of capsules was below 343°C at all times.

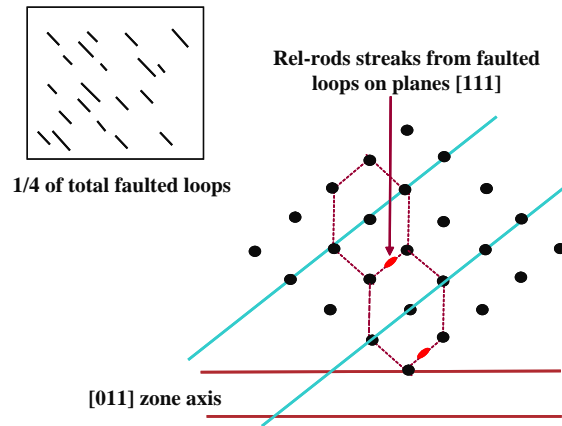
Figure 2. A schematic for relrod imaging condition.

Since the Frank loop is a major irradiation defect in fcc steels, the relrod DF technique can be applied. Irradiation-induced faulted dislocation loops have a Burgers vector of $a/3\{111\}$, and lie on $\{111\}$ planes in the austenitic structure. A relevant diffraction condition can be obtained by tilting the sample close to the $g = [311]$ two-beam condition near the zone axis $[011]$, and the relrod DF images were formed by selecting the relrod streak with the objective aperture. Figure 2 shows a schematic of relrod DF imaging condition. With the relrod DF images, size and density estimate of irradiation defects is much easier because initial nonirradiation microstructure is not present. One of the four variants of Frank loops can be observed in a single relrod picture. Assuming an isotropic distribution at all orientations, the density of Frank loops can be determined. The measurements were also performed near the perforation edge in regions that were less than 100-nm thick, which minimized the overlap of defects and improved the accuracy.

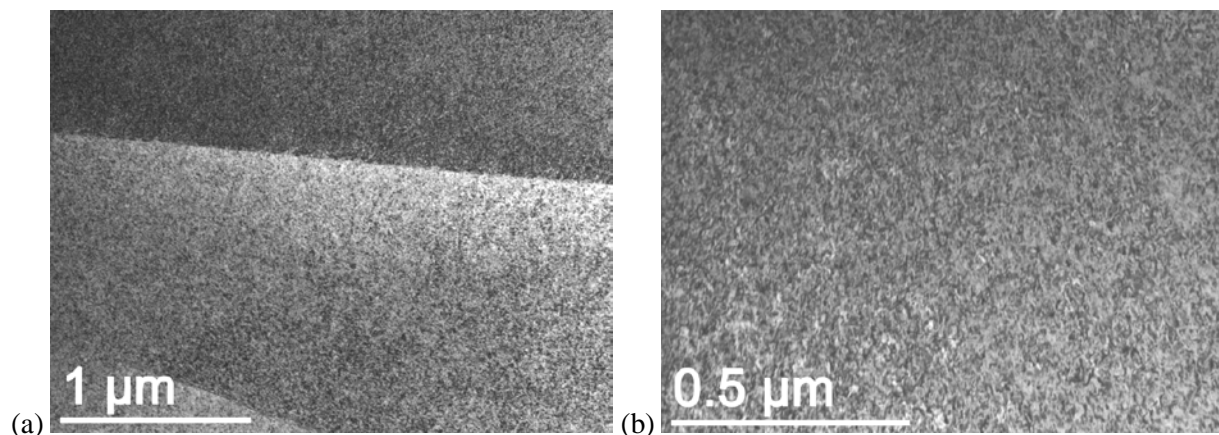
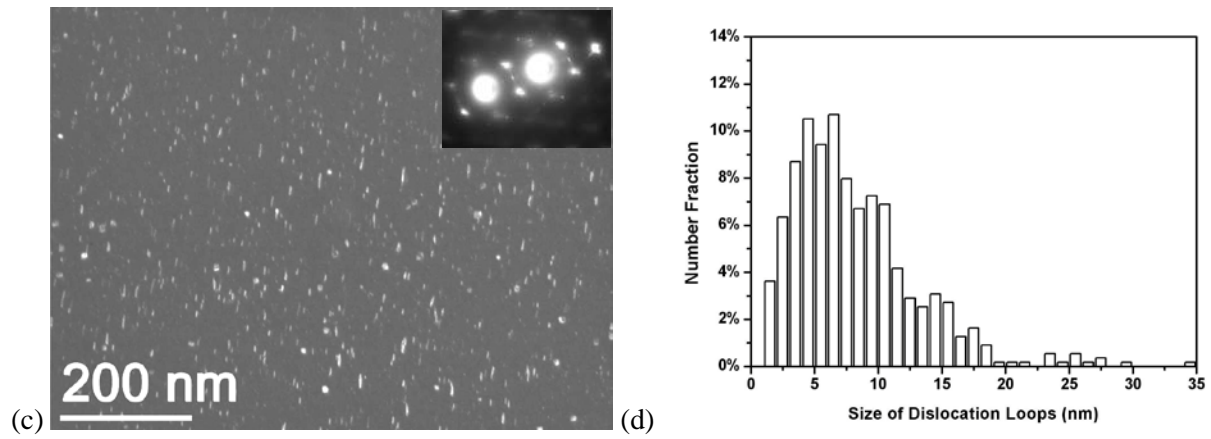
Figure 3. 304 SA-High S (A2). Micrographs were taken with the beam direction B close to $\langle 110 \rangle$: (a) general grain structures (b) bright field image (c) Relrod DF image of dislocation loops (d) size distribution of dislocation loops.

The microstructures of irradiated 304 stainless steels are shown Figures 3-6. No voids were identified in any of these 304 SSs by checking the microstructures carefully at high magnification with a through-focus technique. Additionally no evidence of the existence of stacking fault tetrahedral was obtained. The specimen A2 shows the coexistence of the Frank loops and precipitates in Figure 2(b) and (c), while no significant precipitates were observed in the other three heats of 304 SS. No detectable connection could be found between the precipitates and the dislocation loops. The particles in heat A2 might precipitate synergistically from the relatively high contents of Mn and C. The irradiated microstructures of 304 SSs are dominated with a high density of dislocation loops as shown in the bright field images and relrod dark field images in Figures 3-6, respectively. The density of dislocation loops in 304 SSs are very close to each other, while the 304L SA have the largest average loop size and the 304 SA SSs (A2 and A3) has a very small loop size.

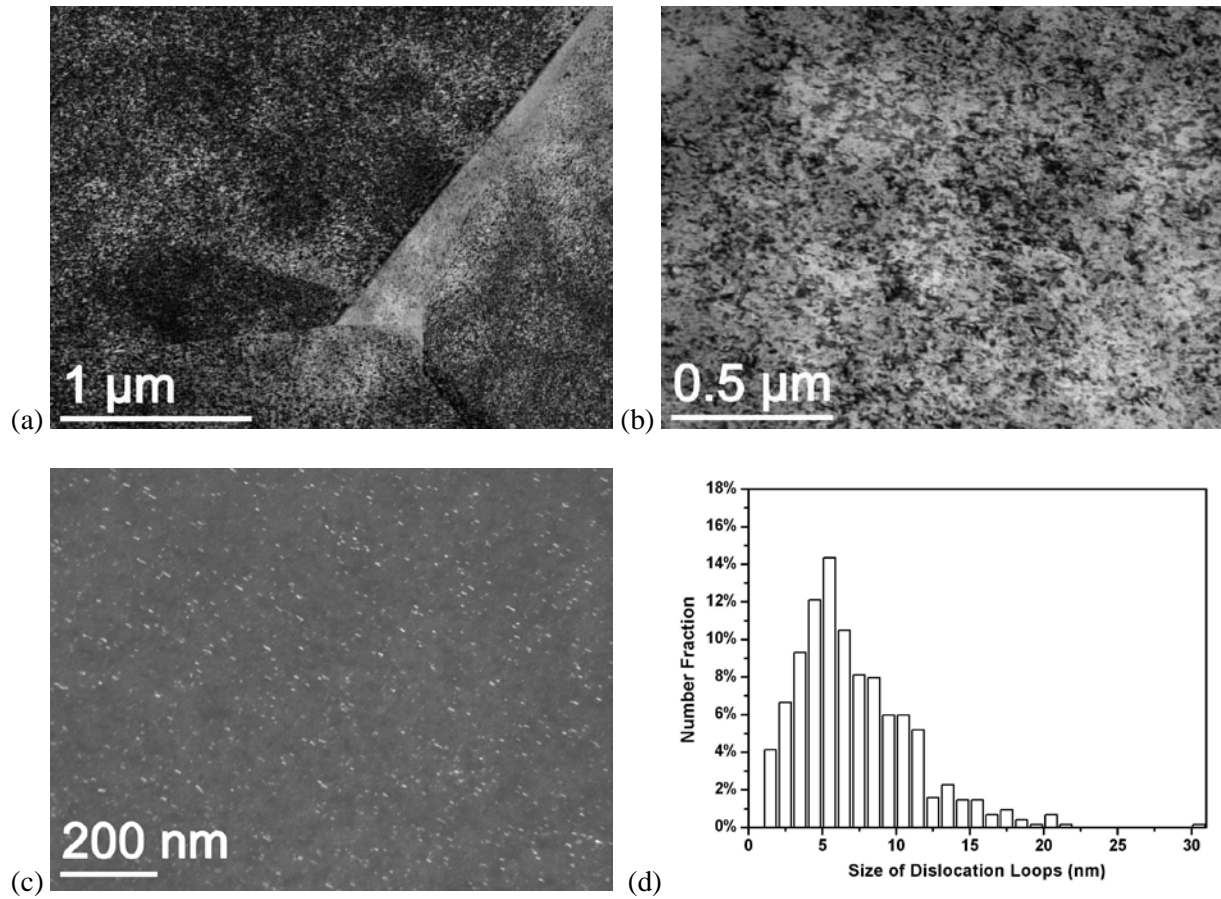
Figure 4. 304 SA-Low S (A3). Micrographs were taken with the beam direction B close to $\langle 110 \rangle$: (a) general grain structures (b) bright field image (c) Relrod DF image of dislocation loops (d) size distribution of dislocation loops.

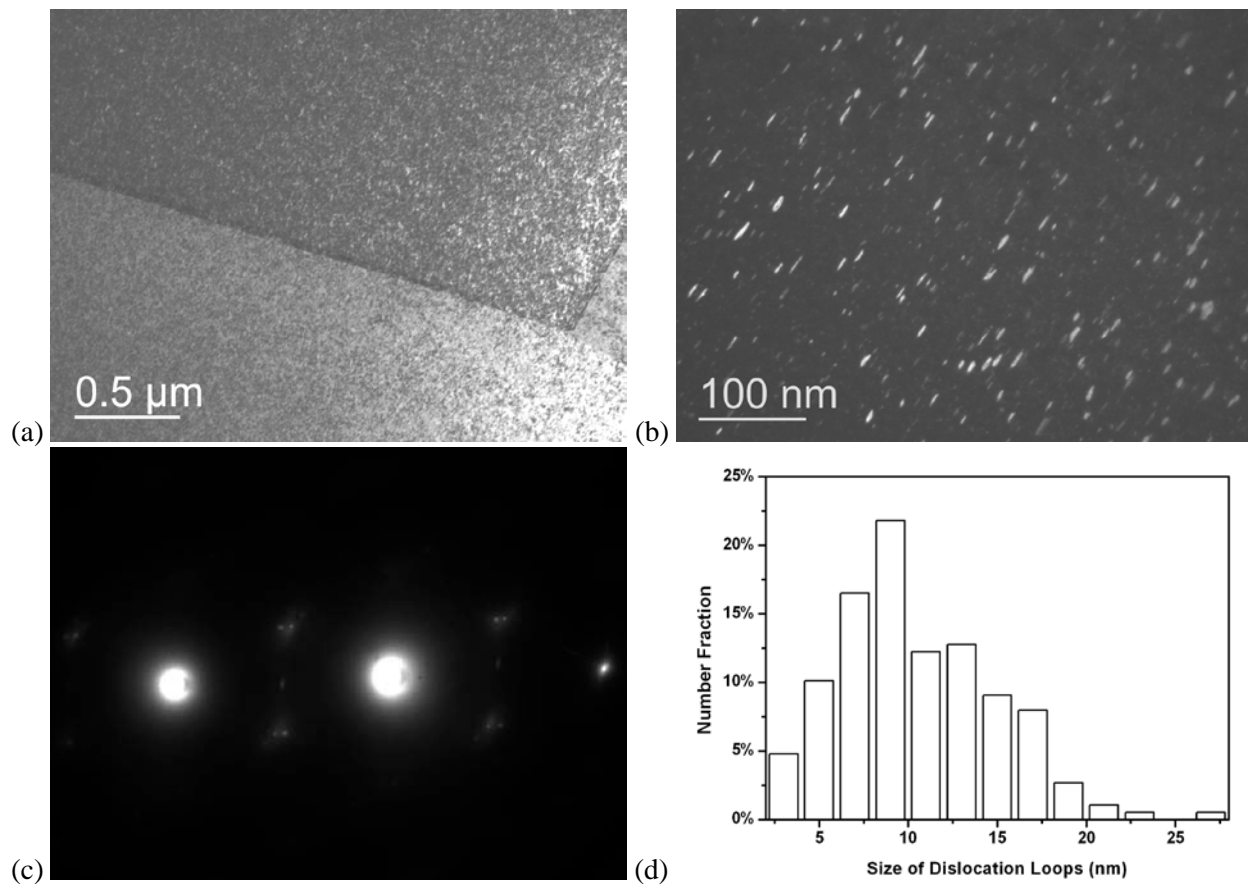
Figure 5. Microstructure of irradiated 304 SA (B1): (a) BF field image, (b) Relrod DF image of dislocation loops (c) Diffraction patterns showing the reflection streaks arising from dislocation loops, and (d) size distribution of dislocation loops.

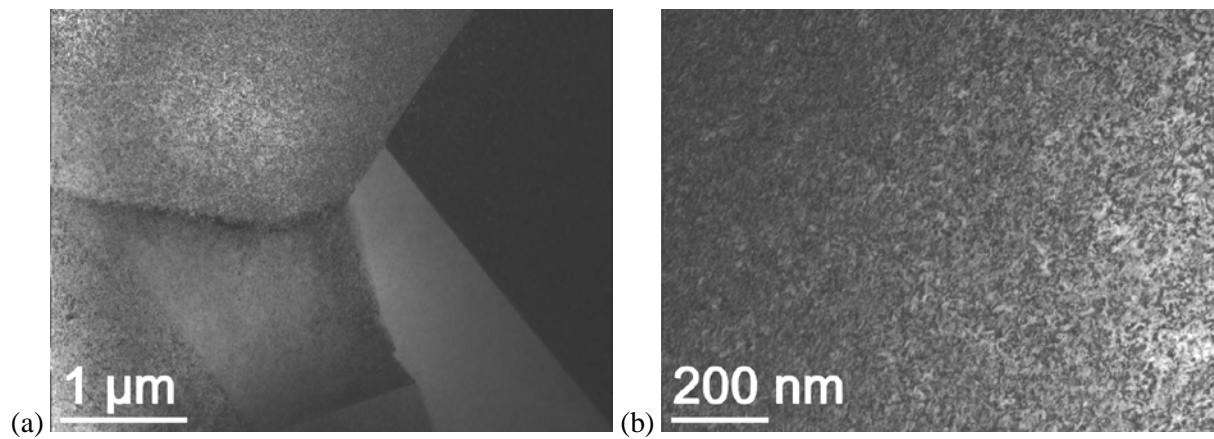
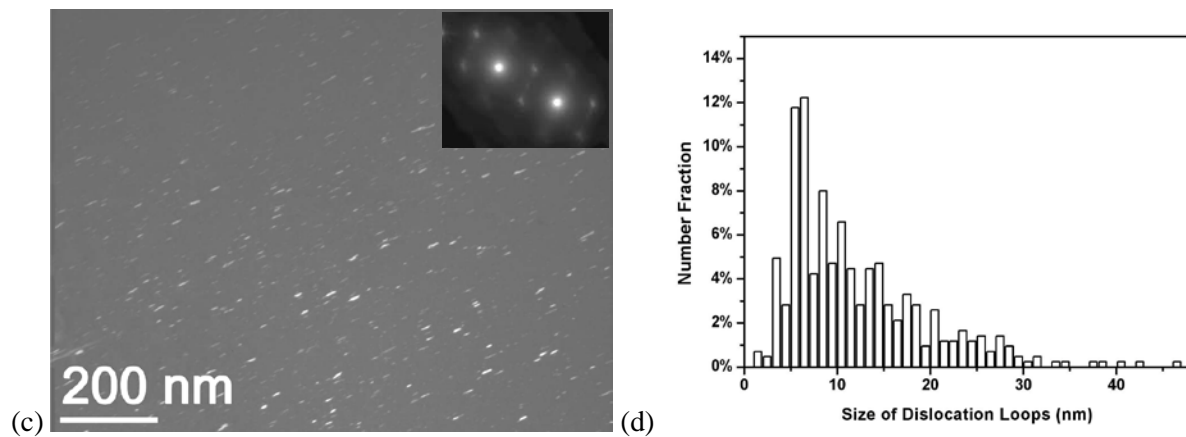
Figure 6. HP 304L SA (A8). Micrographs were taken with the beam direction B close to $\langle 110 \rangle$: (a) general grain structures (b) bright field image (c) Relrod DF image of dislocation loops (d) size distribution of dislocation loops.

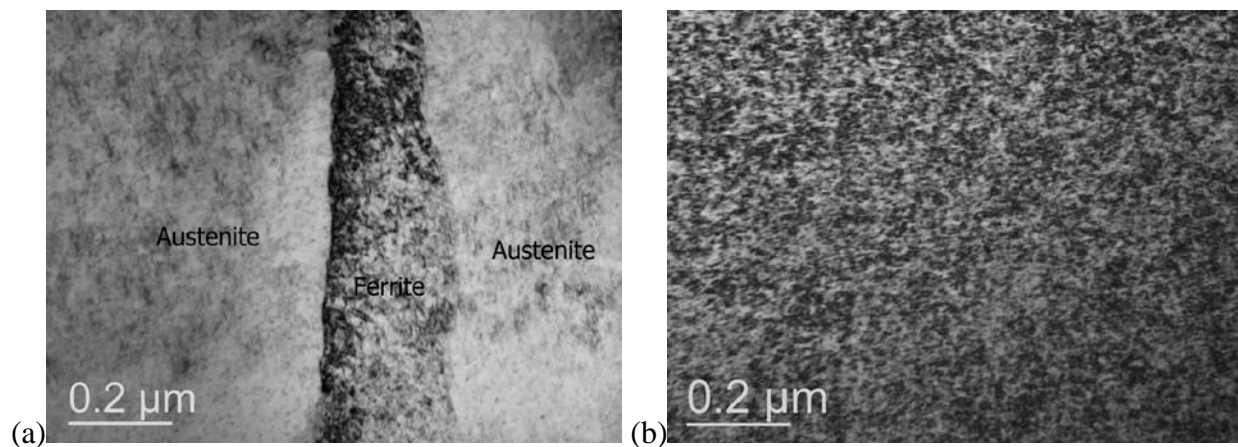
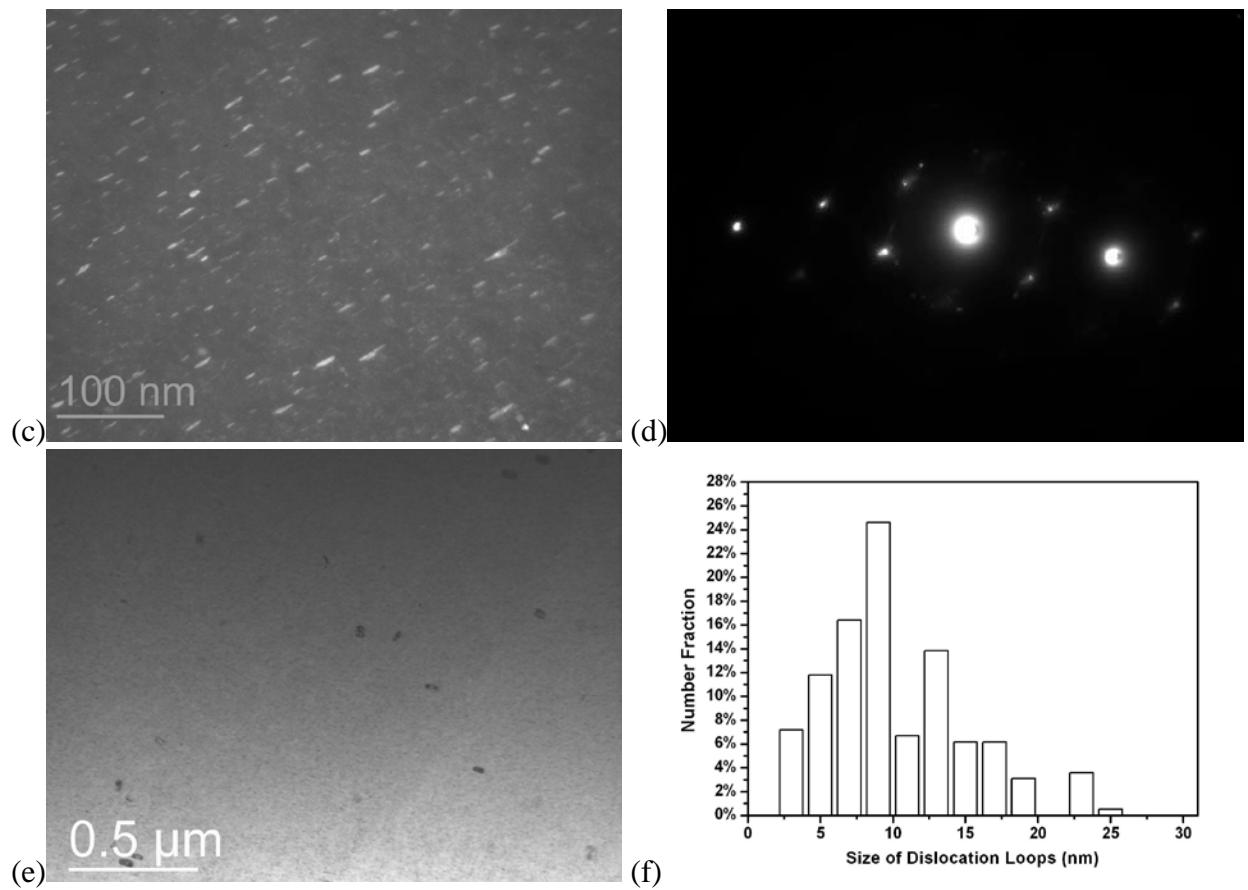
Figure 7. CF-3 cast SS (C1). Micrographs were taken with the beam direction close to $\langle 110 \rangle$: (a) BF field image of austenite and ferrite phases, (b) BF field of dislocation loops at low magnification, (c) Relrod DF image of dislocation loops, (d) Diffraction patterns showing the reflection streaks arising from dislocation loops, (e) precipitates in the austenite grain and (f) the size distribution of dislocation loops.

Figures 7 and 8 show the irradiated microstructures of the cast stainless steels (heat C1 and C2). As noted in Table I, heat C2 contains a much higher carbon content than heat C1 and they both have about 13.5% of δ ferrite phase existing as island bands among austenite phases. Similar to that in irradiated 304 SS, the irradiated microstructures feature a high density of dislocation loops, while no voids appear in either phase. Compared with austenite, the ferrite appears to have a lower density of dislocation loops. Both heats of C1 and C2 contain precipitates after irradiation, while the precipitates in C1 have a large average size but a much lower number density, as shown in Figure 7 (e). Irradiated heat C2 contains a high density of fine precipitates as shown in the dark field image of Figure 8 (c), and the diffraction pattern from both the austenite matrix and precipitates are shown in Figure 8 (d). The precipitate has a lattice parameter of $\sim 1.056\text{nm}$ which corresponds to $M_{23}X_6$ with a fcc crystal structure and the precipitates are coherent with the austenite matrix with orientation relationship of $[011]_{\gamma} \parallel [011]_{M_{23}X_6}$. The average size of fine $M_{23}X_6$ precipitates is about 6.7 nm and the number density is $7.3 \times 10^{21} \text{m}^{-3}$.

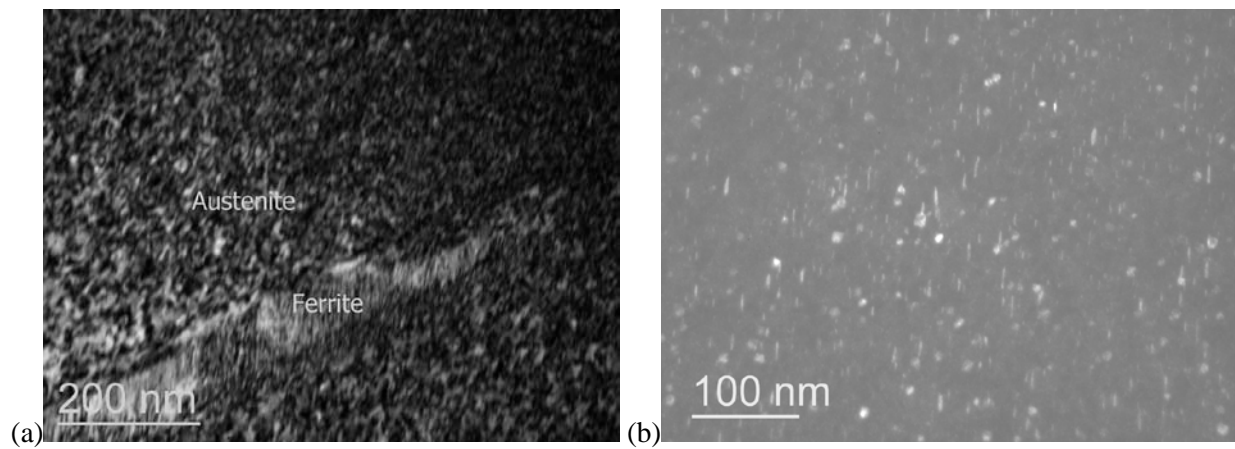
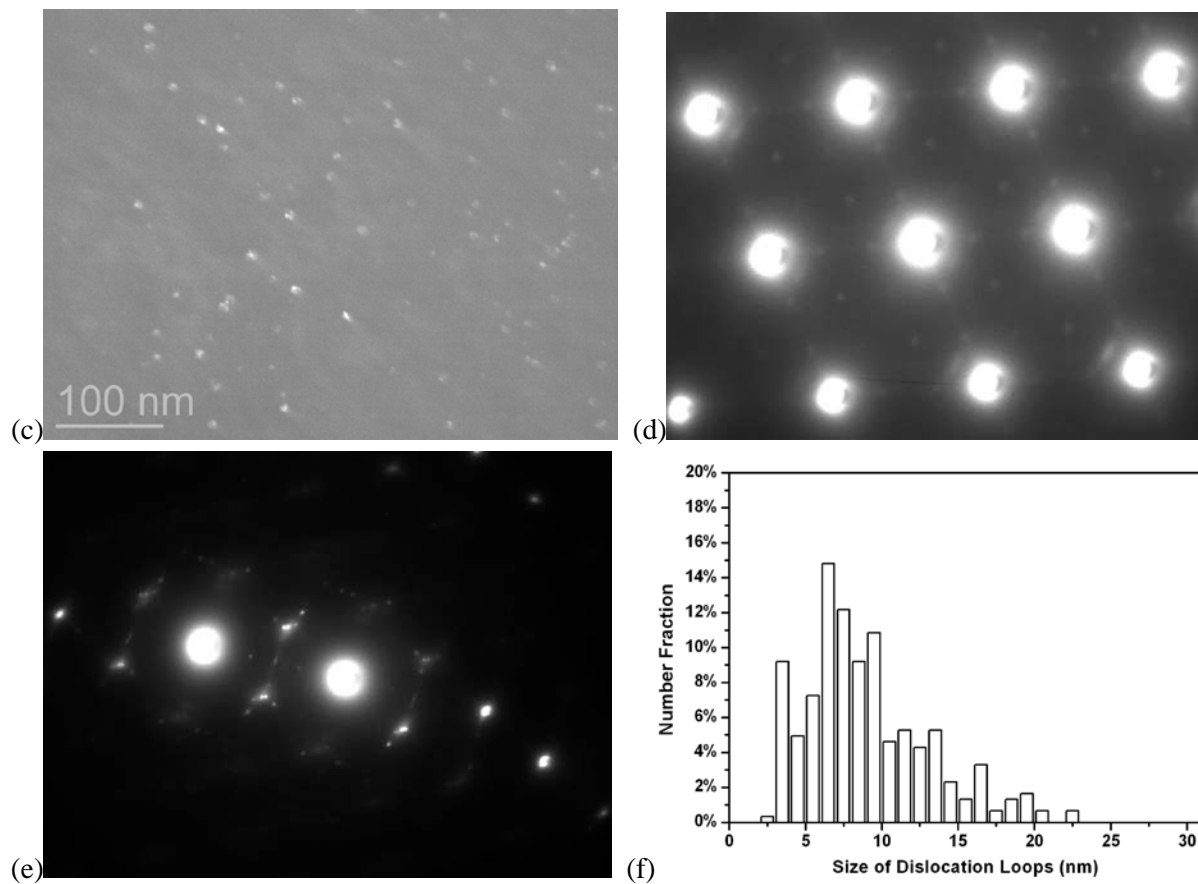
Figure 8. CF-8 cast SS (C2). Micrographs were taken with the beam direction B close to $\langle 110 \rangle$: (a) BF field image of austenite and ferrite phases, (b) Relrod DF image of dislocation loops, (c) Dark filed image of the fine precipitates in austenite grain using the ultra-reflections in (d), and (d) diffraction patterns showing the coherence of the precipitates with the matrix, (e) Diffraction patterns showing the reflection streaks arising from dislocation and (f) the size distribution of dislocation loops.

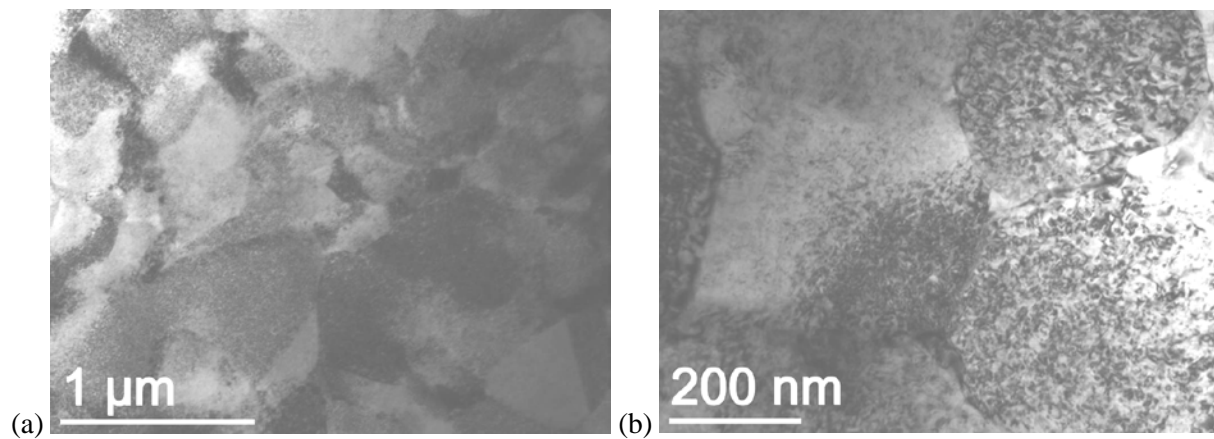
Figure 9. 316 LN SA (a) general grain structures (b) irradiation induced dislocation loops structure.

Figures 9-10 display the irradiated microstructure of 316 LN SA w/o Ti addition. Generally, no voids were observed in those two steels, and the irradiated microstructures are both decorated with a high density of dislocation loops. However, due to the complexity of the grain structure in the pristine materials, the size and number density of the dislocation loops were not quantified. Compared with the 316 LN SA, the irradiated 316 LN-Ti SA appears to have a moderate density of precipitates as shown in Figure 10 (b).

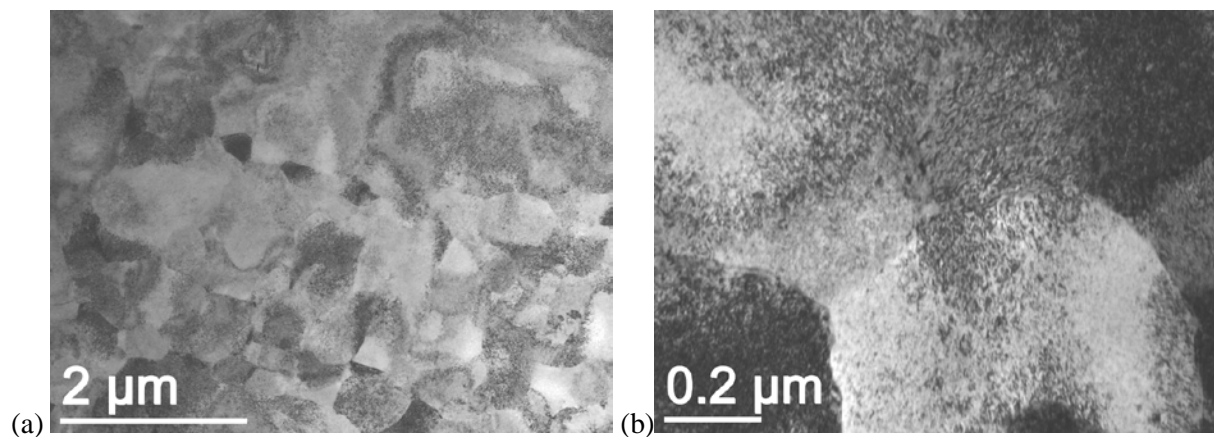
Figure 10. 316 LN-Ti SA (a) general grain structures (b) irradiation induced dislocation loops structure.

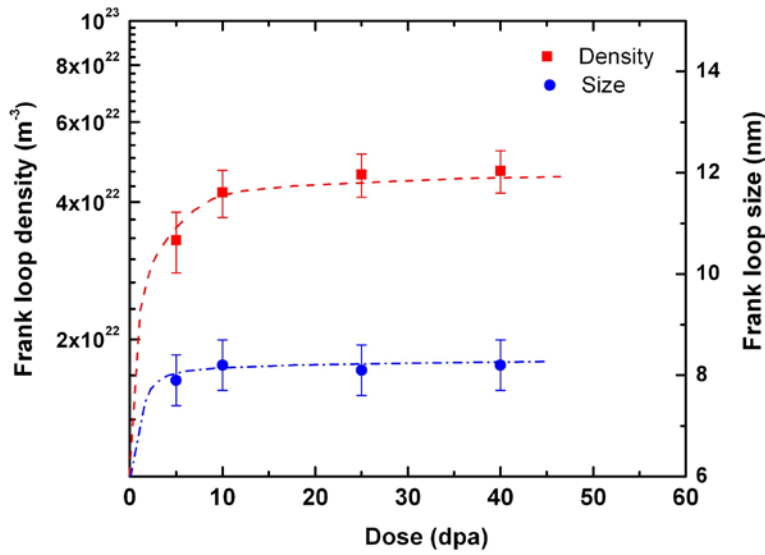
Figure 11. Density and size of Frank loops in irradiated 304 SA-High S.
