**KEWAUNEE NUCLEAR POWER PLANT**

**ANNUAL OPERATING REPORT**

**1993**

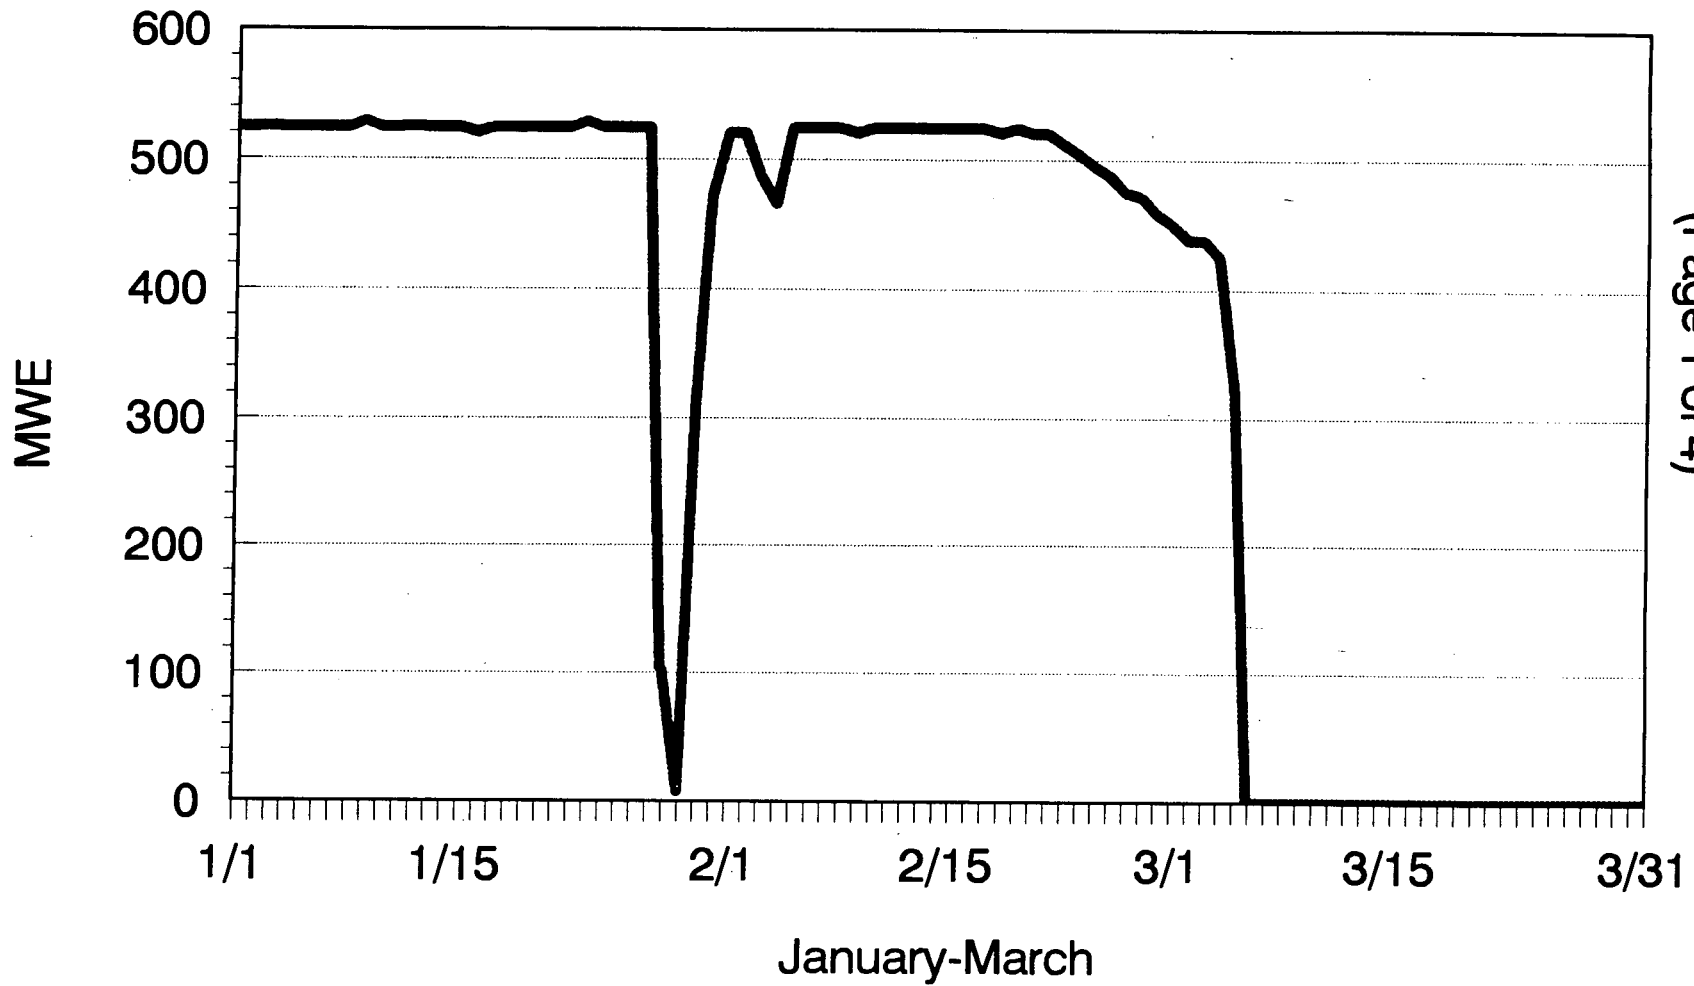
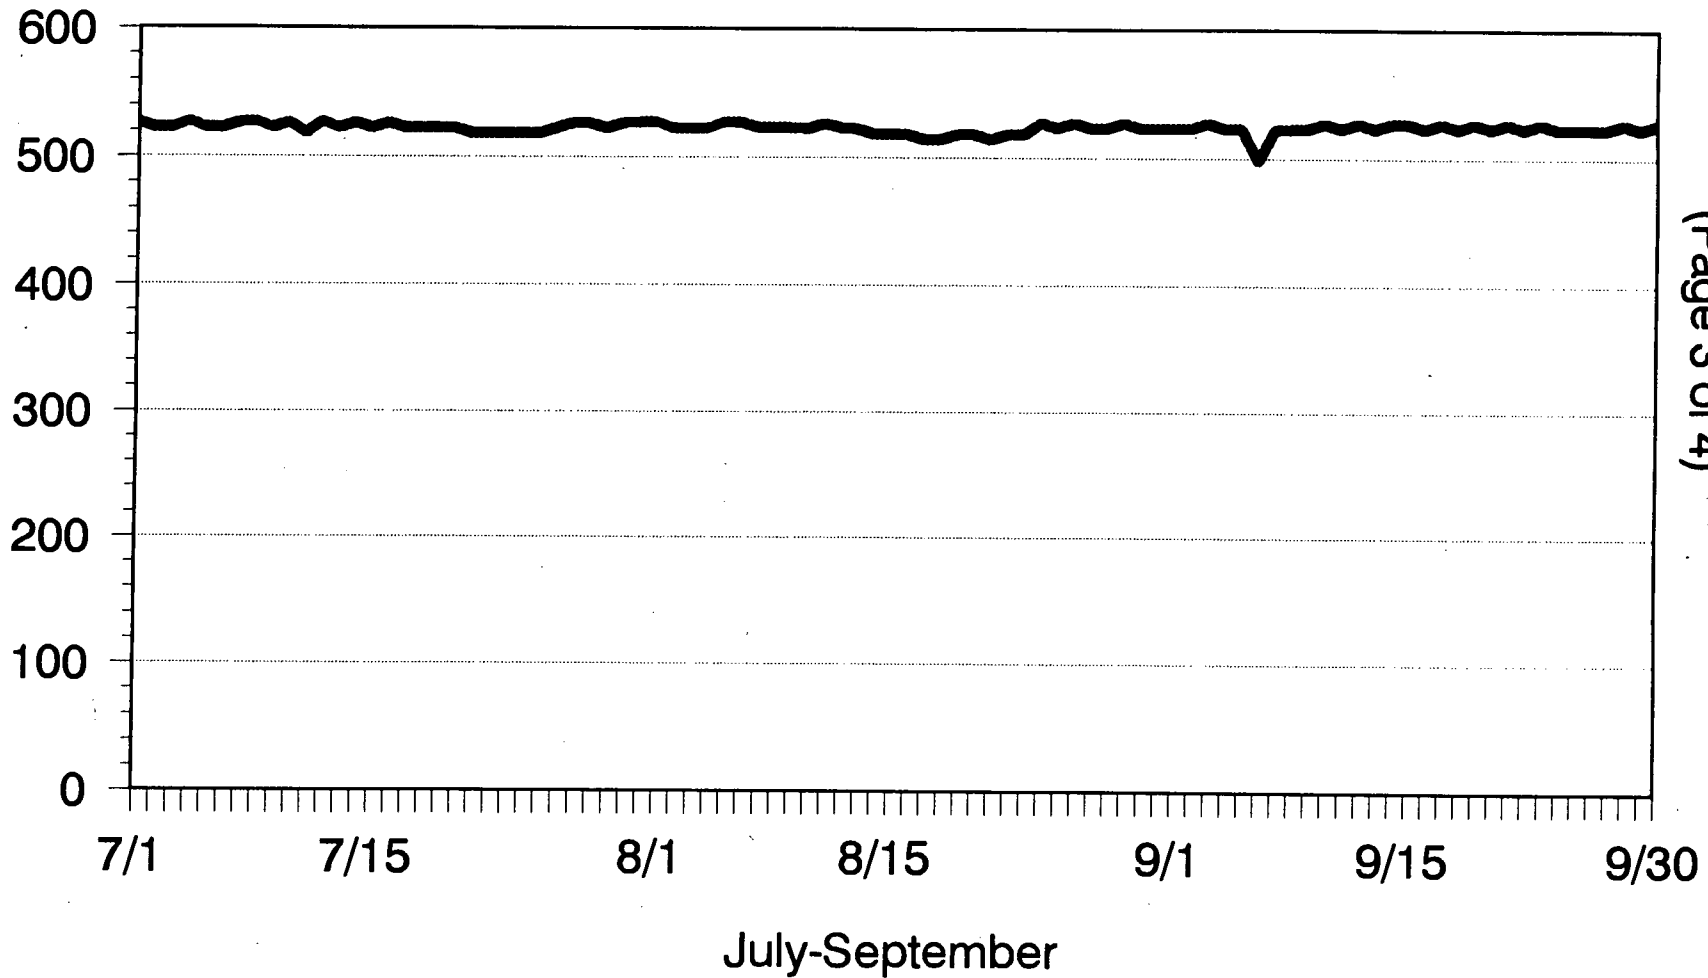
FIGURE 1.1  
(Page 1 of 4)

# KEWAUNEE POWER HISTORY - 1993

## AVERAGE DAILY MWE-NET

During 1993, the Kewaunee Nuclear Power Plant was primarily base loaded. The unit was operated at 85.3% capacity factor (using net MDC) with a gross efficiency of 33.4%. The unit and reactor availability were 86.2% and 86.8% respectively. Figure 1.1 provides a histogram of the average daily electrical output of the Kewaunee Plant for 1993.

As indicated on Figure 1.1, the Kewaunee Nuclear Power Plant experienced an automatic reactor trip on January 28, 1993, due to Bus 1 and 2 undervoltage reactor trip signal. A phase to phase fault in the "B" main feedwater pump motor tripped its supply breaker and caused Bus 1 and 2 undervoltage.

A scheduled outage to repair primary to secondary system leakage in "B" Steam Generator commenced on June 4, 1993, when G-1 was opened. Repairs to a leaking tube plug were successfully completed on June 9, 1993. G-1 was closed on June 12, 1993, and 100% power was reached on June 20, 1993.
