ACCESSION NBR: 9511060042 DOC.DATE: 95/11/01 NOTARIZED: NO DOCKET # 05000305
 FACIL: 50-305 Kewaunee Nuclear Power Plant, Wisconsin Public Service
 AUTH.NAME AUTHOR AFFILIATION
 ROZELL, D.L. Wisconsin Public Service Corp.
 MARCHI, M.L. Wisconsin Public Service Corp.
 RECIP.NAME RECIPIENT AFFILIATION

SUBJECT: LER 95-006-00: on 950420, recent changes in pump operating practice resulted in inadequate thrust bearing lubrication & failed B SI pump. Reviewed procedures. W/951101 ltr.

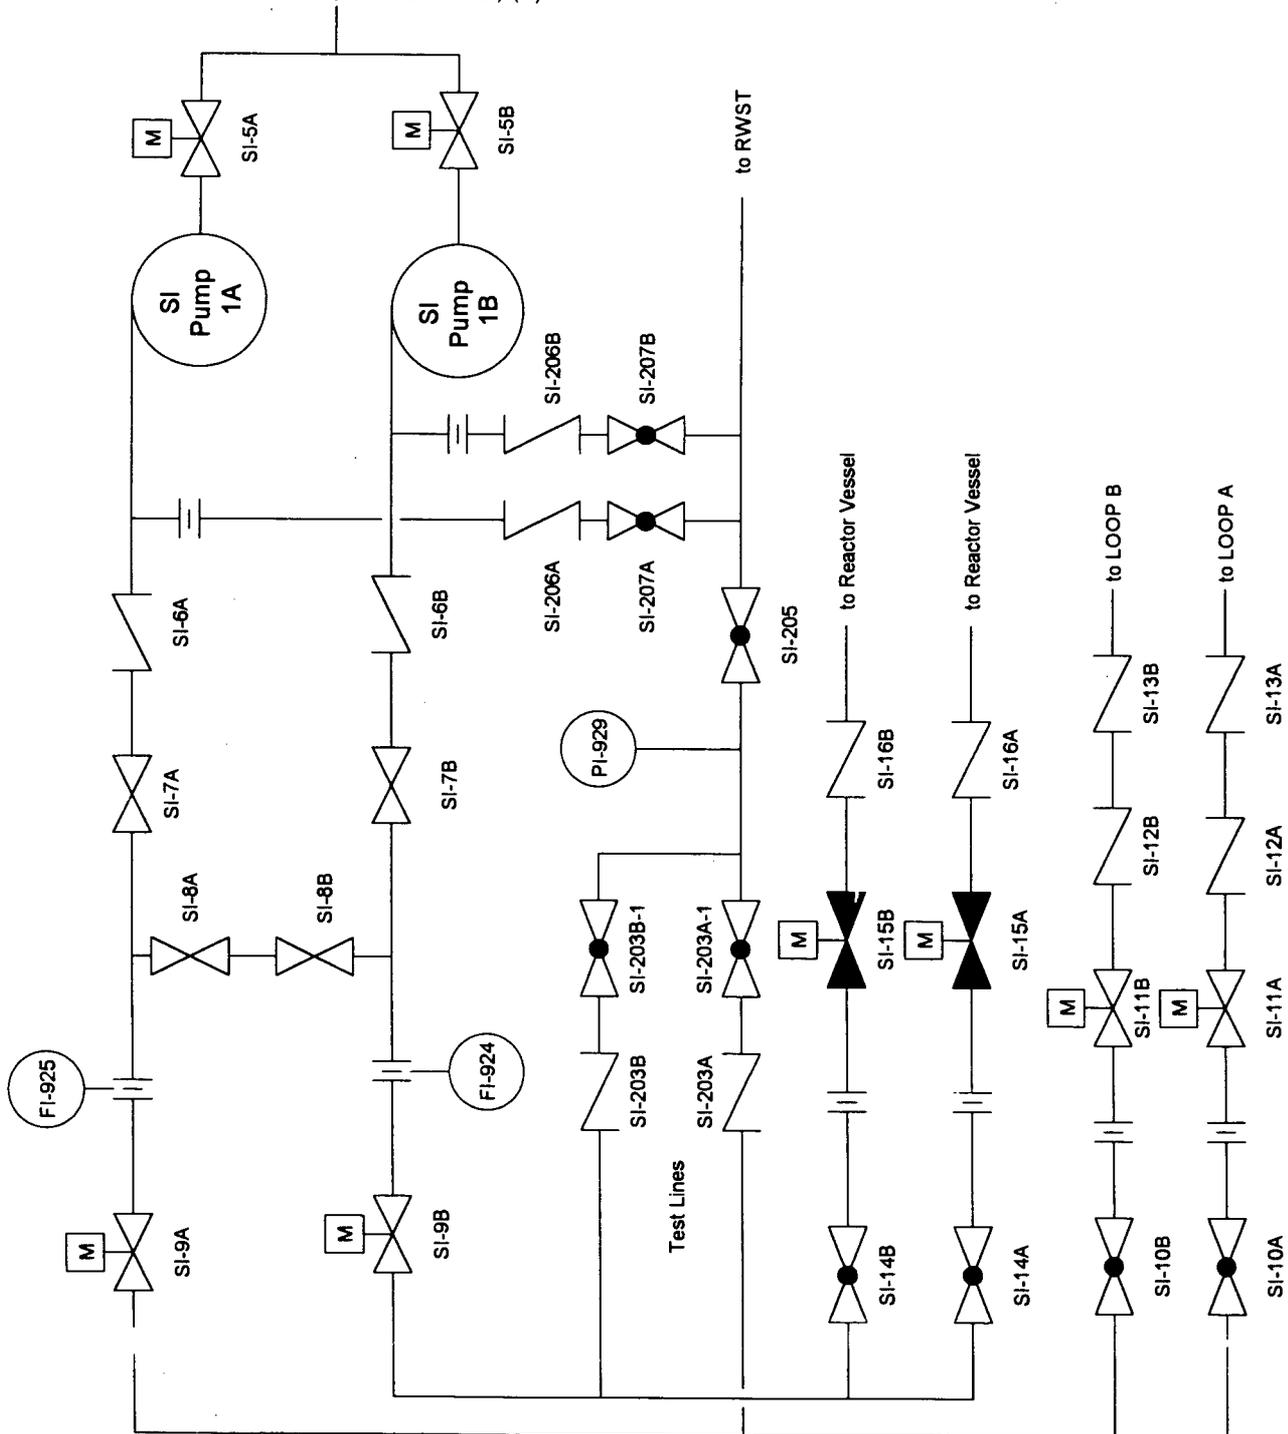
Attachment 1 - Simplified Safety Injection System Diagram

1. A larger gap exists in SI-10A(B) as compared to SI-14A(B),
2. Fragments were found downstream of SI-10 A(B), and
3. The fact that after the pump failure occurred, the B SI Pump injected through the cold leg flow path without plugging SI-10A(B).

1. The SI system piping was radiographed, and portions were removed, cleaned, flushed and reinstalled. Radiography of portions of the system piping, and the throttle valves SI-14A(B) and SI-11A(B) and their downstream orifices, after the pump flow tests confirmed the absence of foreign material in the piping.
2. The RCS, reactor vessel, reactor vessel internals and fuel assemblies were cleaned and inspected to the greatest extent possible.
3. The B SI Pump was repaired and tested. The test results were reviewed and found to be acceptable prior to declaring the pump operable.
4. The A SI Pump was inspected with the assistance of the Technical Representative. The bearings were inspected and the thrust bearing shoes in the outboard thrust bearing were replaced. The A SI Pump was tested using the standard SPs. The test results proved the pump to be operable.
