UNIVERSITY OF CALIFORNIA, IRVINE

**Re: Docket 50-326 Relicense, RAI dated April 5, 2011 (TAC ME1579),  
extension granted to July 1<sup>st</sup>, 2011.**

UCI RESPONSE TO:  
OFFICE OF NUCLEAR REACTOR REGULATION  
REQUEST FOR ADDITIONAL INFORMATION  
UNIVERSITY OF CALIFORNIA IRVINE NUCLEAR REACTOR FACILITY  
LICENSE NO. R-116  
DOCKET NO. 50-326

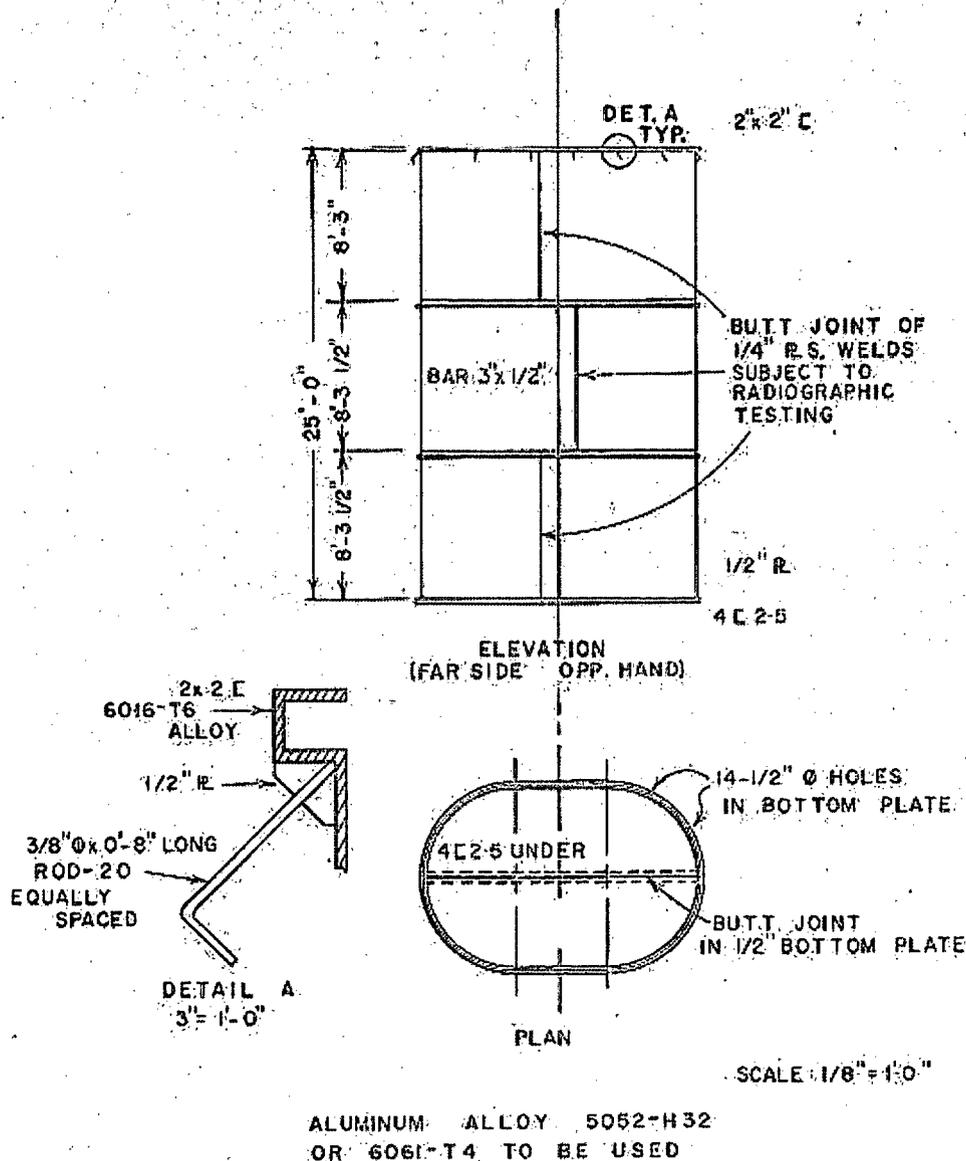
Fig 4-2 Reactor Aluminum Tank Liner

The pool consists of an aluminum tank liner 10 ft wide by 15 ft long and 25 ft deep (Fig. 4-2), 1/4 inch thick on the sides and 1/2 inch thick on the bottom supported by reinforced concrete. At the core end, 2 ft 6 in of concrete surround the liner and 4 ft 6 in of concrete are below the liner to provide support and reduce soil activation (Fig. 4-3).

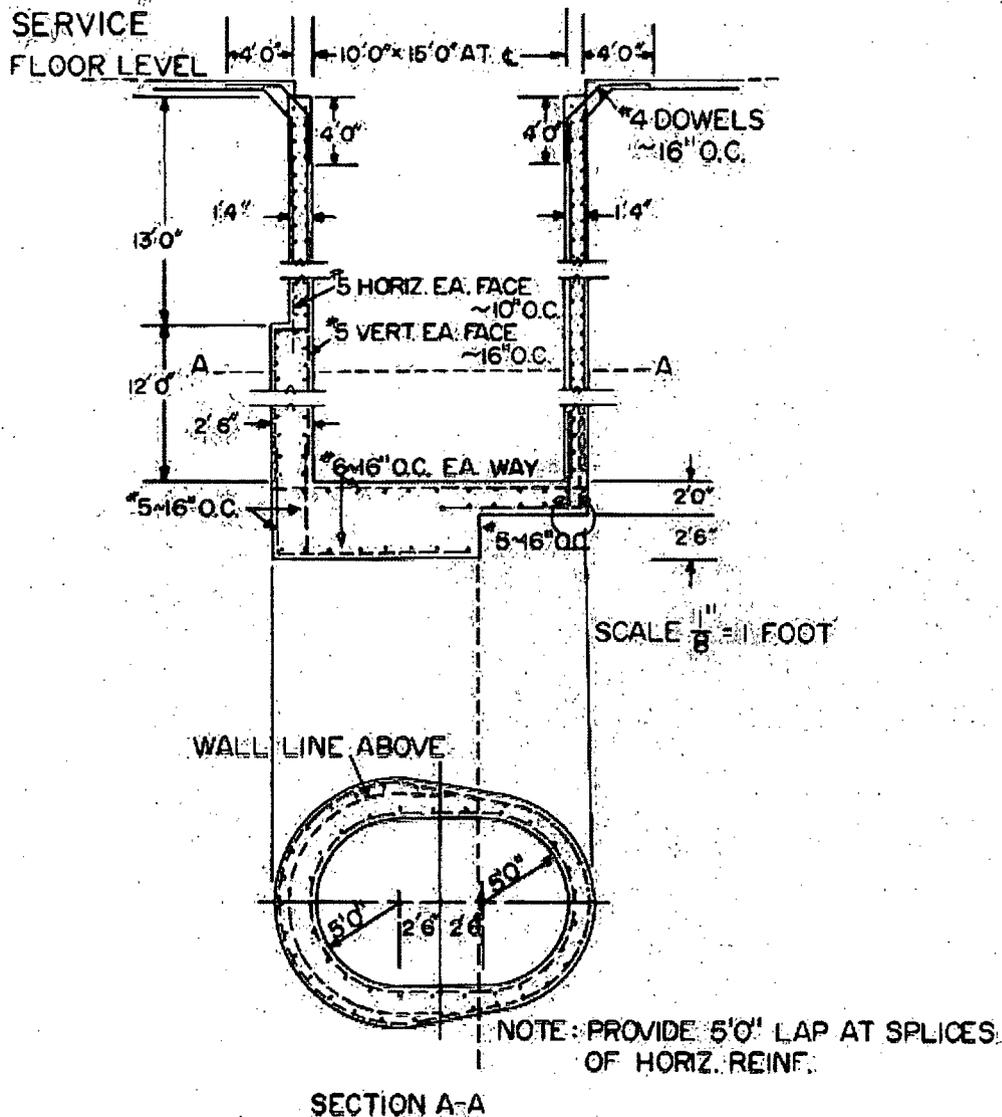
FIG. 4-3 Concrete Reactor Tank

The liner and the concrete pit was constructed to the design and specifications used by Gulf General Atomic for their Mark III TRIGA installation in San Diego. The design is considered to be more than adequate to endure earthquake induced ground motions. An extensive leak-testing procedure coupled with weld radiography at 20% of the welds was performed to ensure integrity of the aluminum liner. The leak tests were repeated with the liner in place on its foundation to ensure against damage during shipping and handling. All surfaces of the tank were tested for iron particles that were removed by grinding before the tank was filled with water.

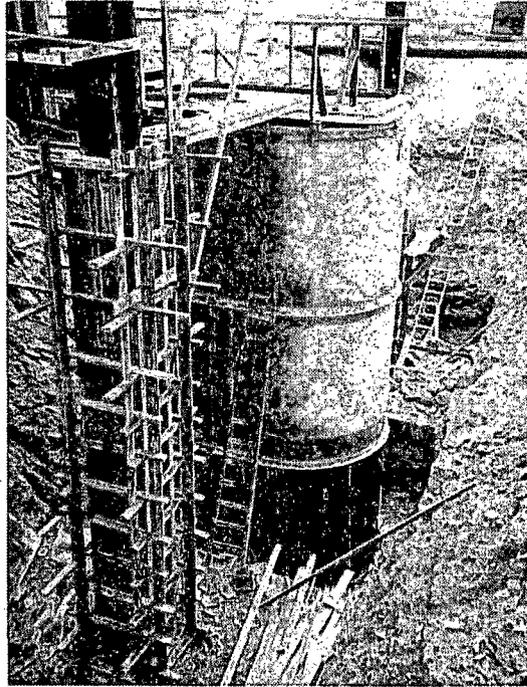
Fig 4-4 Reactor Tank Liner Installation

The tank was installed in an excavated pit shown in the photograph, Fig 4-4, before the concrete shell was poured and before backfill. The tank was double wrapped with hot tarred felt before the concrete surround was poured to provide a water barrier to prevent corrosion from the surrounding concrete. Backfill was then used surrounding the concrete shell and consolidated to specified standards.
