Annual Radioactive Waste Tank Inspection Program - 2008

Washington Savannah River Company
Savannah River Site
Aiken, SC 29808

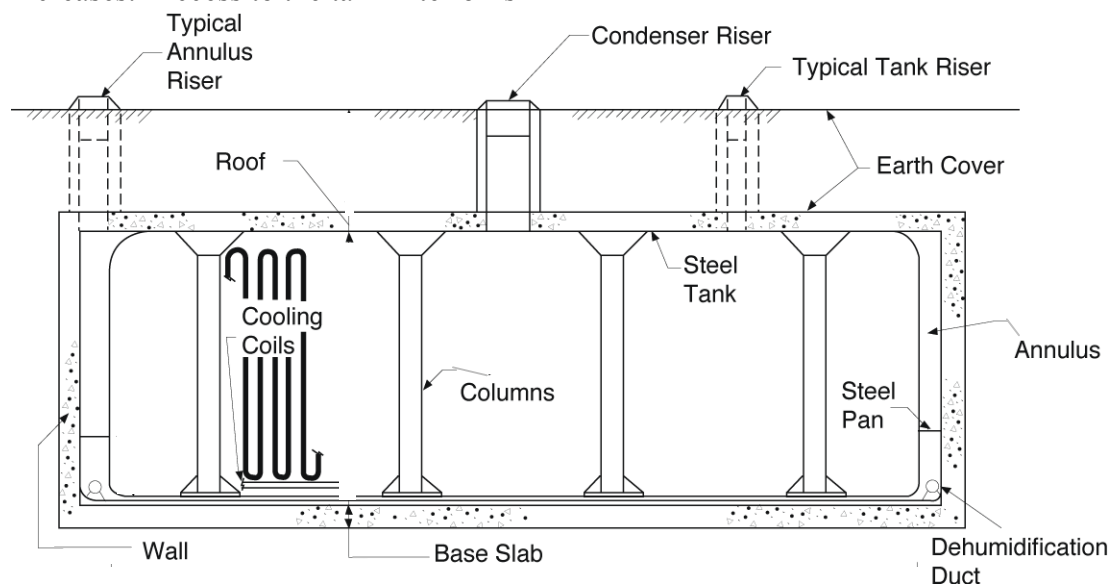
Figure 1. Cooled Waste Storage Tank, Type I (Original 750,000 Gallons).

The 12 original storage tanks constructed between 1951 and 1953 are designated Type I tanks. Tanks 1 through 8 are in F Area and Tanks 9 through 12 are in H Area. Each primary tank has a capacity of 750,000 gallons. Figure 1 shows the general features of Type I tanks, including the primary tank, the secondary pan, and the concrete support structure. Type I tanks are designated as being noncompliant.
