SUBJECT: Requests one time exemption from 10CFR50, App J, Section III.A.6(b) re CILRT during next refueling outage.

Iowa Electric Light and Power Company

April 2, 1990

MATRIX OF IMPROVEMENT FEATURES AND CONTRIBUTING CAUSES OF MSIV FAILURES

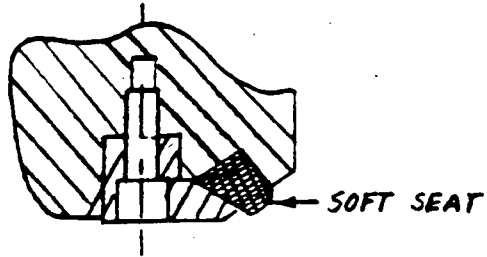
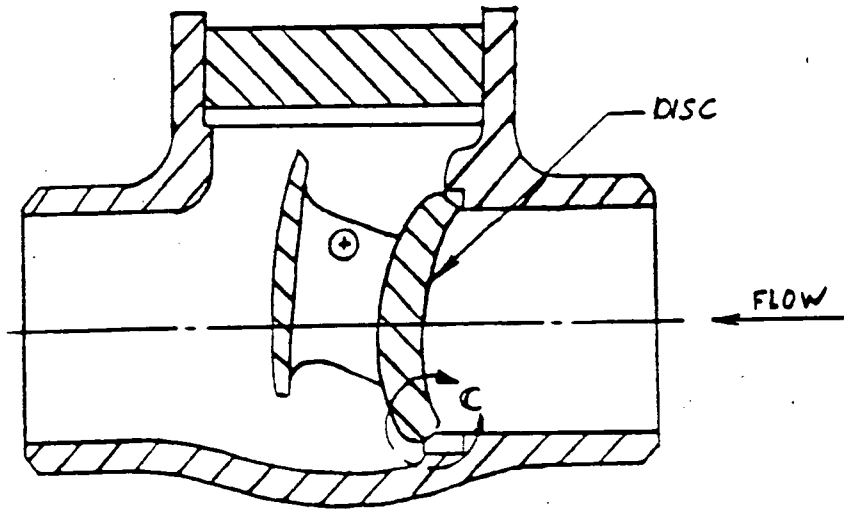
FIGURE 1

VIEW C WITH MODIFICATION

VIEW C WITHOUT MODIFICATION

The industry has experienced problems with hard-seated check valves not passing the low pressure test. Several utilities have tried to resolve the problem by using the secondary soft seat arrangement as shown in Figure 1. The soft seat is designed to provide the sealing at low pressures (i.e., reactor depressurized) while the hard seats provide sealing for higher pressure (i.e., reactor pressurized)
