August 18, 2011  
GO2-11-139

Subject: **COLUMBIA GENERATING STATION, DOCKET NO. 50-397  
RESPONSE TO REQUEST FOR ADDITIONAL INFORMATION  
LICENSE RENEWAL APPLICATION**

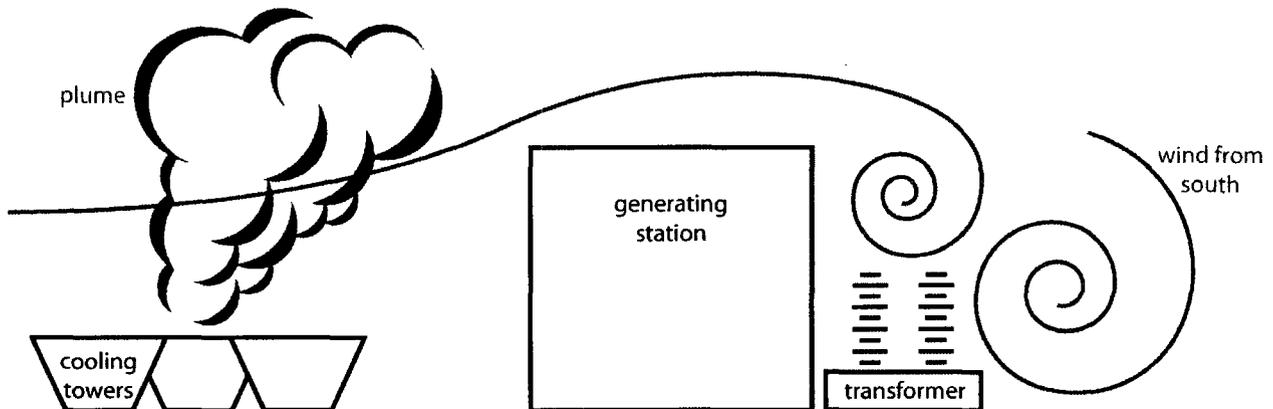
quarter mile north of the main plant. As the drift droplets move northward towards the plant, wind dynamics experienced, as the droplets are carried over the generating station, force much of the droplets down onto the transformer yard, thus making this area the most vulnerable to scintillation. Figure 1 illustrates the effect.

Figure 1: Droplet fallout settling on transformer yard

Under worst-case conditions, the drifting droplets created conditions conducive to arcing in the station's transformer yard. This arcing occurred when a sufficient layer of conductive substances built up on the insulators, became wetted, and formed an electrical track. Columbia Generating Station collects its cooling water from the Columbia River, which it then buffers with various chemicals to temper the water for use in the plant. Thus, the substances found in the drift droplets of the cooling tower are chemical species found naturally in the river, those added to buffer the water, those that form from decomposition of original buffers, and trace minerals and metals from the cooling system. The result is a layer of anions and cations that once settled on the surface of insulators present a prime opportunity for insulator failure.
