**IOEB Analysis Team Study on Recent Operating Experience
Ineffective Use of Vendor Technical Recommendations**
(public version)

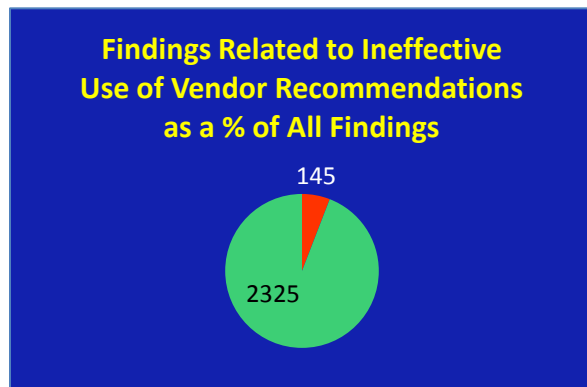
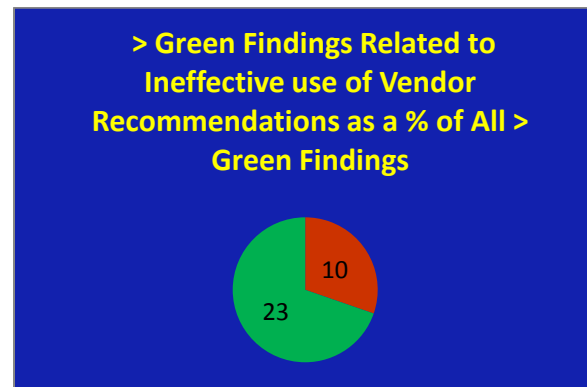
In an effort to categorize and trend the performance deficiencies and related findings that were considered, the staff observed the following characteristics of failures from the inspection data:

- Ineffective use of vendor recommendations has caused or contributed to the complexity of reactor trips/transients and failures in safety-related components,
- Their numbers appear to be relatively consistent in frequency and in severity,
- They are not limited to any particular component, system, or reactor type,
- They are typically accompanied by a cross cutting aspect,
- They have caused or contributed to performance indicators crossing the green-white Operformance threshold, and
- They have occurred at plants with good over performance.
