MODULE 3.0: FIRE HAZARDS AND FIRE PROTECTION CONCERNS AT FUEL CYCLE FACILITIES

Welcome to Module 3.0 of the Fire Protection for Fuel Cycle Facilities Directed Self-Study Course! This is the third of four modules in this self-study course. The purpose of this module is to identify fire hazards and fire protection concerns associated with the processes conducted at fuel cycle facilities. This self-study module is designed to assist you in accomplishing the learning objectives listed at the beginning of the module. There are eight learning objectives in this module. The module has self-check questions and activities to help you assess your understanding of the concepts presented in the module.

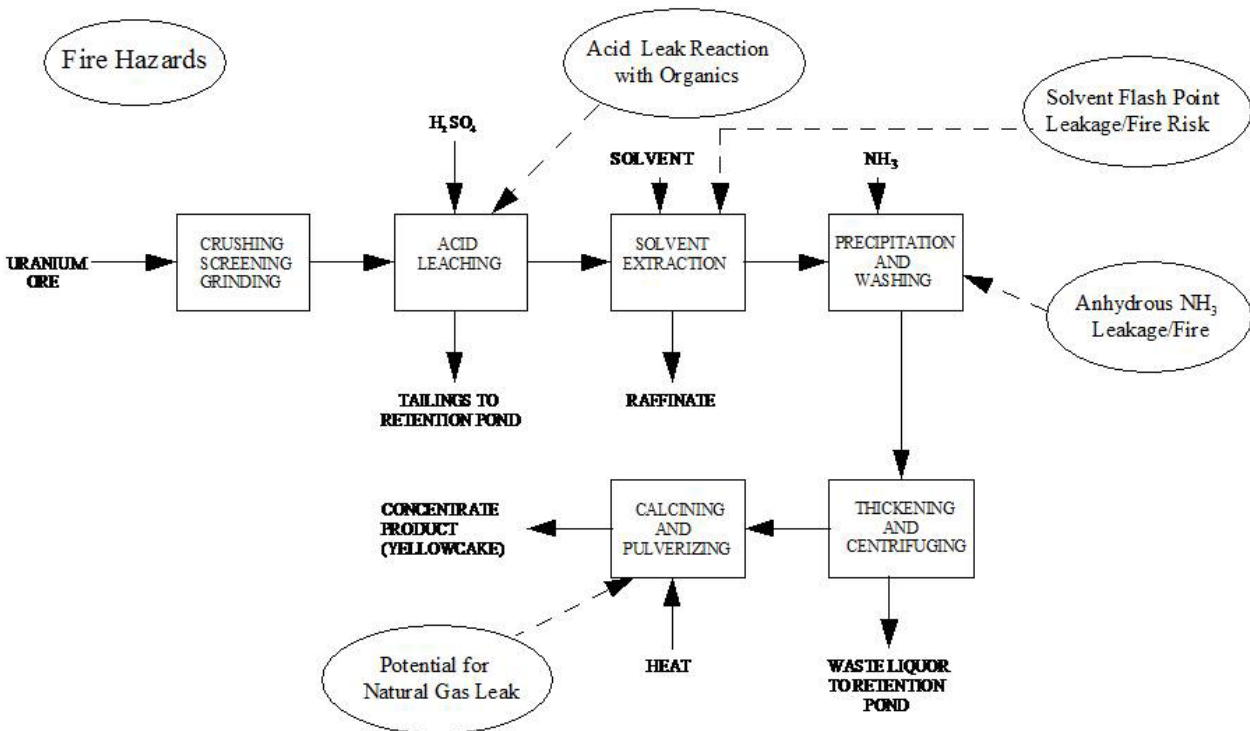
Figure 3-1. Uranium Mill Process Diagram

The ore is crushed and wet-ground in a rod or ball mill. It is then transferred as a slurry to leaching tanks. Most mills use a sulfuric acid leach process. Other mills use a sodium carbonate (alkaline) leach process. The product liquor of the acid leach process is pumped through a solvent extraction circuit, while that of the alkaline process is extracted through a sodium hydroxide solution. The uranium is further concentrated by precipitation with ammonia and centrifuging to separate the concentrate from the residual liquid. The concentrate is then calcined in a rotary furnace at temperatures ranging from 900°F to 1300°F and pulverized to form the end product, yellowcake. See Figure 3-1.

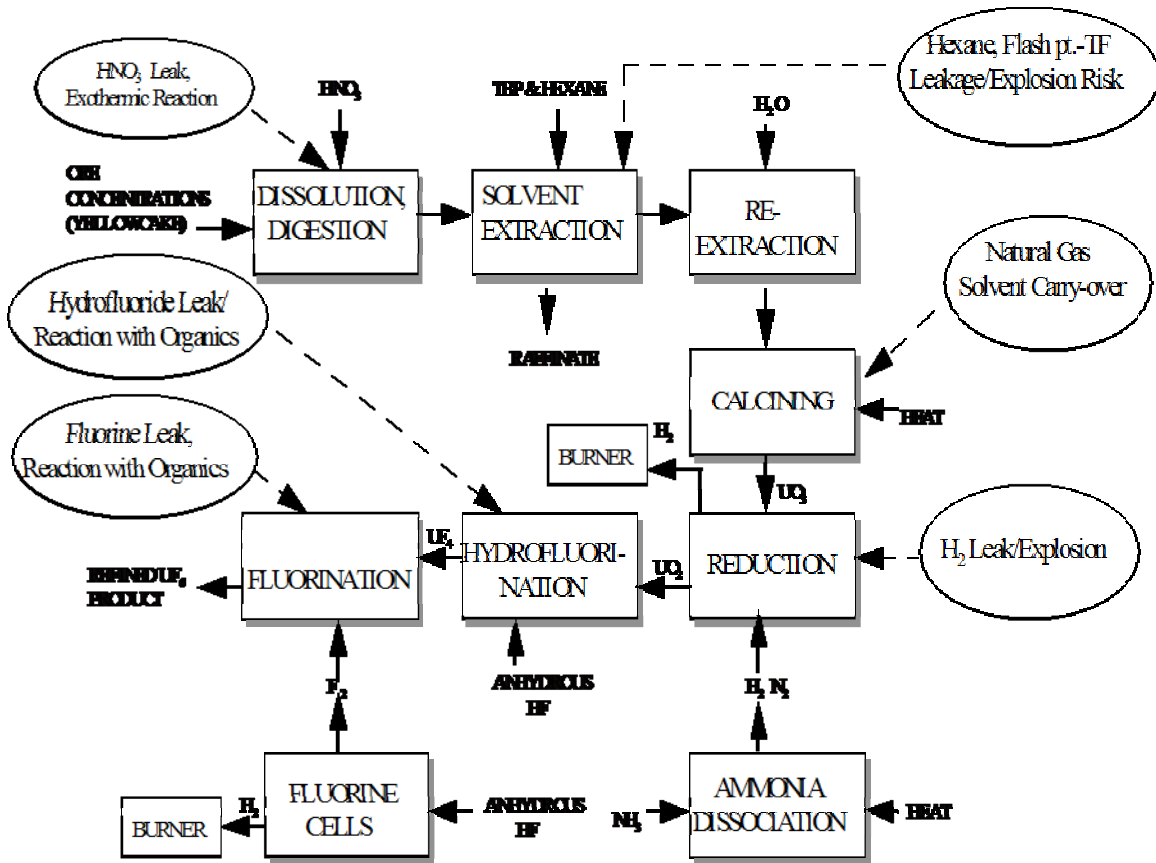
Figure 3-2. Solvent Extraction Process

The solvent extraction process consists of digestion of the feed in nitric acid and a wet chemical solvent extraction step at the beginning of the process followed by reduction, hydrofluorination, and fluorination. See Figure 3-2. Solvent extraction processes are dominant overseas, while the dry fluoride process is dominant domestically.

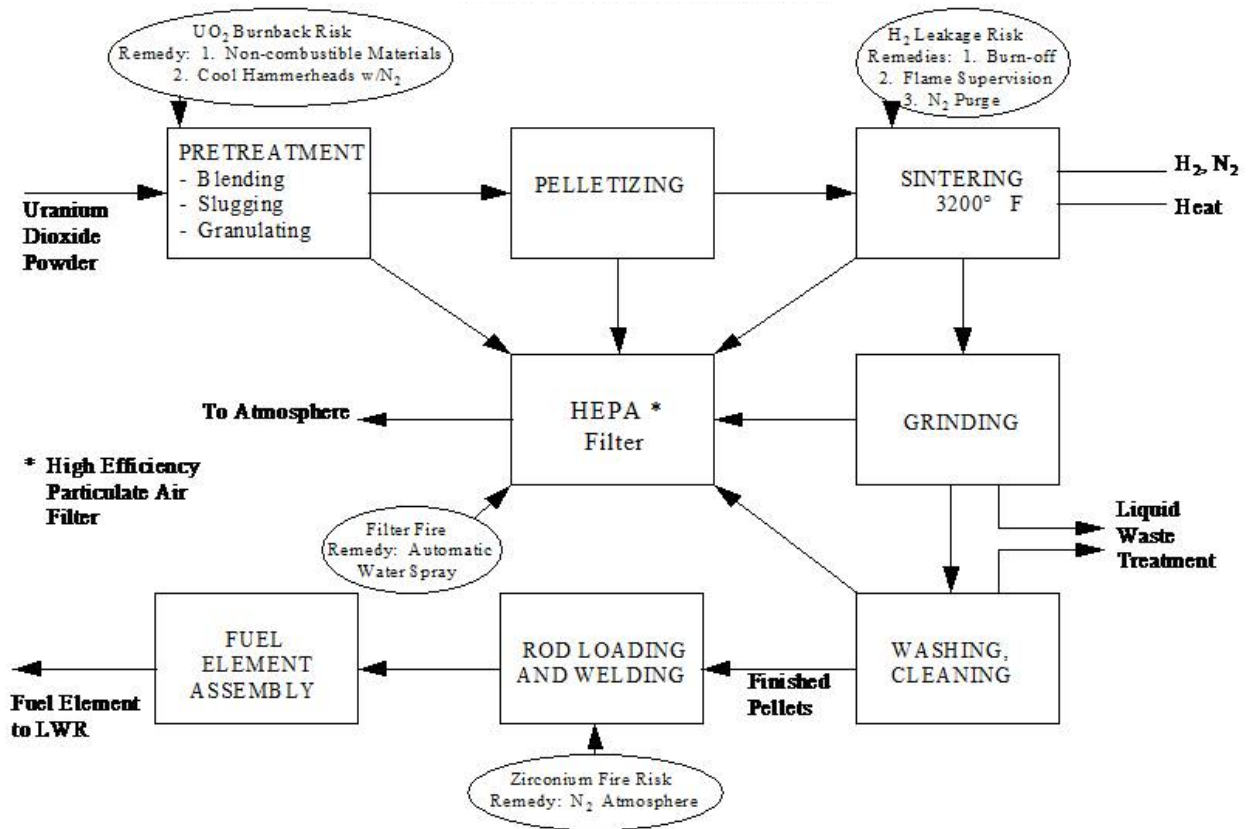
Figure 3-9. Fuel Fabrication Block Diagram

Figure 3-9 indicates areas of fire concern in a fuel fabrication block diagram.
