Office of Nuclear Regulatory Research Division of Risk Analysis Fire Research Branch

Development of Metric Monitoring Methodologies

September 27th, 2011

By: N. Melly K. Hill

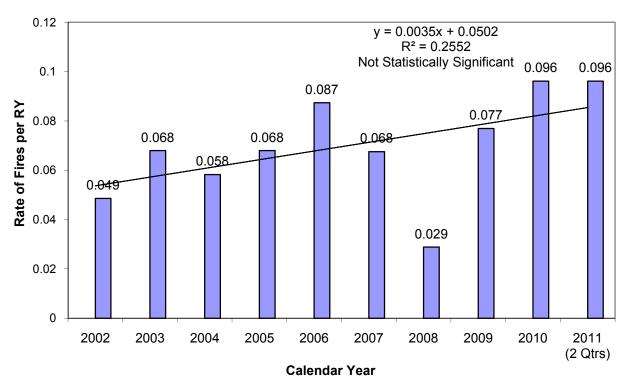
Significant Fires per Reactor Year

Figure 1: Number of Significant Fires Reported per Reactor Year 2002-2011

Figure 1 shows the rate of significant fires per reactor year by calendar year between 2002 and 2011, normalized by the number of operating plants and reactor years and represents *significant fires* reported under the 10 CFR 50.72 and 50.73. Based on Figure 1, between 2002 and 2011 there is no apparent trend to determine the effectiveness of the fire protection regulations. Figure 1 takes a narrow view of the fire frequency for the last 10 years to see if there have been any significant trends surfacing throughout the plants. There have been no significant changes to reporting criteria in this timeframe which RES believes would skew the data in any significant manor. Along with this narrow view approach, more research has been conducted by RES to determine if the number of reportable fires has changed as a result of major refinements to the regulations promulgated in the 1980s. Based on Figure 3, between 1985 and 2011 there is a statistically significant, downward trend in the incidences of reported, significant fires. Statistical methods used to evaluate trends were taken from the NRC Industry Trends Program. The reference is available in Inspection Manual Chapter (IMC) 0313, "Industry Trends Program" (Ref. 3) and on the NRC web site (NRC Industry Trends Program Web Site). http://www.nrc.gov/reactors/operating/oversight/industry-trends.html

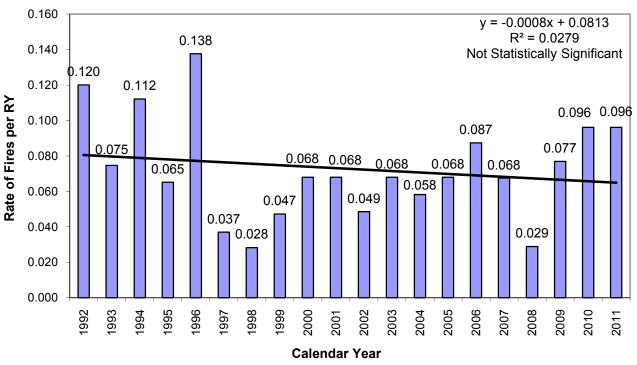
Significant Fires per Reactor Year

Figure 2: Number of Significant Fires Reported per Reactor Year 1992-2011

To report the results, the number of plant fires that occurred in prior 12 months that met the 10 CFR 50.72/73 reporting threshold and the criteria for "significant fires" (described above) were normalized by the number of operating reactors (Fire Events). The overall result of the data collection for the last 10 year period is that the rate of fire events is increasing slightly, but the trend is not statistically significant. ($R^2 < .399$, n = 10, 95% confidence Figure 1). The overall result for the data collection for the last 20 year period indicates a slightly improving (not statistically significant) trend ($R^2 < .197$, n = 20, 95% confidence Figure 2). The data collection

for the last 27 year period indicates a statistically significant improving trend. ($R^2 > .157$, n = 27, 95% confidence Figure 3). The change in fire event trending can be clearly is lustrated by comparing Figures 2 and 3. There appears to be a downward trend in significant fire events. RES will continue to compile data for time periods predating 1985 in order to evaluate any possible trends which arise.

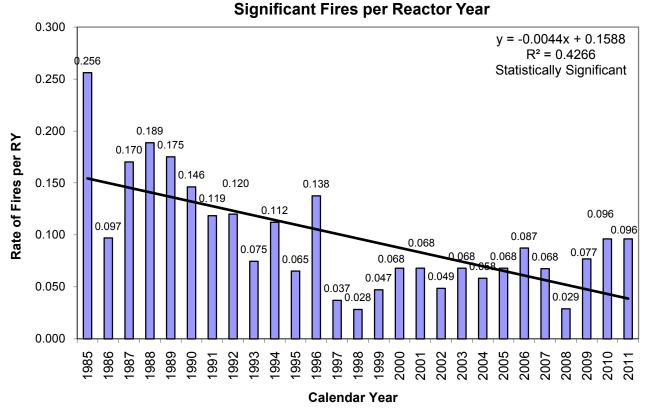
Figure 3: Number of Significant Fires Reported per Reactor Year 1985-2011

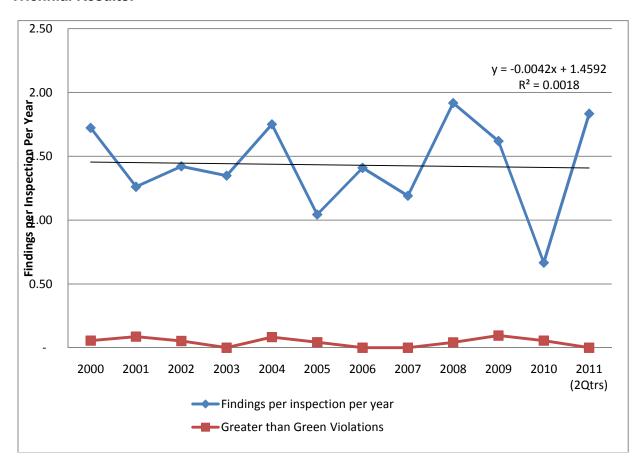
Figure 4: Triennial Fire Protection Findings Normalized per Year

Figures 4 and 5 show the results of the fire protection inspection findings data collection process. Refer to Appendix B for the complete set of data for all inspections.

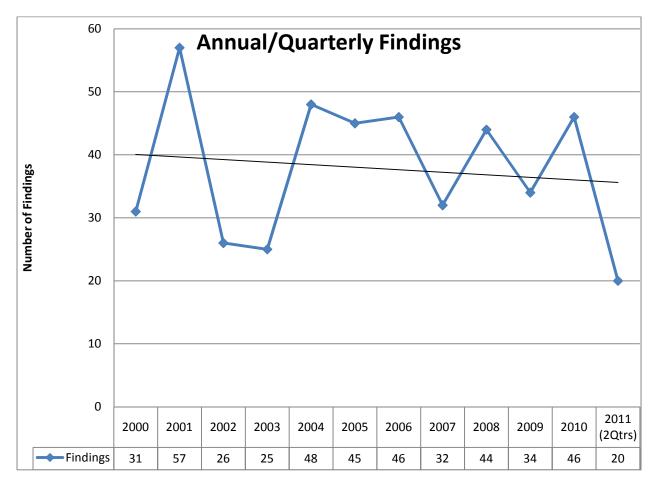
Figure 4: Annual/Quarterly Fire Protection Findings Normalized per Year

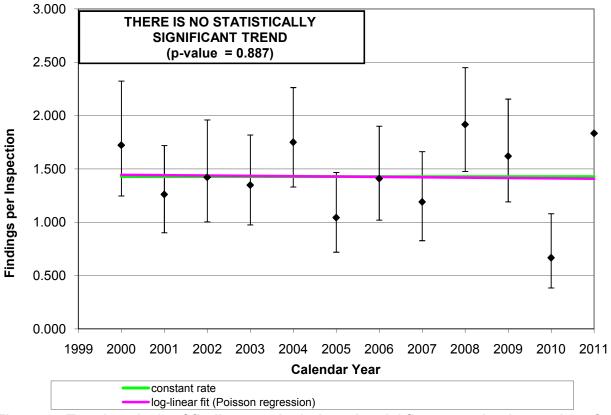
Results of Triennial Inspections

Figure 5: Trend analysis of findings made during triennial fire protection inspections for the period 2000-2011.

The results of the trend analysis for the triennial fire protection inspections are shown in Figure 5. The fitted values of *a* and *b* are 0.3729 and -0.0023, respectively. Analysis indicates that there is no statistically significant trend for the findings noted during the triennial fire protection inspections (p-value of 0.887). The values for 2011 are uncertain due to the reporting time lag for inspections. The values currently in use are those which were publically available on September 1st 2011.

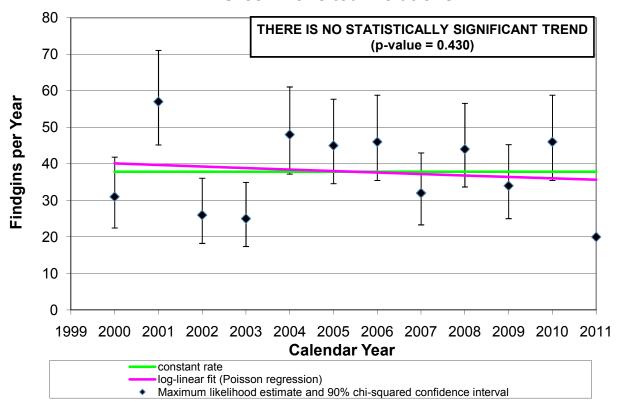
Results of Quarterly Inspections Green Noncited Violations

Figure 6: Trend analysis of findings noted during quarterly fire protection inspections for the period 2000-2011.

The results of the trend analysis for the quarterly fire protection inspections are shown in Figure 6. The fitted values of *a* and *b* are 3.661 and -0.0013, respectively. Analysis indicates that there is no statistically significant trend for the findings made during the annual/quarterly fire protection inspections (p-value of 0.4304). The values for 2011 are uncertain due to the reporting time lag for inspections. The values currently in use are those which were publically available on September 1st 2011.
